State F-1 #17
(1RP-3214)

Termination Request

**RE: Termination Request
ConocoPhillips State F-1 #17 (1RP-3214)
UL/R sec. 1 T21S R36E
API No. 30-025-38429**

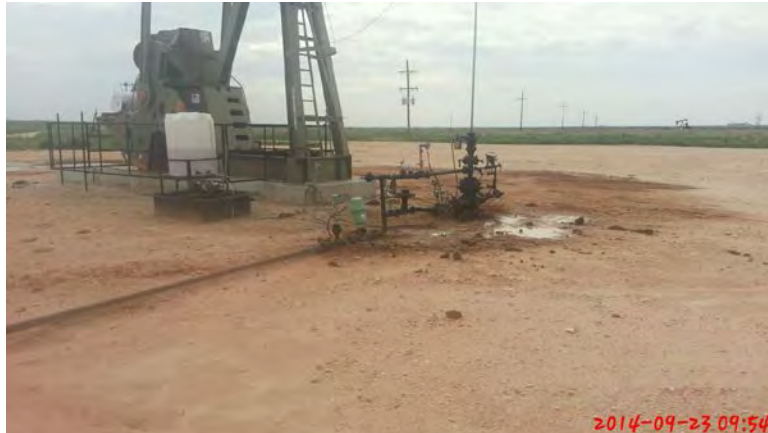
Initial release area, facing southeast

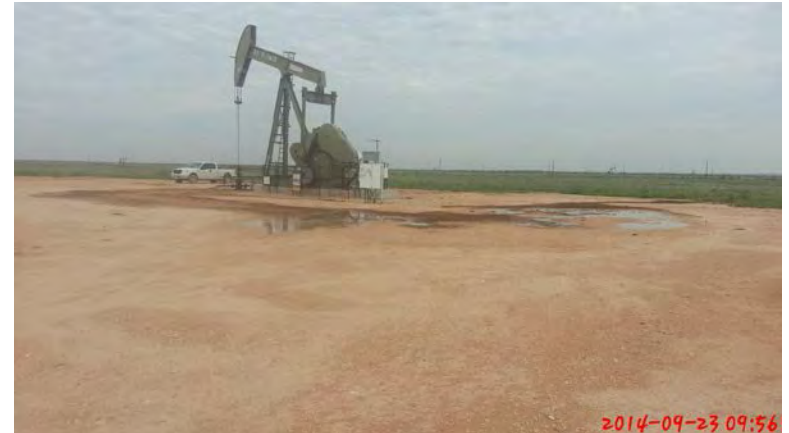
Initial release area, facing northwest

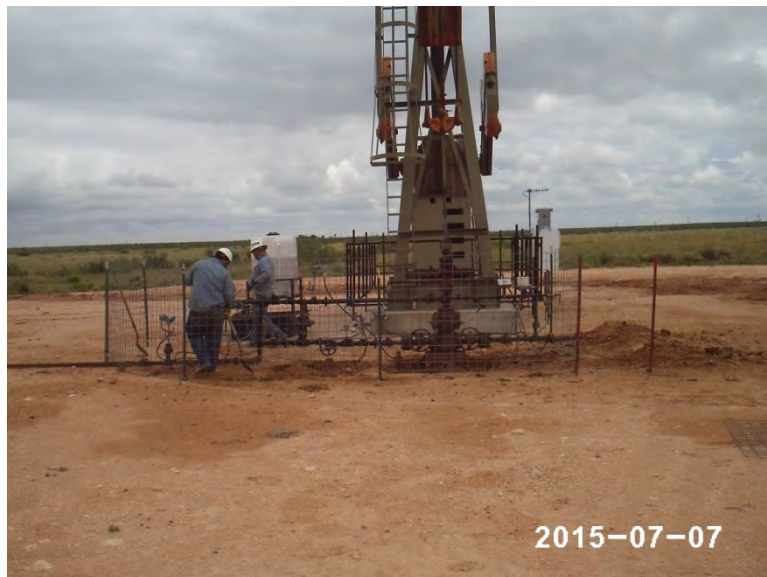
Scraping release, facing east

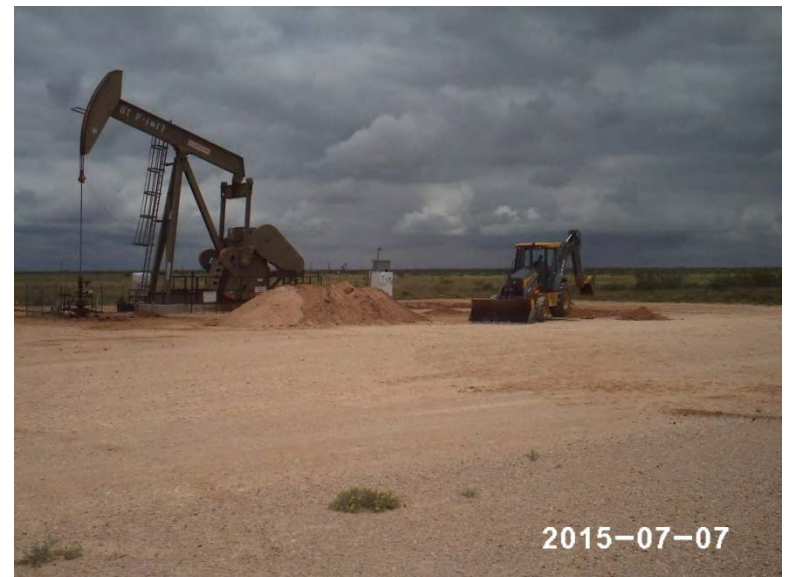
Scraping release, facing northeast

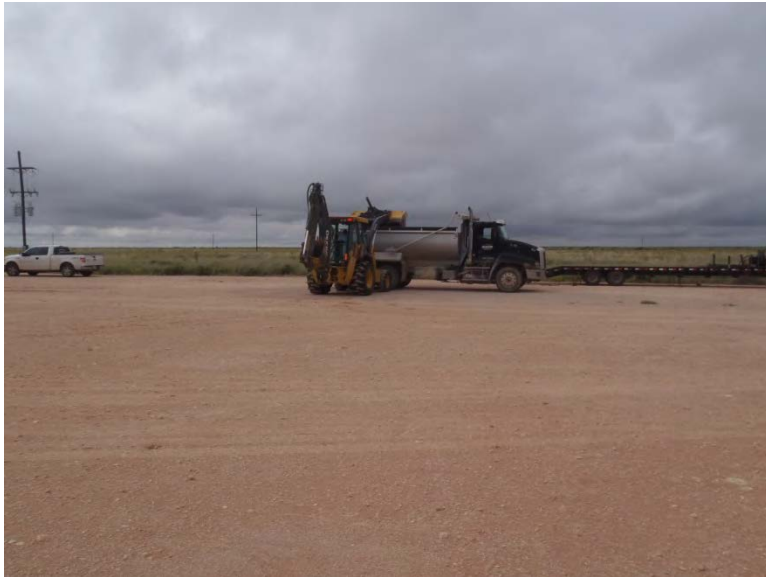
Exporting soil, facing east

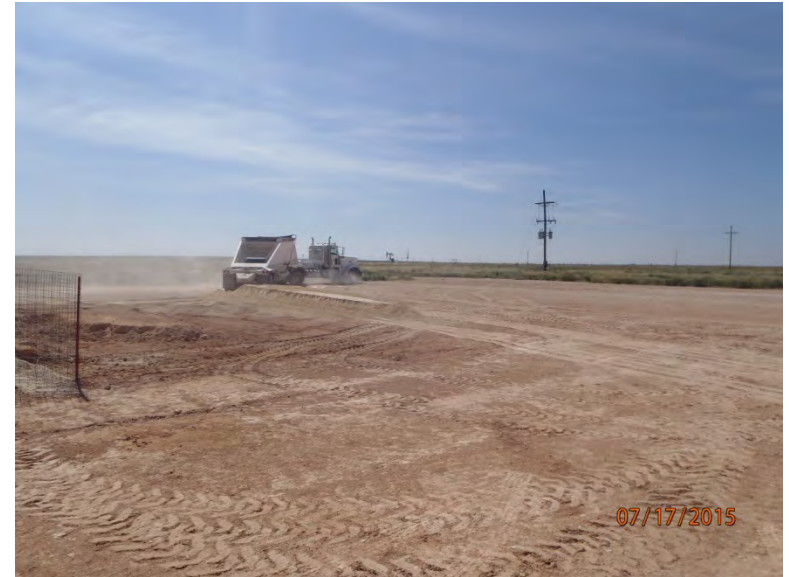
Importing caliche, facing southeast

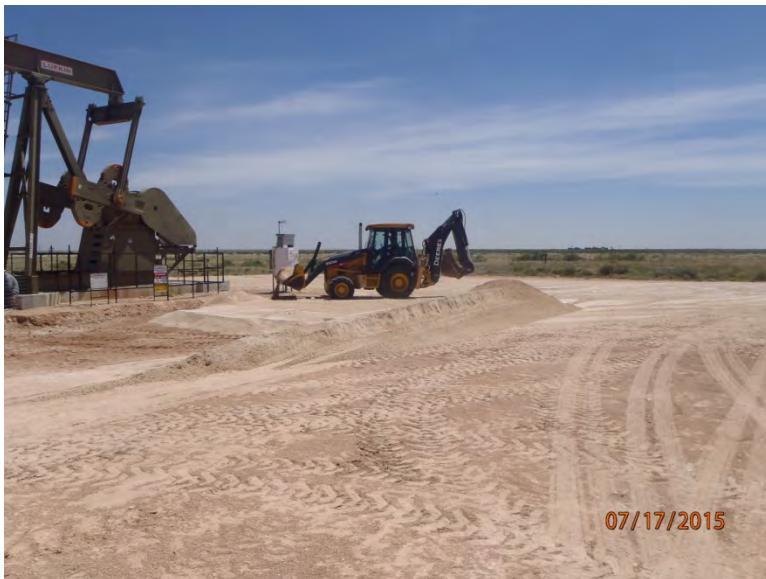
Backfilling scrape, facing northeast

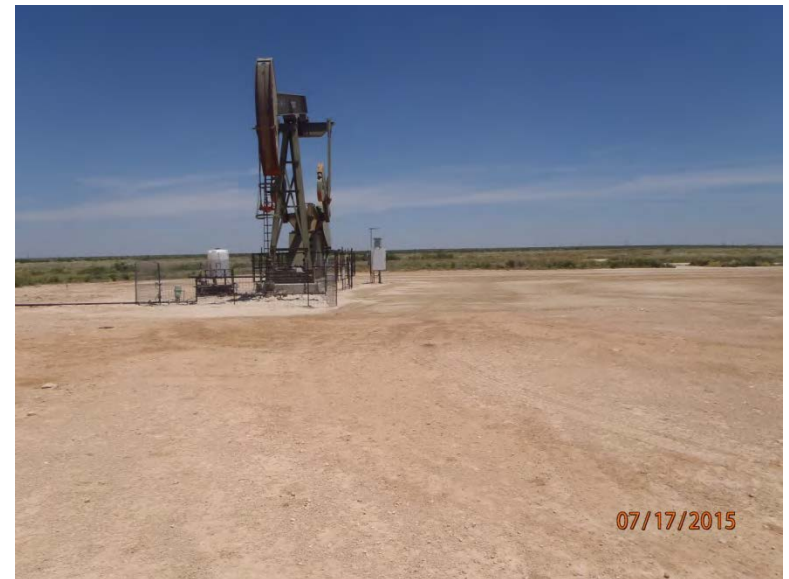
Completed site, facing east

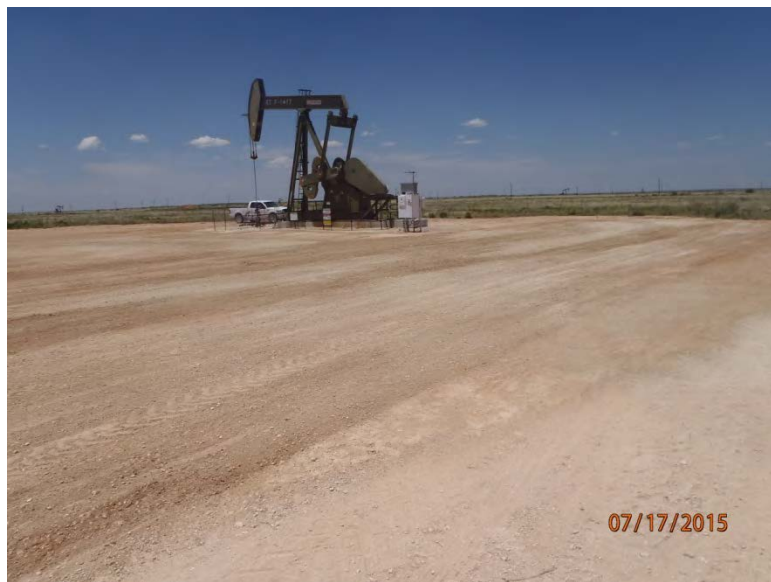
Completed site, facing northwest

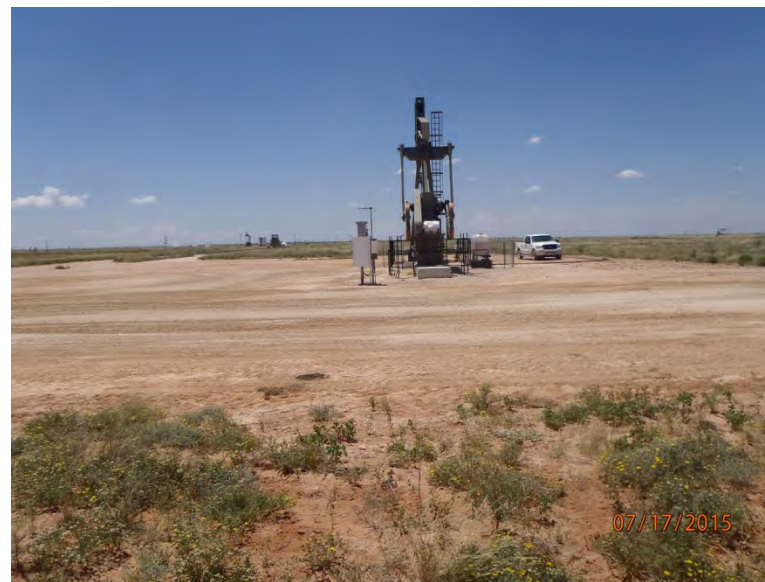
Completed site, facing west
