VGEU Well 02-27

1RP-3116

Termination Request

**RE: Termination Request
ConocoPhillips VGEU 02-27 (1RP-3116)
UL/G sec. 32 T17S R35E
API No. 30-025-3**

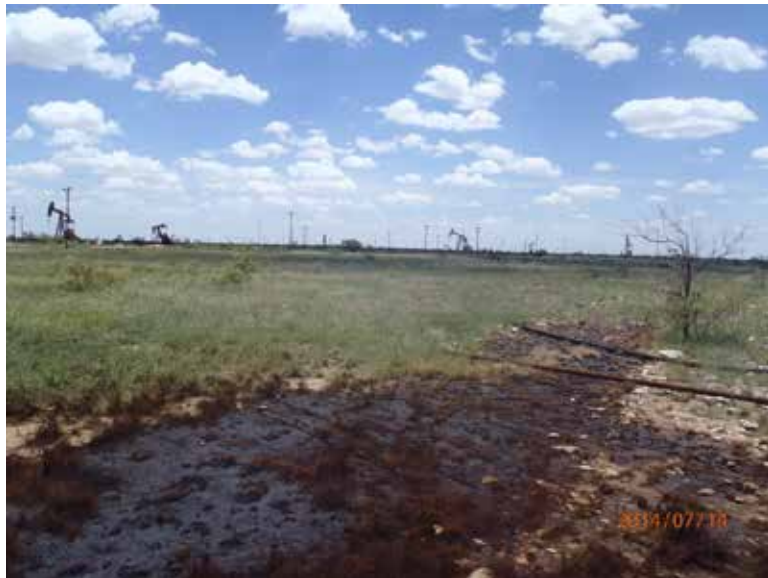
Initial release area, facing southeast

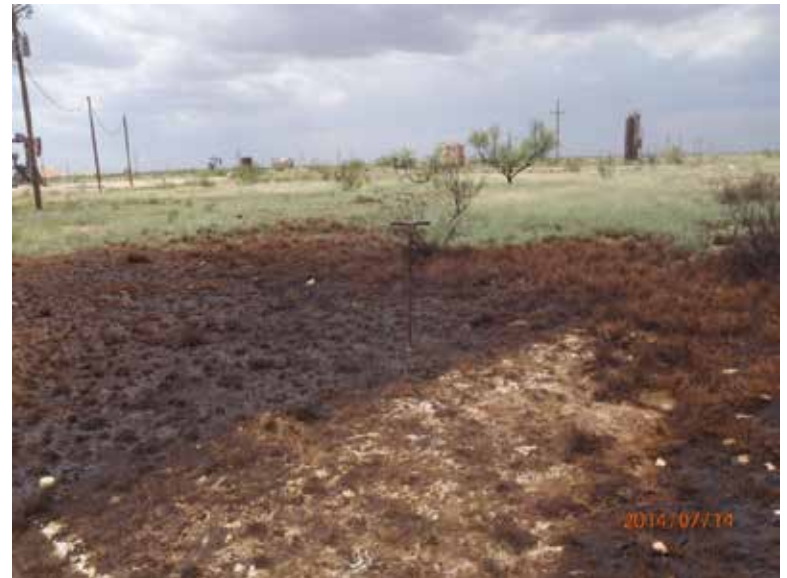
Initial release area, facing northwest

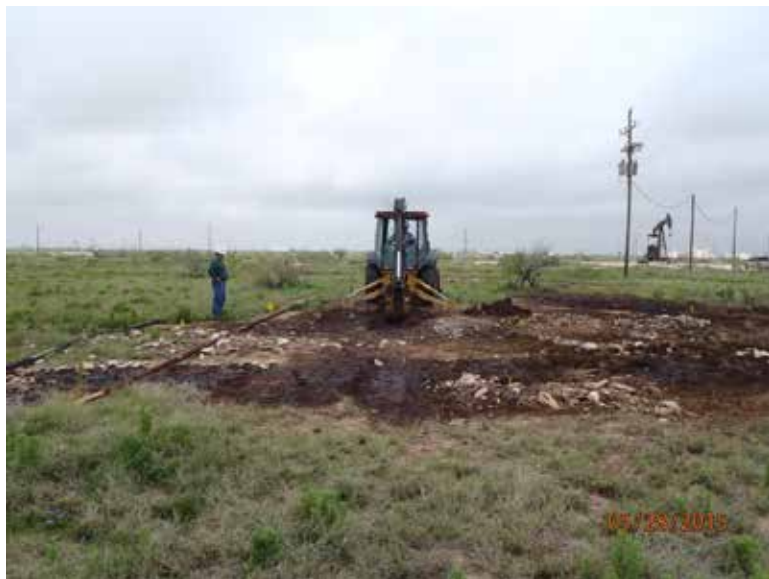
Excavating release, facing west

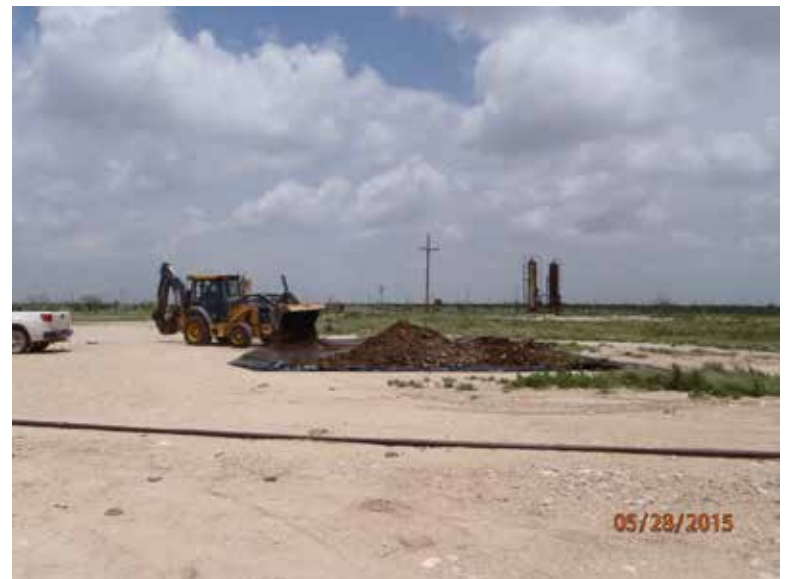
Building spoil pile, facing north

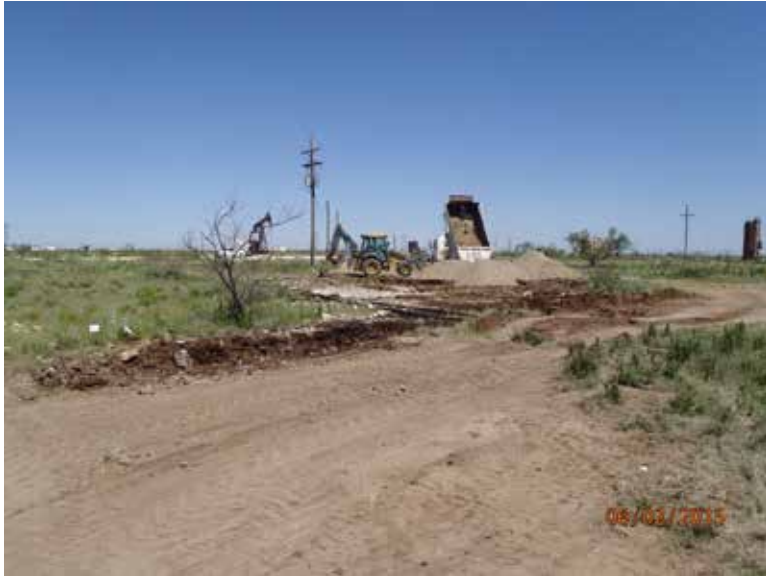
Importing top soil, facing northwest

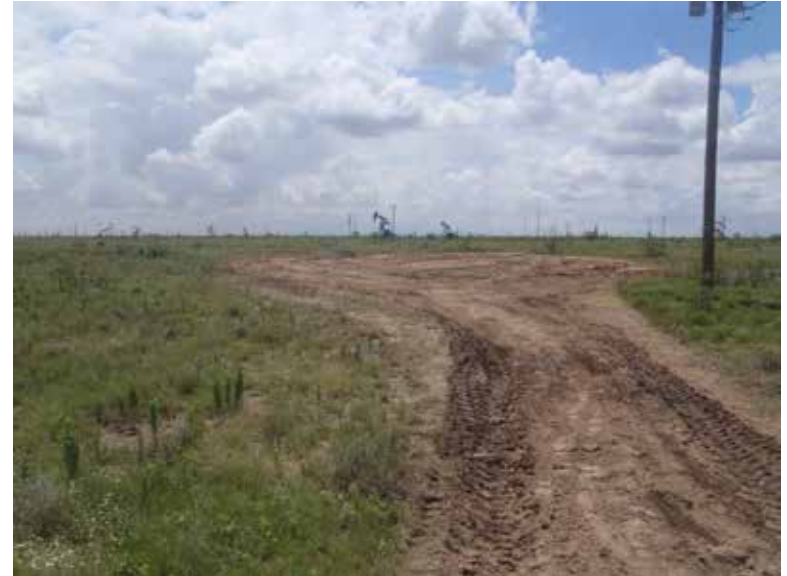
Backfilled excavation, facing southeast

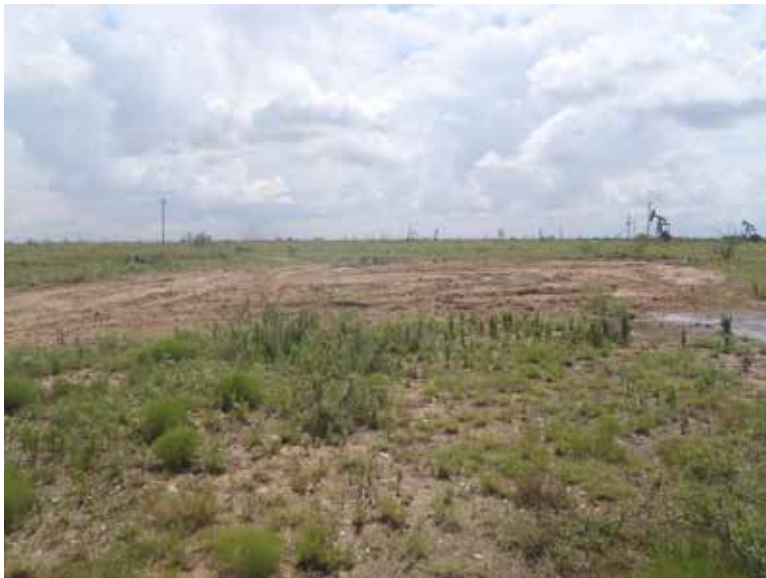
Backfilled excavation, facing east

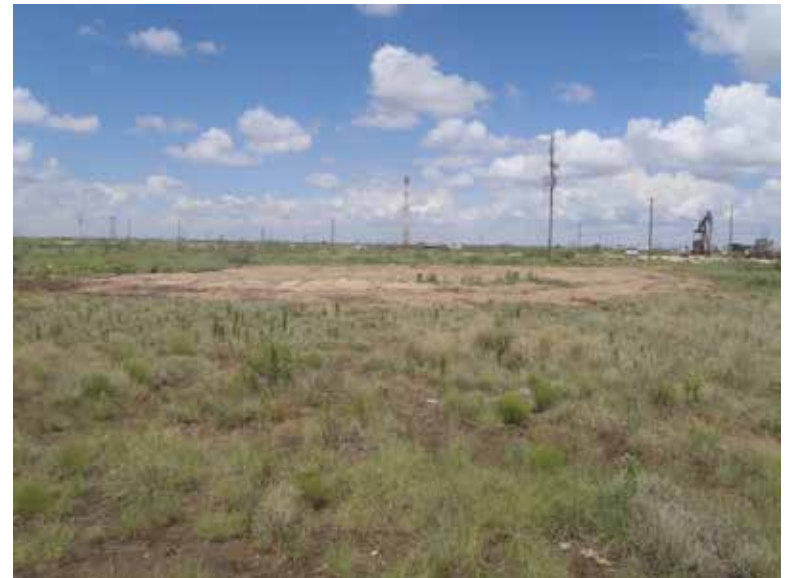
Completed site, facing west
