EVGSAU 2622-002
(1RP-3396)

Termination Request

**RE: Termination Request
ConocoPhillips EVGSAU 2622-002 (1RP-3396)
UL/G sec. 26 T17S R35E
API No. 30-025-26573**

ConocoPhillips EVGSAU 2622-002

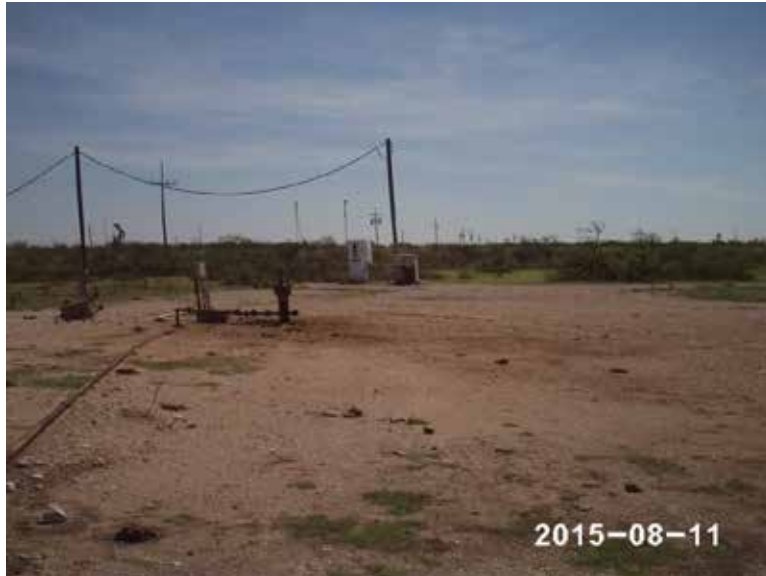
Initial release area, east

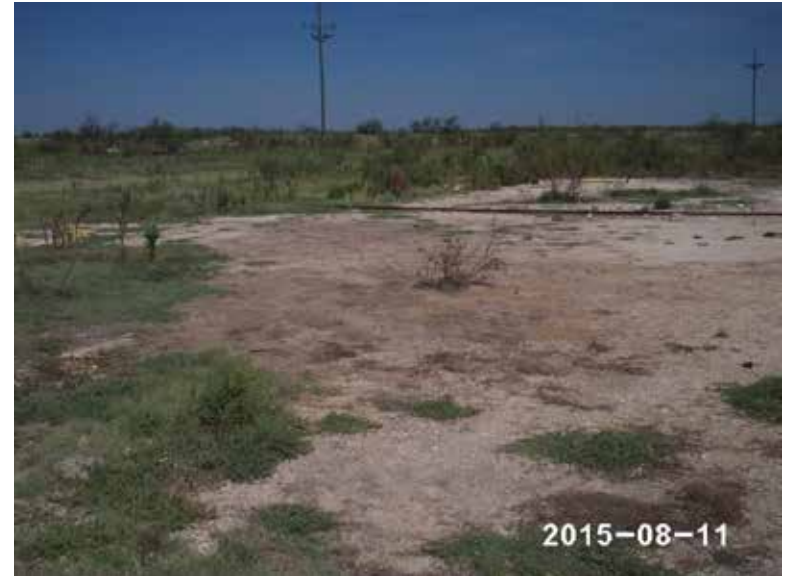
Initial release area, facing west

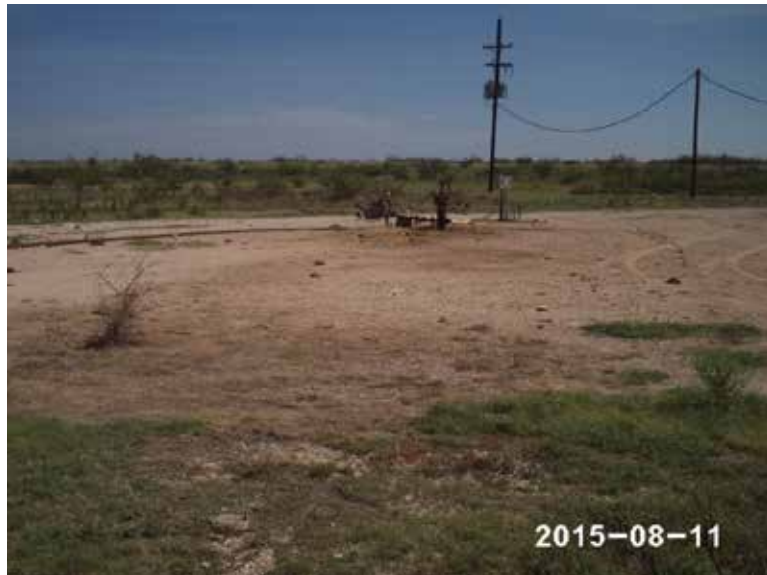
Initial release area, facing north

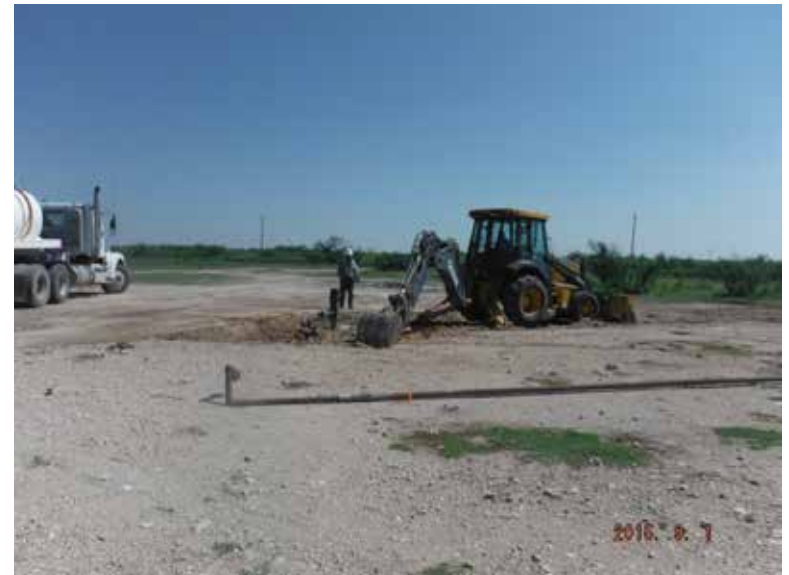
Excavating to 1.5', facing south

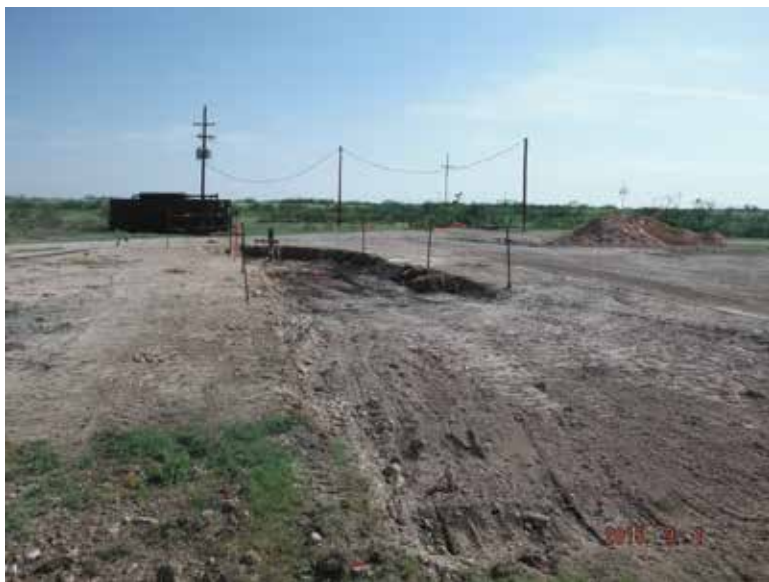
Excavation completed, facing north

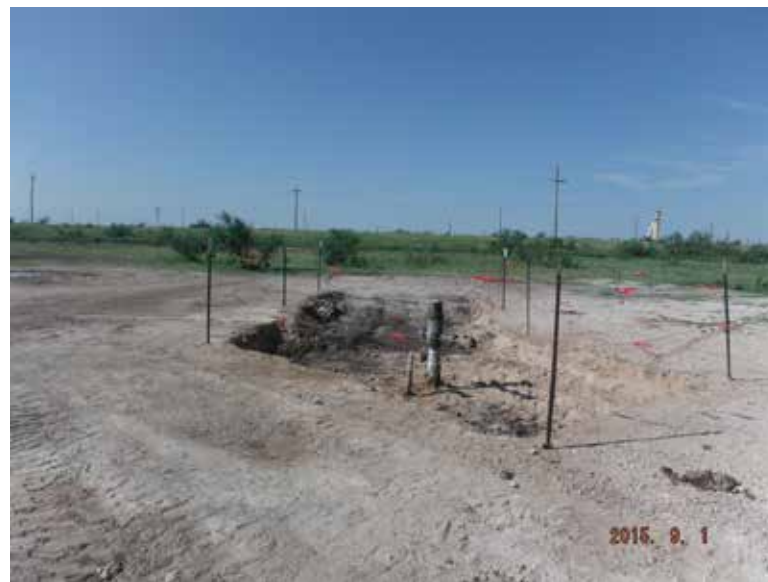
Excavation completed, facing south

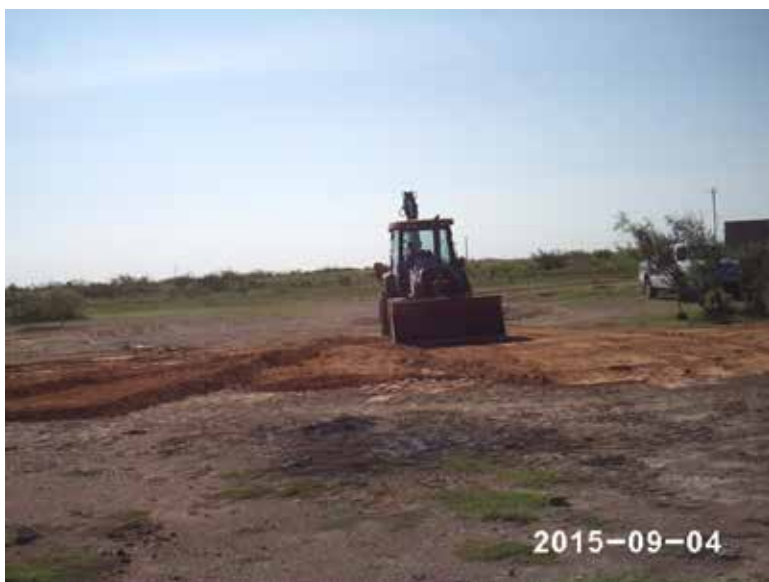
Backfilling site, facing south

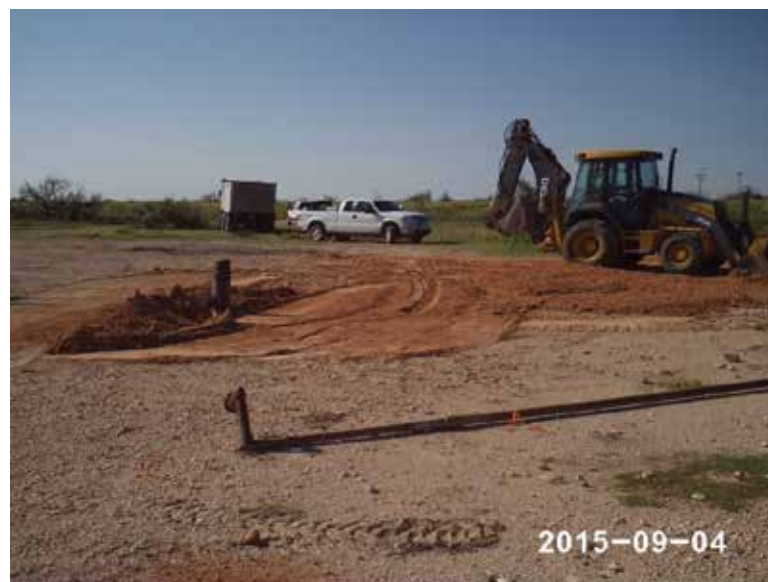
Backfilling site, facing southwest

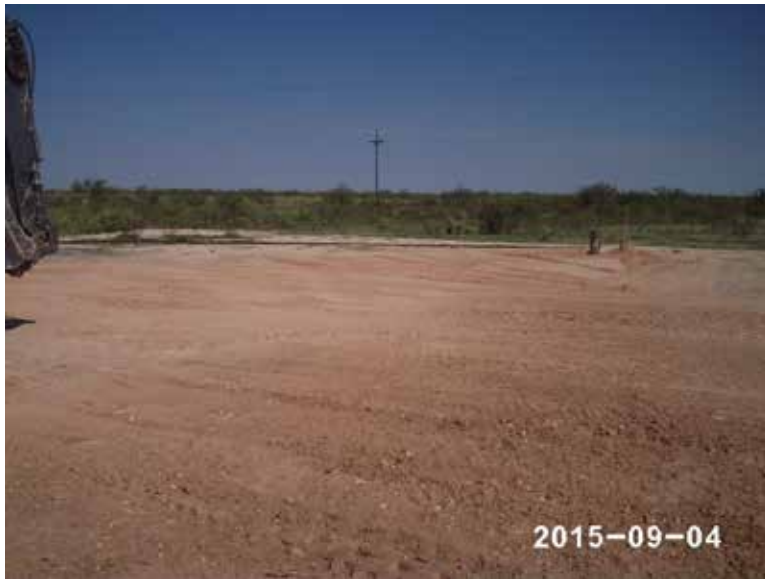
Site completed, facing north

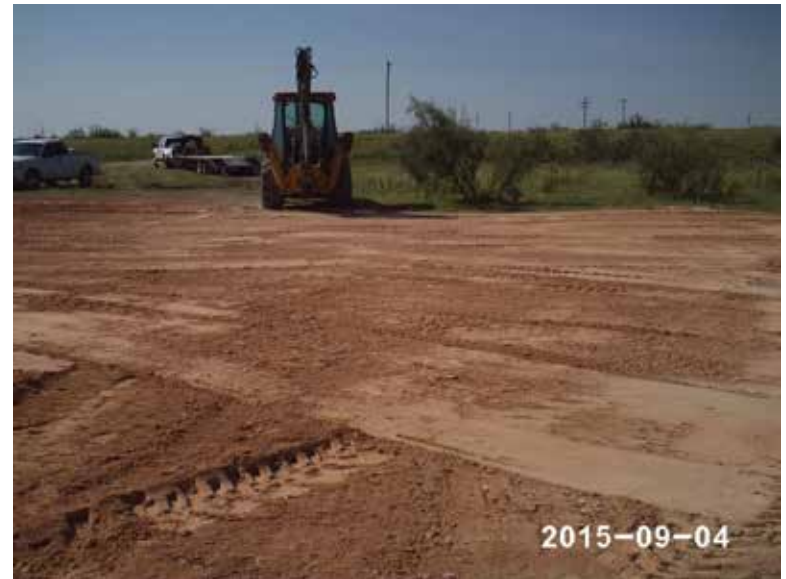
Site completed, facing southwest
