SEMU Permian Battery (1RP-3139)

Termination Request

**RE: Termination Request
ConocoPhillips SEMU Permian Battery (1RP-3139)
UL/K sec. 19T20S R38E
API No. 30-025-07820**

Excavation Map

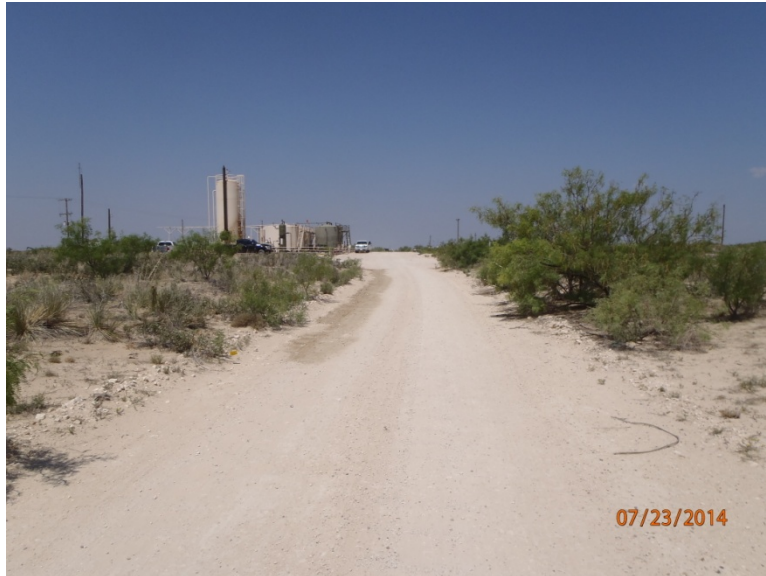
7/23/14

Initial release area, facing west

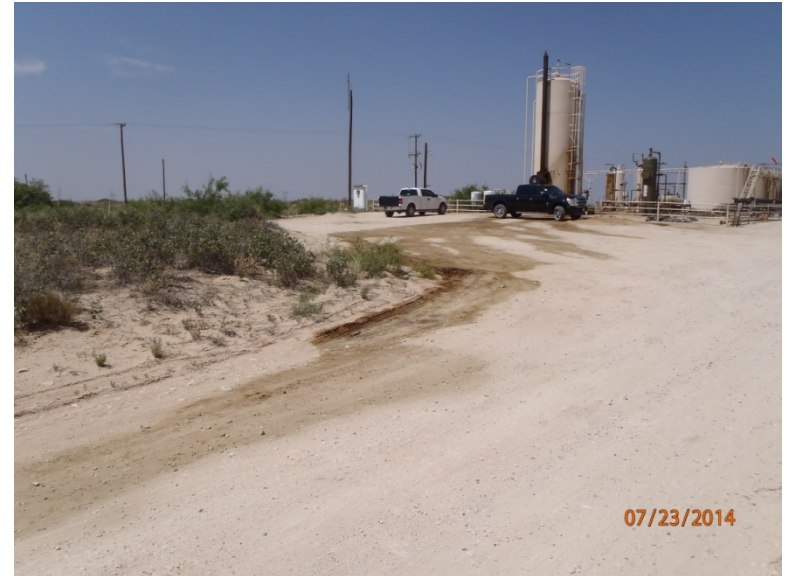
7/23/14

Initial release area, facing southwest

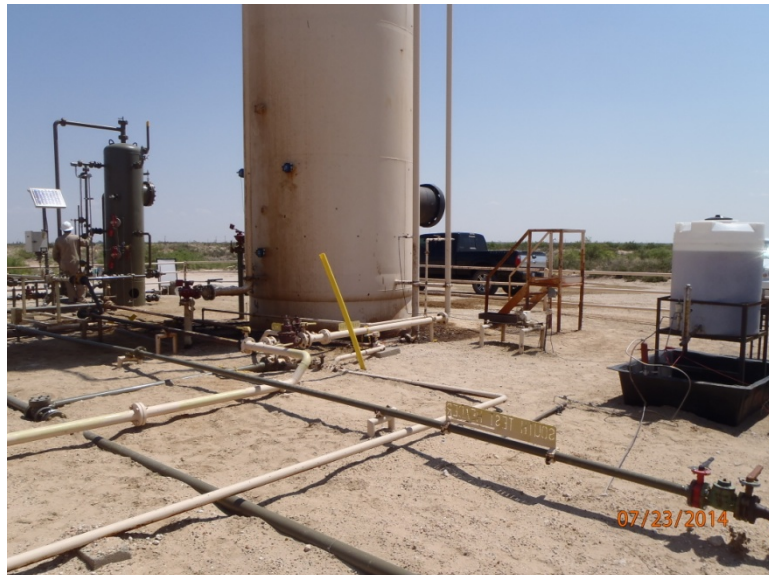
7/23/14

Initial release area, facing northeast

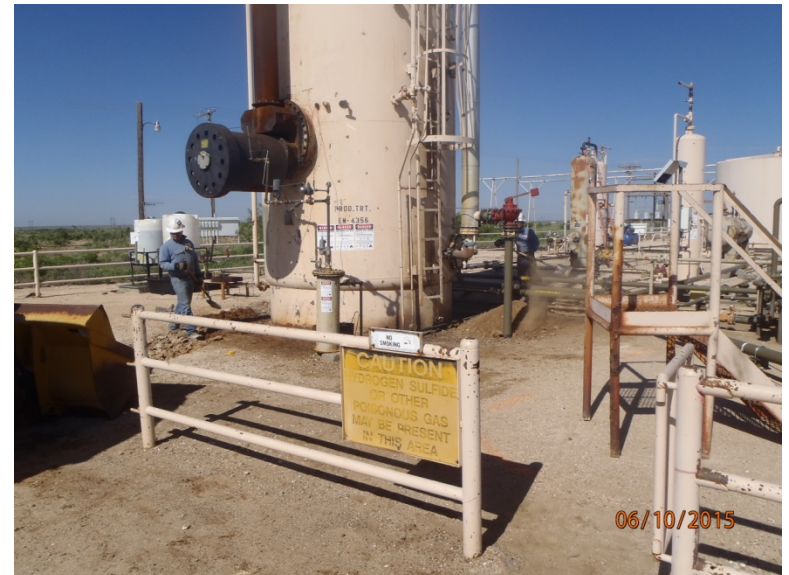
6/10/15

Scraping release, facing southwest

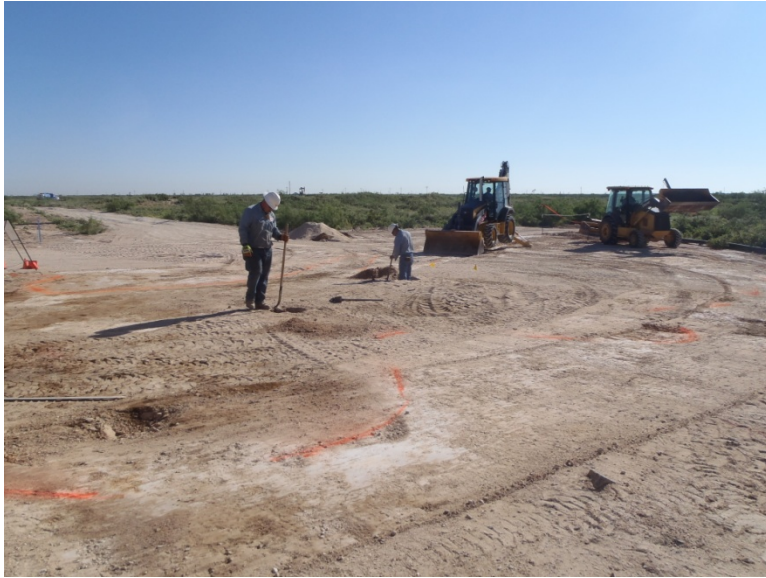
6/11/15

Scraping release, facing northeast

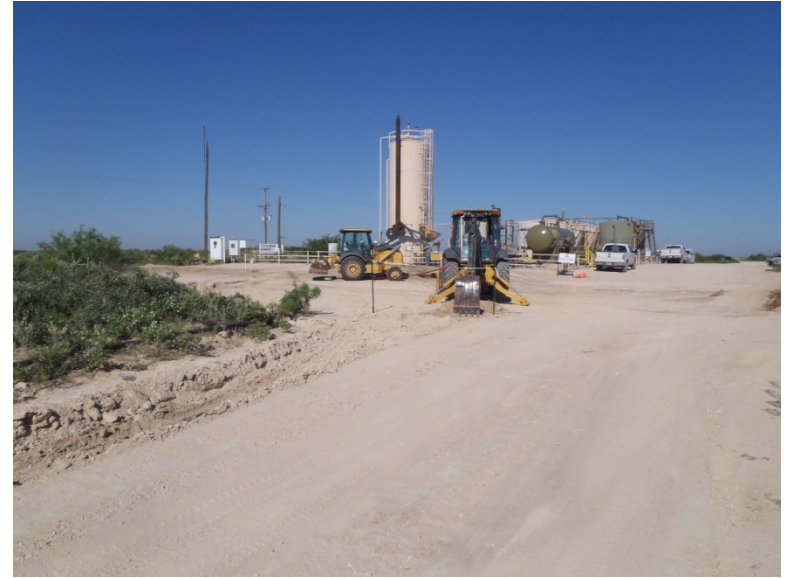
6/11/15

Scraping release, facing southwest

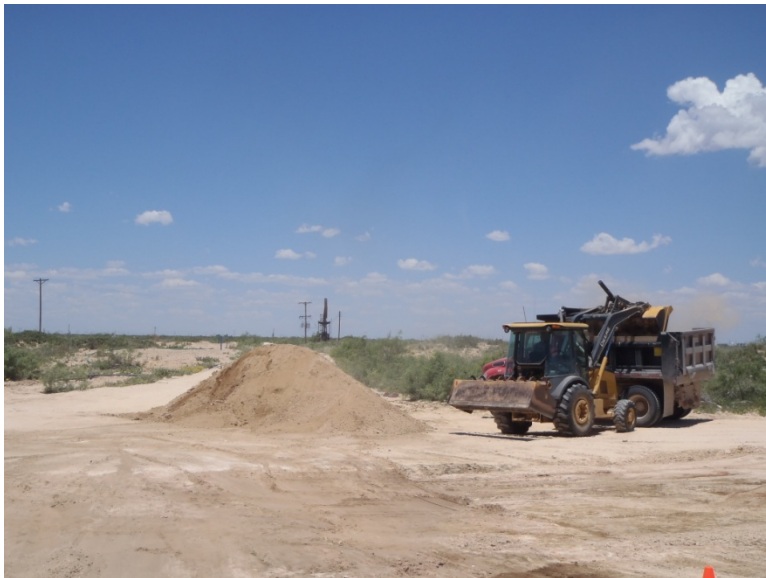
6/11/15

Exporting soil, facing north

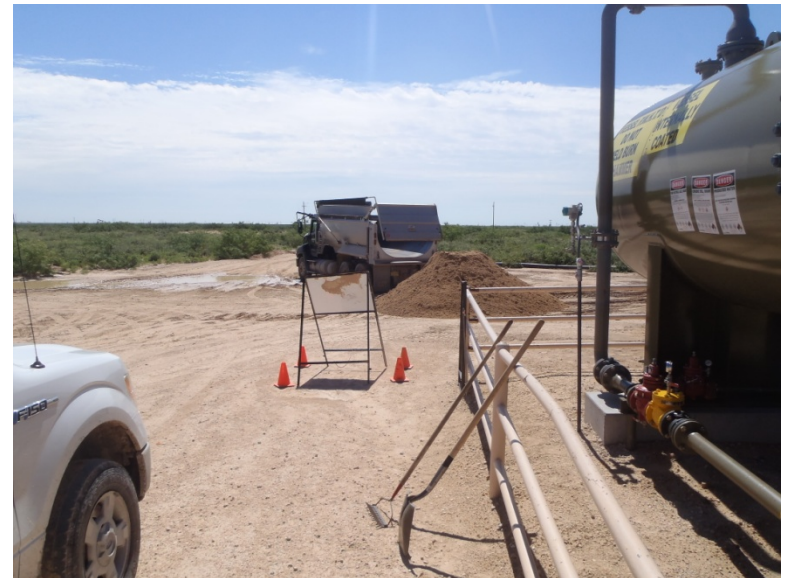
6/5/15

Importing caliche, facing east

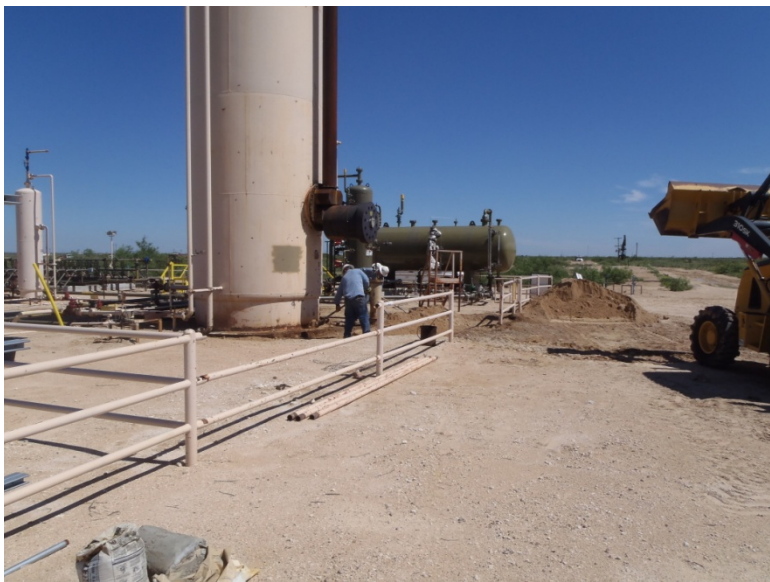
6/15/15

Backfilling, facing northwest

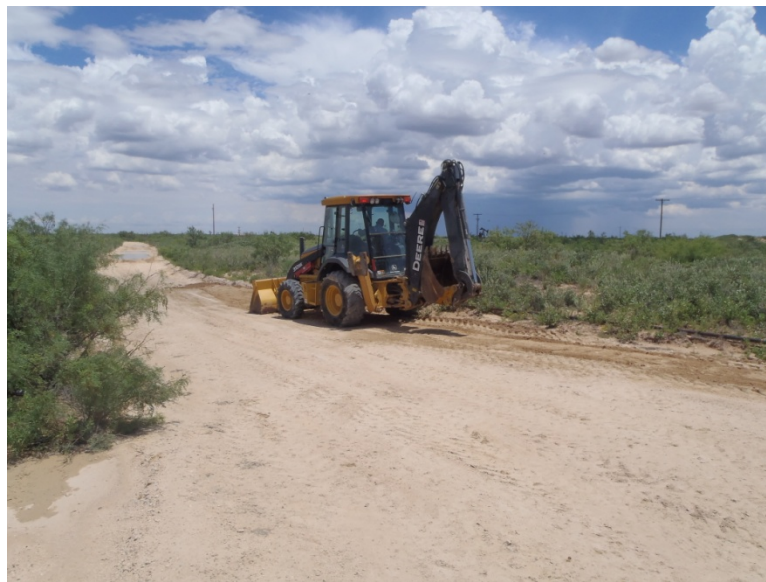
6/15/15

Backfilling, facing southeast

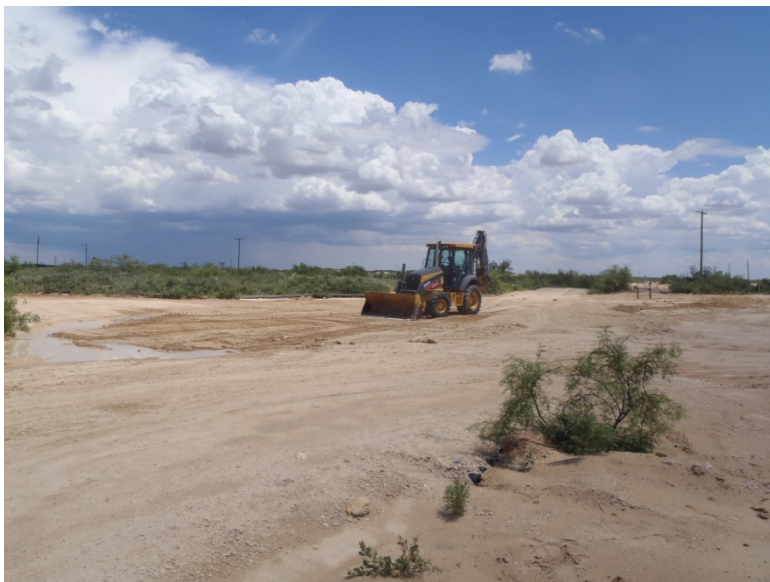
6/15/15

Backfilling, facing southeast

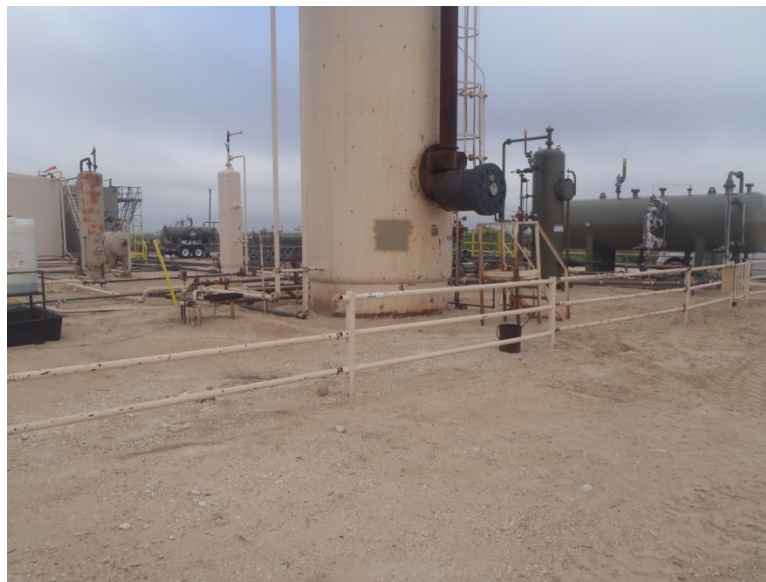
6/16/15

Completed site, facing northwest

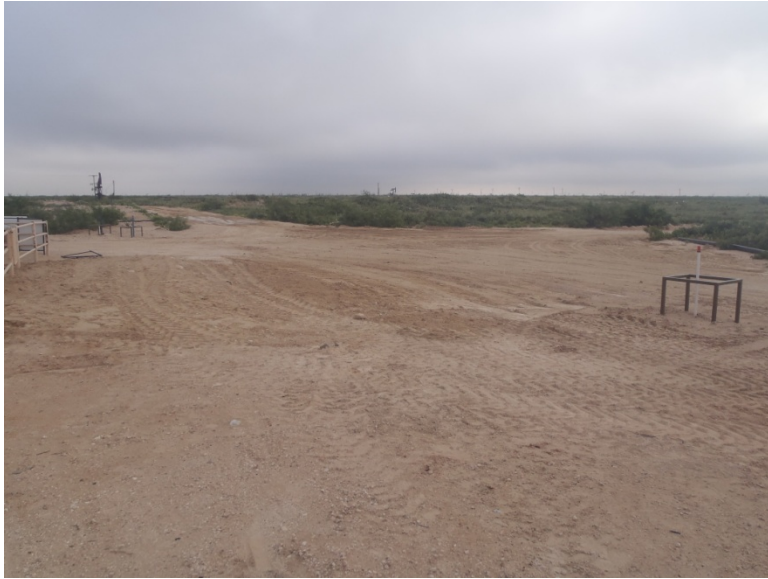
6/16/15

Completed site, facing northeast

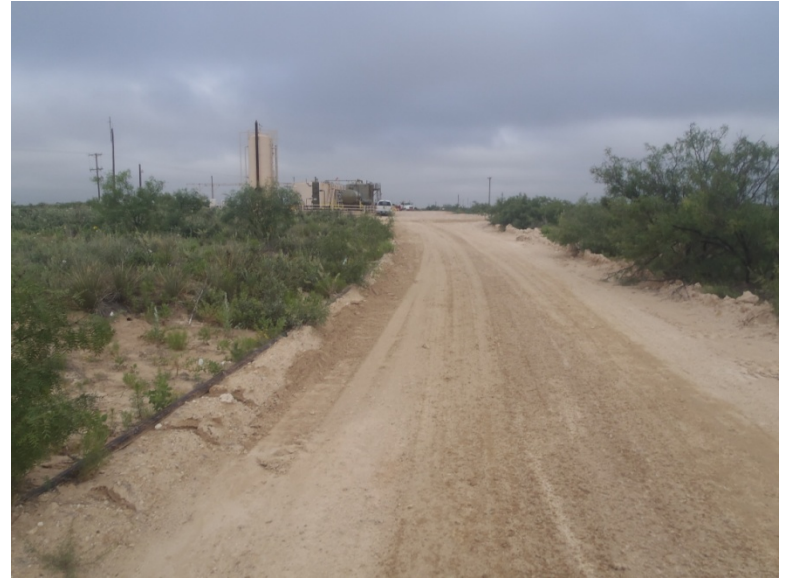
6/16/15

Completed site, facing west
