Re: West Dollarhide Drinkard Unit No. 148, RP # 10-52512
Vacuum Grayburg San Andres Unit No. 250

- Site Closure Report, Chevron West Dollarhide Drinkard Unit # 148, Section 31 (Unit I), Township 24 South, Range 38 East, Lea County, NM, RP# 10-5-2512 (Final Form C-141 also included with report)
- Pit Closure Report (As attachment to Form C-144), Vacuum Grayburg San Andres Unit #250, API #30-025-38001, Unit Letter H, Section 1, Township 18 South, Range 24 East, Lea County, New Mexico

PHOTOGRAPH LOG
Chevron West Dollarhide Drinkard Unit#148
Lea County, New Mexico

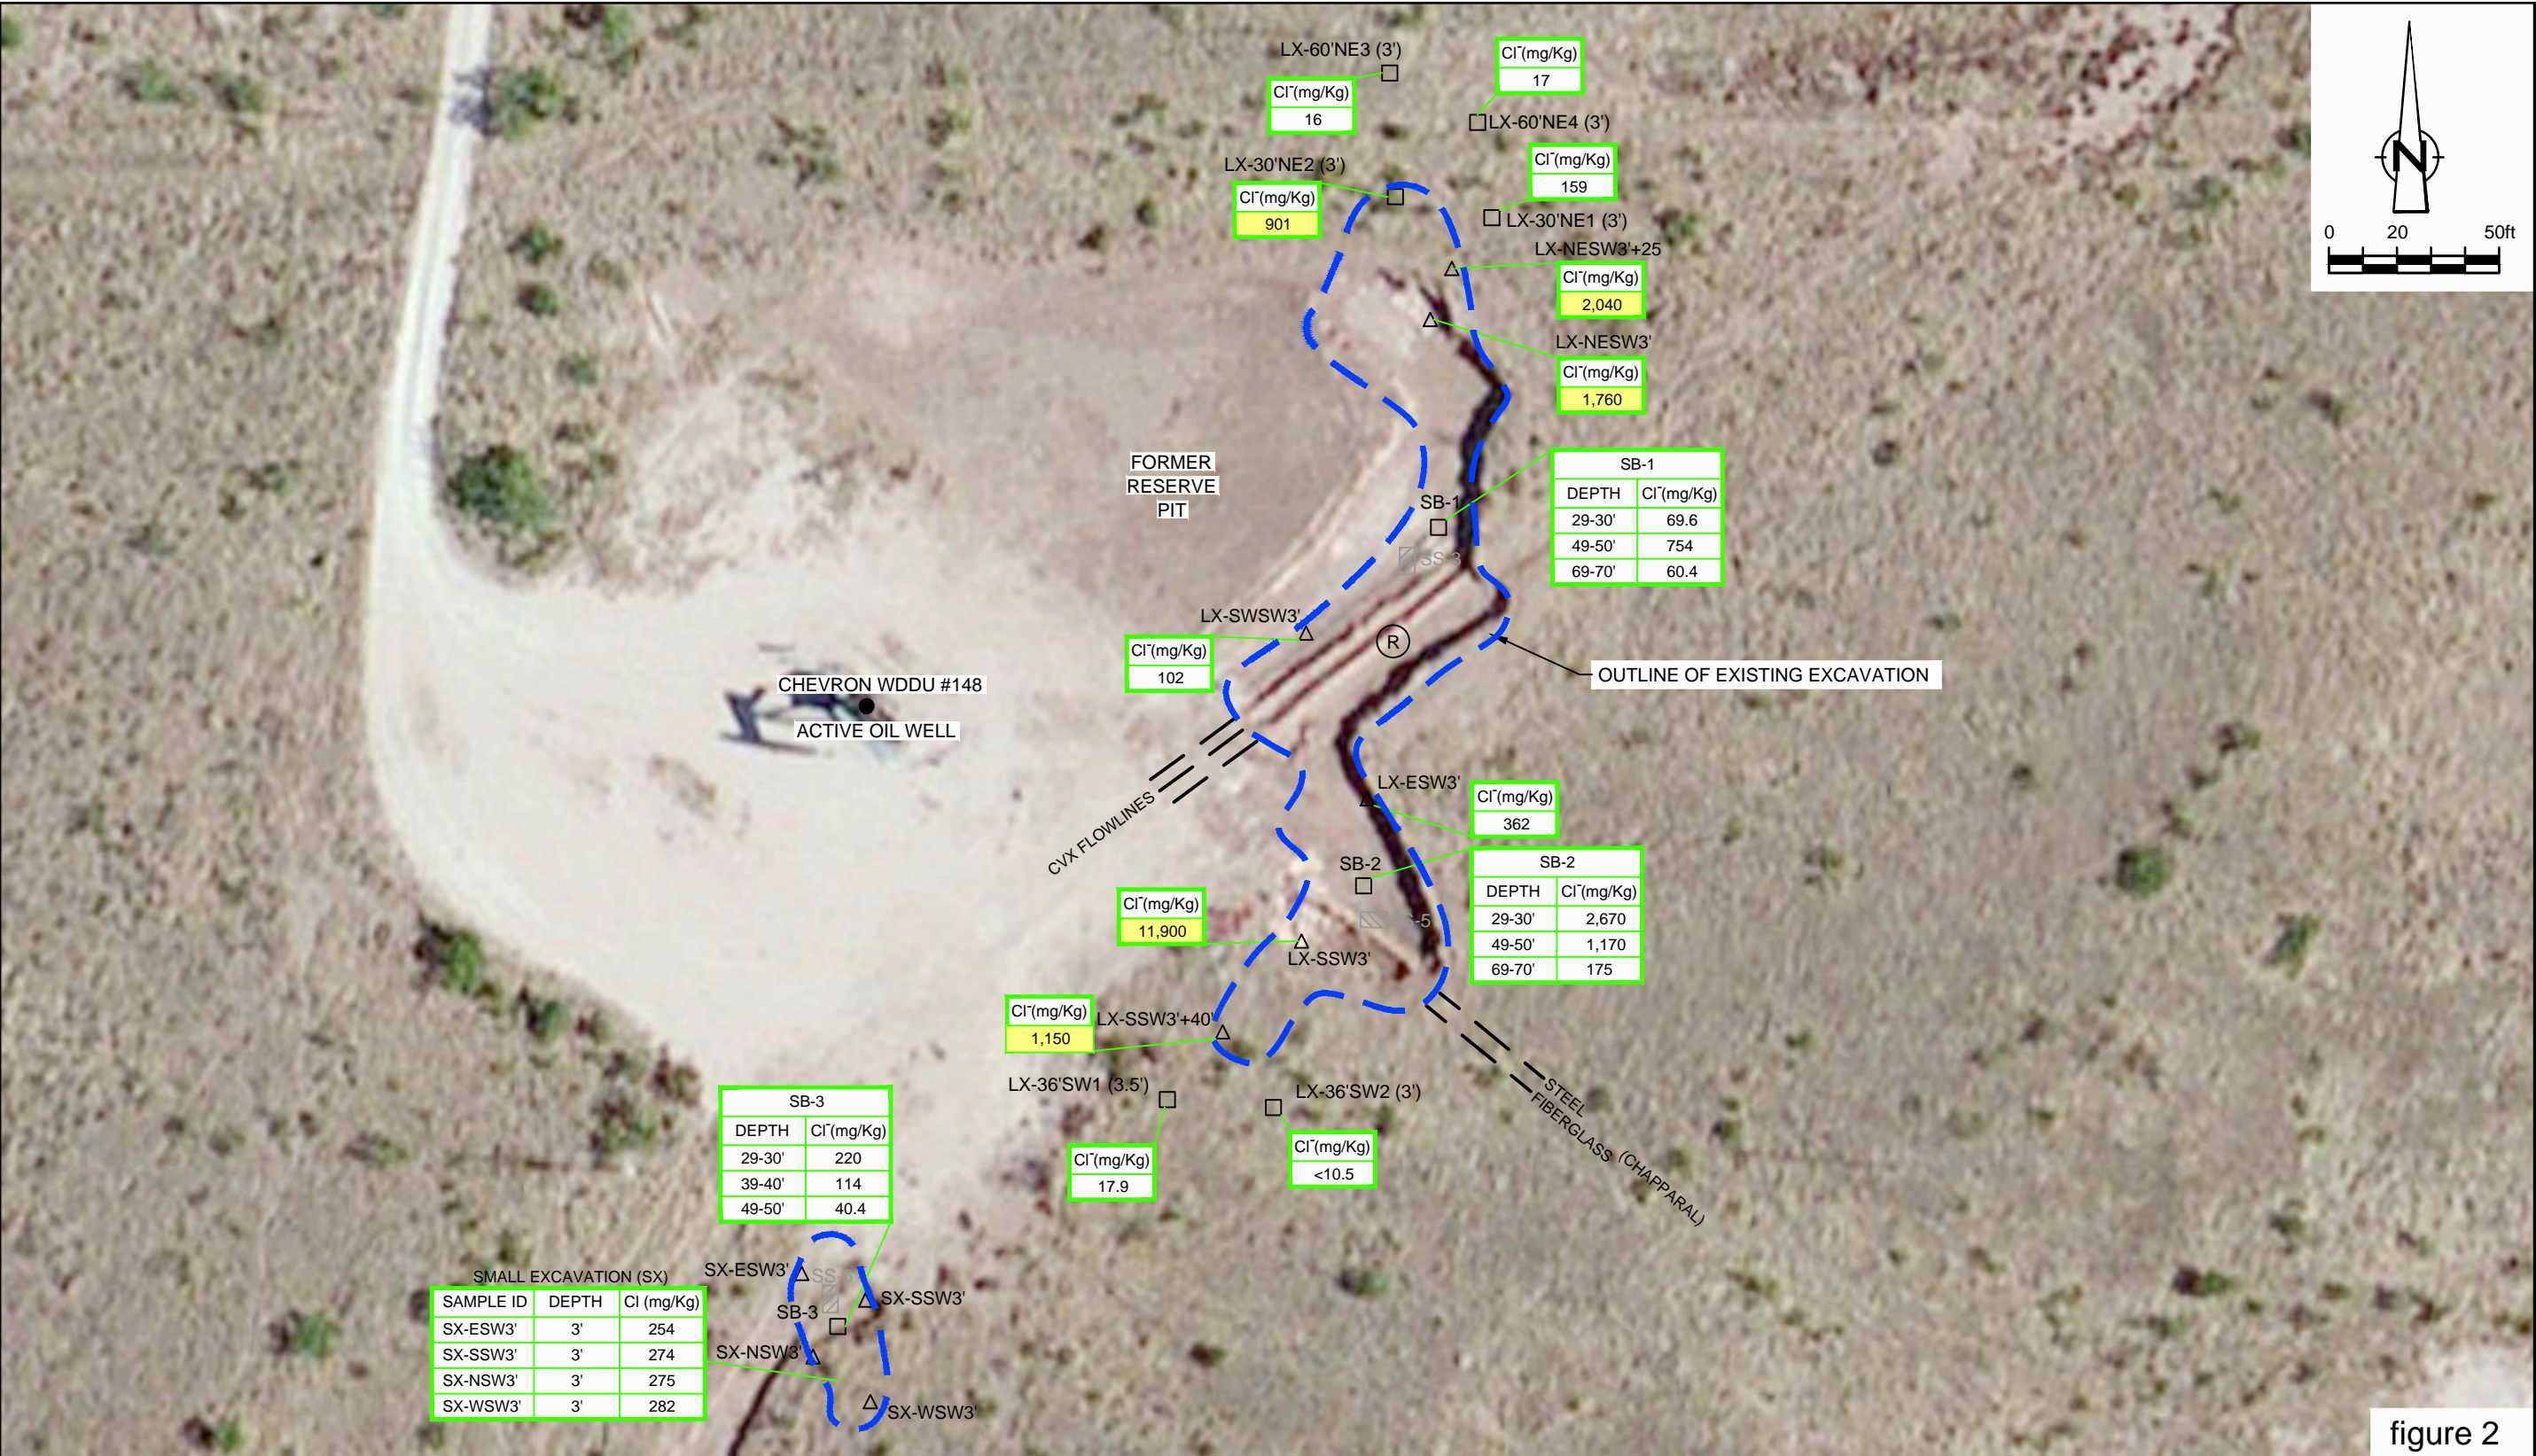
figure 2

SOIL BORING AND SIDEWALL SAMPLING RESULTS
SITE CLOSURE REPORT
SECTION 31(I); T-24-S; R-38-E
LEA COUNTY, NEW MEXICO
Chevron Environment Management Company

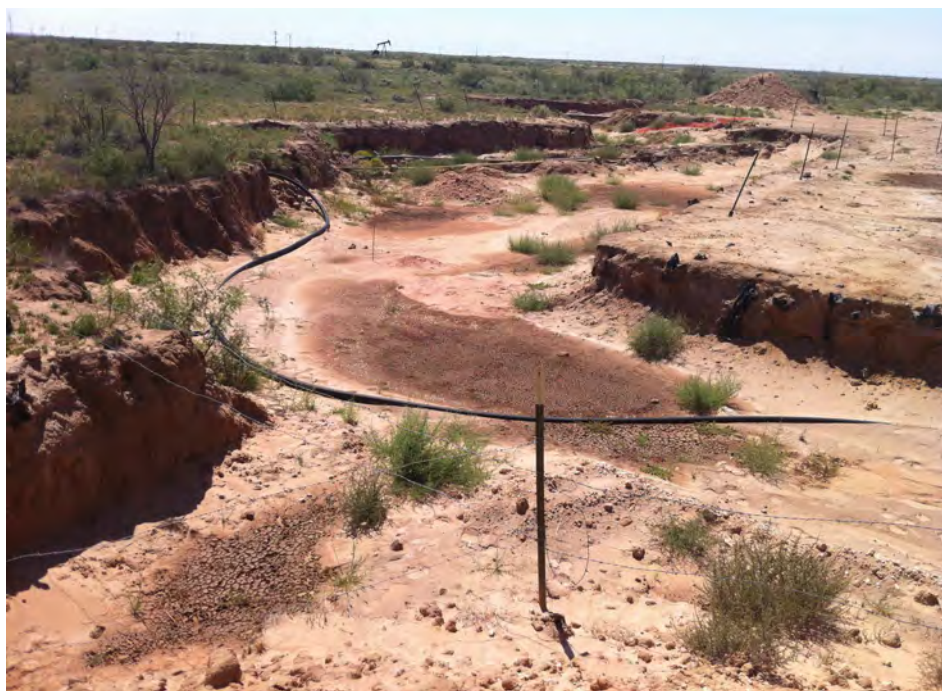
PHOTO 1: Remedial Excavation – May 2010

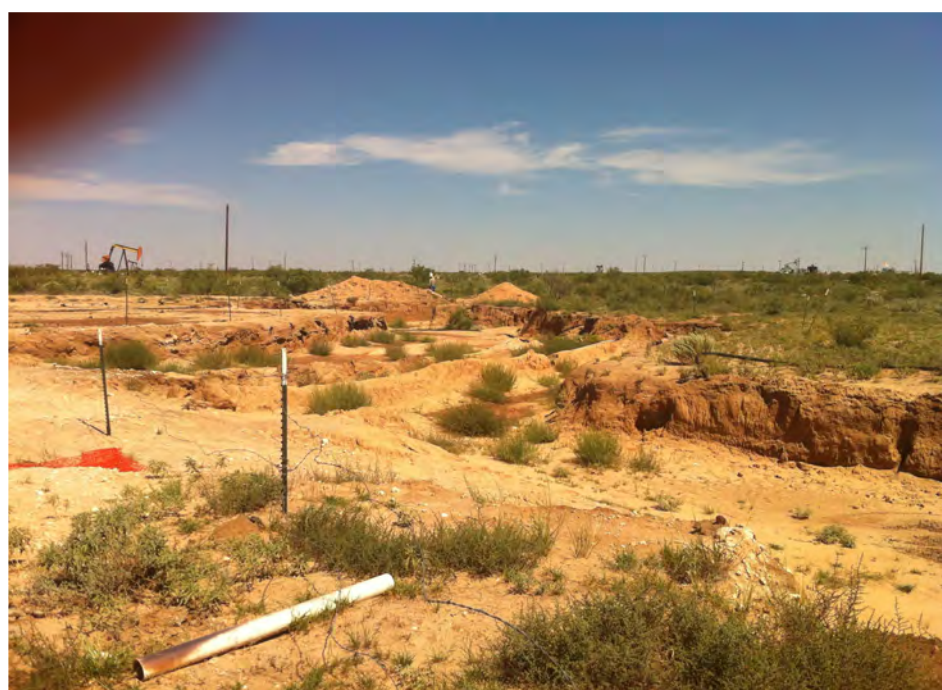
PHOTO 2: Remedial Excavation – May 2010

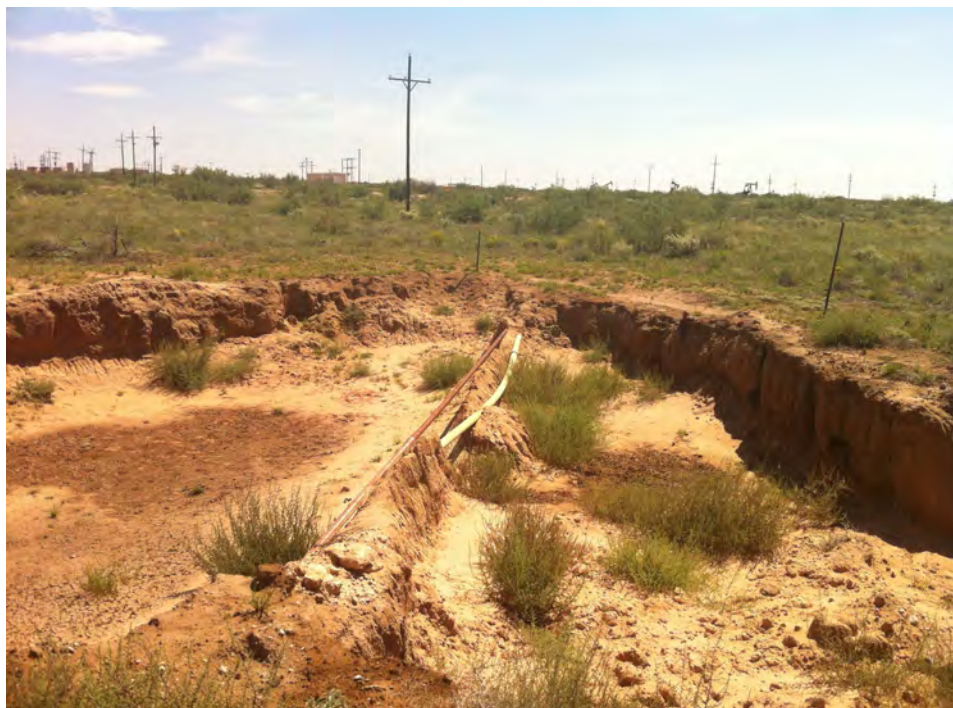
PHOTO 3: Remedial Excavation – May 2010

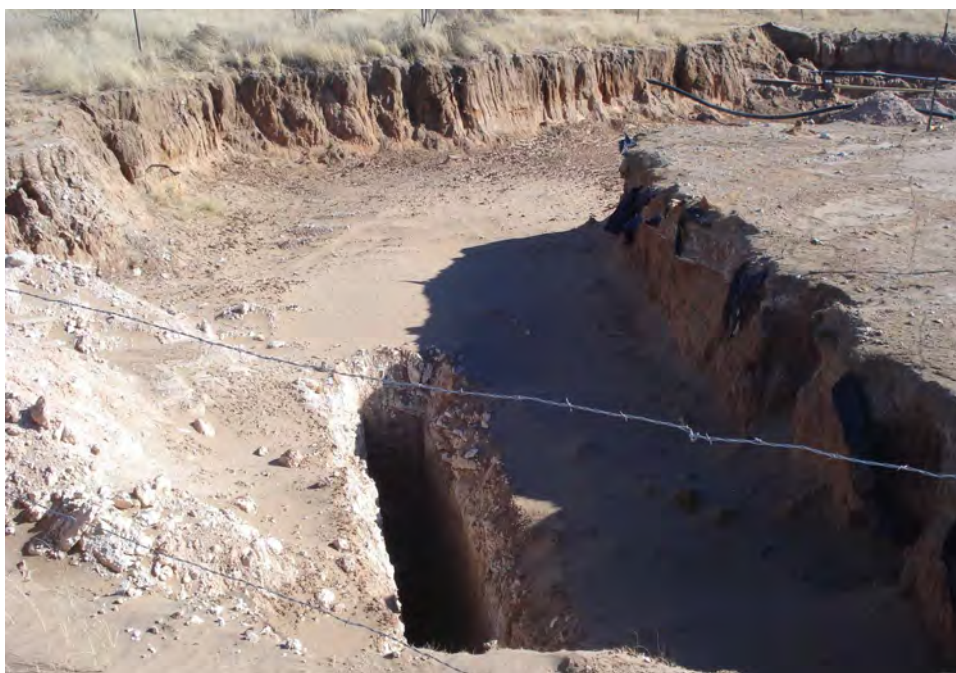
PHOTO 4: Remedial Excavation – May 2010, Showing Test Pit Location

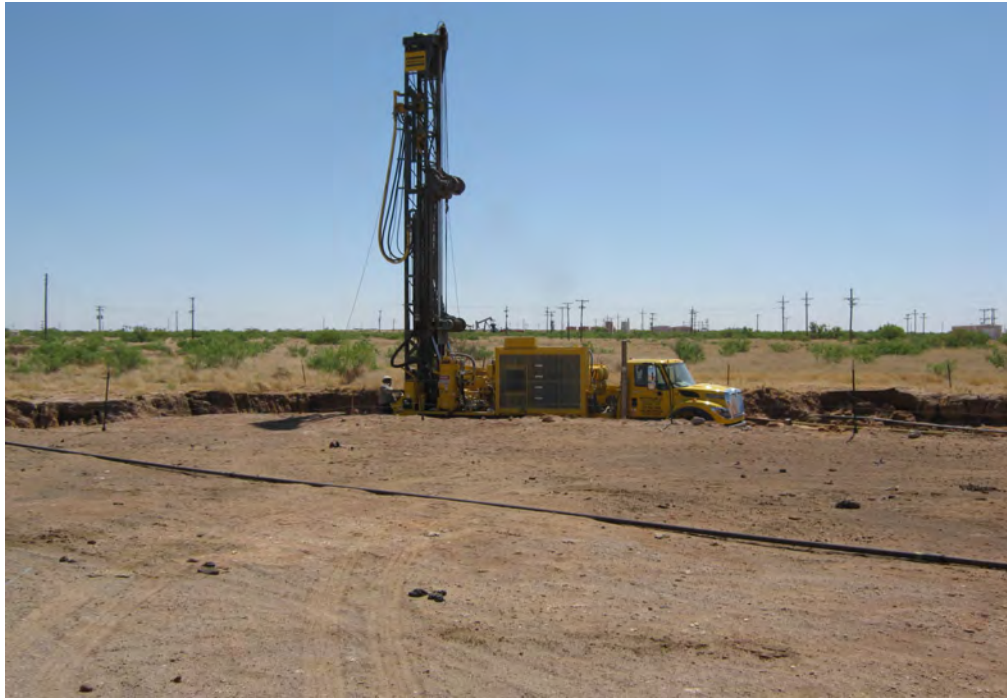
PHOTO 5: View of Soil Boring Activities – April 2011

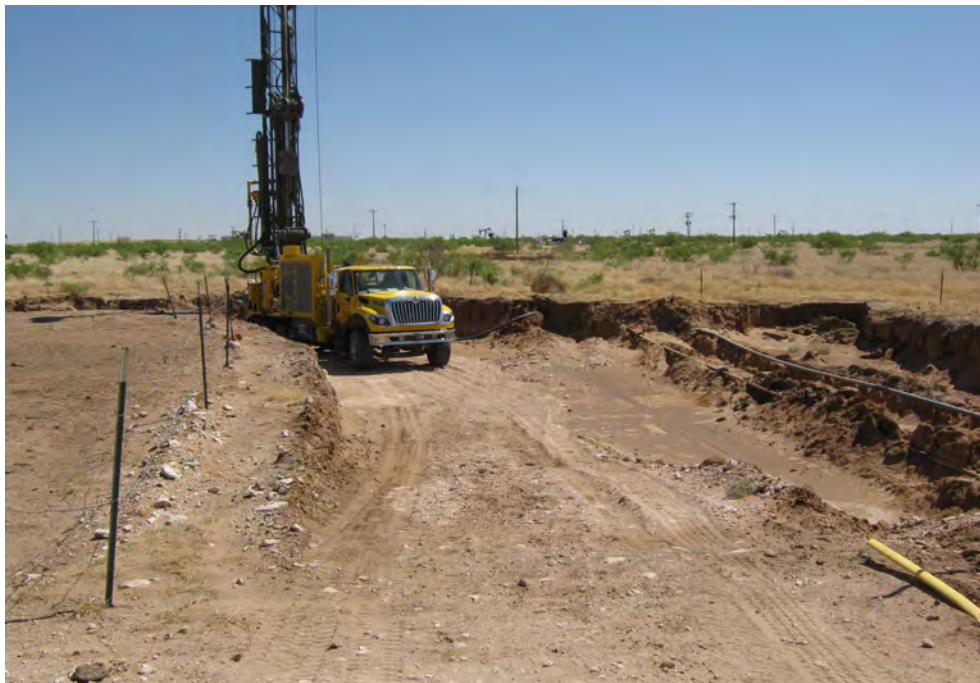
PHOTO 6: View of Soil Boring Activities – April 2011

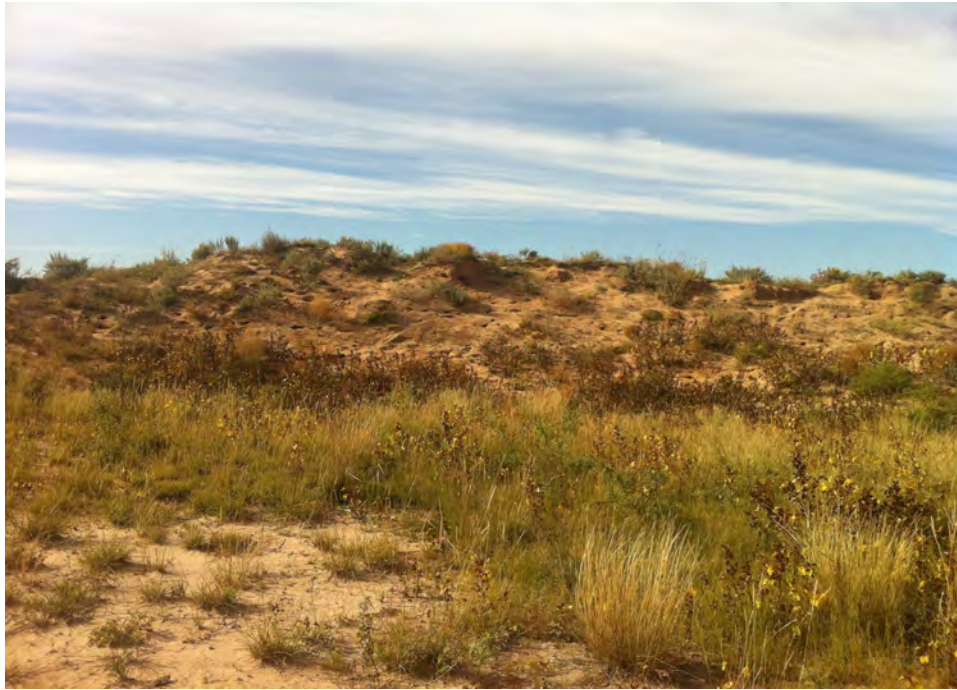
PHOTO 7: Sand material to be used for backfill (Mr. George Willis Property)

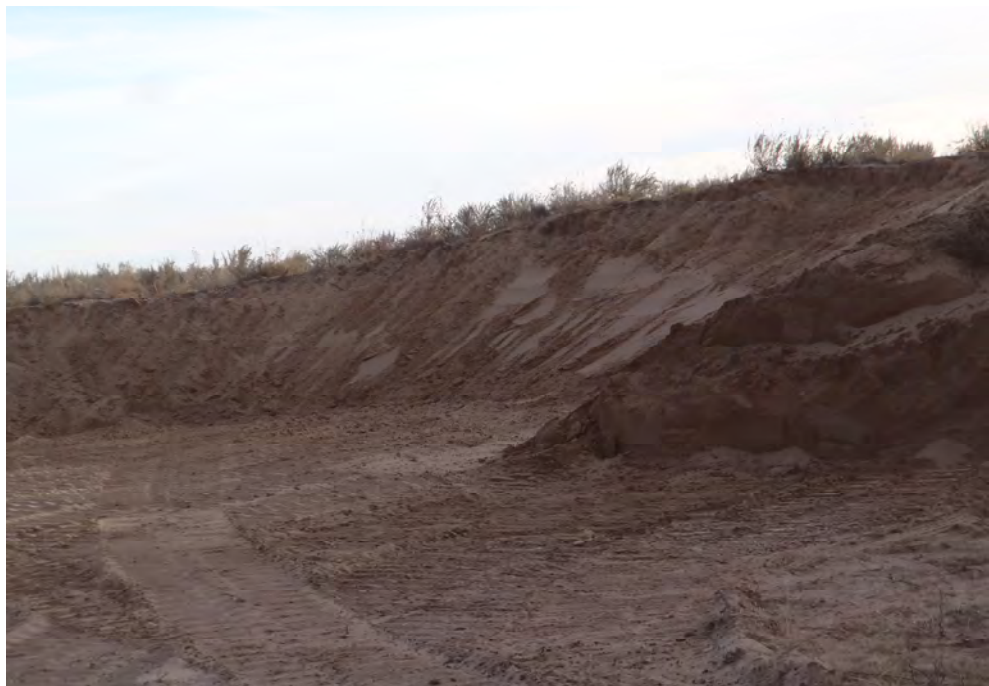
PHOTO 8: Sand material used to backfill (Mr. George Willis Property)

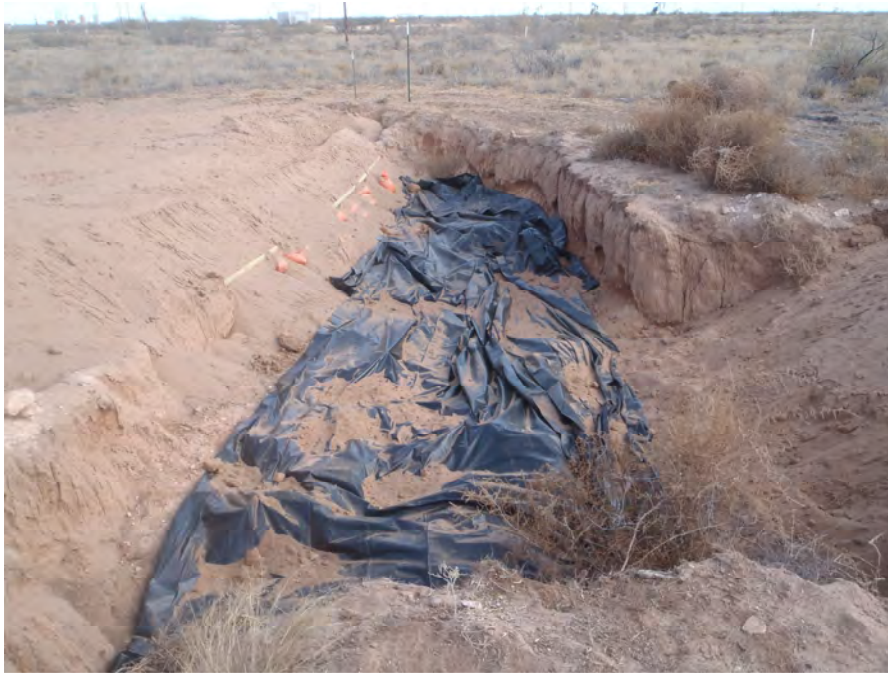
PHOTO 9: View of Supported Chaparral Water Injection Lines
and Backfilling Activities - December 2012

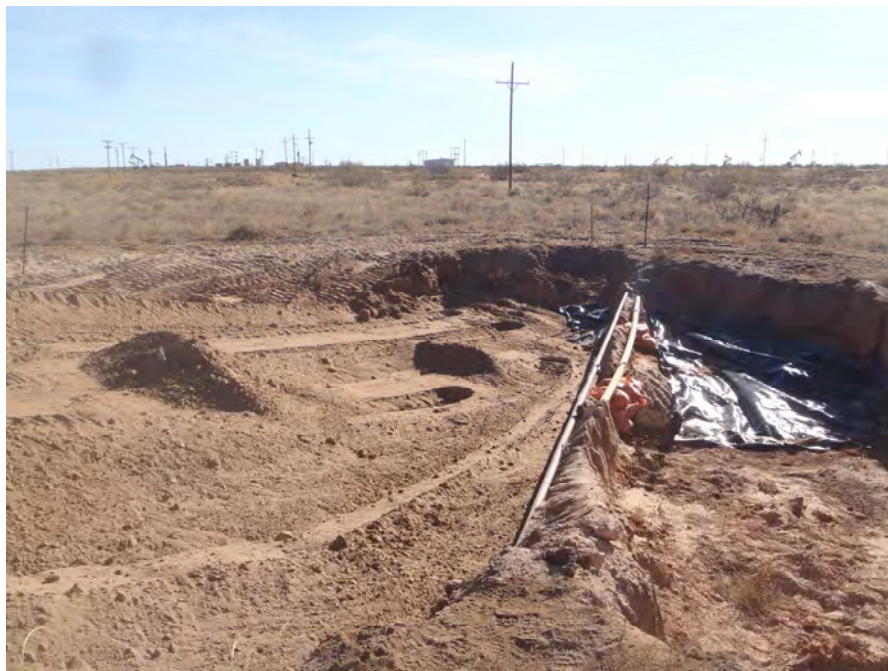
PHOTO 10: View of Supported Chaparral Water Injection Lines
and Backfilling Activities - December 2012

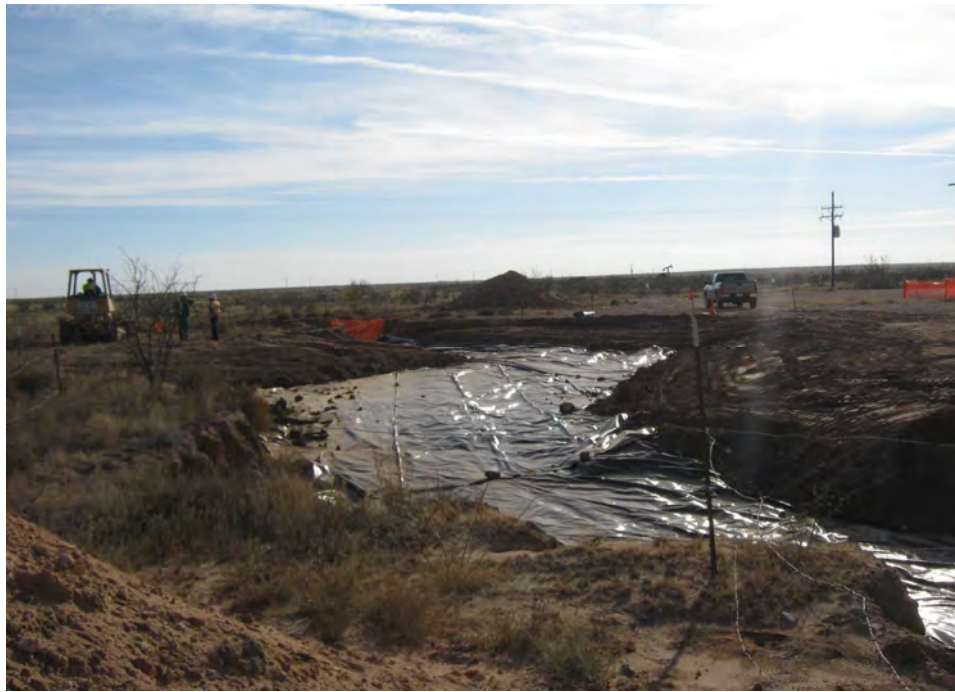
PHOTO 11: View of Backfilling Activities (20 mil Poly Liner) – December 2012

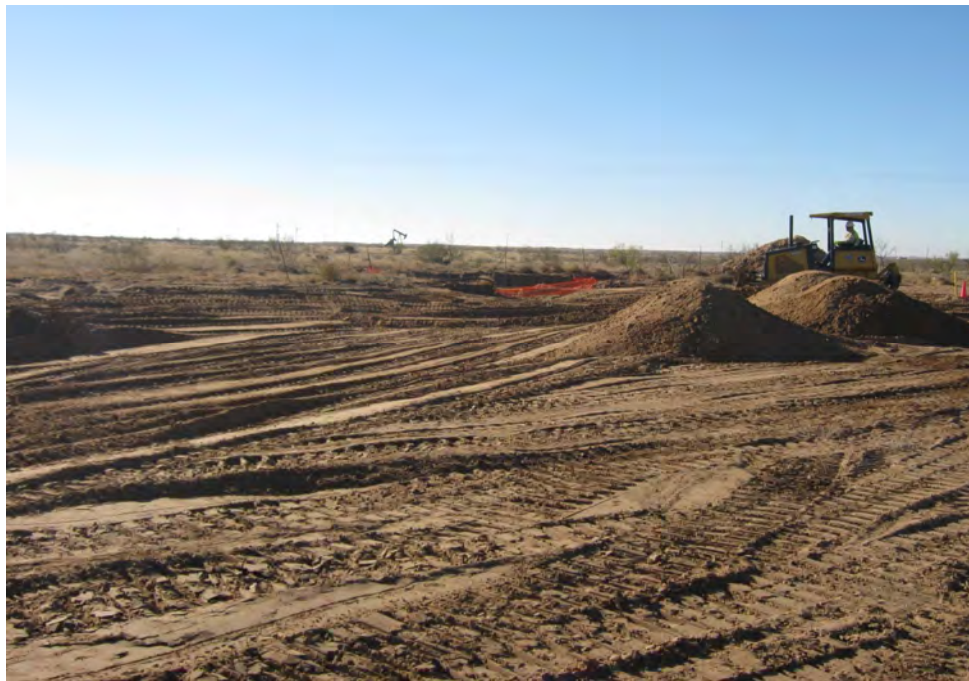
PHOTO 12: View of Backfilling Activities – December 2012

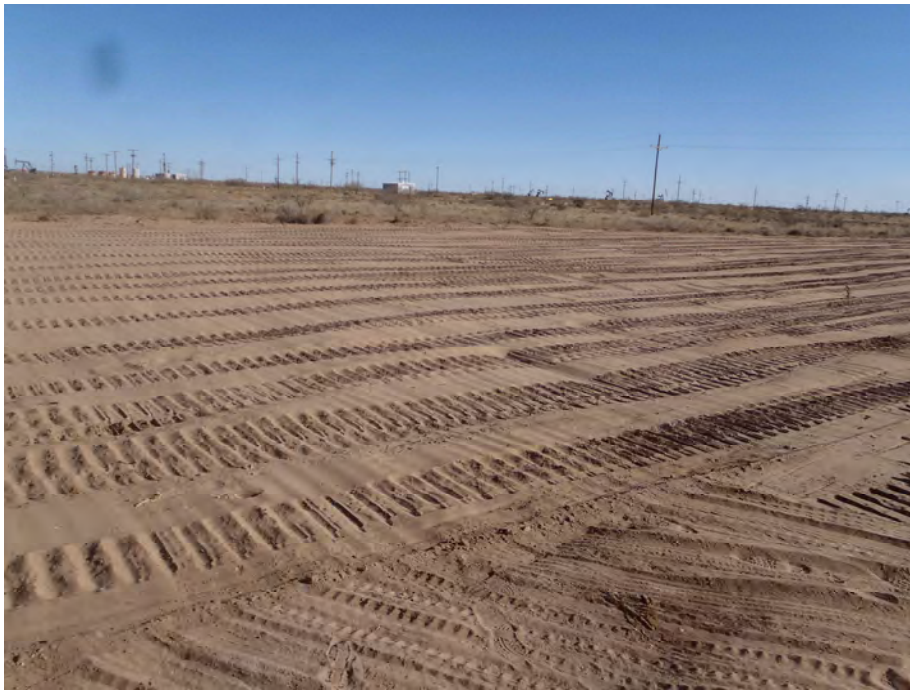
PHOTO 13: View of Final Grading Activities – December 2012

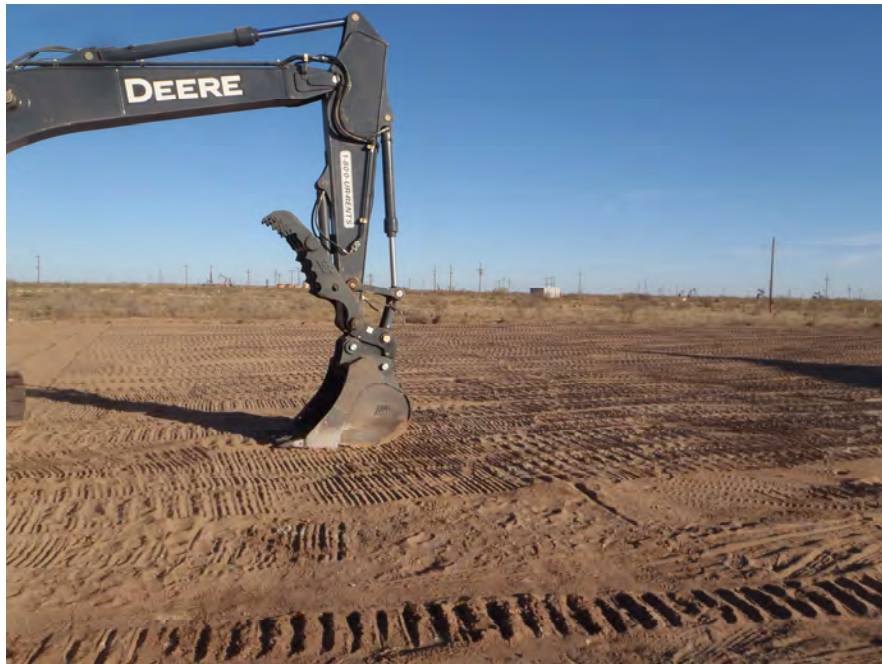
PHOTO 14: View of Final Grading Activities – December 2012
