Subject: **Remediation and Closure Report**  
Oxy USA Inc.  
Prize Federal #002  
API #: 30-025-31902  
1RP-3559

Oxy USA Inc. (Oxy) had contracted Talon/LPE (Talon) to perform soil assessment and remediation services at the above referenced location. The incident description, soil sampling results, remediation activities and closure request are submitted herein.

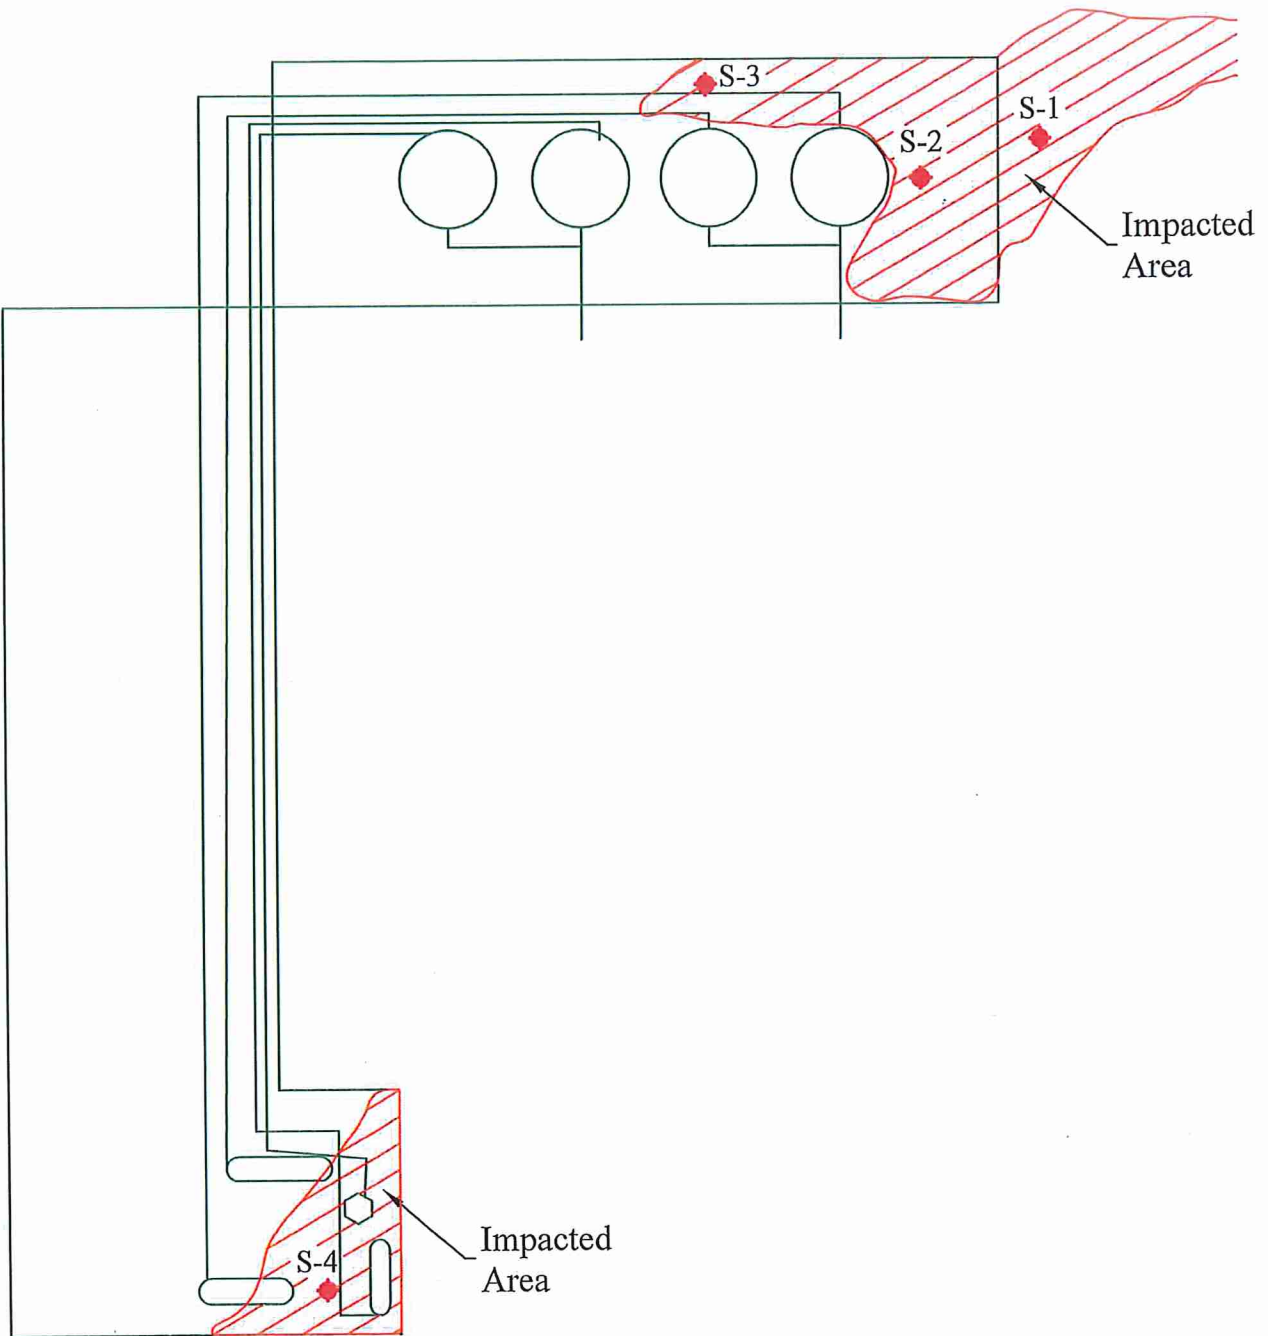
Prize 27 CTB  
 Oxy - NM - North  
 Lea County, New Mexico  
 Figure 1 - Site Plan

Following site assessment activities and a work plan approved by OCD and BLM, Talon mobilized personnel to perform remediation activities. The impacted areas in the vicinity of sample location S-1 and S-4 under the steel flow lines were hand-excavated to a depth of 0.5-feet.

The impacted areas S-2 and S-3 in the tank battery were hand excavated to a depth of 4-feet deep then treated with a bioremediation agent (Mircoblaze). Upon NMOCD and BLM approval of the confirmation samples a 20 mil liner will be installed in the bottom of the excavation.
