Release Notification and Corrective Action

Name of Company Matador Production Company	Contact Catherine Green	
Address 500 N Main St Ste One	Telephone No. 575-623-6601	
Facility Name Chevron 12 Fed # 5	Facility Type Oil Well	
Surface Owner	Mineral Owner	API No. 30-025-30682

Chevron 12 Fed #5 Final Report Dec. 7, 2015

SUBJECT: SUMMARY OF WORK PERFORMED AT THE CHEVRON 12 #005, LEA COUNTY, NEW MEXICO

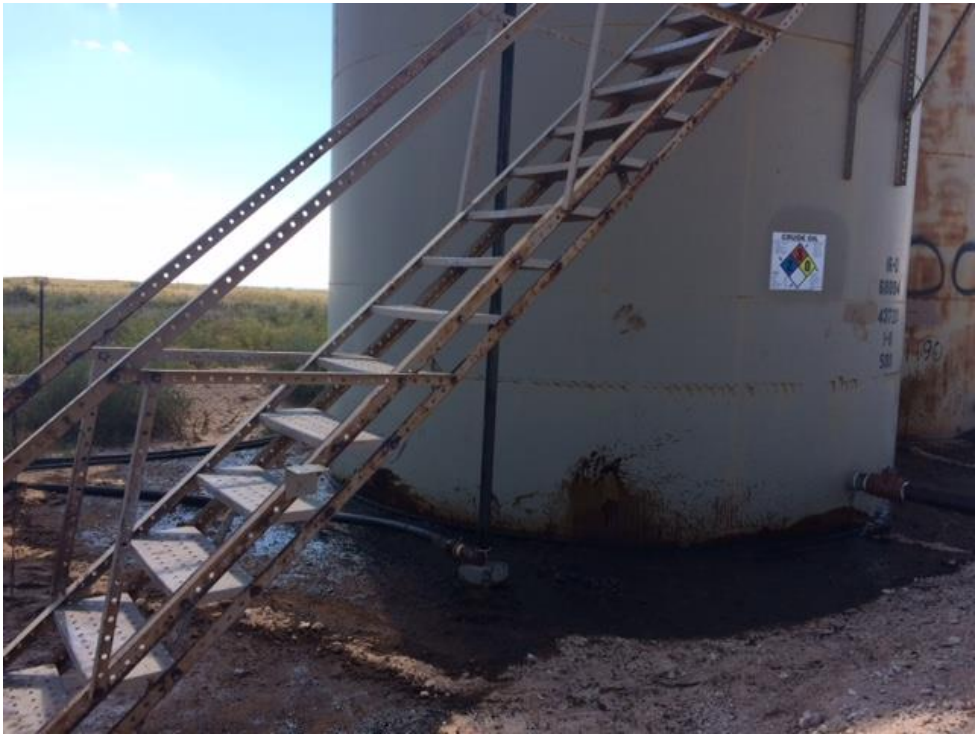
Pictures of spill, September 16, 2015

Matador Resources Production Foreman encountered a broken coupling on a transfer pump on Sept. 16, 2015 at 10:00am. It was estimated that 35 barrels of fluid had spilled into the earthen dike. See attached photos. The foreman turned the well off, telephoned to report the spill, telephoned for a vacuum truck to vacuum up as much fluid as possible, and ordered a new pump. 25 barrels of fluid were recovered.

Coupling on a pump failed. Fluid contained in dike. Hauler recovered 25 bbls of fluid. Contaminated soil was removed from containment. Soil samples were collected and sent to labs for analysis. Uncontaminated soil was placed in the containment, and was rebuilt.

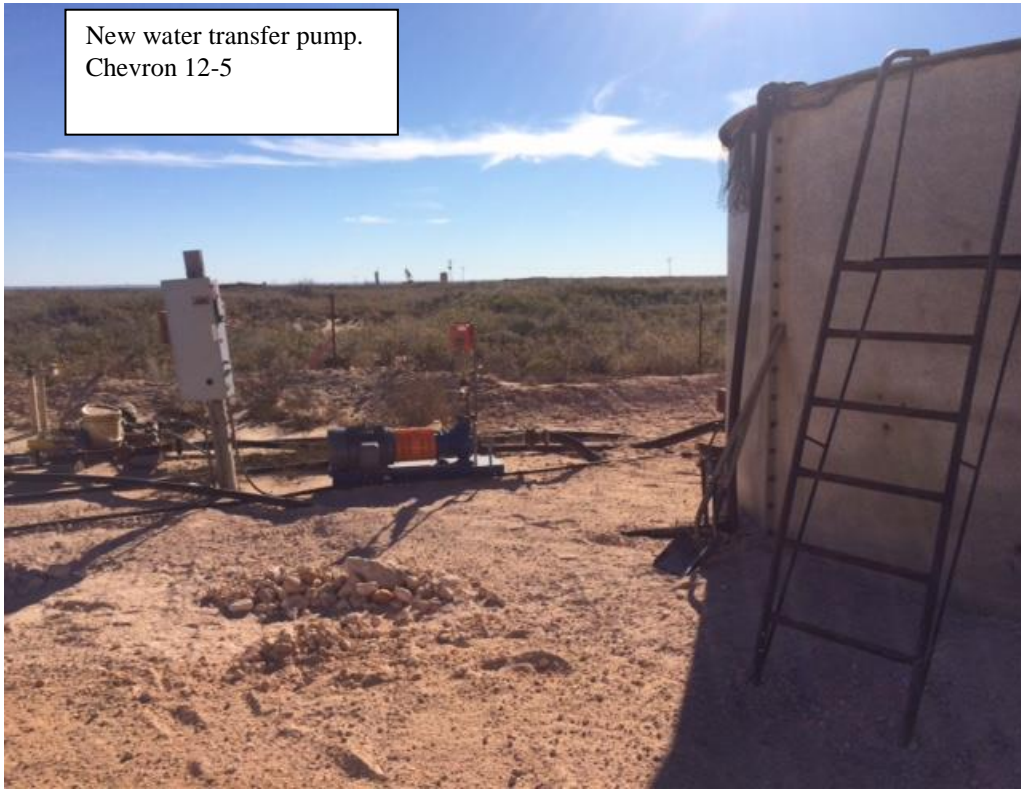
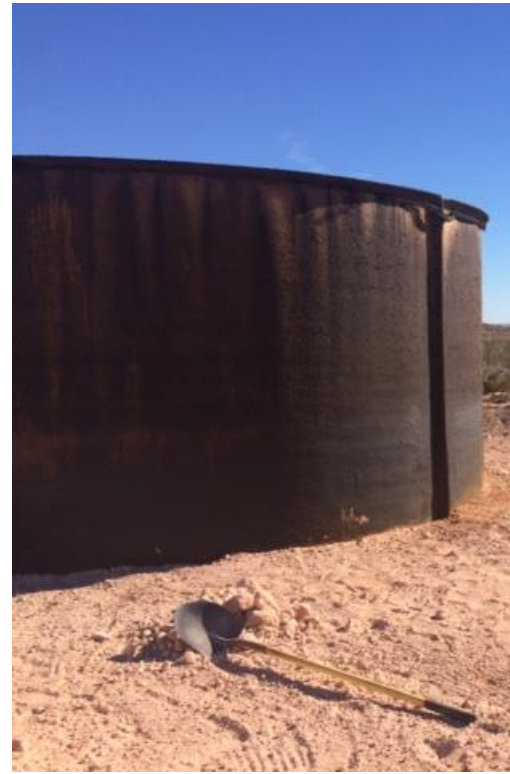
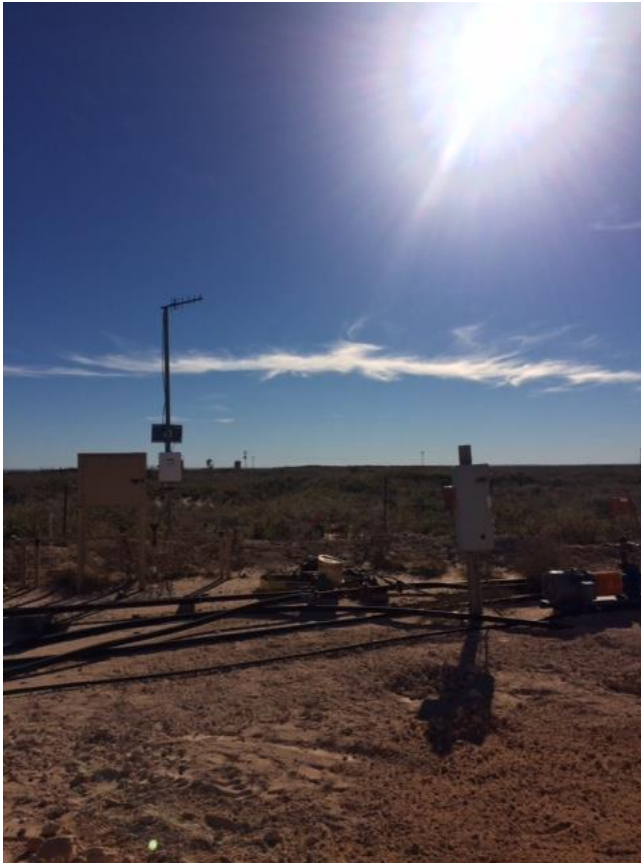
Soil samples collected and analyzed by Cardinal
Labs. Final results below. New transfer pump.

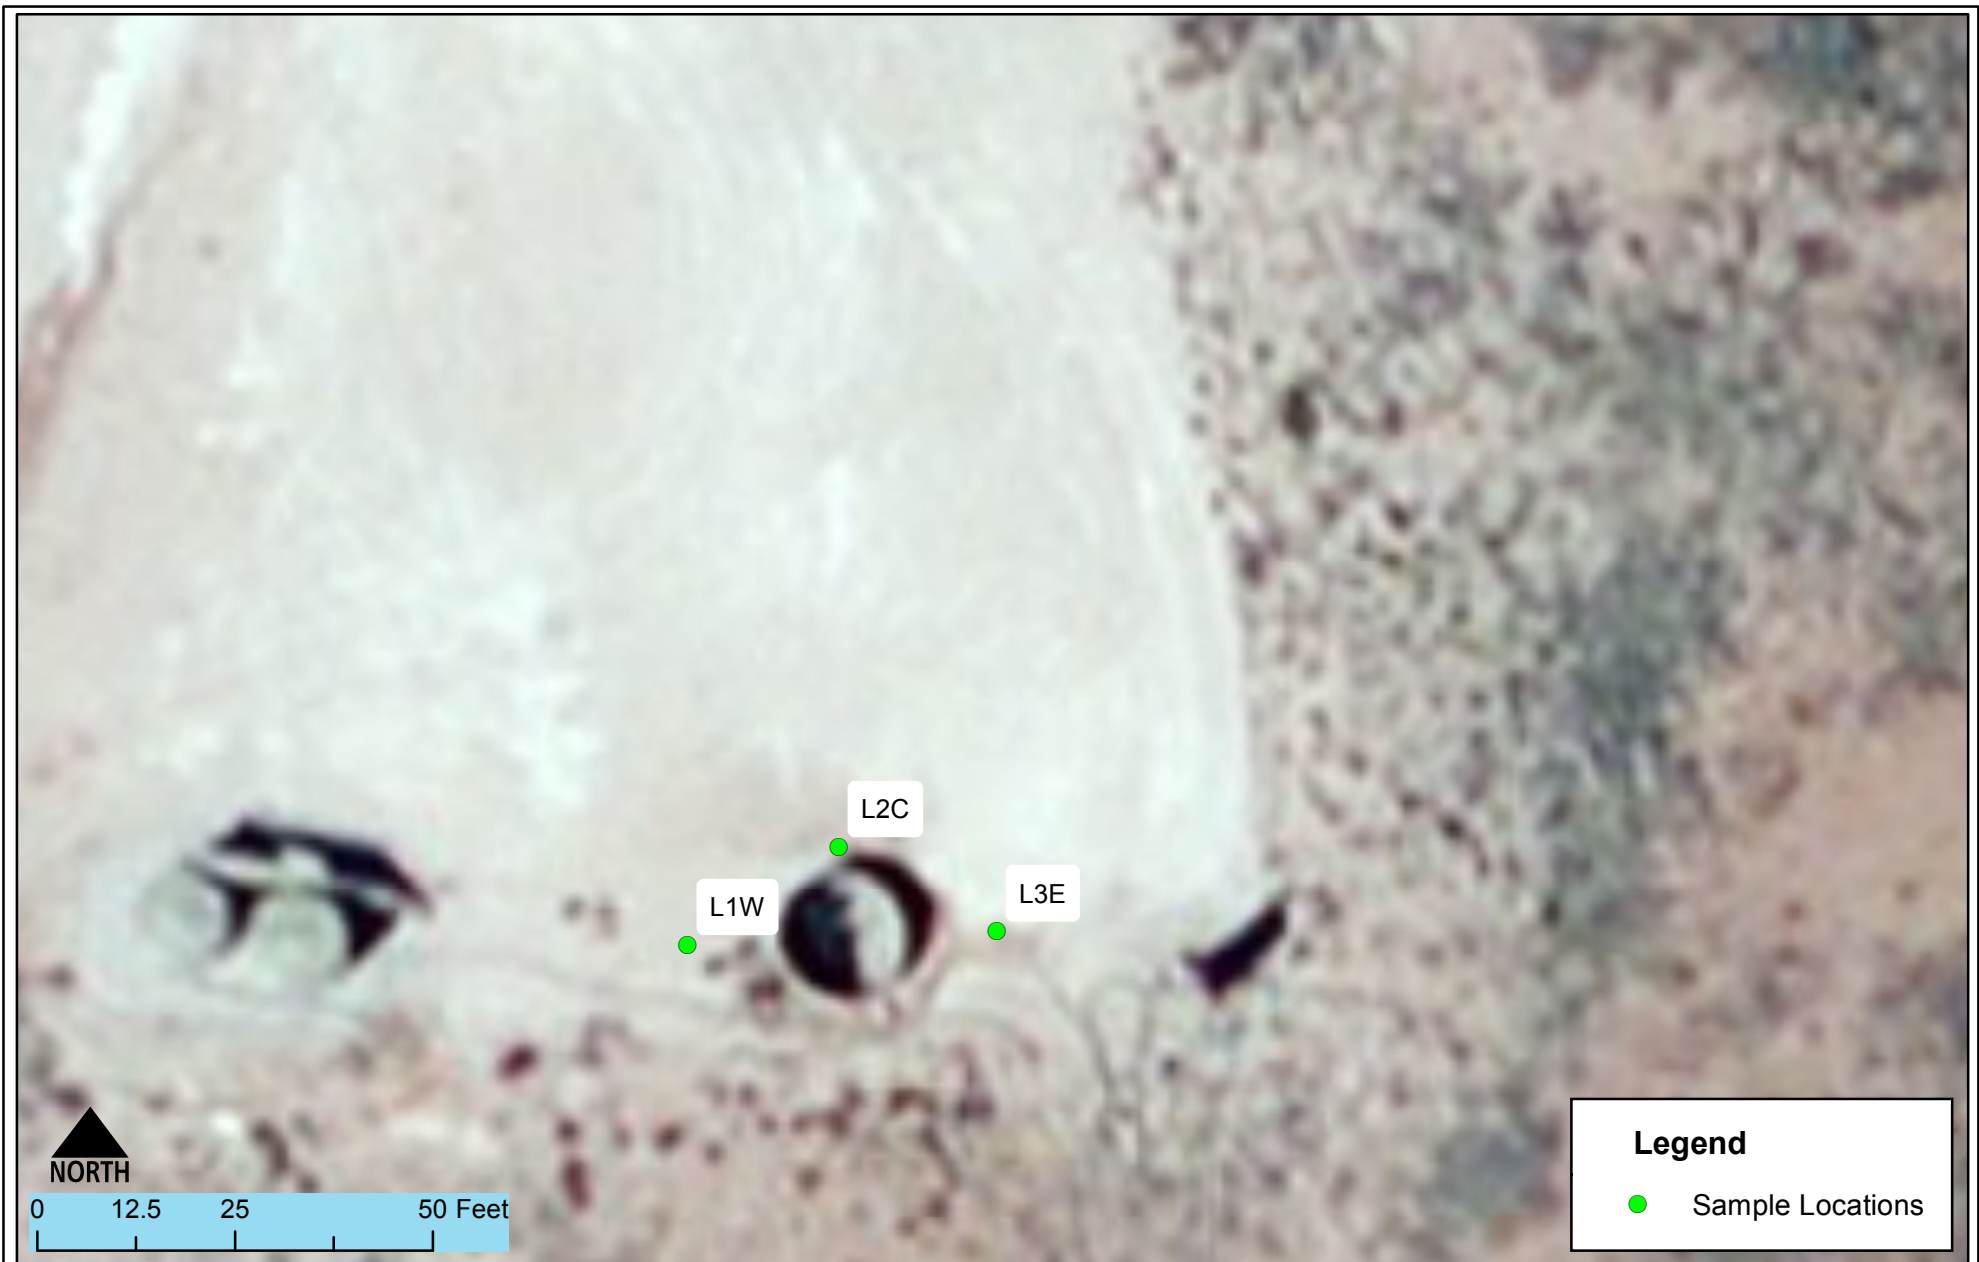
FIGURE 2

Soil sample locations are illustrated in Figure 2. A summary of laboratory analytical results is included in Table 2. Laboratory reports are included in Appendix A. Photo documentation is in Appendix B.

DETAILED SITE AND SAMPLE MAP

Site Detail and Sample Locations
Matador Resources Company- Chevron 12 Federal #5
Hobbs, New Mexico

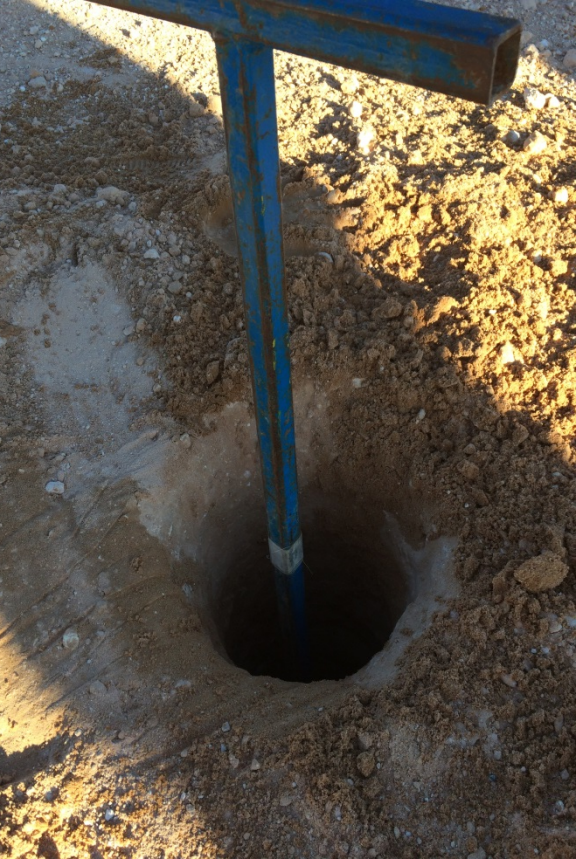
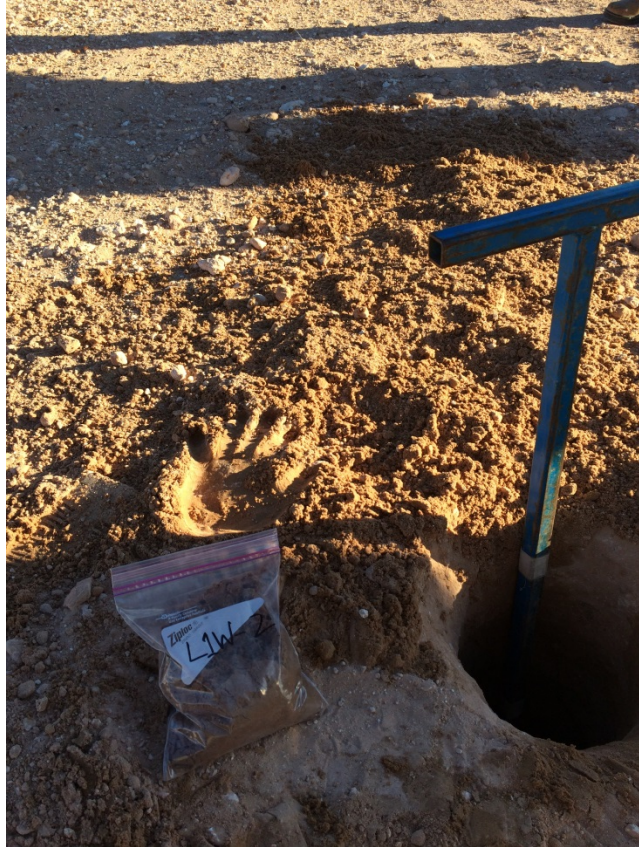
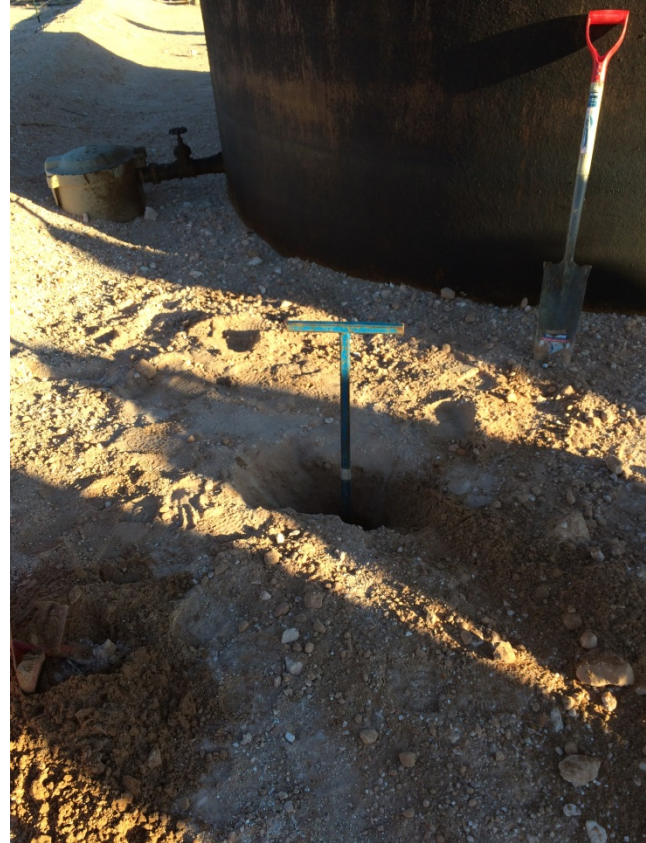
Collected 3 foot delineation samples in three locations around the tank battery
