Report Type: Closure Report

Site:	Crockett State #2H					
Company:	COG Operating LLC					
Section, Township and Range	Unit H	Sec 20	T 21S	R 33E		
Lease Number:	API-30-025-41080					
County:	Lea County					
GPS:	32.46523° N			103.58663° W		
Surface Owner:	State					
Mineral Owner:						
Directions:	From intersection of Hwy 176 and CR 27-A (Marathon Road), go 2.2 miles east on Hwy 176 and turn right (south) go 3.7 miles on lease road, turn right (west) go 4.8 miles and turn right (north) and go 1.9 miles to location.

Re: Closure Report for the COG Operating LLC., Crockett State #2H, Unit H, Section 20, Township 21 South, Range 33 East, Lea County, New Mexico.

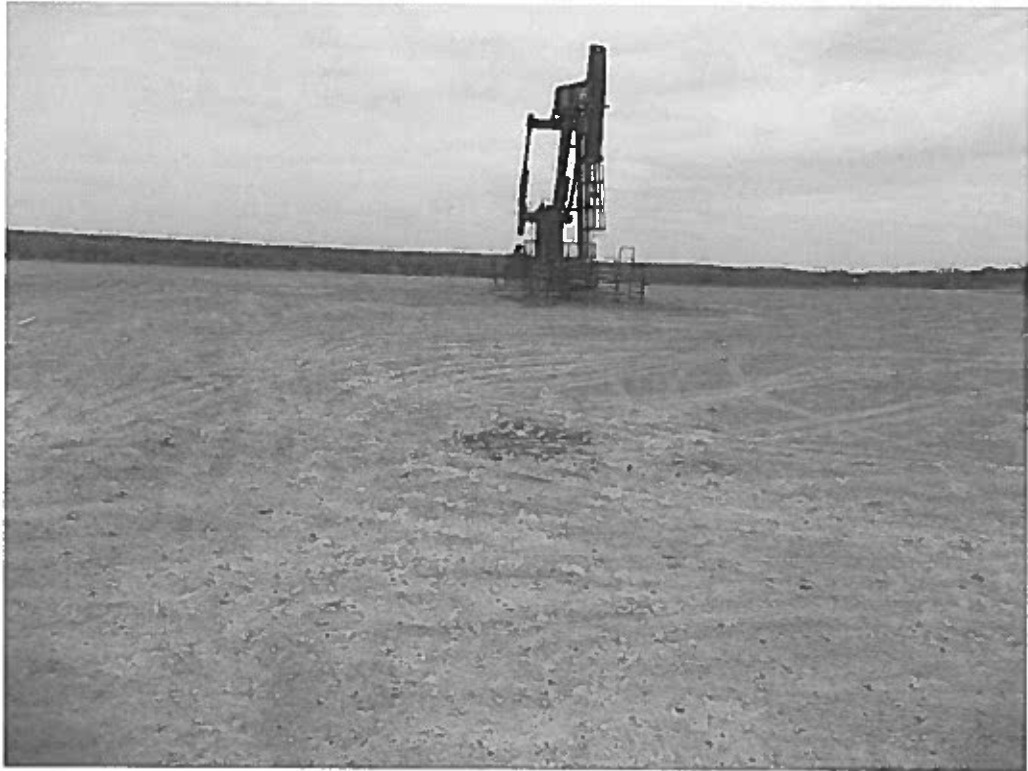
View East – Area of AH-1

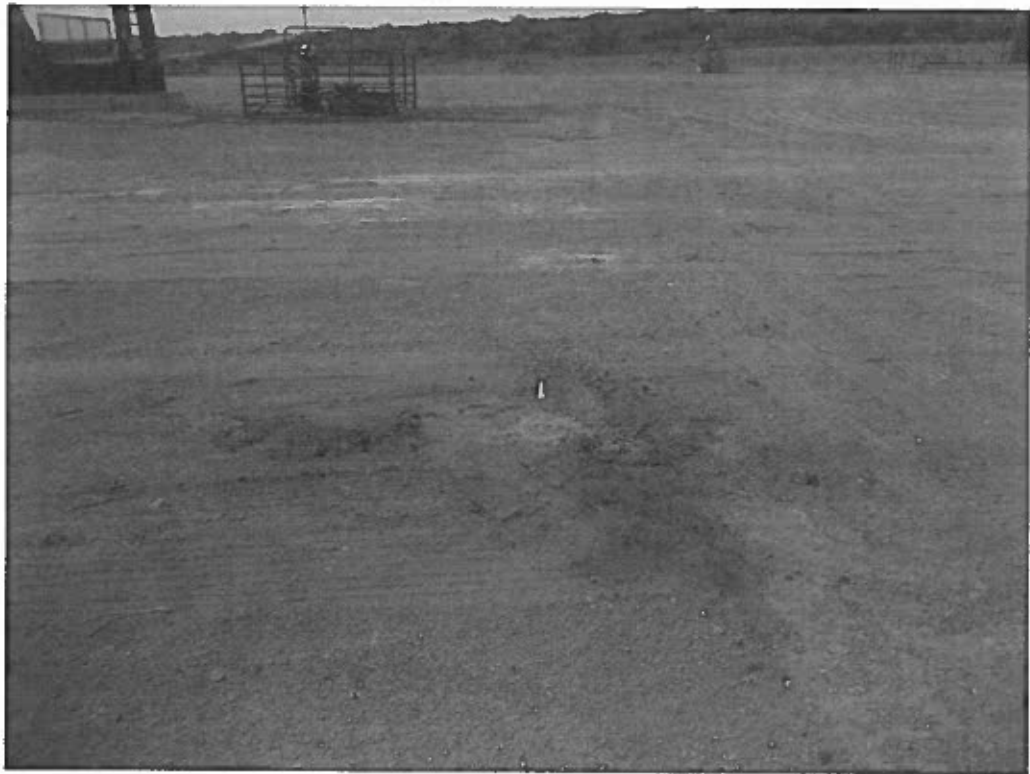
View South – Areas of AH-4, AH-5, and AH-6

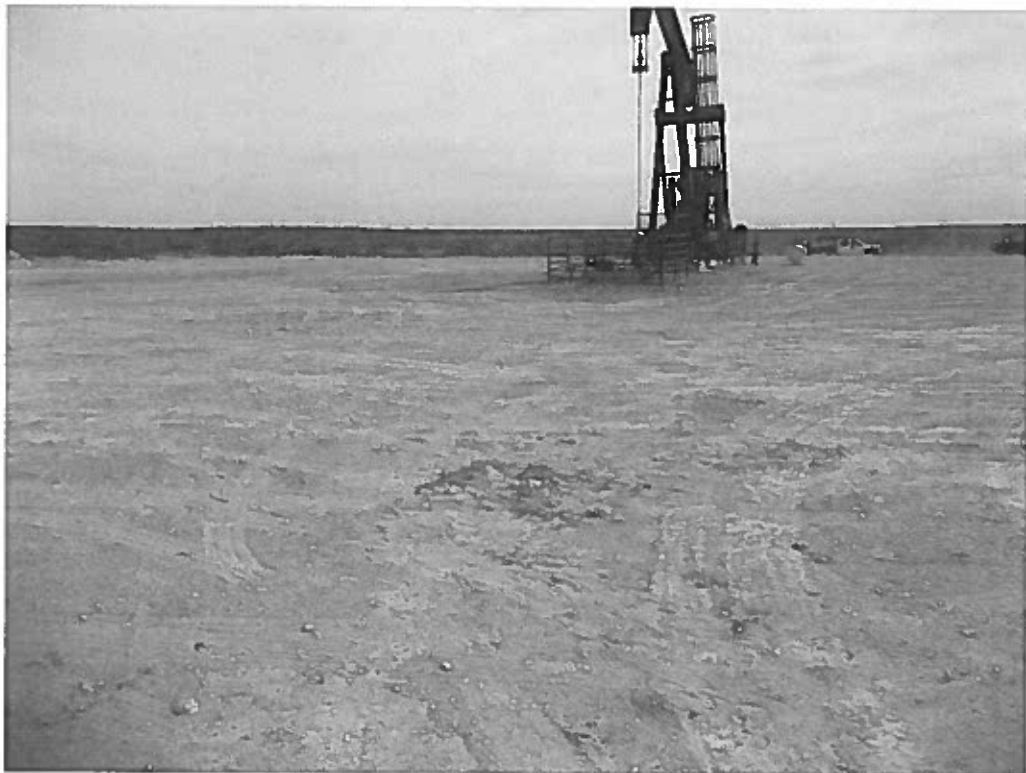
View East – Areas of AH-6 and AH-7

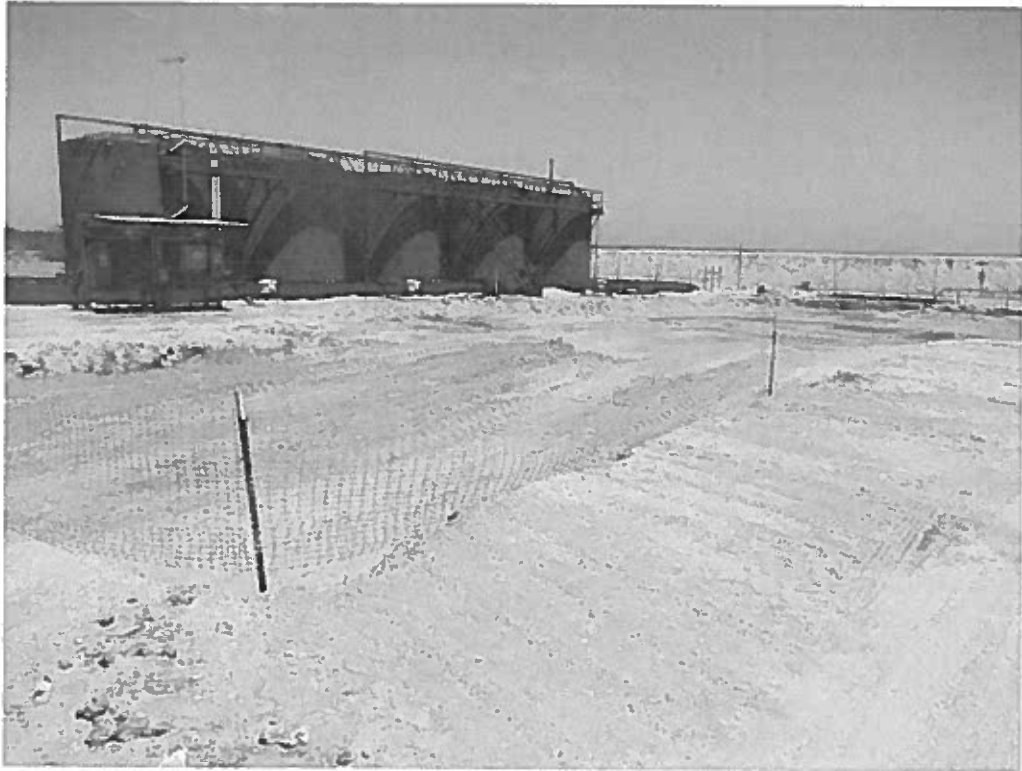
View Northwest – Excavated Areas of AH-1, AH-2, AH-3 and AH-7

On June 10, 2014, Tetra Tech personnel supervised the removal of impacted material as highlighted (green) in Table 1 and shown on Figure 4. As proposed in the work plan, the areas of auger holes (AH-1, AH-4, and AH-5) were excavated to depths of approximately 1.0'-1.5' below surface, the areas of auger holes (AH-2 and AH-3) were excavated to depths of approximately 2.0'-2.5' below surface, the area of auger hole (AH-6) was excavated to a depth of approximately 3.0'-3.5' below surface, and the area of auger hole (AH-7) was excavated to a depth of approximately 6.0' below surface.

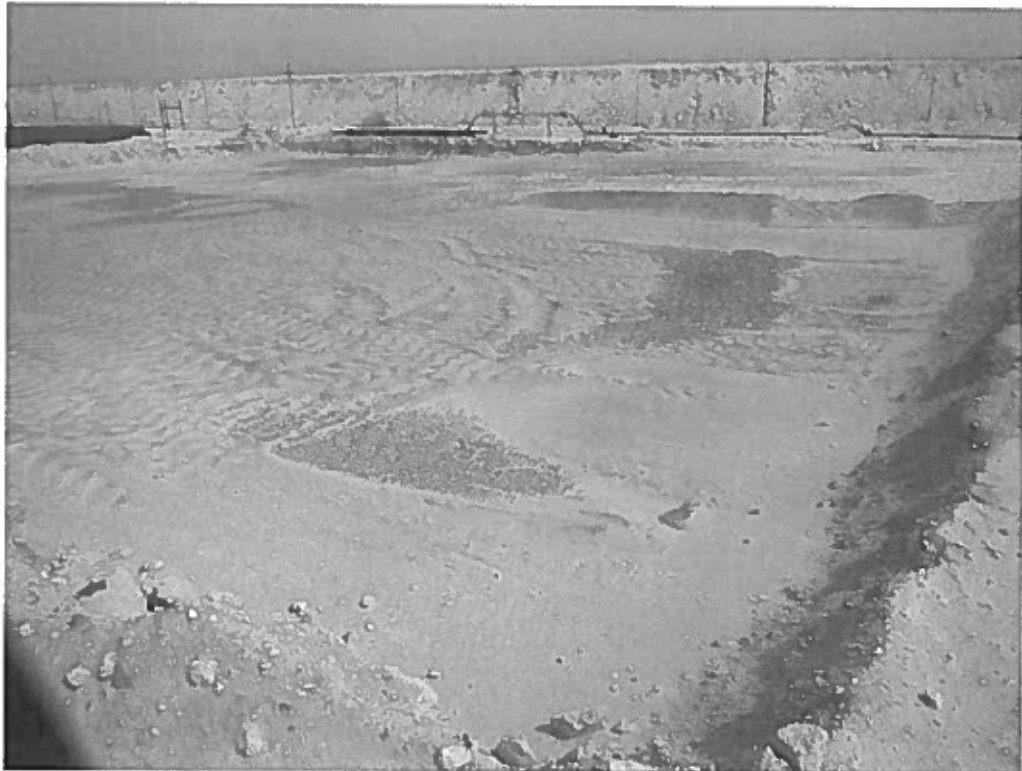
View Northwest – Excavated areas of AH-4 and AH-5

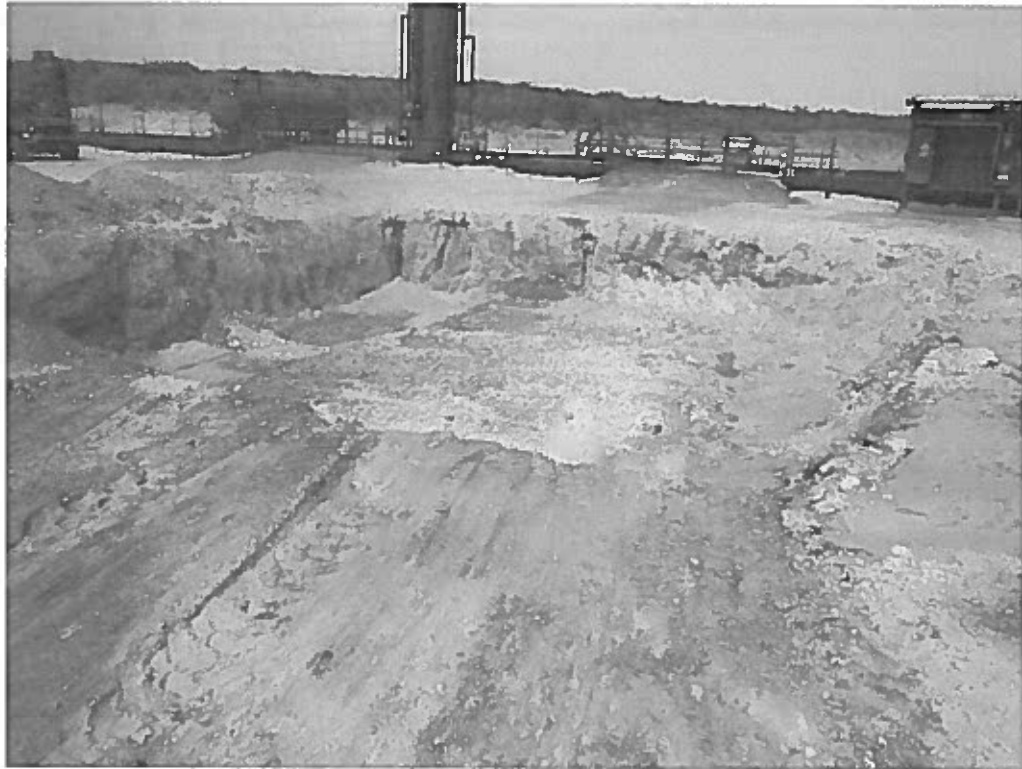
View West –Excavated area of AH-7

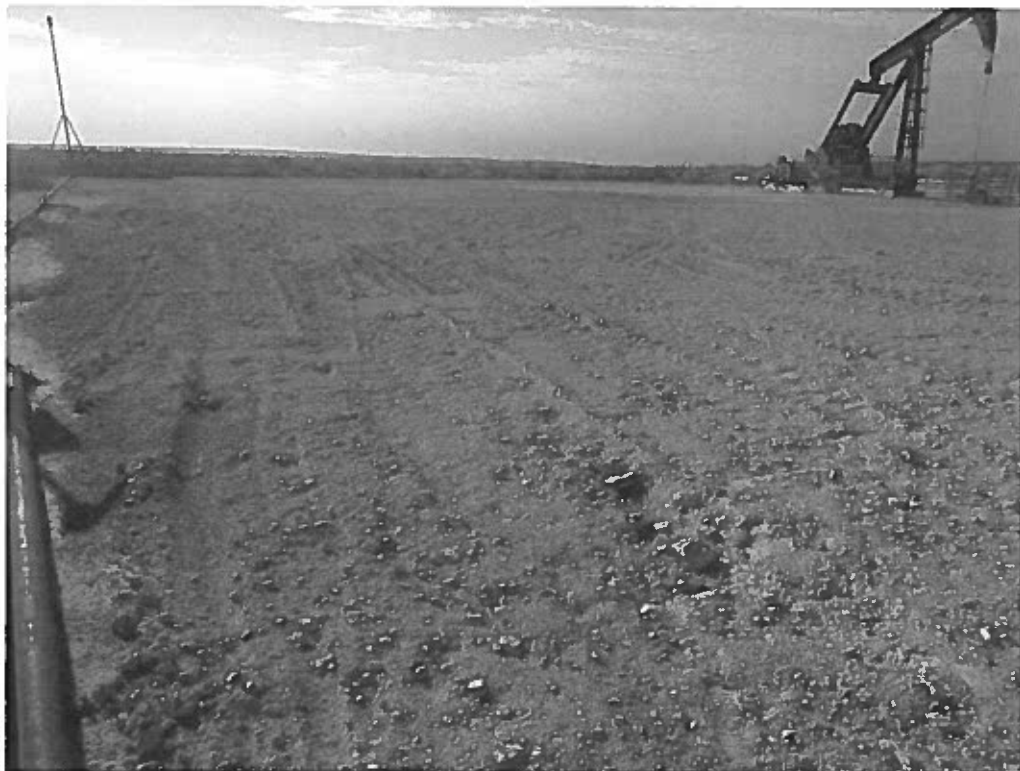
View Southeast – Backfilled areas of AH-2, AH-3, AH-4 and AH-5

Referring to Table 1, the bottom confirmation samples did not show any significant chloride concentrations in the subsurface soils. Based on the results, the excavations were backfilled with clean soil to grade, and approximately 960 cubic yards of excavated material was hauled to proper disposal.

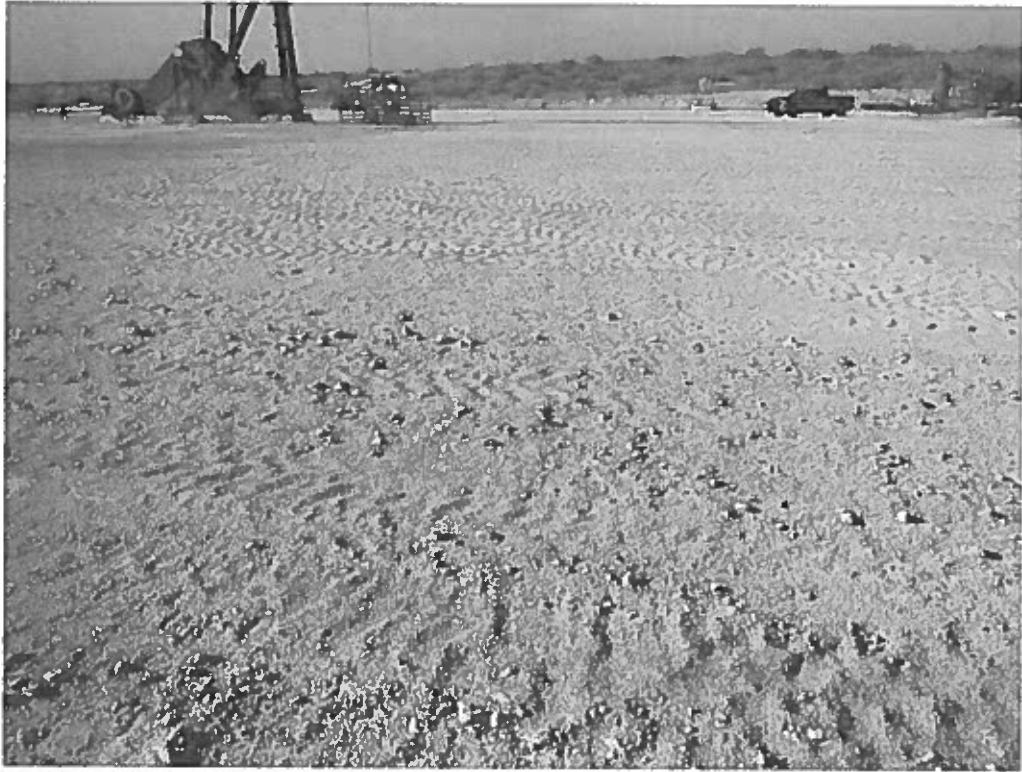
View South – Backfilled area of AH-1 and AH-7
