RE: Final Closure Report  
Chevron – WDDU Tank Battery  
UL-D, Section 32, Township 24 South, Range 38 East  
Lea County, New Mexico  
NMOCD Reference # 1RP-3805

The following *Final Closure Report* serves as a condensed update on closure activities for the above referenced Site.

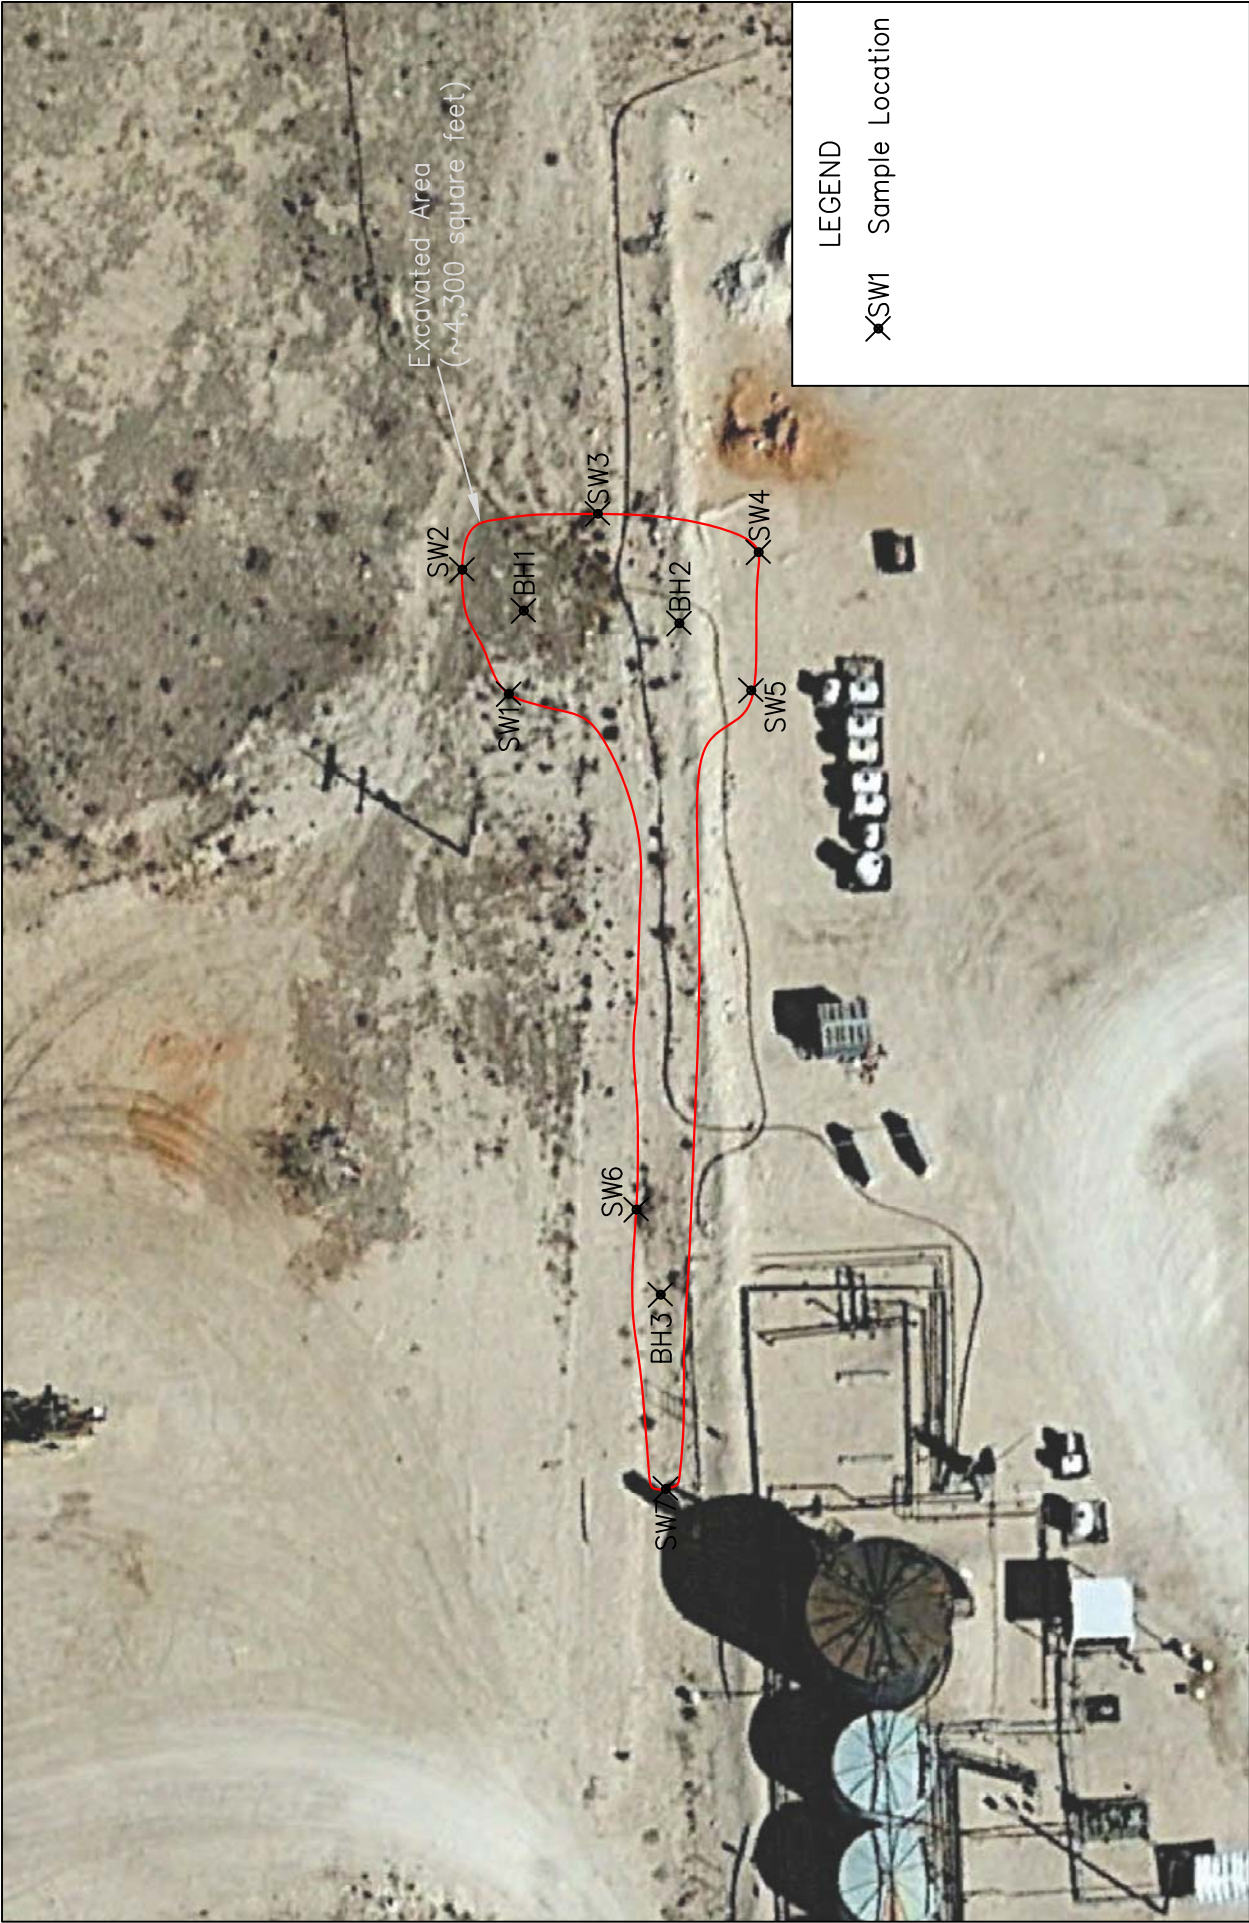
Figure 3 Sample/Site Map Chevron WDDU Tank Battery	Lea County, New Mexico NW 1/4 of NW 1/4, Sec. 32, T24S, R38E N 32° 10' 45.40" W 103° 5' 13.76" Elevation: 3,179 feet amsl	DWG By: D Dominguez October 2015		REVISED:	 
		0 40 80		SHEET	
		  Feet		1 of 1

On October 13, 2015 ten (10) soil samples were collected from ten (10) sample locations; SW1 – SW7 and BH1 – BH3. All samples were sent to Cardinal Labs in Hobbs, New Mexico for testing. Laboratory analytical results indicate the excavated area is void of Benzene, BTEX, TPH and Chloride concentrations in excess of NMOCD Recommended Remedial Action Levels (RRALs) of 10 mg/Kg, 50 mg/Kg, 5,000 mg/Kg, and 1,000 mg/Kg respectively (reference *Figure 3* and *Table 2*).

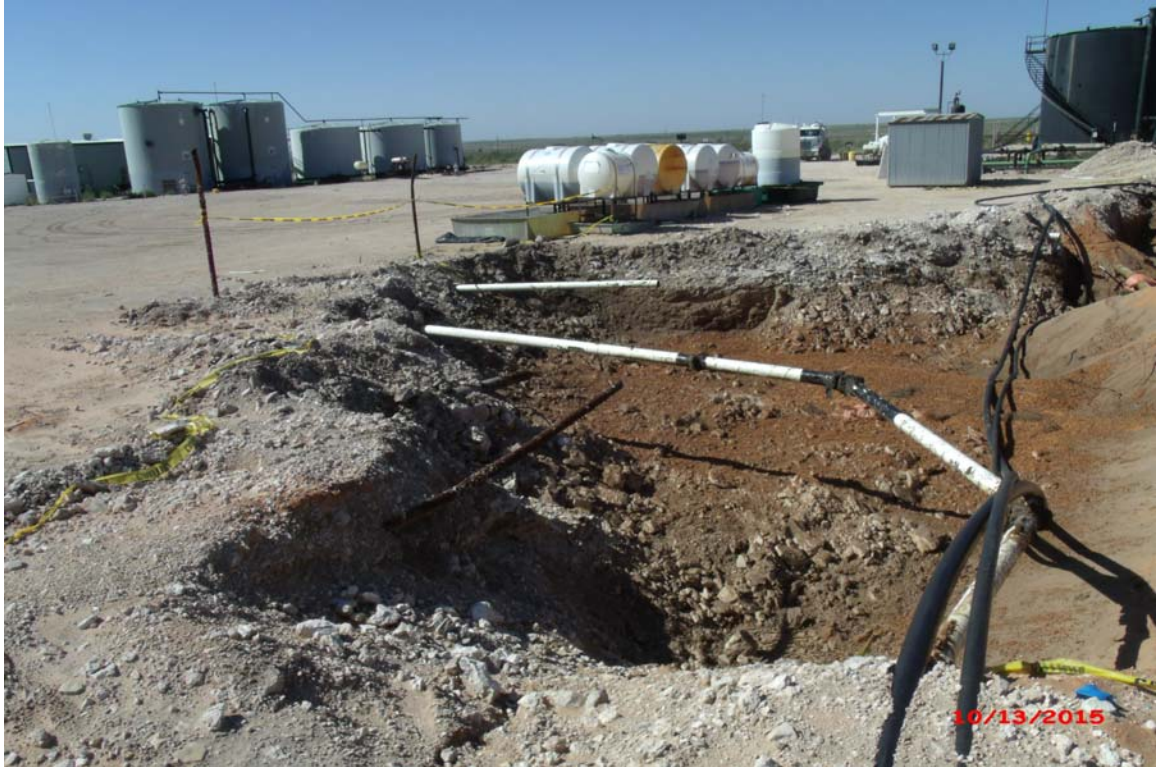
Photograph #1 – Looking west across excavation

The release area has been excavated to a depth of approximately six (6) feet bgs. Contaminated material was excavated and transported to a state approved facility for disposal.

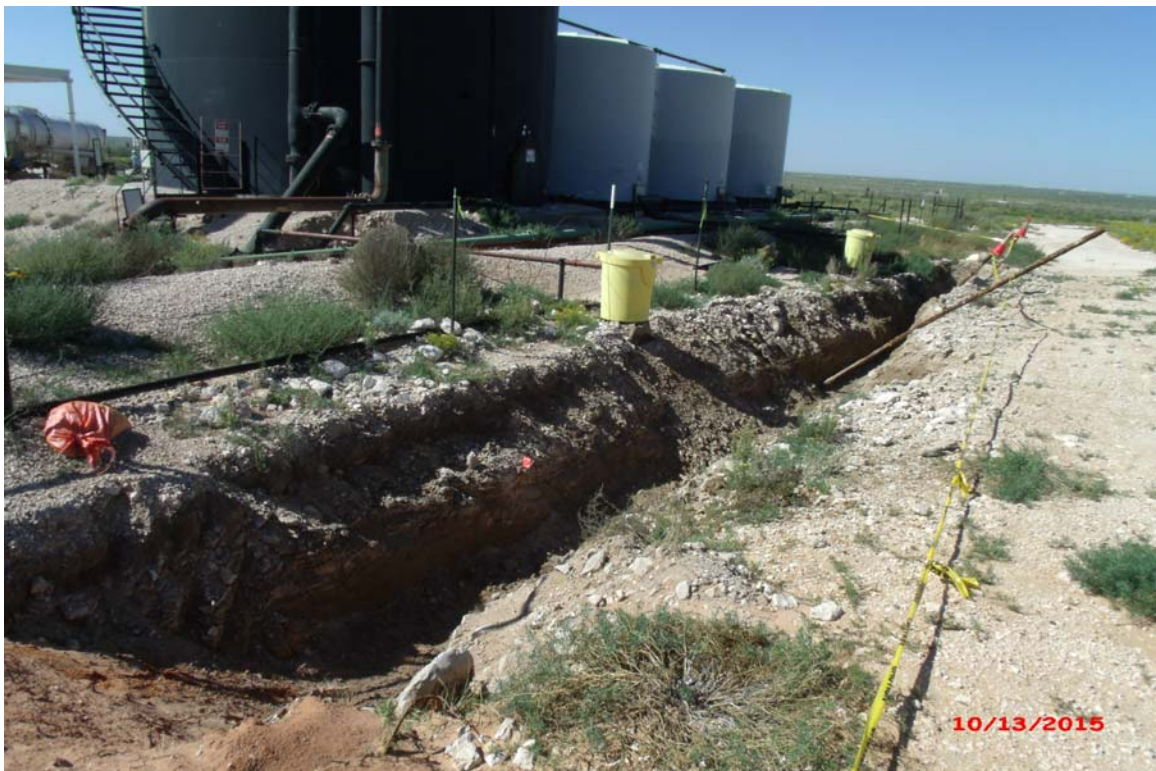
Photograph #2 – Looking west across excavation

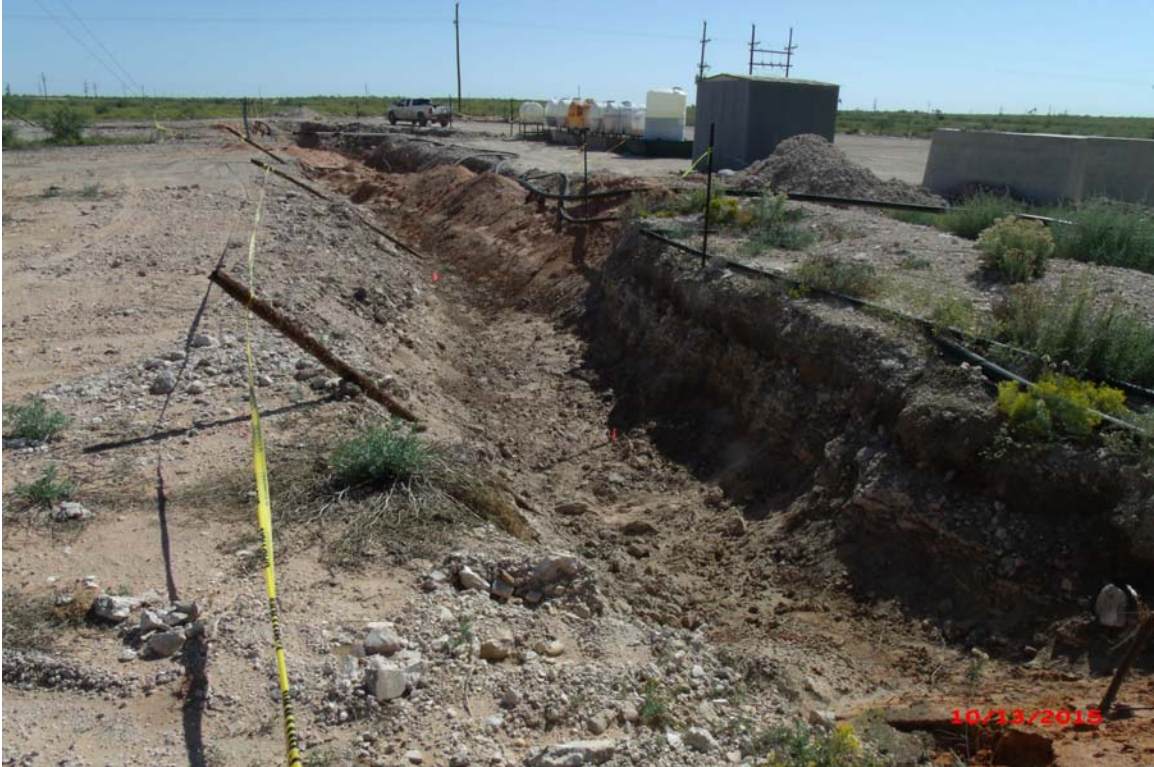
Photograph #3 – Looking east across excavation

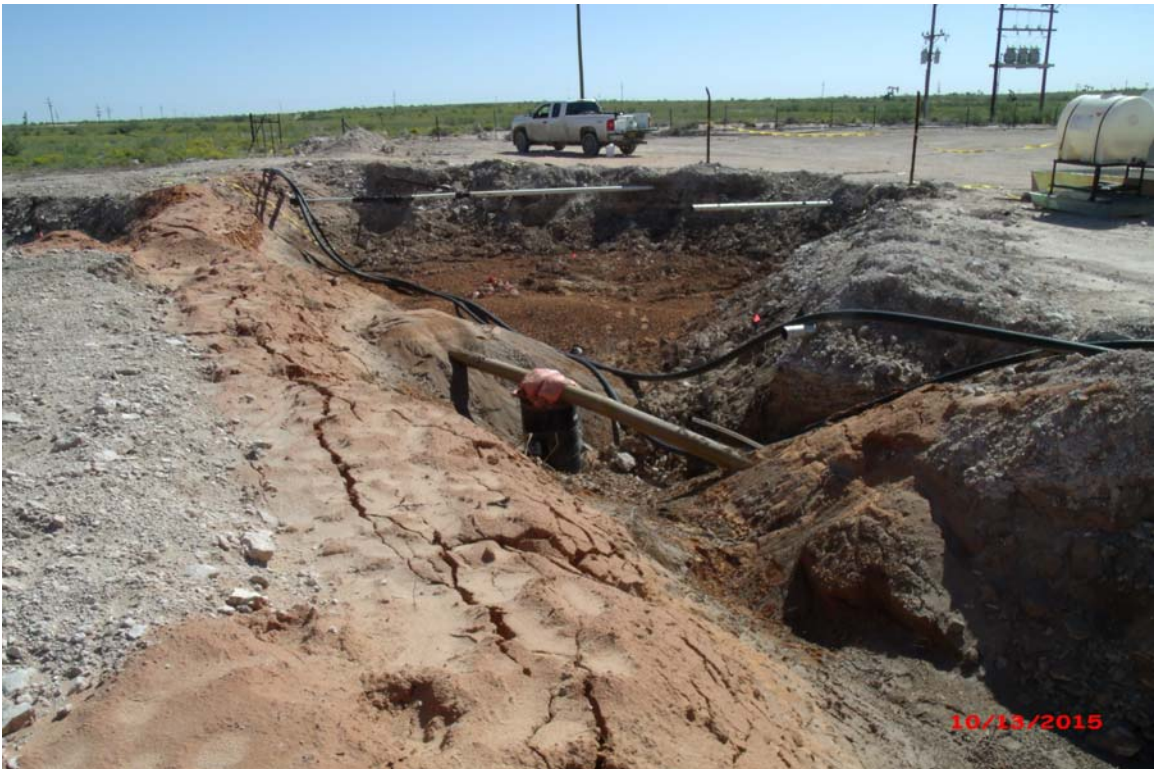
Photograph #4 – Looking east across excavation

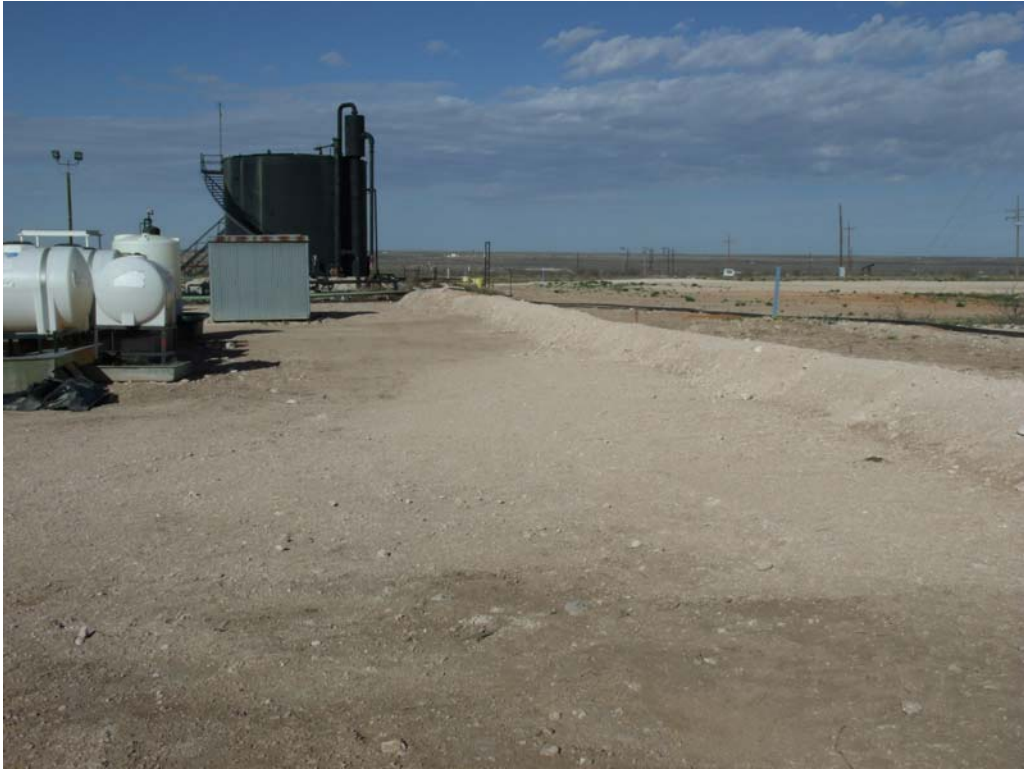
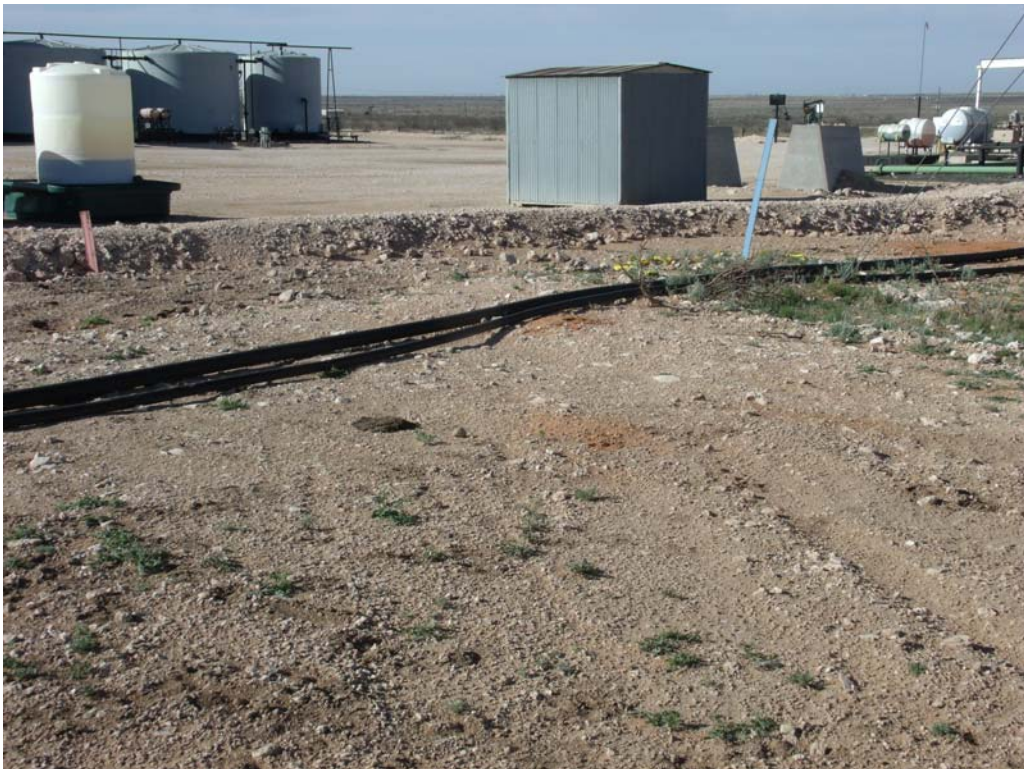
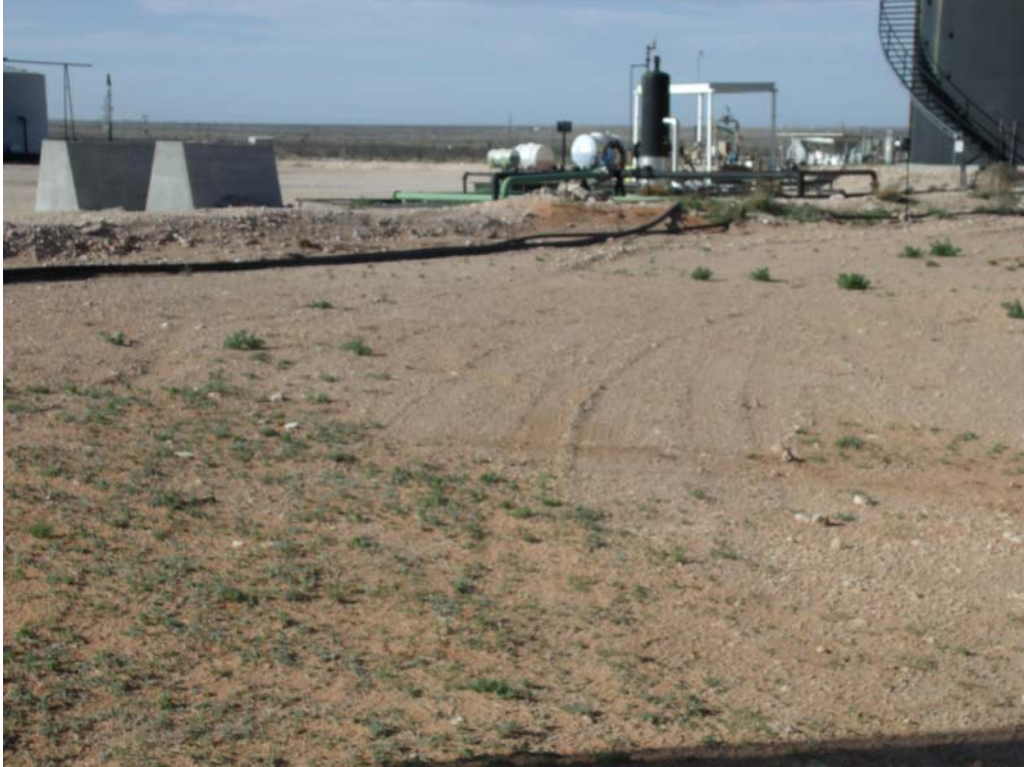
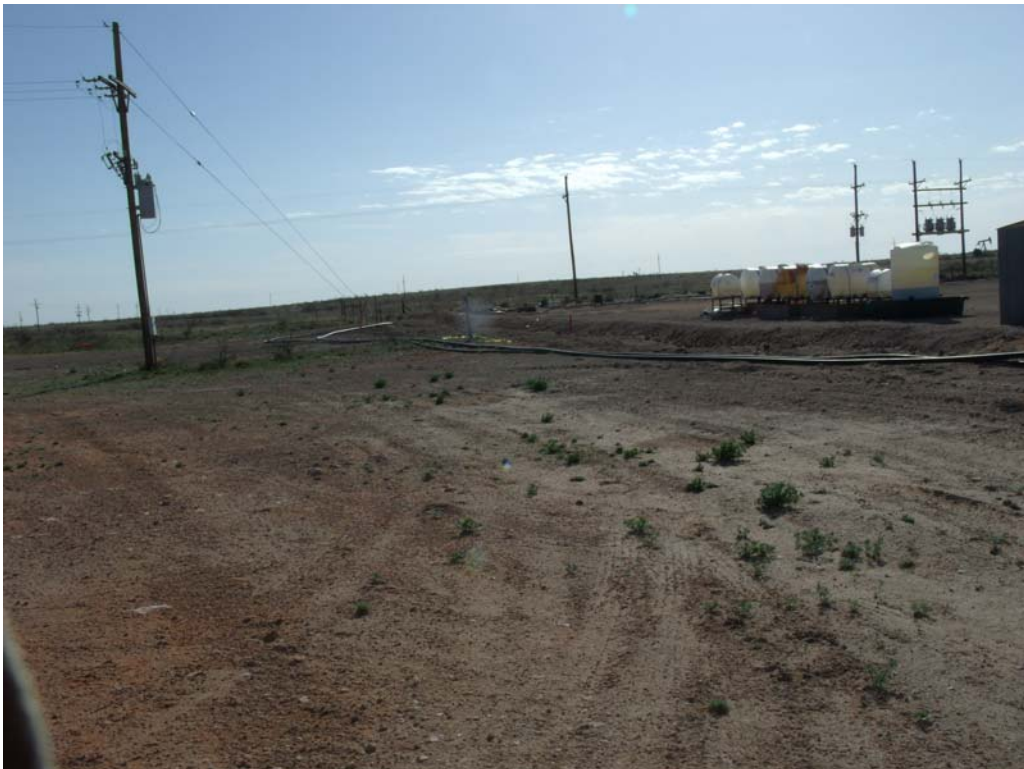
Photograph #5 – Backfilled

Photograph #6 – Backfilled

Photograph #7 – Backfilled

Photograph #8 – Backfilled

Based on laboratory analytical data indicating the excavation is void of contamination in excess of NMOCD RRALs, and with NMOCD approval the excavation has been backfilled with clean soil. Selected clean soil is free of deleterious material or rocks or large clumps.

Backfilling continued until the entire excavation was closed. Upon completion of backfill activities, the entire disturbed area was contoured to blend with existing pad location and pasture area, and protected against wind/water erosion.
