Hale State Battery

REMEDIATION WORK PLAN

API No. 30-025-02154 (Closest Well)

RE: Linn Energy, Hale State Battery – Remediation Work Plan
UL/E, Section 31, T17S, R34E
API No. 30-025-02154

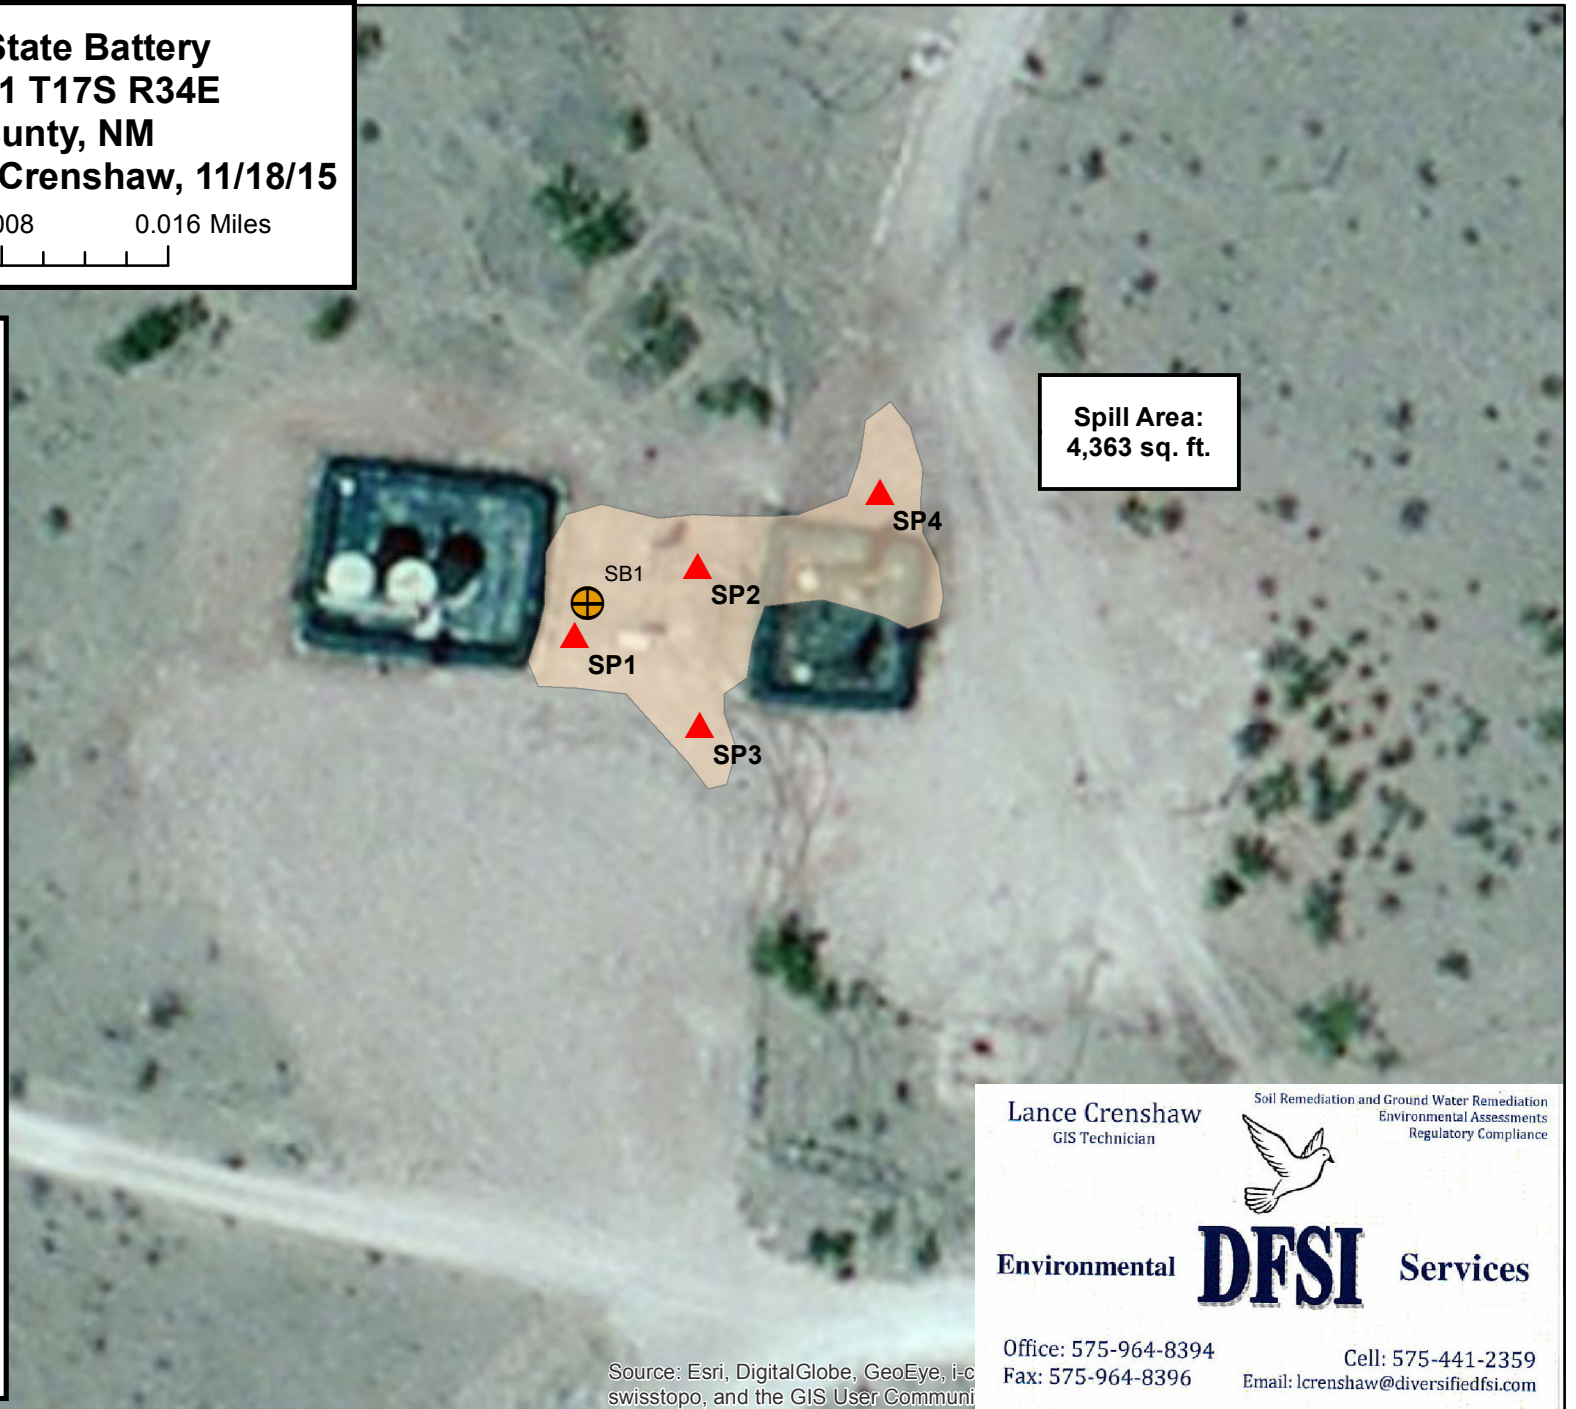
Site Diagram

Linn, Hale State Battery
UL/E, Sec. 31 T17S R34E
Eddy County, NM
Drafted By: Lance Crenshaw, 11/18/15

Spill Area:
4,363 sq. ft.

Scrape the spill area to 6" BGS except in the area of SP1 and SB1. The area of SP1 and SB1 will be excavated to 4' BGS. The entire excavated area will be backfilled with fresh caliche.

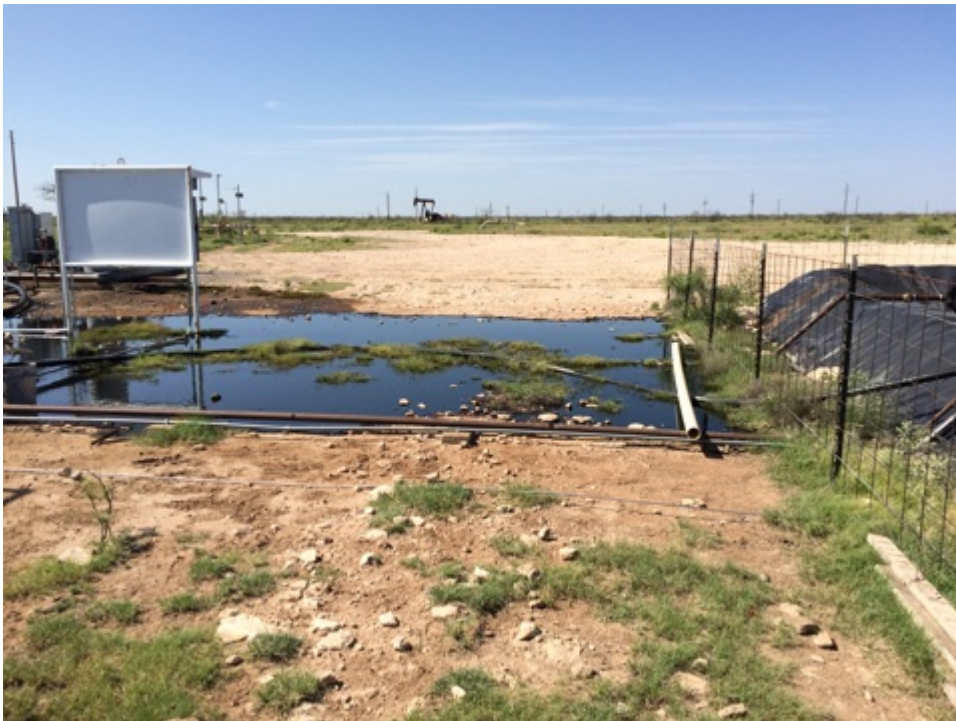
The site is located southeast of Maljamar, NM, in Eddy County. The leak site resulted from the heater losing all pressure, causing it to fill up with liquid, which came up through the gas line into separator, and popped off the ground. The impacted area was contained between the tanks and the heater, with some residual spray into the pasture. Approximately 50 bbls of oil was released, with 40 bbls recovered. A site map is attached. A C-141 was drafted on June 26, 2015, and is attached.

Initial spill photo

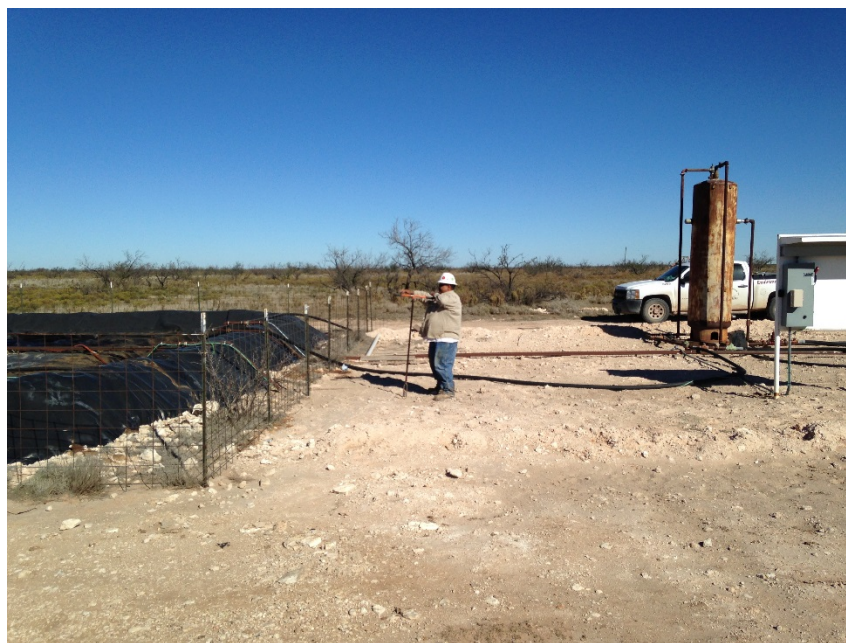
On June 30, 2015 DFSI personnel responded to the spill area and scraped up visible staining on the ground. On November 20, 2015, DFSI personnel returned to the location to begin sampling. Four points were sampled, and one bore hole was drilled. The samples were tested for chloride levels as well as BTEX. The BTEX samples were performed using a Mini Rae Photoionization Detector (PID). The field samples that field tested below state/BLM requirements were taken to Cardinal Lab of Hobbs to obtain confirmation sample. The results are attached.

Sampling spill area vertically

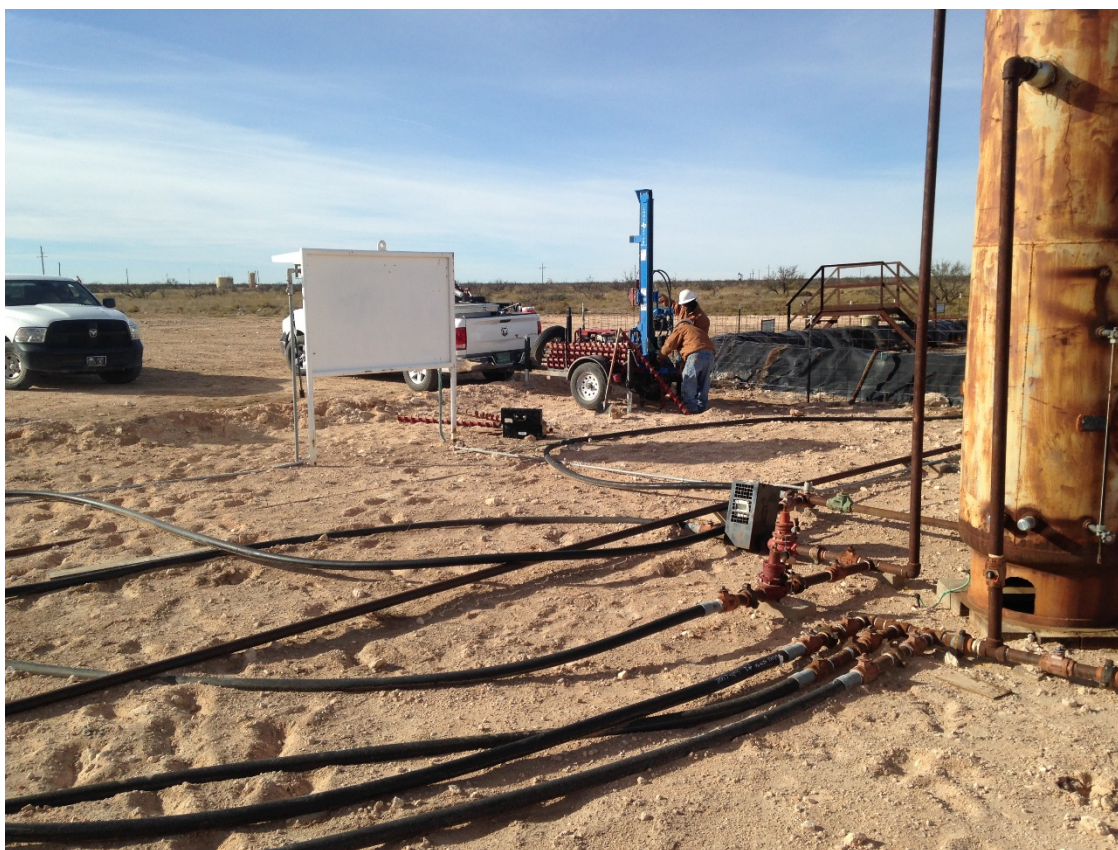
Using drill for bore hole
