SUBJECT: FINAL CLOSURE REPORT FOR INCIDENT 1RP-3943 at the ARMSTRONG ENERGY CORP,
GOVERNMENT E #7, API# 30-025-27896 LEA COUNTY, NEW MEXICO

SOIL REMEDIATION FINAL CLOSURE FOR INCIDENT 1RP-3943

ARMSTRONG ENERGY CORPORATION
GOVERNMENT E #7
API# 30-025-27896
UL C SECTION 25, T19S R34 E, NMPM
LEA COUNTY, NM

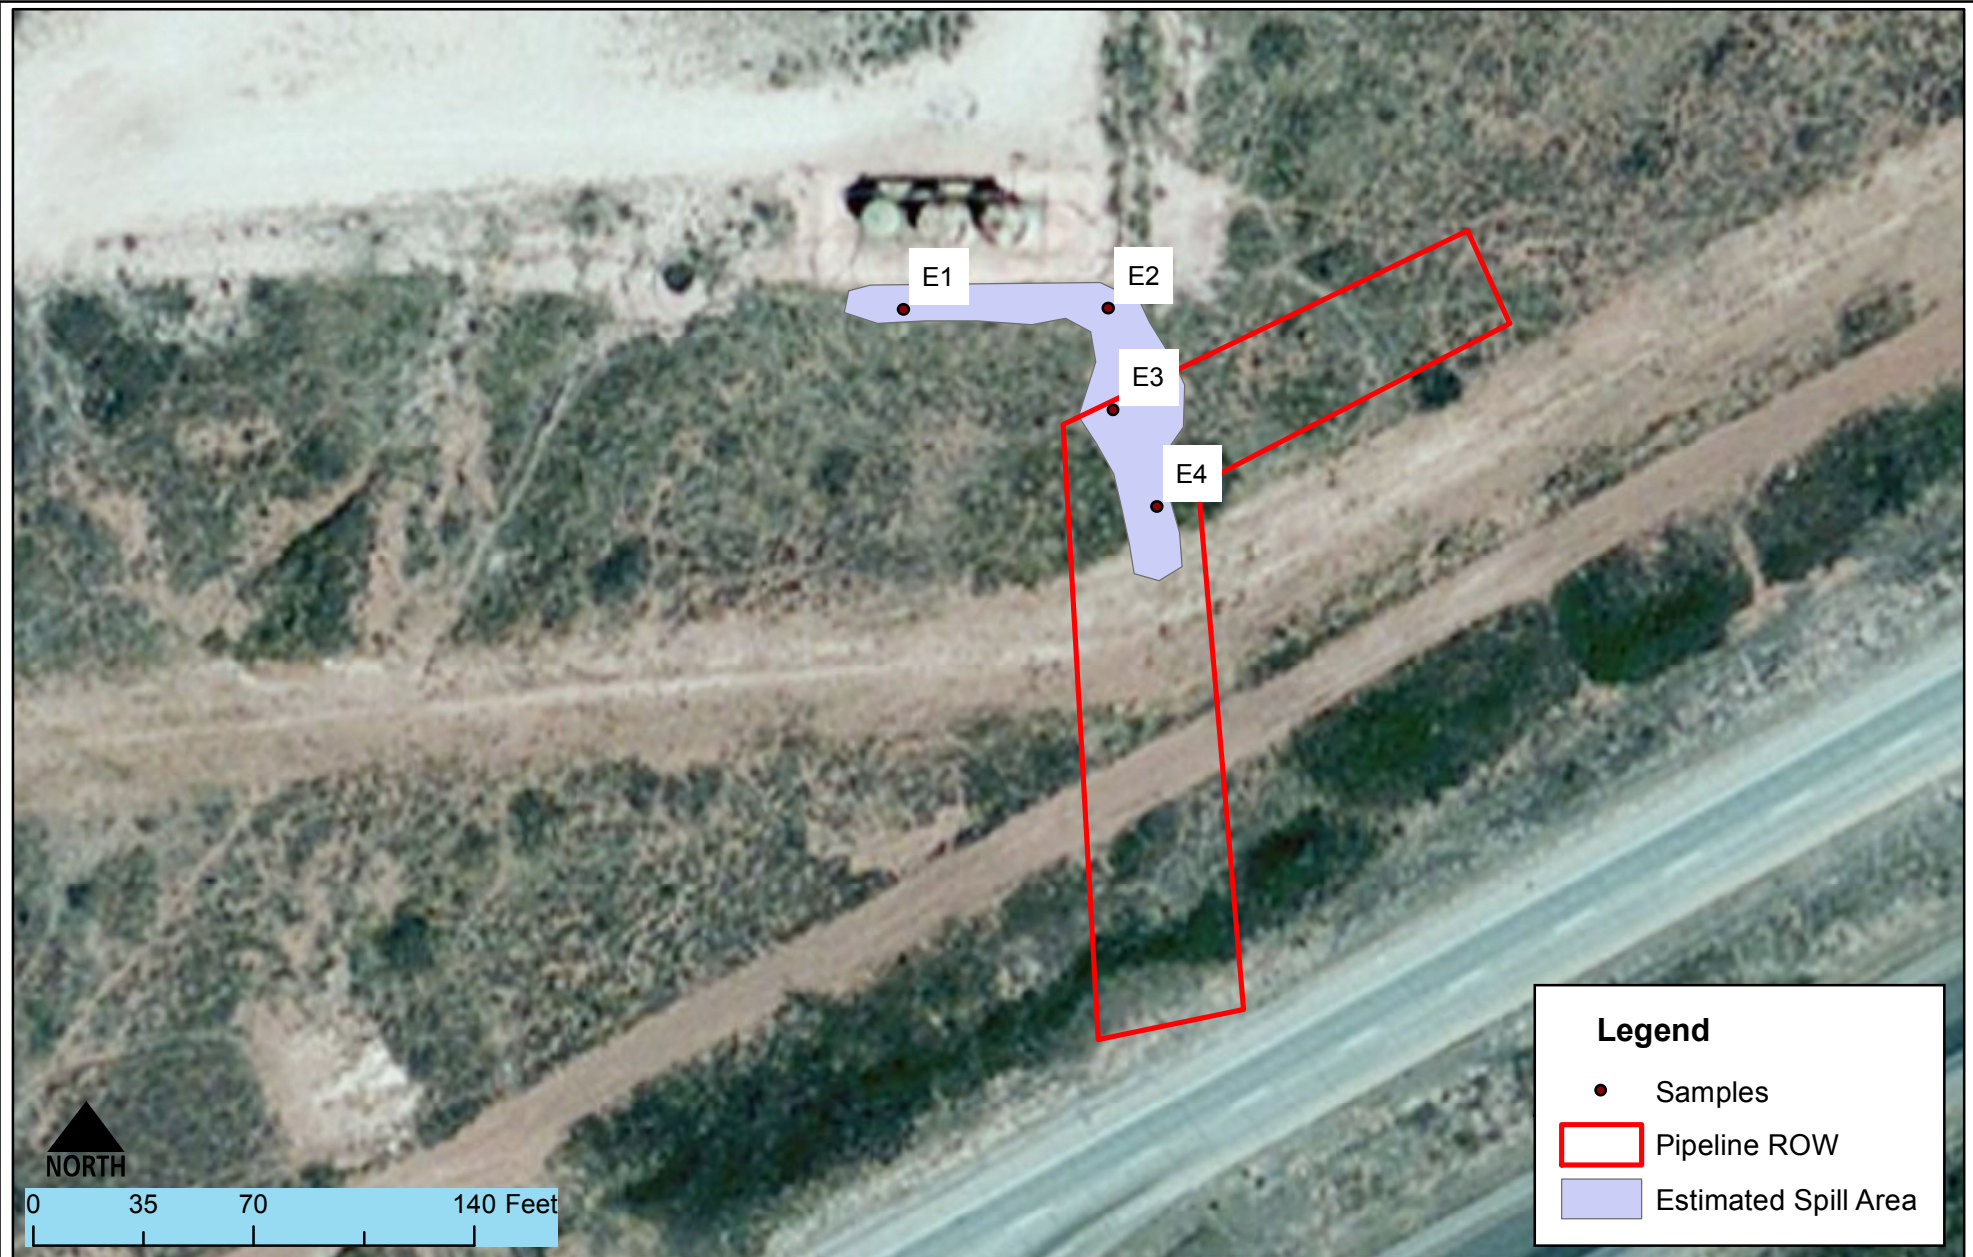
Figure 2: Site Details and Sample Location Map

Soil sample locations taken during the initial delineation are illustrated in Figure 2. A summary of laboratory analytical results is included in Table 4. Laboratory analytical reports are included in Appendix A.

Site Detail and Sample Locations
Armstrong Energy- Government E #7
Hobbs, New Mexico
