State J2 Battery (1RP-3466)

Termination Request

**RE: Termination Request
ConocoPhillips State J2 Battery (1RP-3466)
UL/I sec. 2 T22S R36E
API No. 30-025-33277**

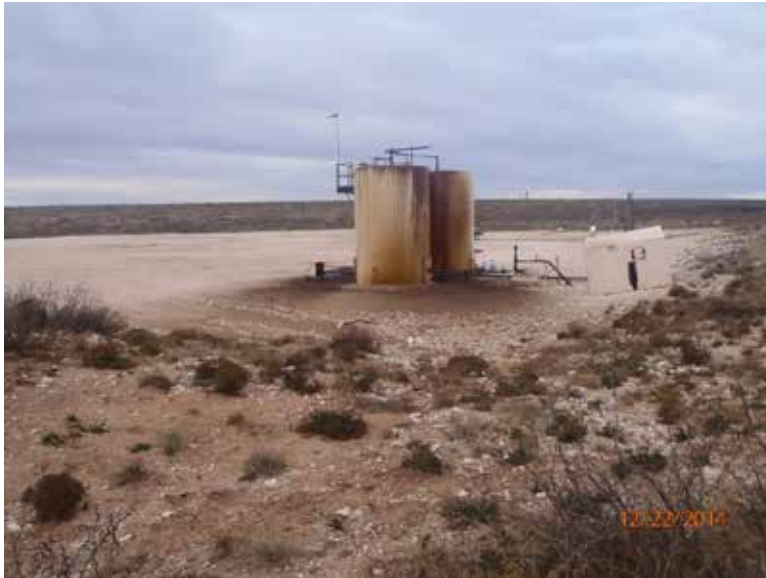
12/22/14

Initial release area, facing southwest

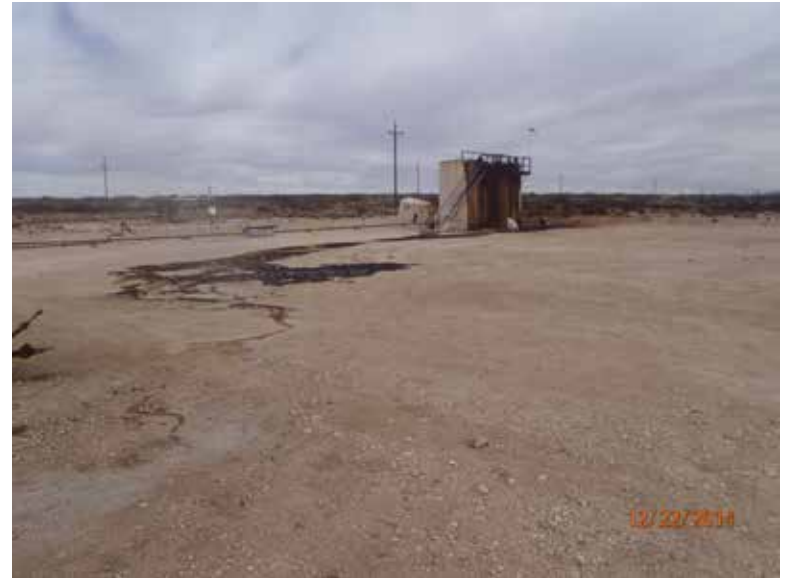
12/22/14

Initial release area, facing northeast

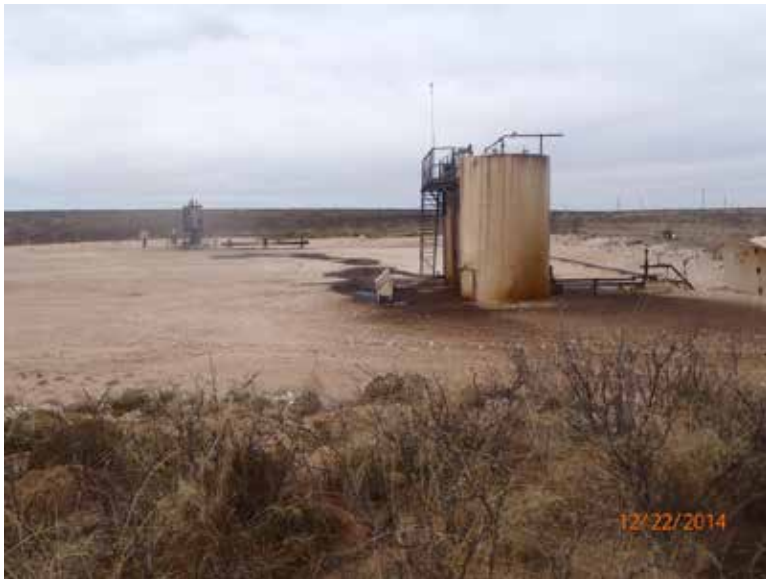
12/22/14

Initial release area, facing west

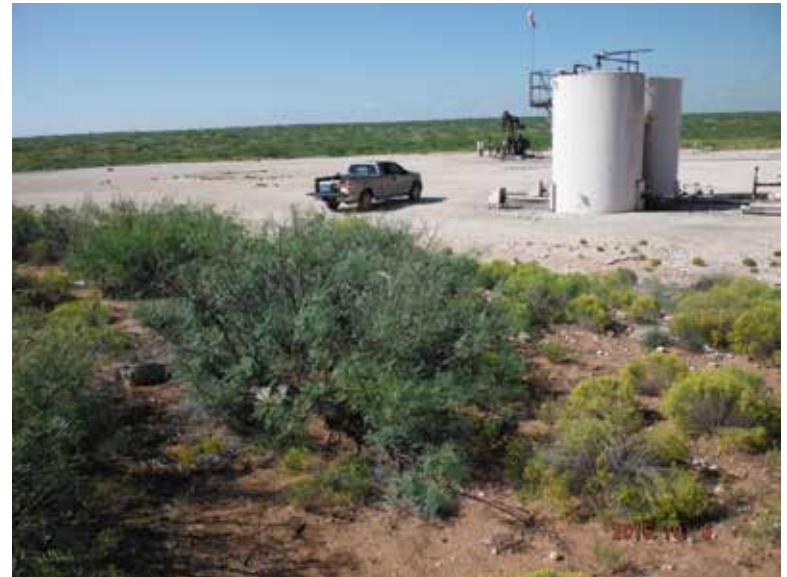
10/06/15

Washed overspray area, Facing southwest

The overspray on the pasture and pad around Points 1 and 2 was washed with clean water and Dawn dish soap to remove any staining.

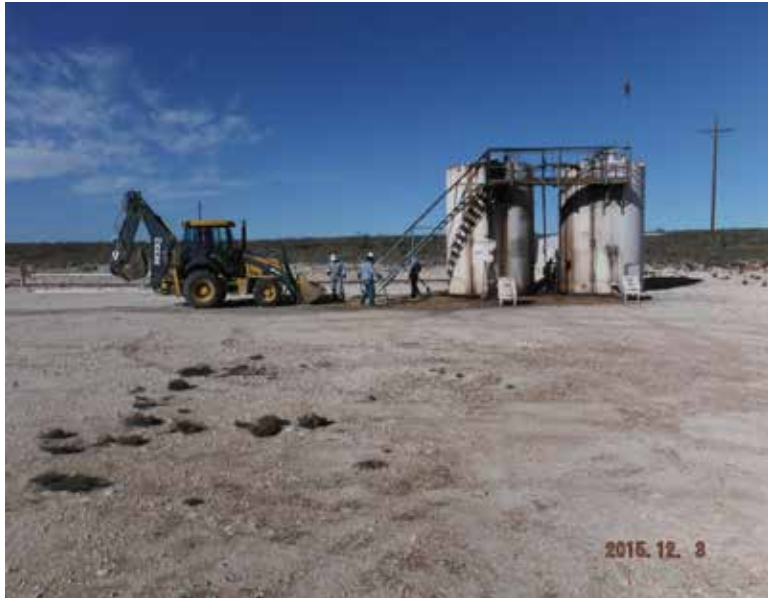
12/3/15

Scraping leak area, facing north

CAP activities began on December 3rd, 2015. The release was scraped to a depth of 6" around points 3 & 4 and approximately 30 yards was taken to NMOCD approved facility for disposal. At the base of the scrape 2 discreet samples were obtained and sent to a commercial laboratory for analysis (Appendix B). The discreet sample at PT. 1 @6" returned a chloride result of 48 mg/kg, GRO of < 10 and DRO of 15.8. The discreet sample at PT. 2 @6" returned a chloride result of <16 mg/kg, GRO of <10 and GRO <10. Basin received backfill approval from NMOCD on December 9th, 2015 and on December 16th, 2015 approximately 30 yards base course was imported to site. A sample of the imported soil was also taken to a commercial laboratory for analysis. The imported sample returned a chloride result of 32 mg/kg. Site was backfilled with imported material.

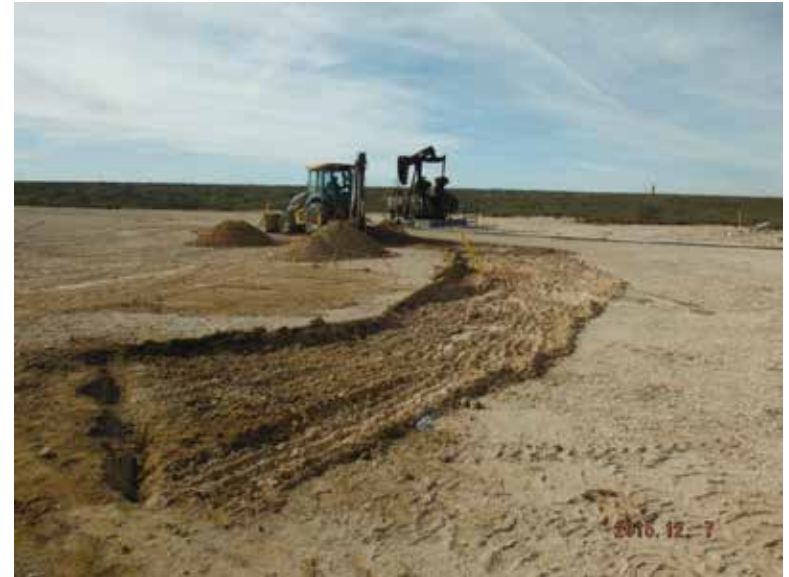
12/7/15

Scraping leak area, facing south west

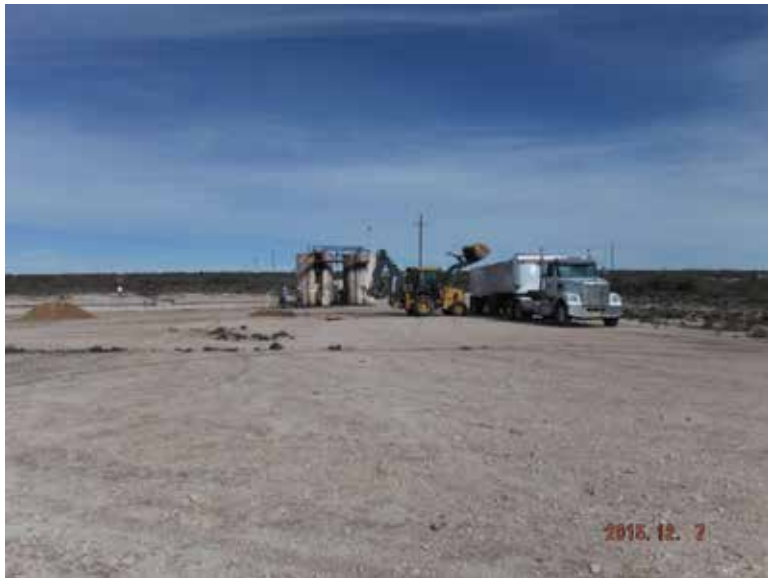
12/7/15

Exporting soil, facing north east

All excavated soils will be taken to a NMOCD approved facility for disposal. Clean soil will be imported to the site to use as backfill. A sample of the imported soil will be taken to a commercial laboratory to confirm that the chloride reading is below regulatory standards. The scrape will be backfilled with the clean, imported soil and contoured to the surrounding location.

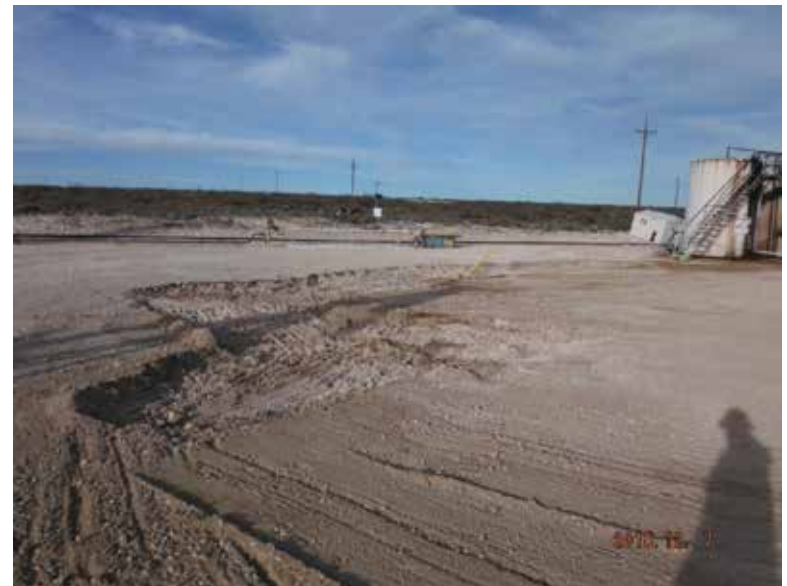
12/7/15

Final scrape photo, facing north east

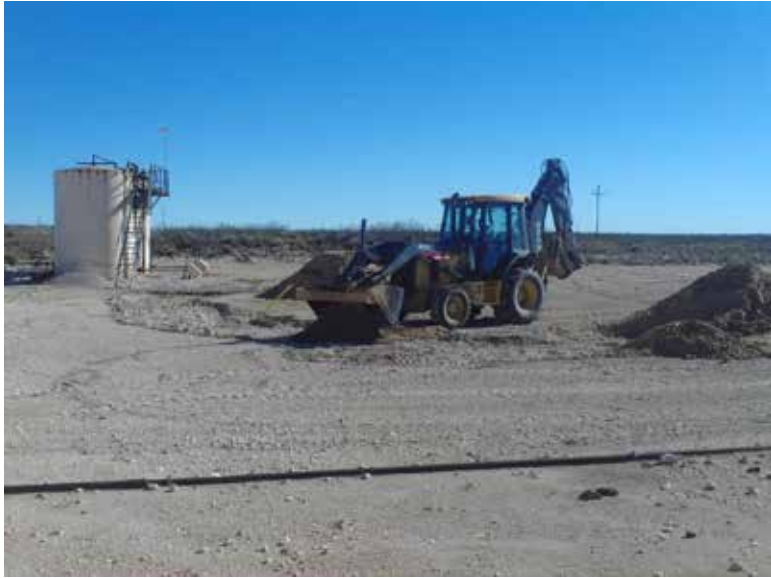
12/16/15

Backfilling site, facing east

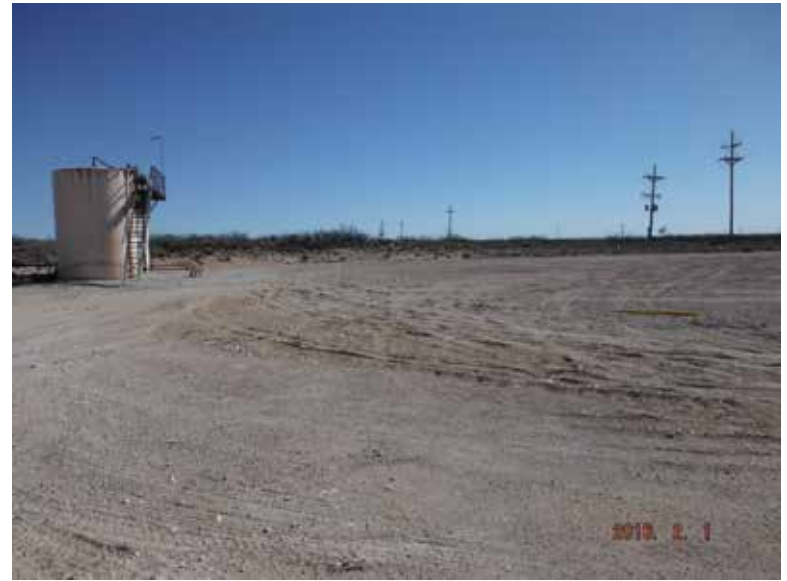
2/1/16

Final photo, facing west

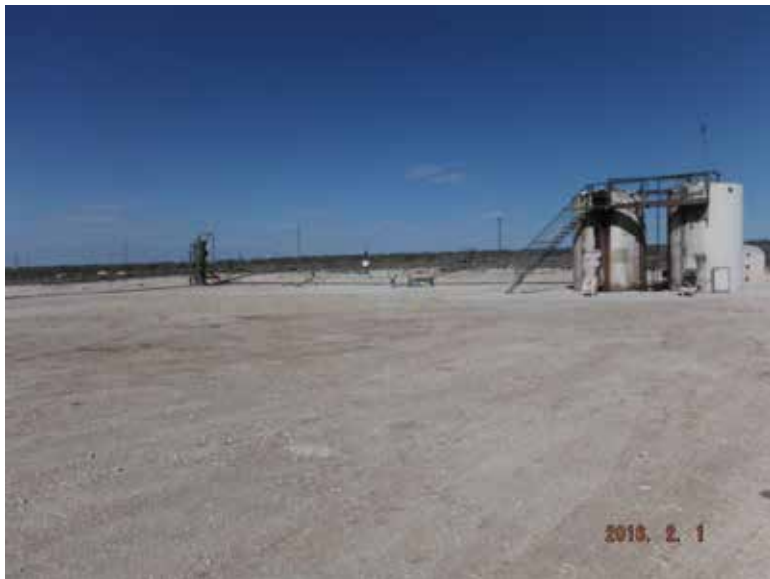
2/1/16

Final photo, facing west
