Meyer B-31 #006
(1RP-3484)

Termination Request

**RE: Termination Request
ConocoPhillips Meyer B-31 #006 (1RP-3484)
UL/C sec. 31 T20S R38E
API No. 30-025-35143**

CONOCOPHILLIPS
MEYER B-31 #006

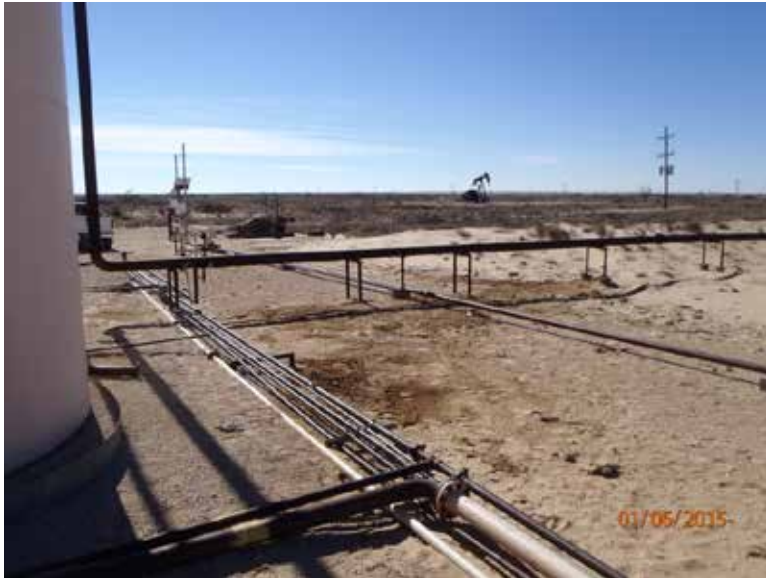
1/6/15

Initial release area, facing southwest

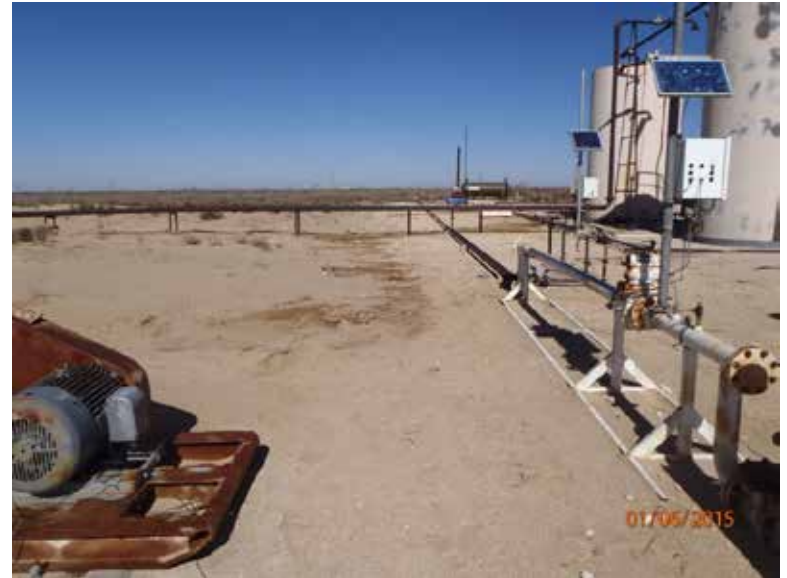
1/6/15

Initial release area, facing north

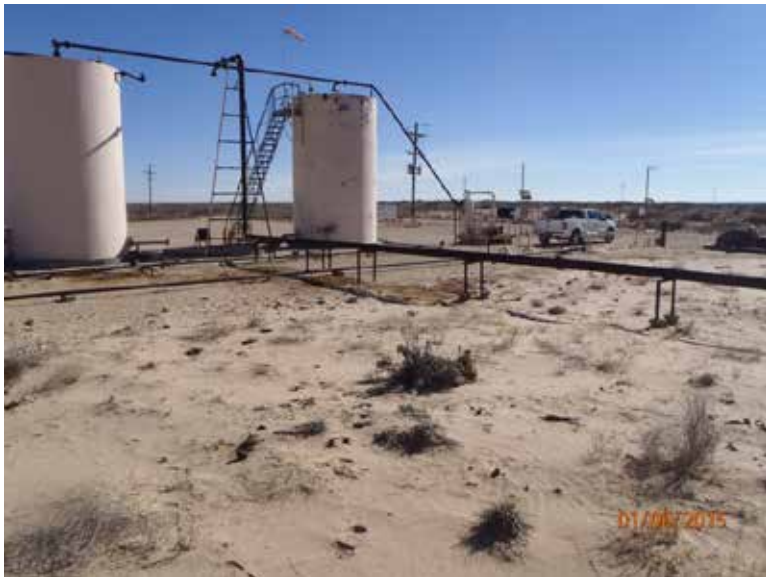
1/6/15

Initial release area, facing southeast

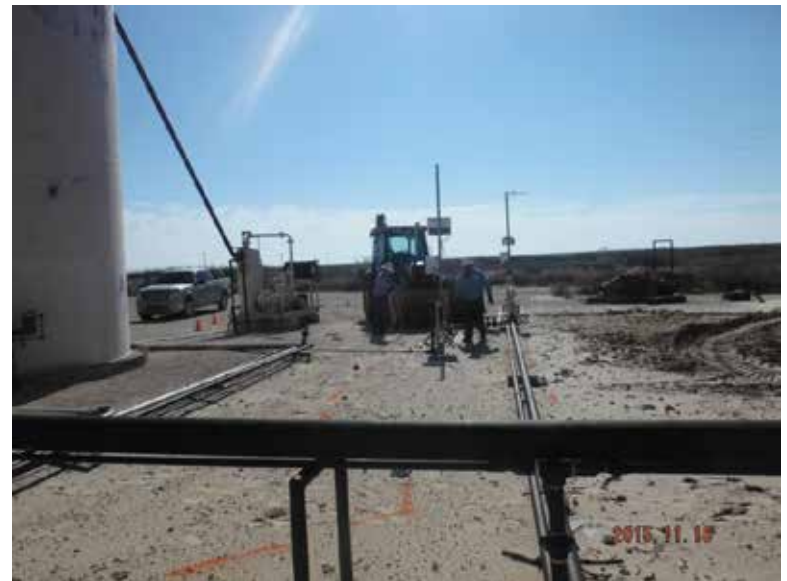
11/16/15

Hand Shoveling 6" scrape, facing south

CAP activities began November 16th, 2015. The release area around Point 2 was scraped 6" bgs (Figure 1). Two discreet bottom samples were taken from the base of the excavation and sent to a commercial laboratory for analysis. Laboratory analysis of Point 1 & Point 2 returned a chloride and a GRO and DRO and BETEX values of non-detect. A request to backfill the site was sent to BLM and NMOCD November 18th, 2015 both agencies approved on November 19th, 2015. Approximately 12 cubic yards of contaminated soil was exported and disposed of at a NMOCD approved facility. A total of 12 cubic yards of caliche was imported for backfill. A sample of the imported soil was taken and sent to a commercial laboratory for analysis. Laboratory analysis returned a chloride level of 64.0 mg/kg. The site was backfilled with the clean, imported soil and contoured to the surrounding location.

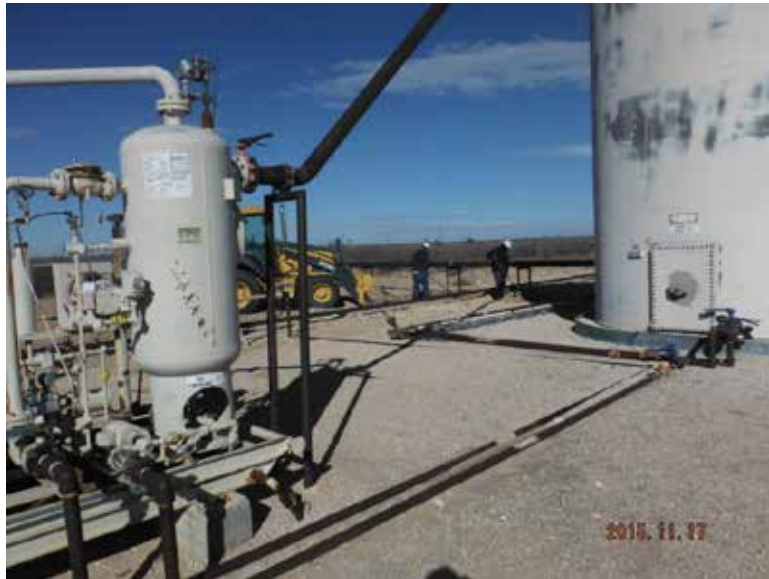
Hand Shoveling 6" scrape, facing north west 11/17/15

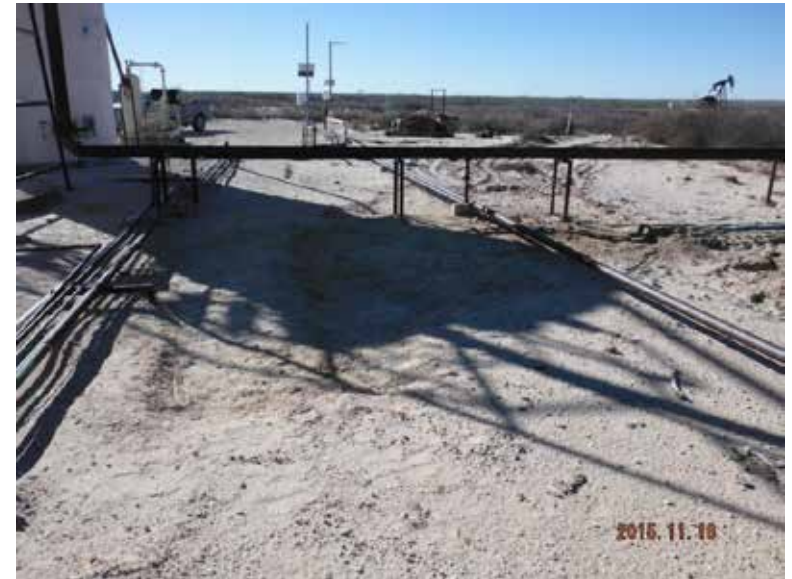
6" scrape complete, facing south 11/18/15

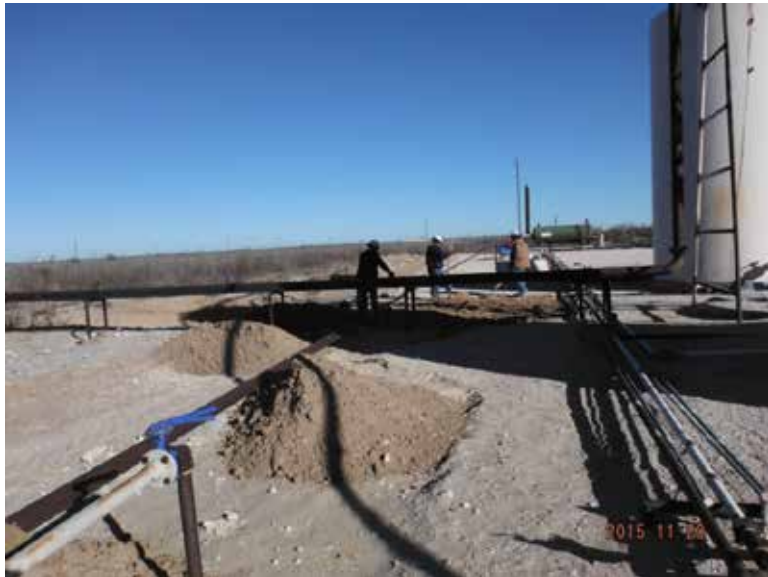
Backfilling, facing north 11/20/15

All excavated soils would be taken to a NMOCD approved facility for disposal. Clean soil would be imported to the site to serve as backfill. A sample of the backfill soil would be taken to a commercial laboratory to confirm that the chloride reading is below regulatory standards. The scrape would be backfilled with clean, imported caliche and contoured to the surrounding location.

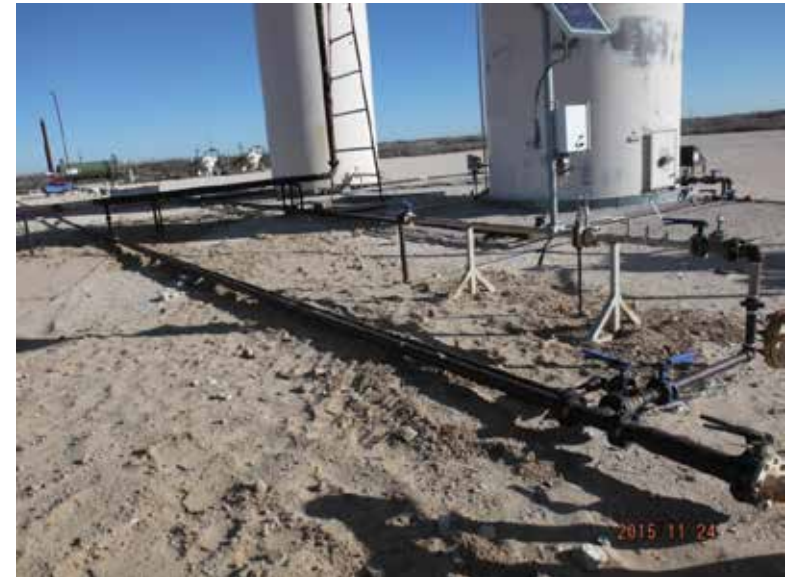
Site backfilled, facing north 11/24/15
