# CONOCOPHILLIPS

Vac Abo #04  
(1RP-3714)

## Corrective Action Plan

**RE: Corrective Action Plan  
ConocoPhillips Vac Abo #04 (1RP-3714)  
UL/D sec. 35 T17S R35E  
API No. 30-025-26931**

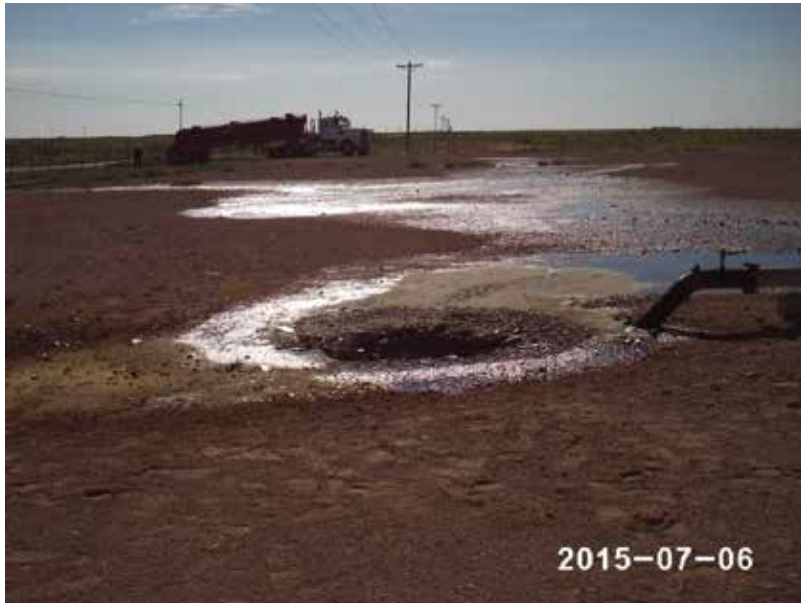
7/6/15

Source, facing east

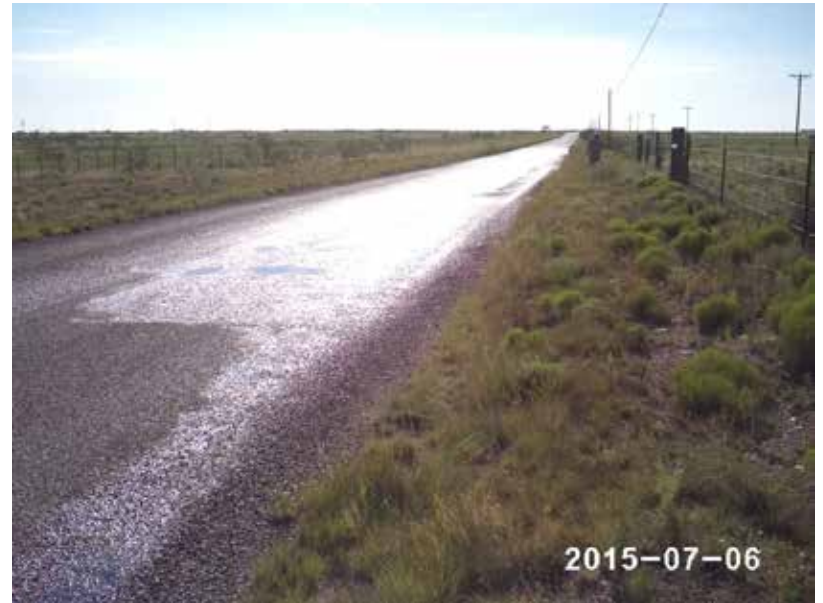
7/6/15

Spill down roadway facing east

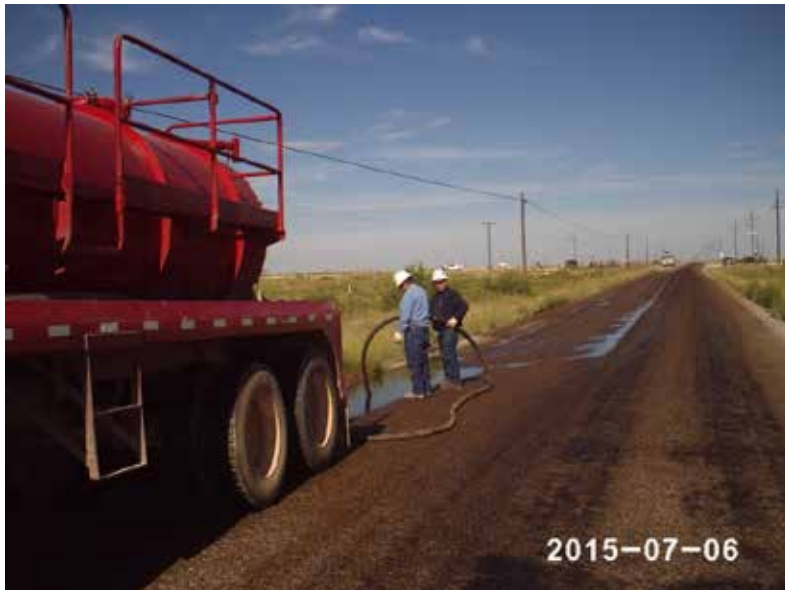
7/6/15

Vacuuming spill off road

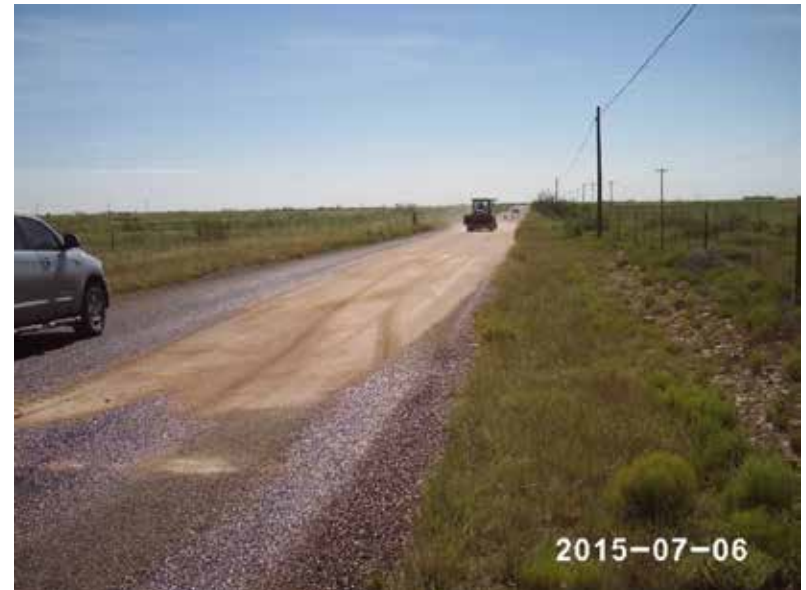
Covering spill area on road with caliche facing east 7-6-15

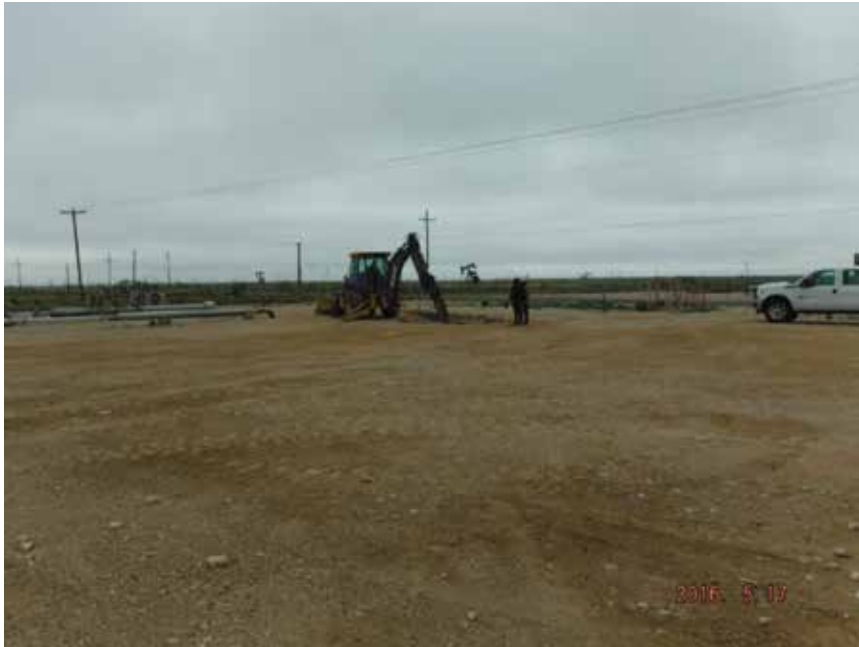
5/17/16

Installing vertical facing northwest

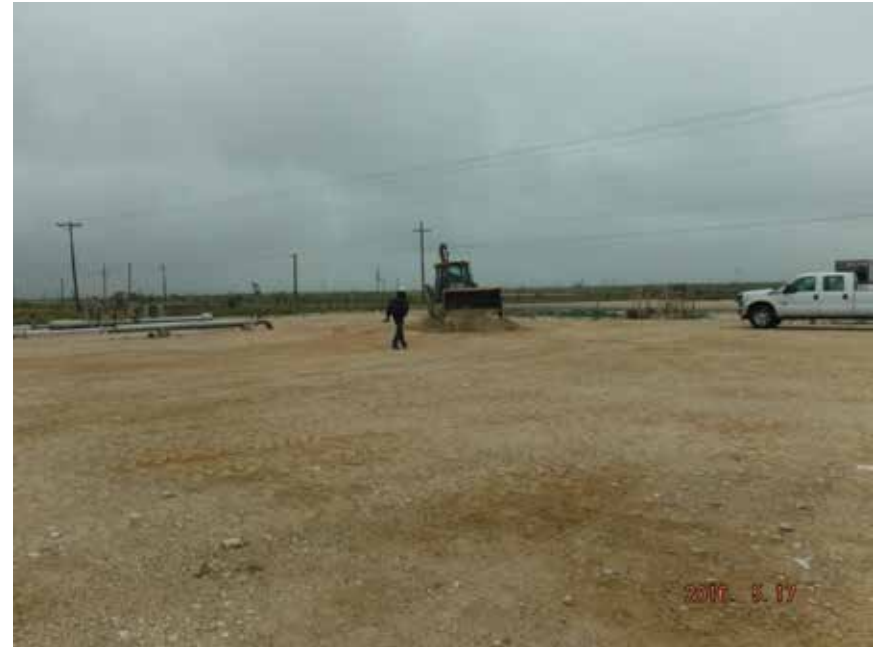
5/17/16

Backfilling vertical facing northwest

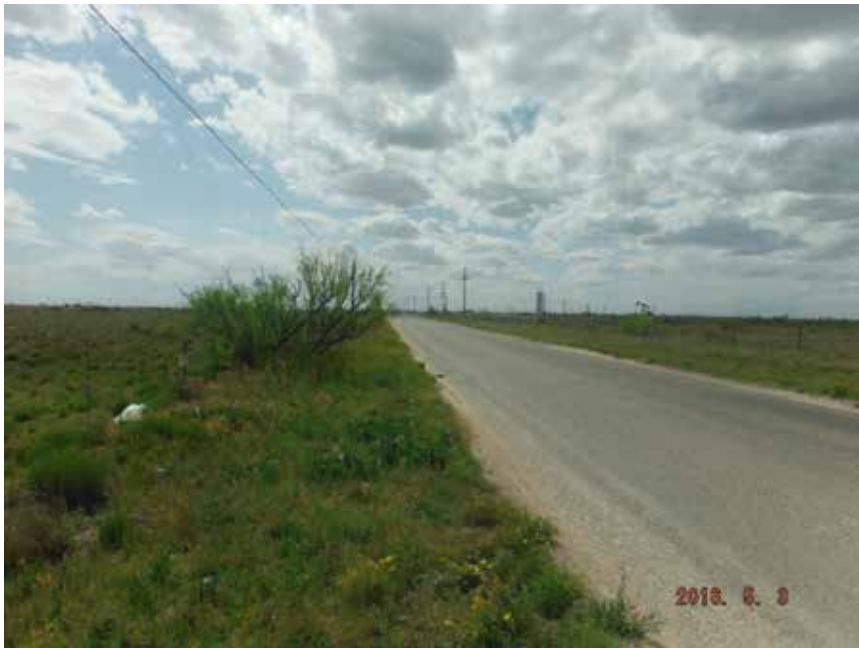
5/3/2016

Road facing west

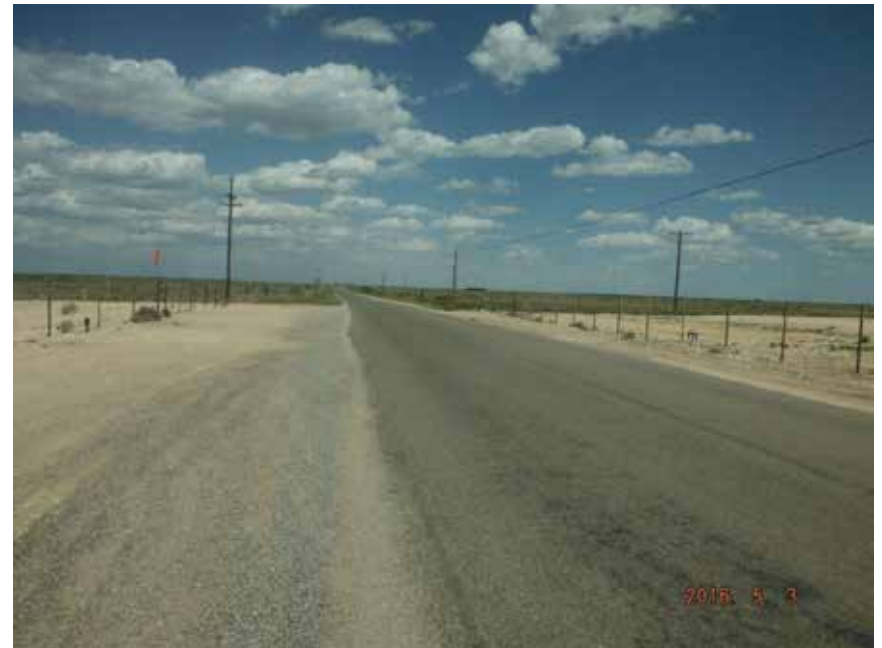
5/3/2016

Road facing east
