# Remediation Summary and Closure Report

New McKee Junction Sump
Plains SRS No. 2015-175
NMOCD Ref. No. 1RP-3841
Lea County, New Mexico
Unit Letter "K", Section 29, Township 20 South, Range 38 East
Latitude 32.54213° / Longitude -103.17194°

June 13, 2016 Terracon Project No. AR157452

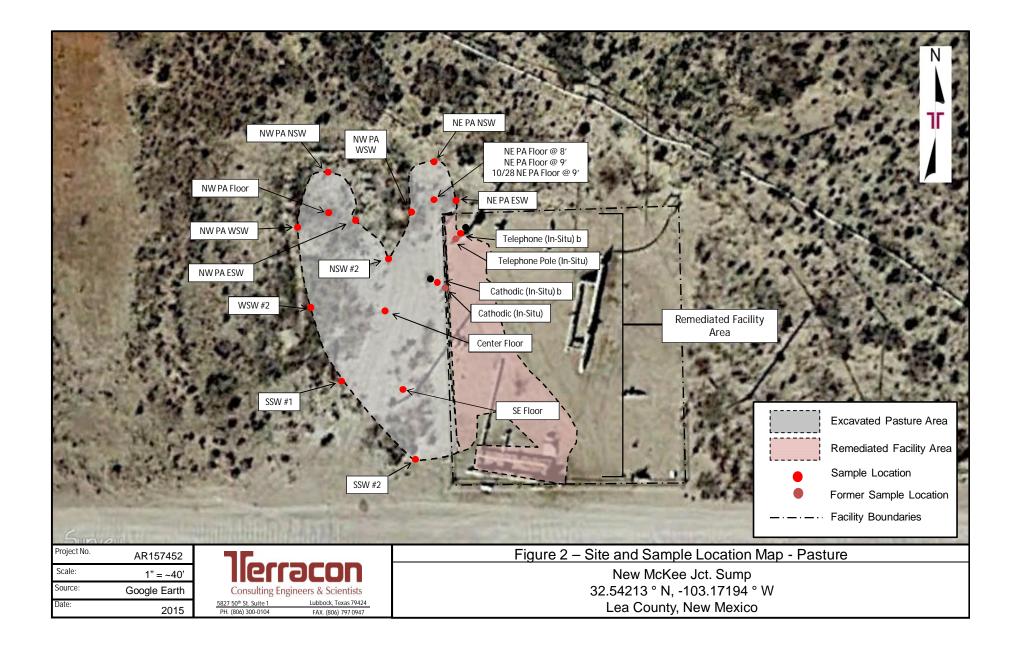
Figure 1 – Site Location Map Figure 2 – Site Diagram - Pasture Figure 3 – Site Diagram - Facility

Following notification of a crude oil release that occurred on August 28, 2015 at the New McKee Junction facility, Terracon visited the site with a Plains representative. The release was attributed to the failure of a check valve causing an on-site sump to overfill. It is estimated that approximately 40 bbls of crude oil were released, with approximately 35 bbls being recovered. The release affected an area measuring approximately 1,800 sq. ft. within the facility boundaries before flowing west affecting area measuring approximately 6,000 sq. ft. adjacent to the facility. During initial response activities, Plains personnel responded to the reported incident, secured the release site, recovered free-standing fluid and repaired the affected check valve. A "Site Diagram" is provided as Figure 2 in Appendix A.

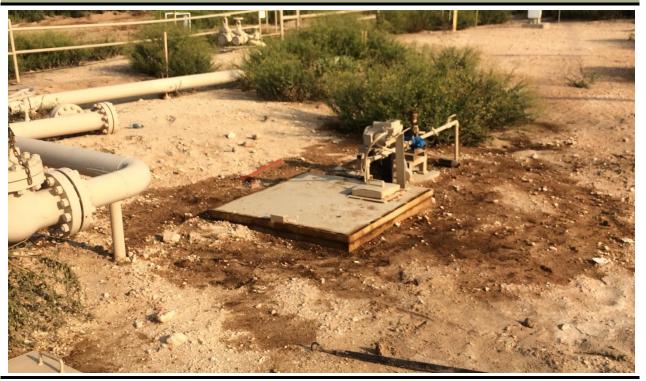
PHOTO 1: View of surface staining from the initial release, facing northwest.

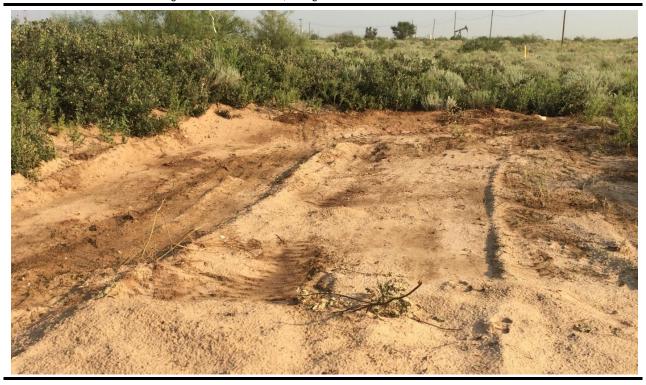
**PHOTO 2:** View of surface staining from the initial release, facing north.

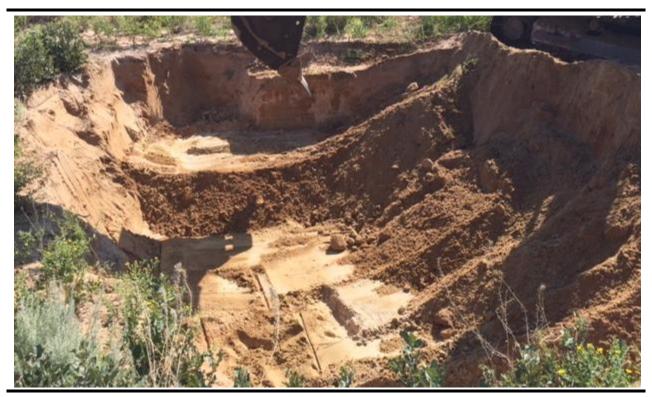
PHOTO 3: View of excavation activities within the affected pasture, facing east.

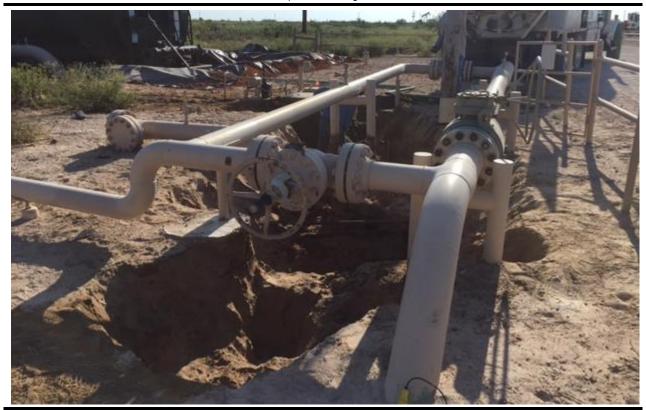
**PHOTO 4:** View of hydroexcavation activities under facility piping, facing east.

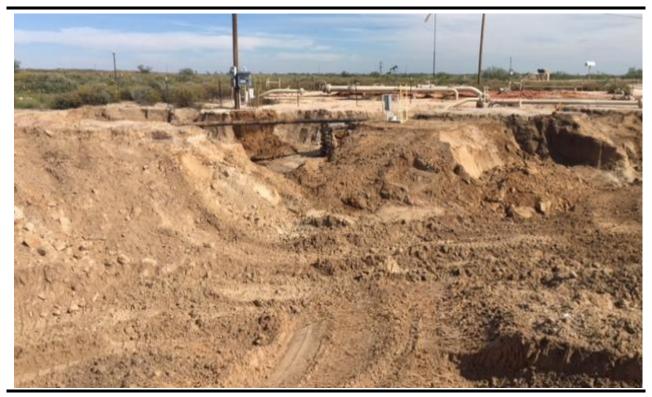
PHOTO 5: View of the excavated area within the affected pasture, facing east.

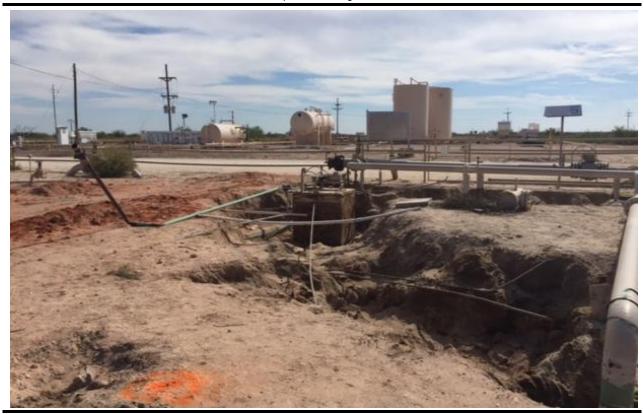
**PHOTO 6:** View of portion of the excavated area within the facility before installation of new piping, facing southeast.

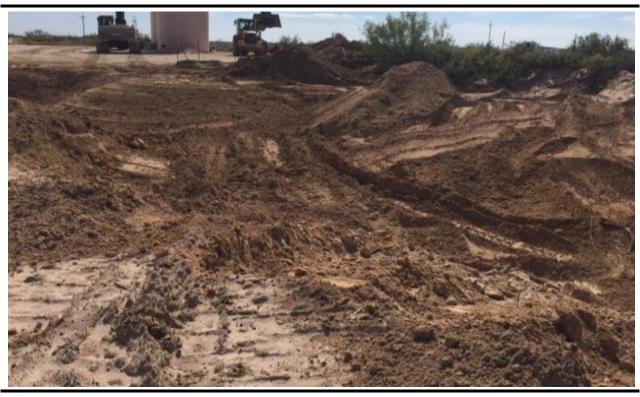
PHOTO 7: View of backfilling activities within the affected pasture, facing south.

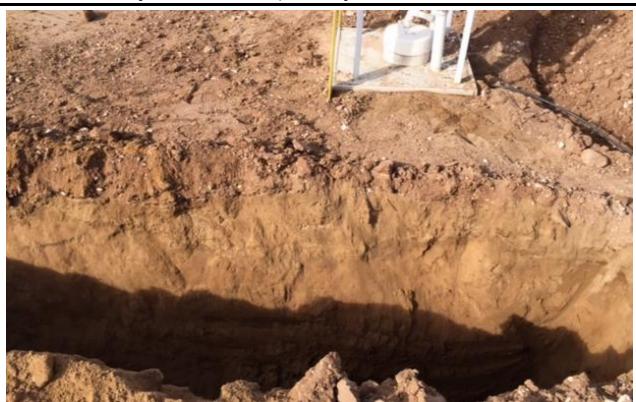
PHOTO 8: View of excavation of affected soil adjacent to cathodic protection system, facing west.

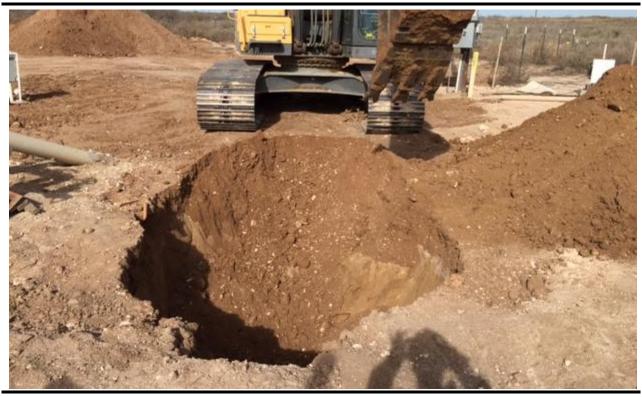
PHOTO 9: View of the advancement of DT-1, facing northwest.

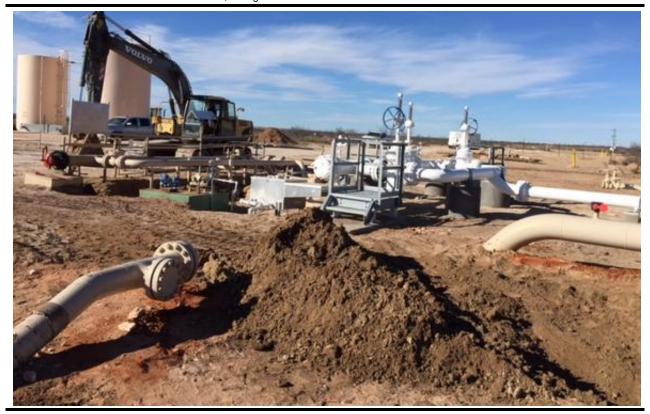
PHOTO 10: View of delineation activities, facing southwest.

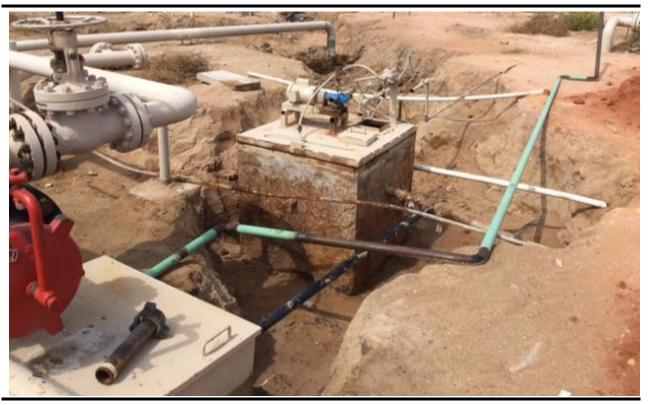
PHOTO 11: View of portion of excavated area, facing northwest.

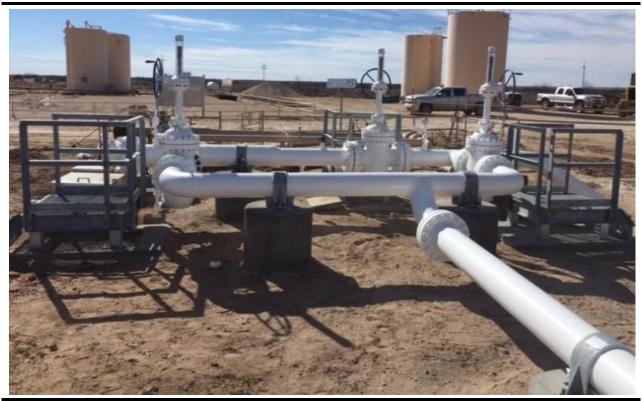
PHOTO 12: View of newly installed piping and valve settings, facing south.

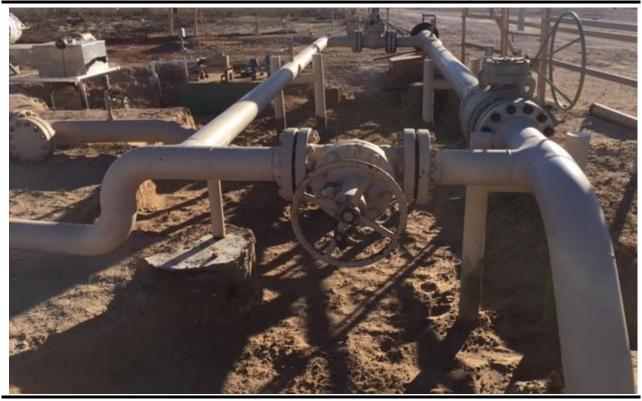
PHOTO 13: View of portion of the excavated area within the facility, facing east.

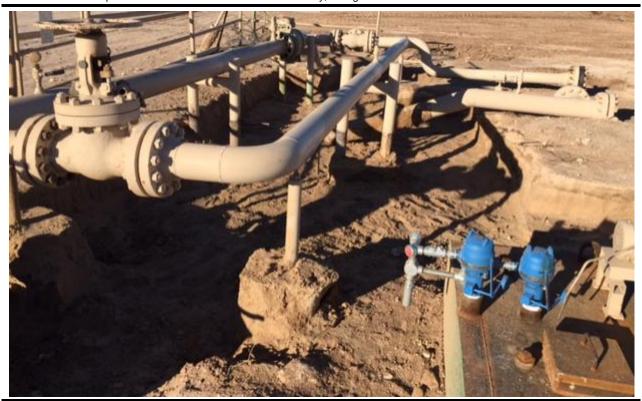
PHOTO 14: View of portion of the excavated area within the facility, facing west.

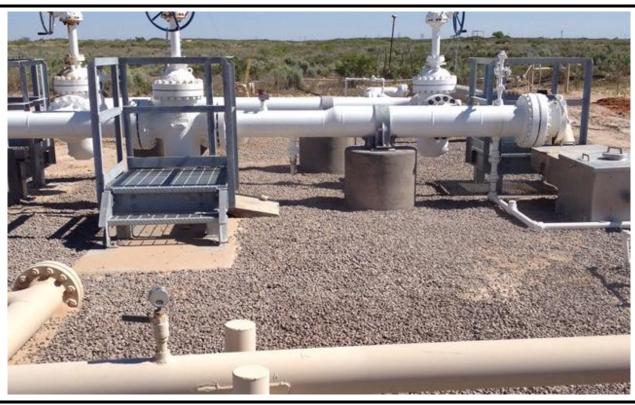
**PHOTO 15:** View of the affected facility after remediation activities, facing north.

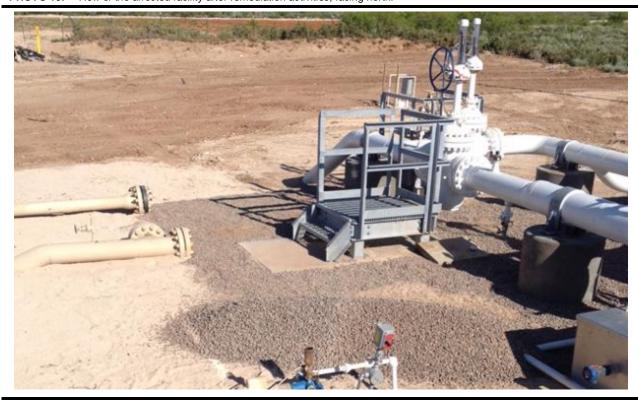
PHOTO 16: View of the affected pasture after remediation activities, facing northwest.
