RE: Remediation Progress Report and Closure Proposal  
XTO Energy – SDE 31 Tank Battery  
UL-F, Section 31, Township 23 South, Range 32 East  
Lea County, New Mexico

The following *Remediation Progress Report and Closure Proposal* serves as a condensed update on remedial activities undertaken and closure proposal for the above referenced Site.

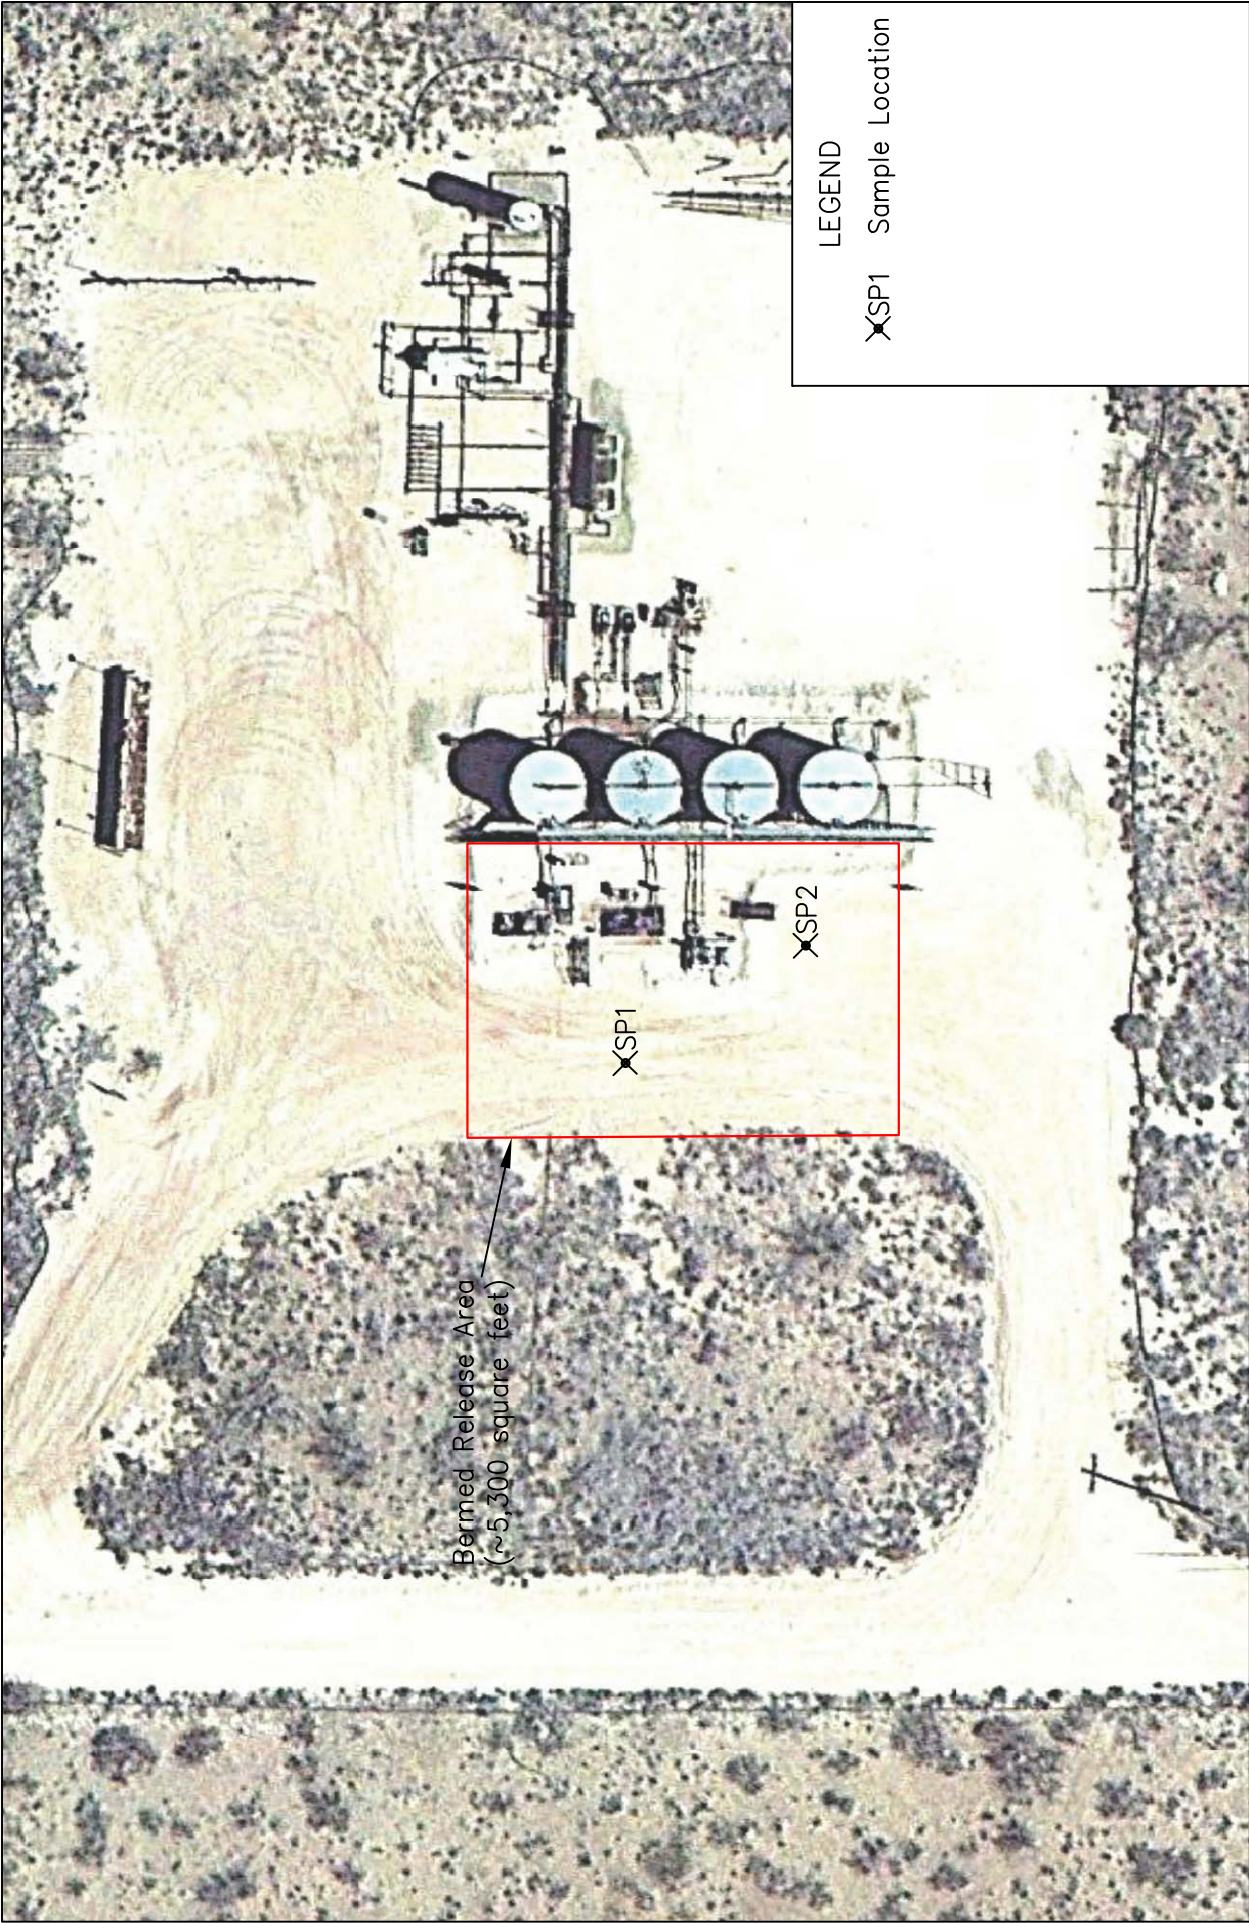
<p>Figure 3 Sample/Site Map XTO Energy SDE 31 Battery</p>	<p>Lea County, New Mexico SE 1/4 of NW 1/4, Sec. 31, T23S, R32E N 32°15' 52.78" W 103°42' 59.72" Elevation: 3,586 feet amsl</p>	<p>DWG By: D Dominguez August 2016</p>	<p>REVISED:</p>	 
		<p>0 40 80 Feet</p>	<p>SHEET 1 of 1</p>

EPI personnel mobilized on the site on August 12, 2016 to collect soil samples to determine the vertical extent of contamination. A total of ten (10) soil samples were collected from two (2) sample locations; SP1 and SP2. All samples were jarred, chilled and sent to Cardinal Labs for Chloride testing. Laboratory analytical results indicate Chloride concentrations in excess of NMOCD Recommended Remedial Action Levels (NMOCD RRALs) of 1,000 mg/Kg at SP1 to three (3) feet bgs and SP2 to two (2) feet bgs (reference *Figure 4* and *Table 2*).

LEGEND  
X SP1 Sample Location

SP 1 should be excavated to 3' bgs, with confirmation samples taken at that depth, SP 2 should be excavated to 2' bgs, due to the fact of the high Cl- content still being high at both sample points. Confirmation sidewall samples. Please Notify NMOCD prior to sampling to give witnessing opportunities.

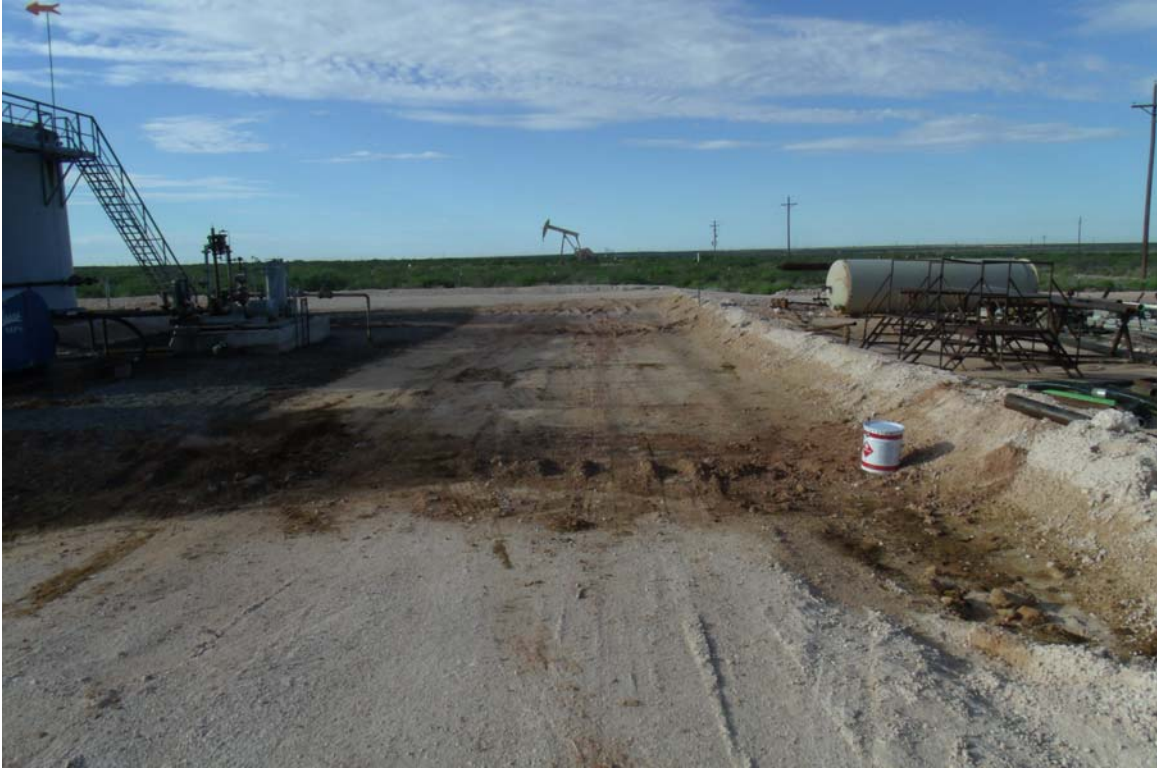
Photograph #1 – Looking across release area

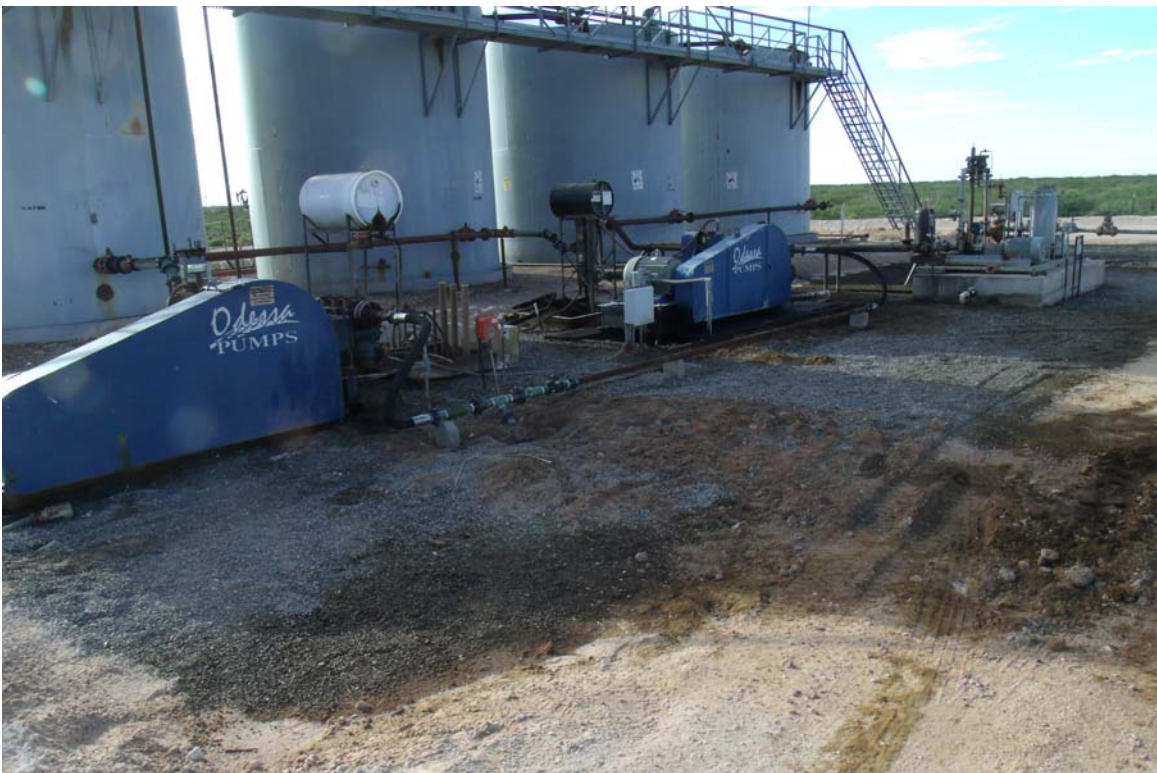
Photograph #2 – Looking across release area

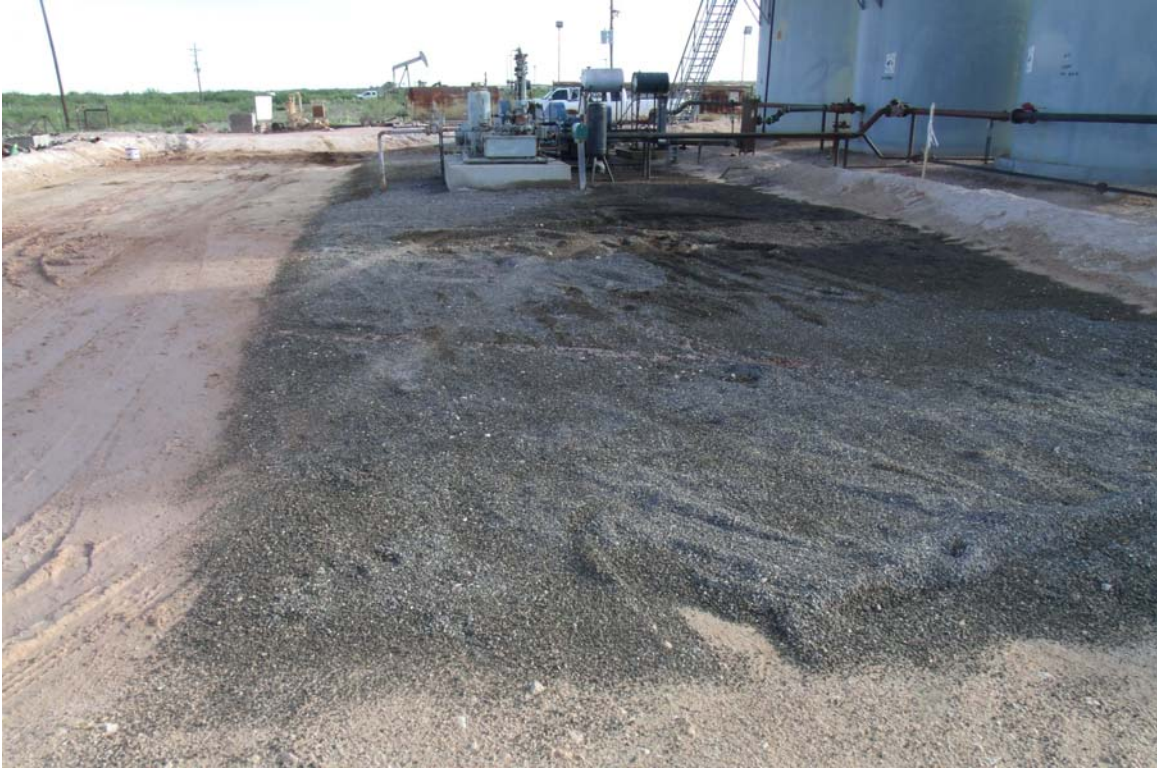
Photograph #3 – Looking across release area

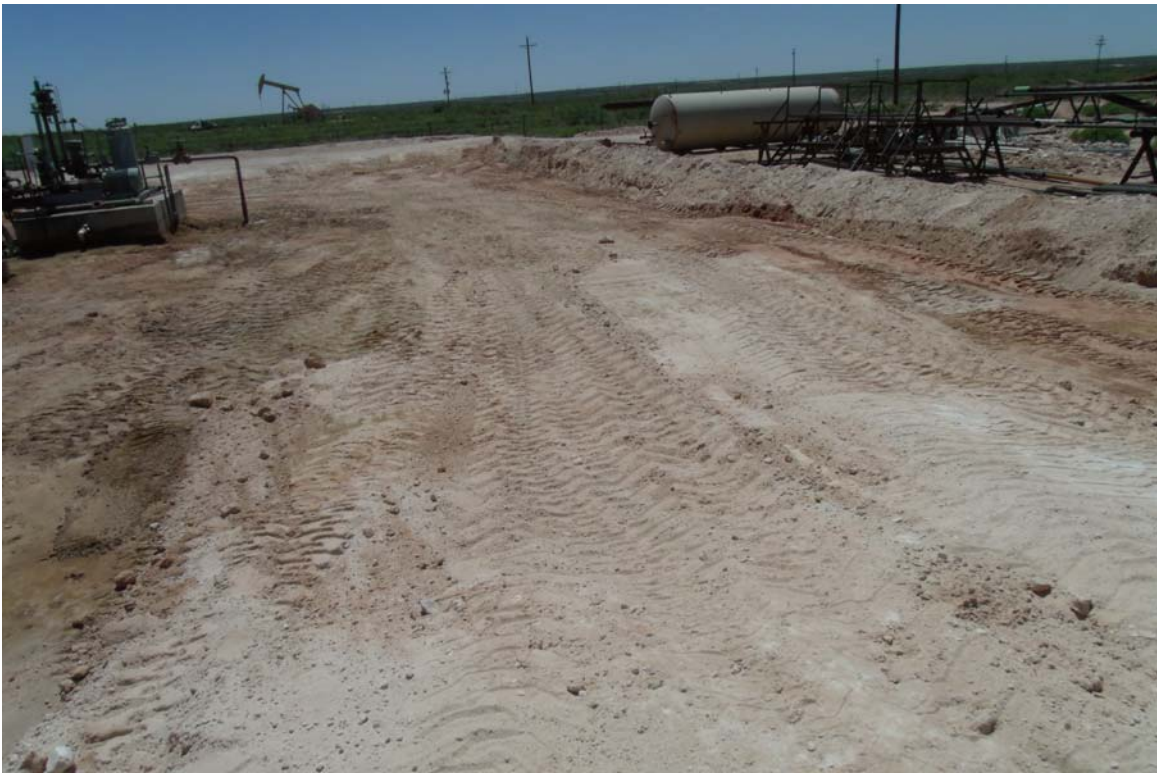
The entire release area has been excavated approximately six (6) inches bgs and the contaminated soil has been hauled to a state approved facility for disposal.

Photograph #4 – Excavated area

As the release area was contained within the berm and is located on an active tank battery, EPI proposes to backfill the excavated area with clean soil. All soil will be free of rocks, clumps or deleterious material. Backfilling will continue until the entire excavation is closed. Upon completion of backfill activities, the entire disturbed area will be contoured to blend with existing tank battery location and protected against wind/water erosion.

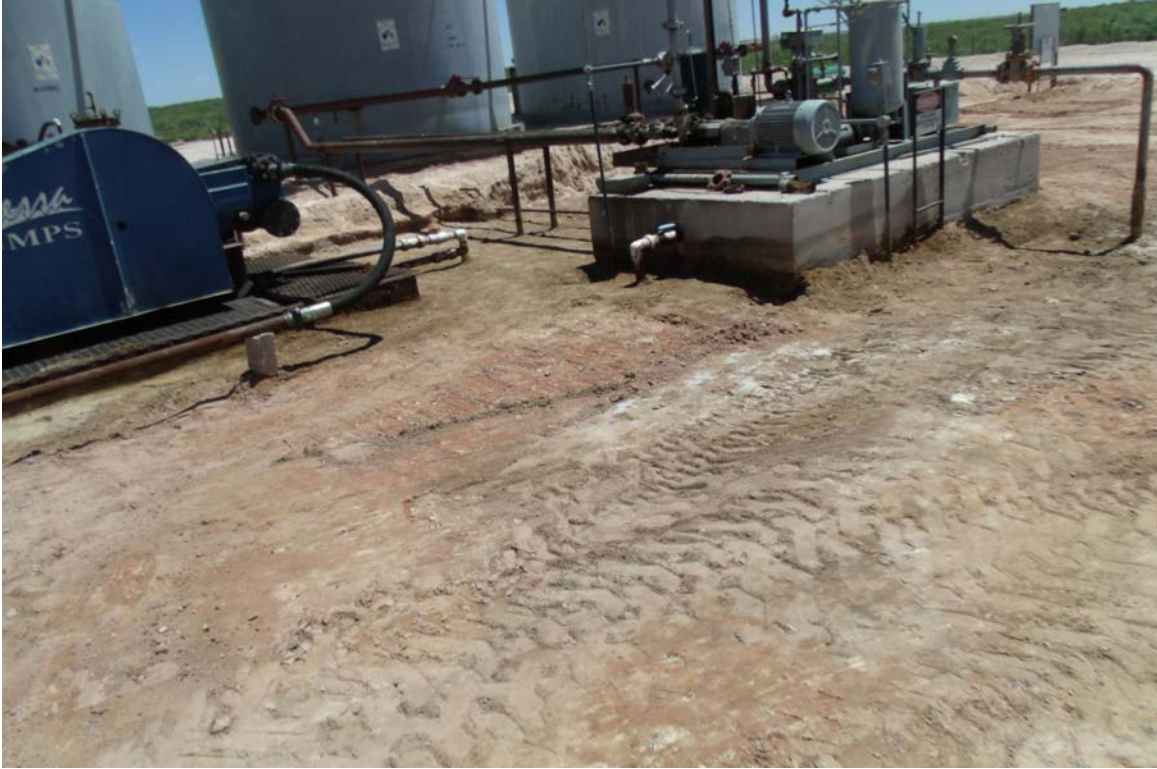
Photograph #5 – Excavated area

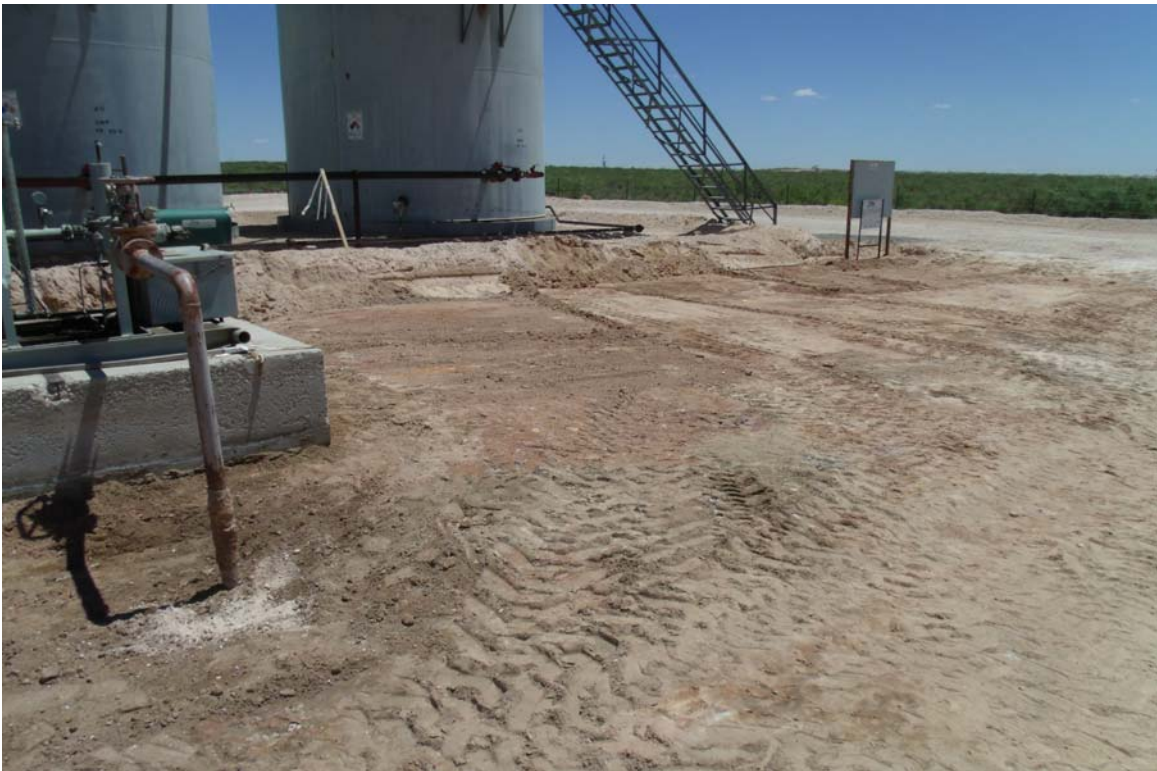
Photograph #6 – Excavated area
