**Re: Initial C-141
Legacy, L.P.
Rainer State #1
UL-B, Section 28, Township 10 South, Range 37 East
Lea County, New Mexico**

Release Notification and Corrective Action

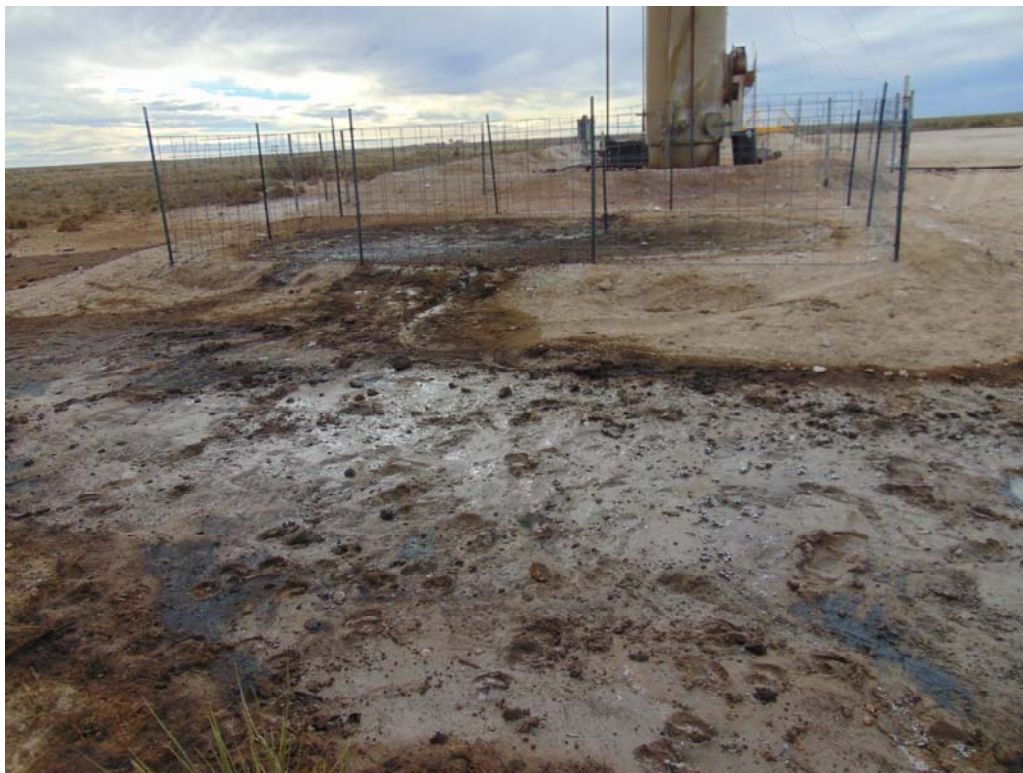
Photograph #2- Release area

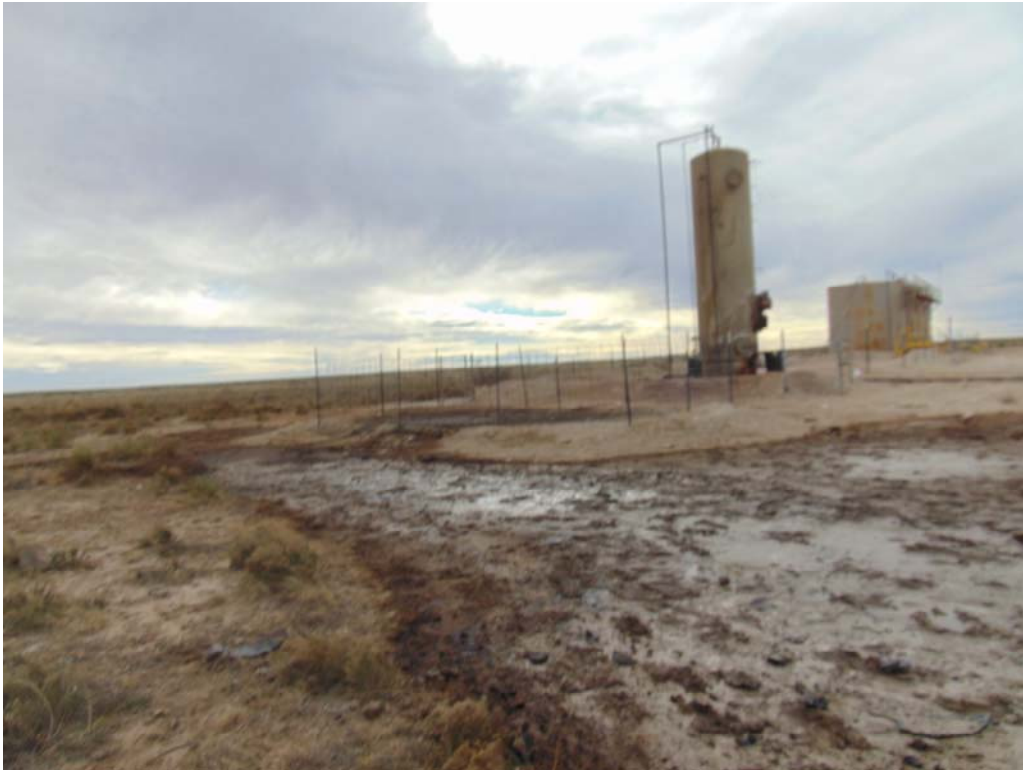
Photograph #3- Release area

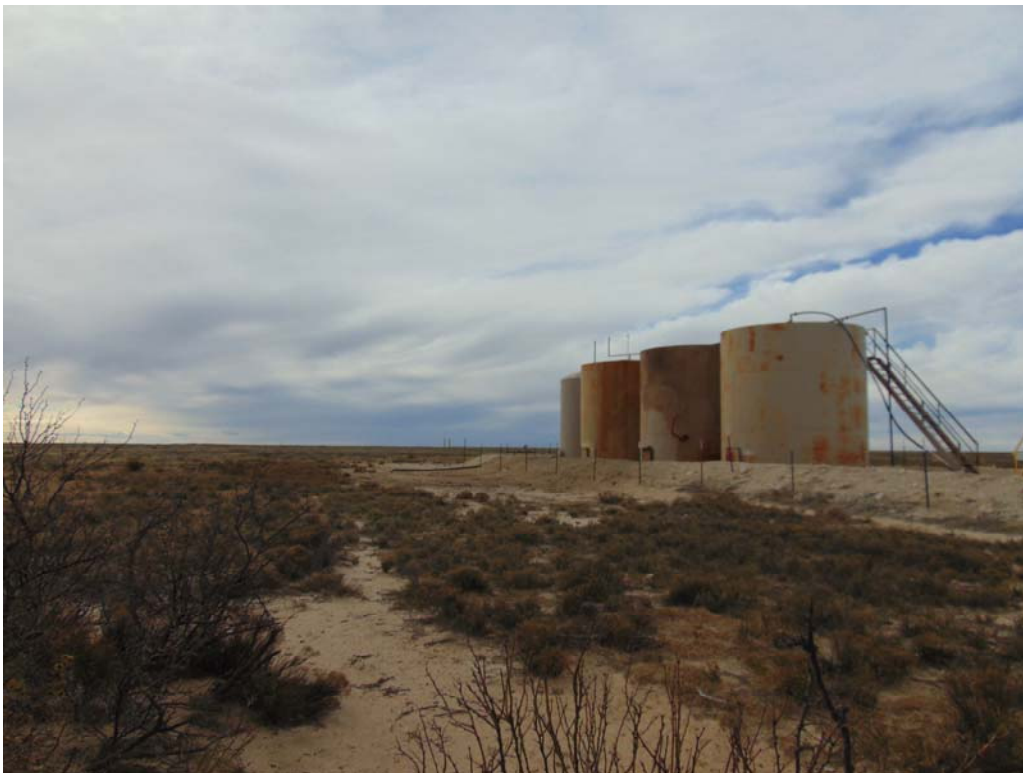
Photograph #4- Release area

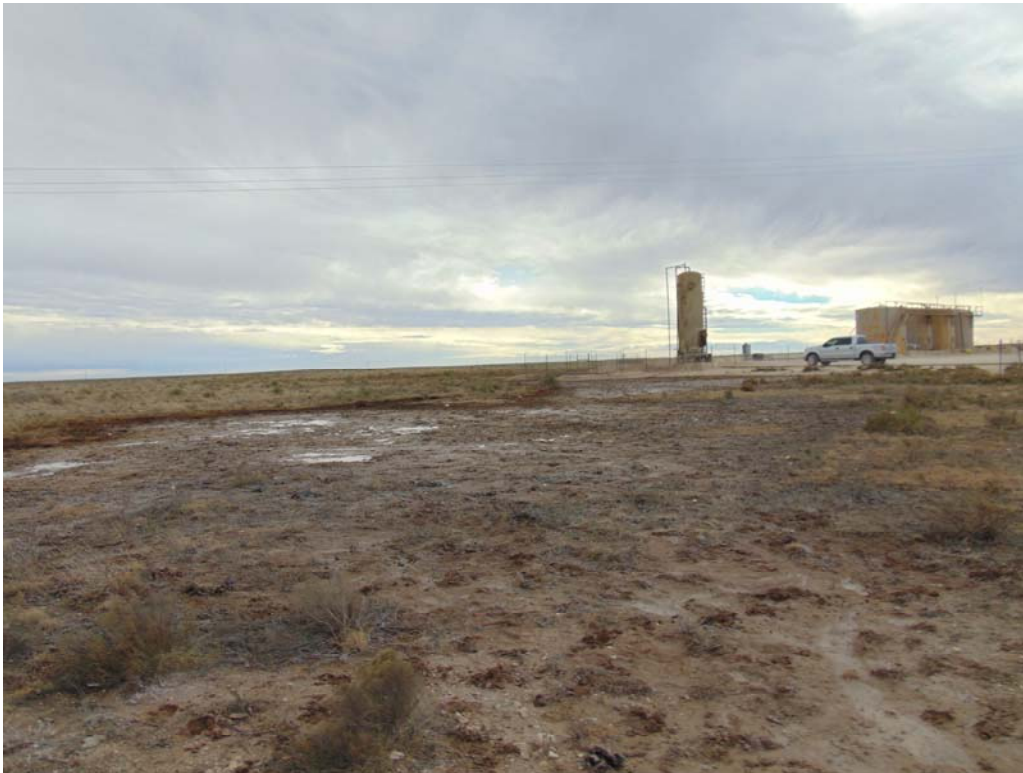
Photograph #5- Release area

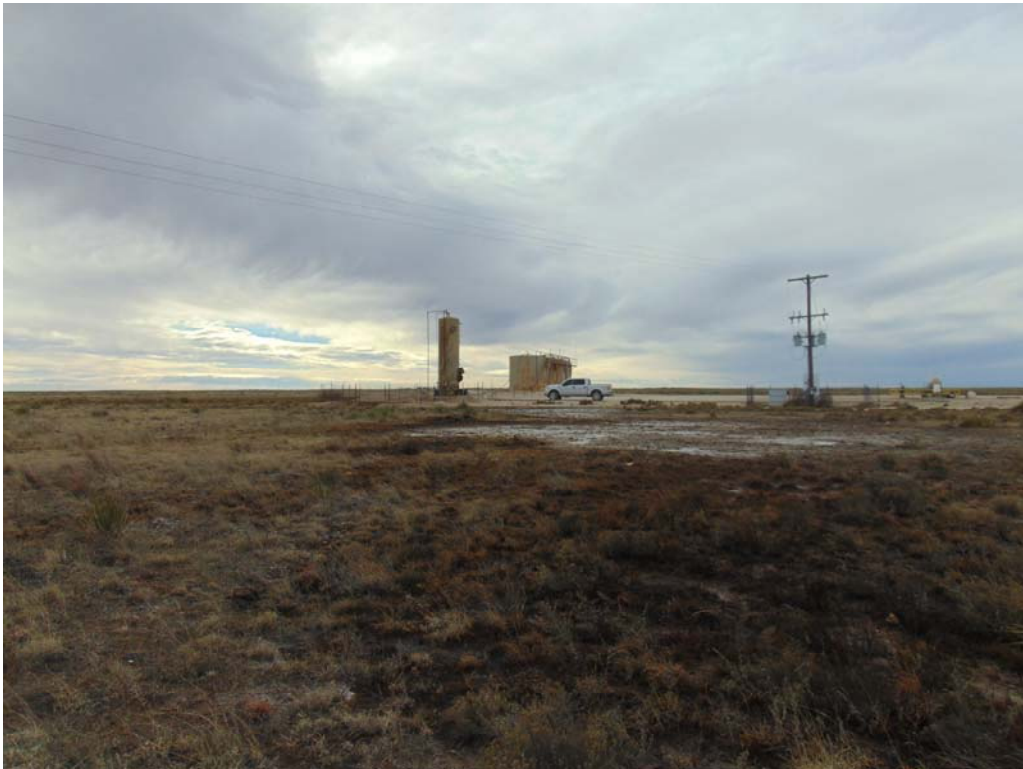
Photograph #6- Release area
