RE: Remediation Progress Report and Proposal of No Further Action
Vanguard Operating, LLC – Hill Tank Battery
UL-B, Section 4, Township 21 South, Range 37 East
Lea County, New Mexico
NMOCD Reference # 1RP 4450

The following *Remediation Progress Report and Proposal of No Further Action* serves as a condensed update on remedial activities undertaken and closure proposal for the above referenced Site.

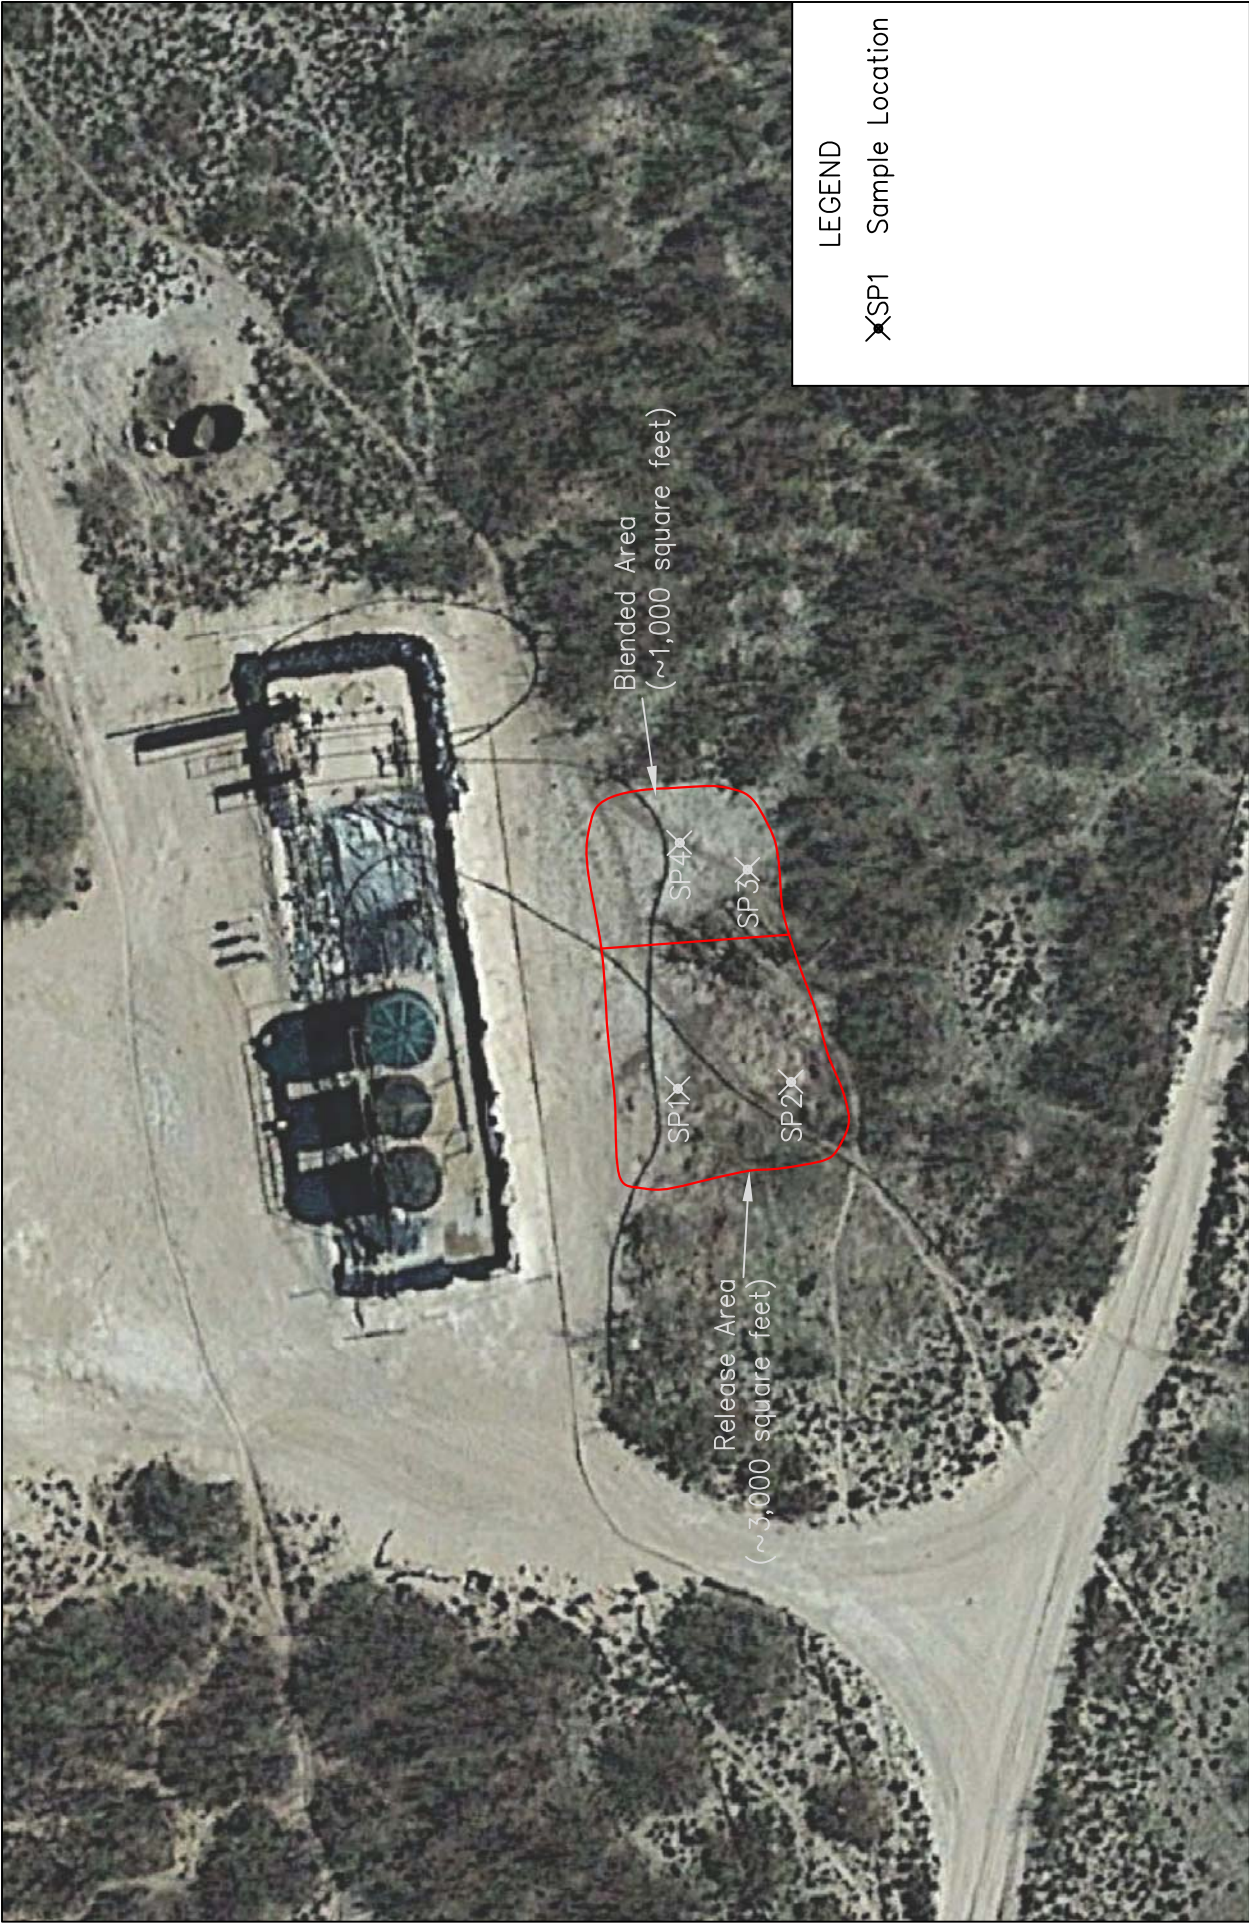
Figure 3 Site/Sample Map Vanguard Hill Tank Battery	Lea County, New Mexico NW 1/4 of NE 1/4, Sec. 4, T21S, R37E N 32° 30' 46.70" W 103° 09' 53.66" Elevation: 3,436 feet amsl	DWG By: D Dominguez December 2016	REVISED:		 
			SHEET 1 of 1		
			  Feet

EPI personnel mobilized on the site on October 7, 2016 to collect soil samples to determine the vertical extent of contamination. A total of twelve (12) soil samples were collected from four (4) sample locations; SP1 – SP4. Four (4) representative samples, one (1) from each sample point, were jarred, chilled, and sent to Cardinal Labs for chloride testing. Laboratory analytical results indicate the release area is void of Chloride concentrations in excess of NMOCD Recommended Remedial Action Levels (NMOCD RRALs) of 250 mg/Kg (reference *Figure 3* and *Table 2*).

Field testing of the surface sample from SP4 indicated elevated chlorides above NMOCD RRALs. In lieu of excavation the area was dug up, blended, resampled, and backfilled. The composite sample collected was sent to Cardinal Labs for chloride testing. Laboratory analytical results indicate the area to be void of Chloride concentrations in excess of NMOCD Recommended Remedial Action Levels (NMOCD RRALs) of 250 mg/Kg (reference *Figure 3* and *Table 2*).

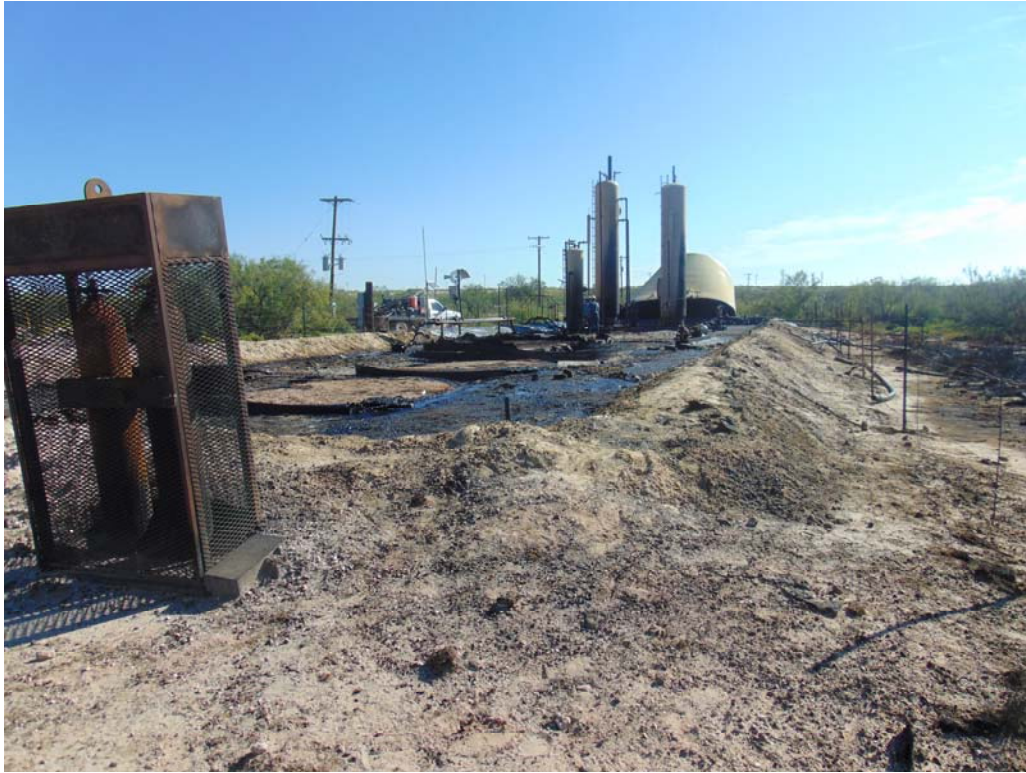
Photograph #1 – Tank battery struck by lightning

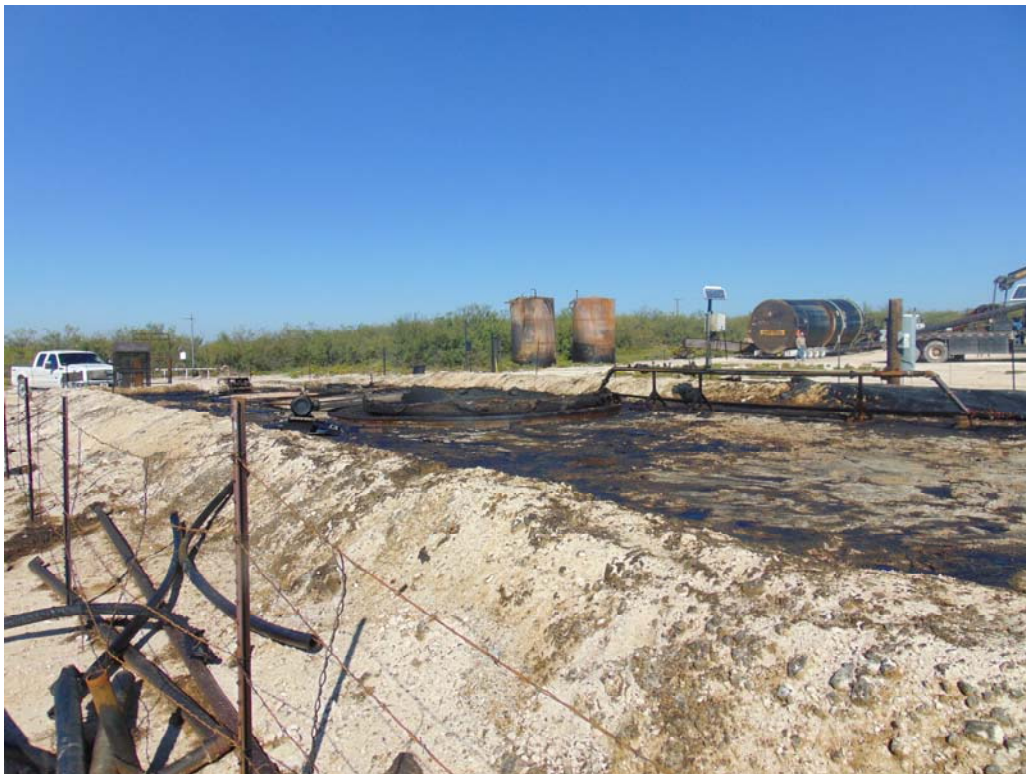
Photograph #2 – Tank battery struck by lightning

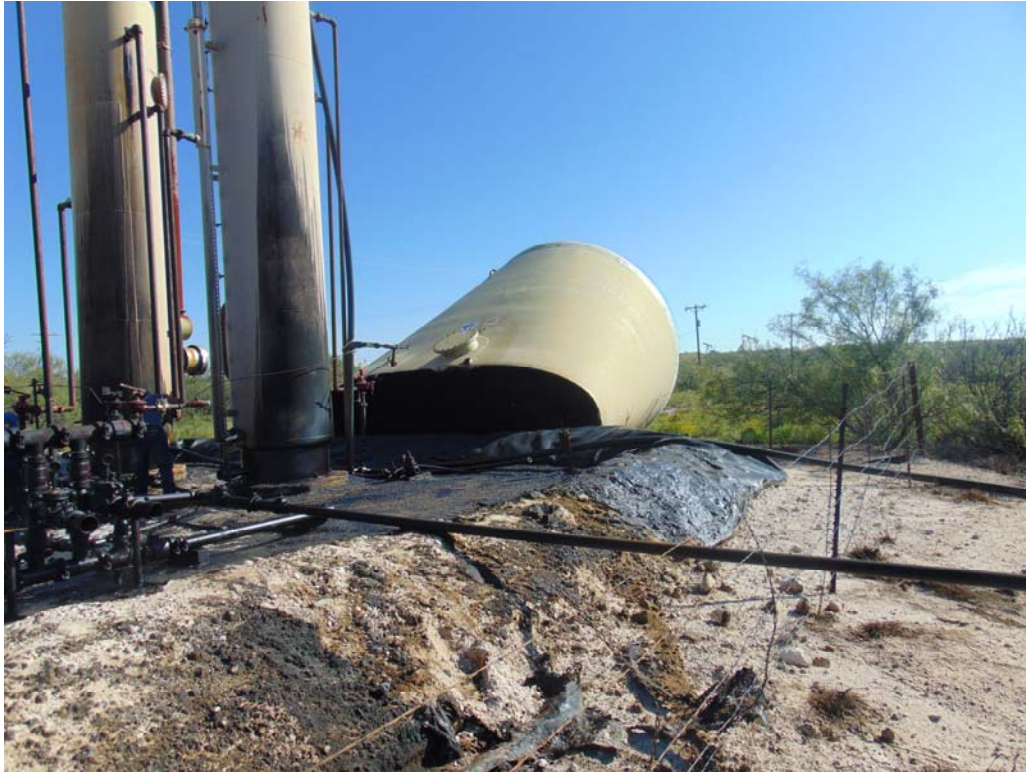
Photograph #3 – Tank battery struck by lightning

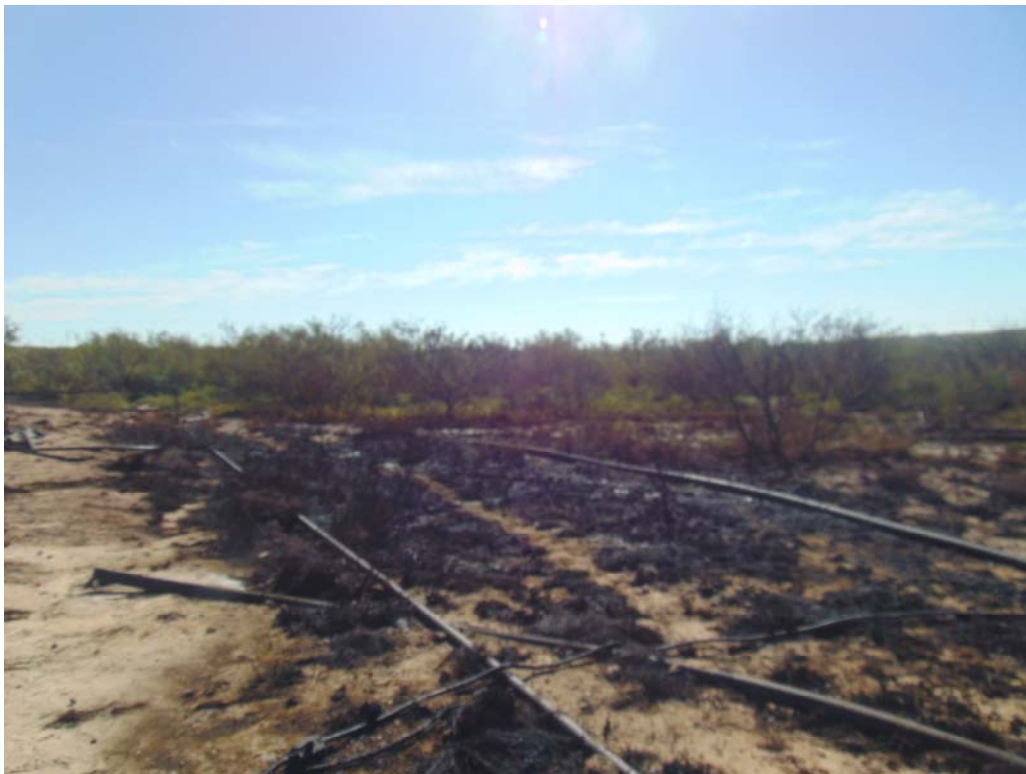
Photograph #4 – Looking across release area

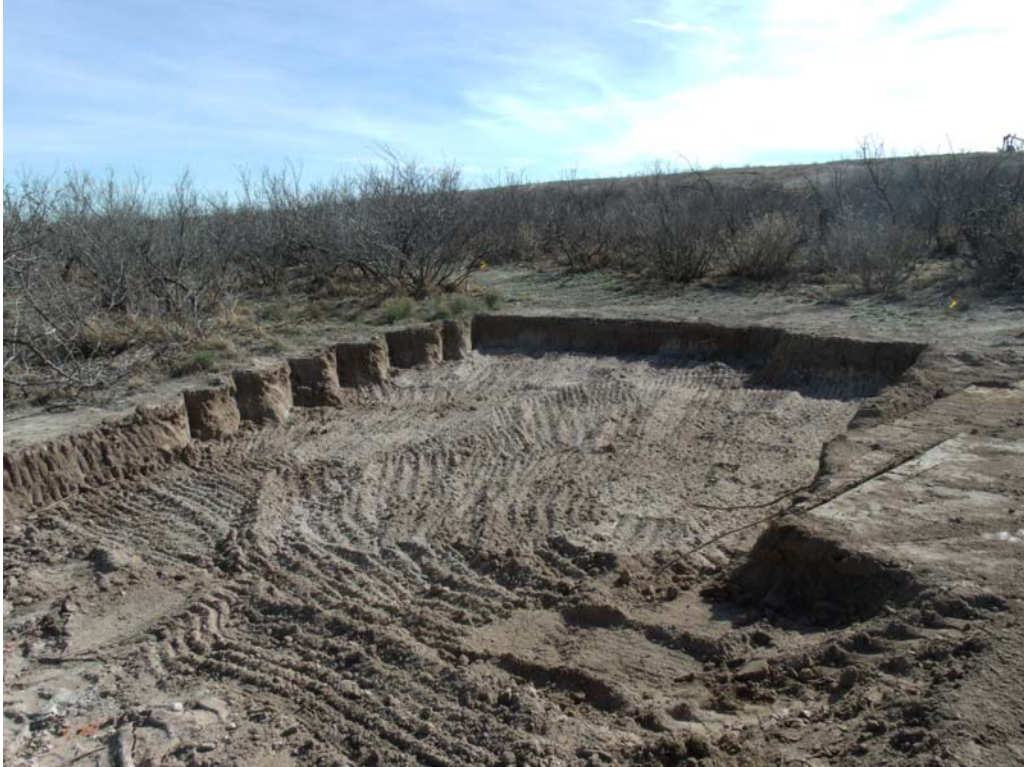
Photograph #5 – Blending the soil around SP4

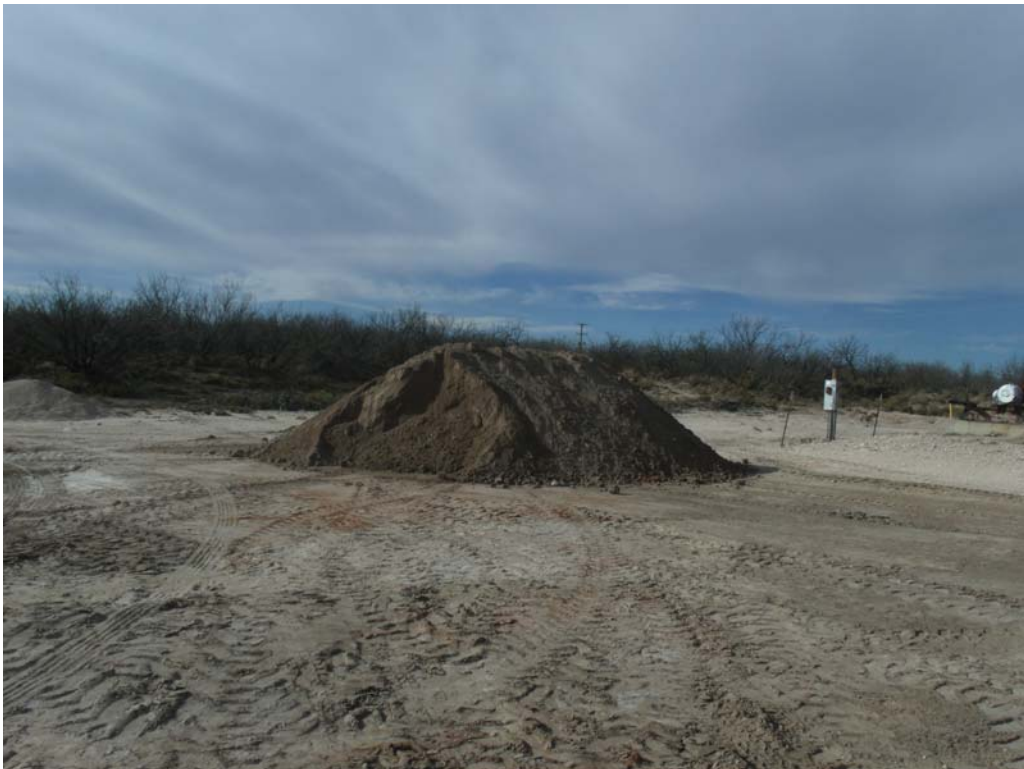
Photograph #6 – Blending the soil around SP4

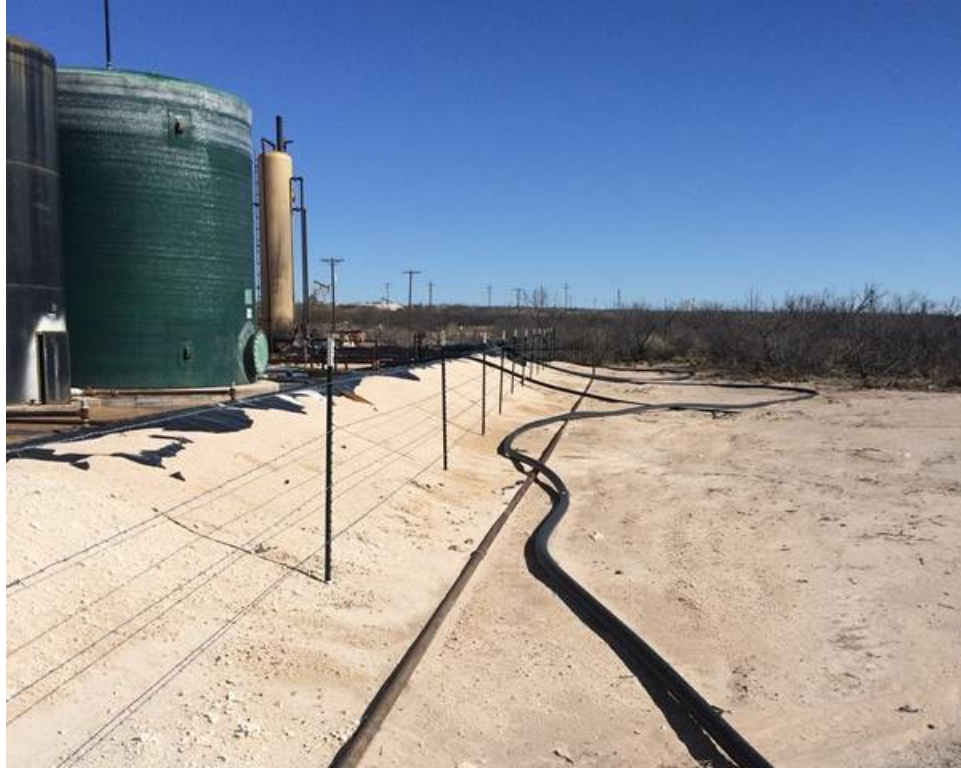
Photograph #7 – Blended soil backfilled

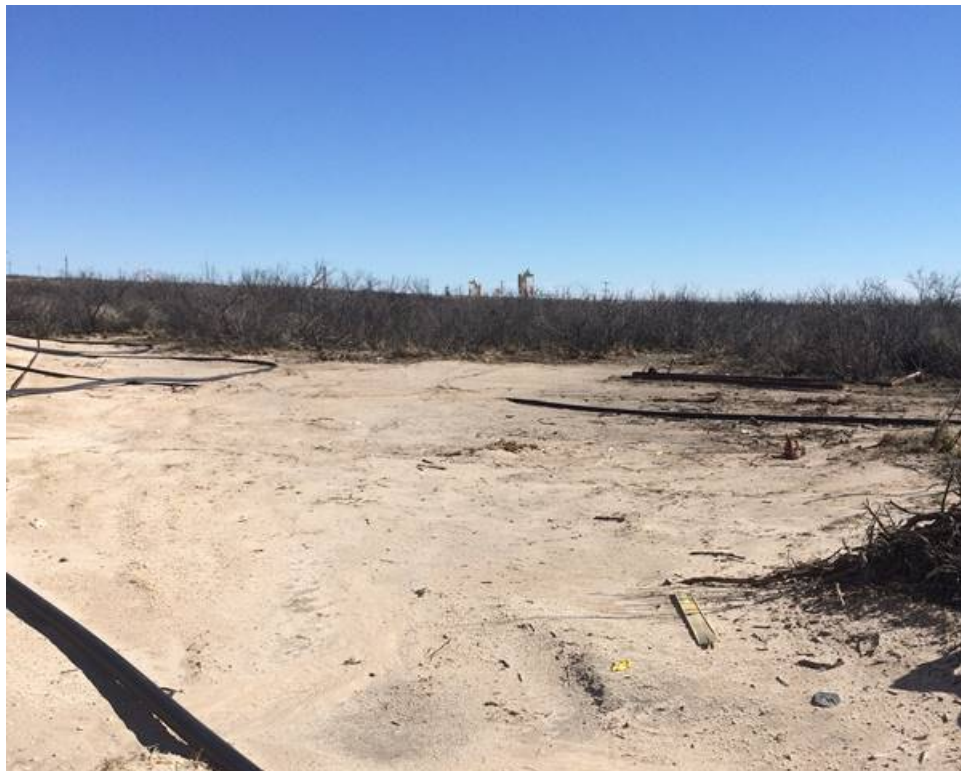
Photograph #8 – Blended soil backfilled
