Reference: Remediation Work Plan

Operator: Cambrian Management (Grand Banks Energy)

Location: Anderson Ranch Unit #16

Release Notification and Corrective Action

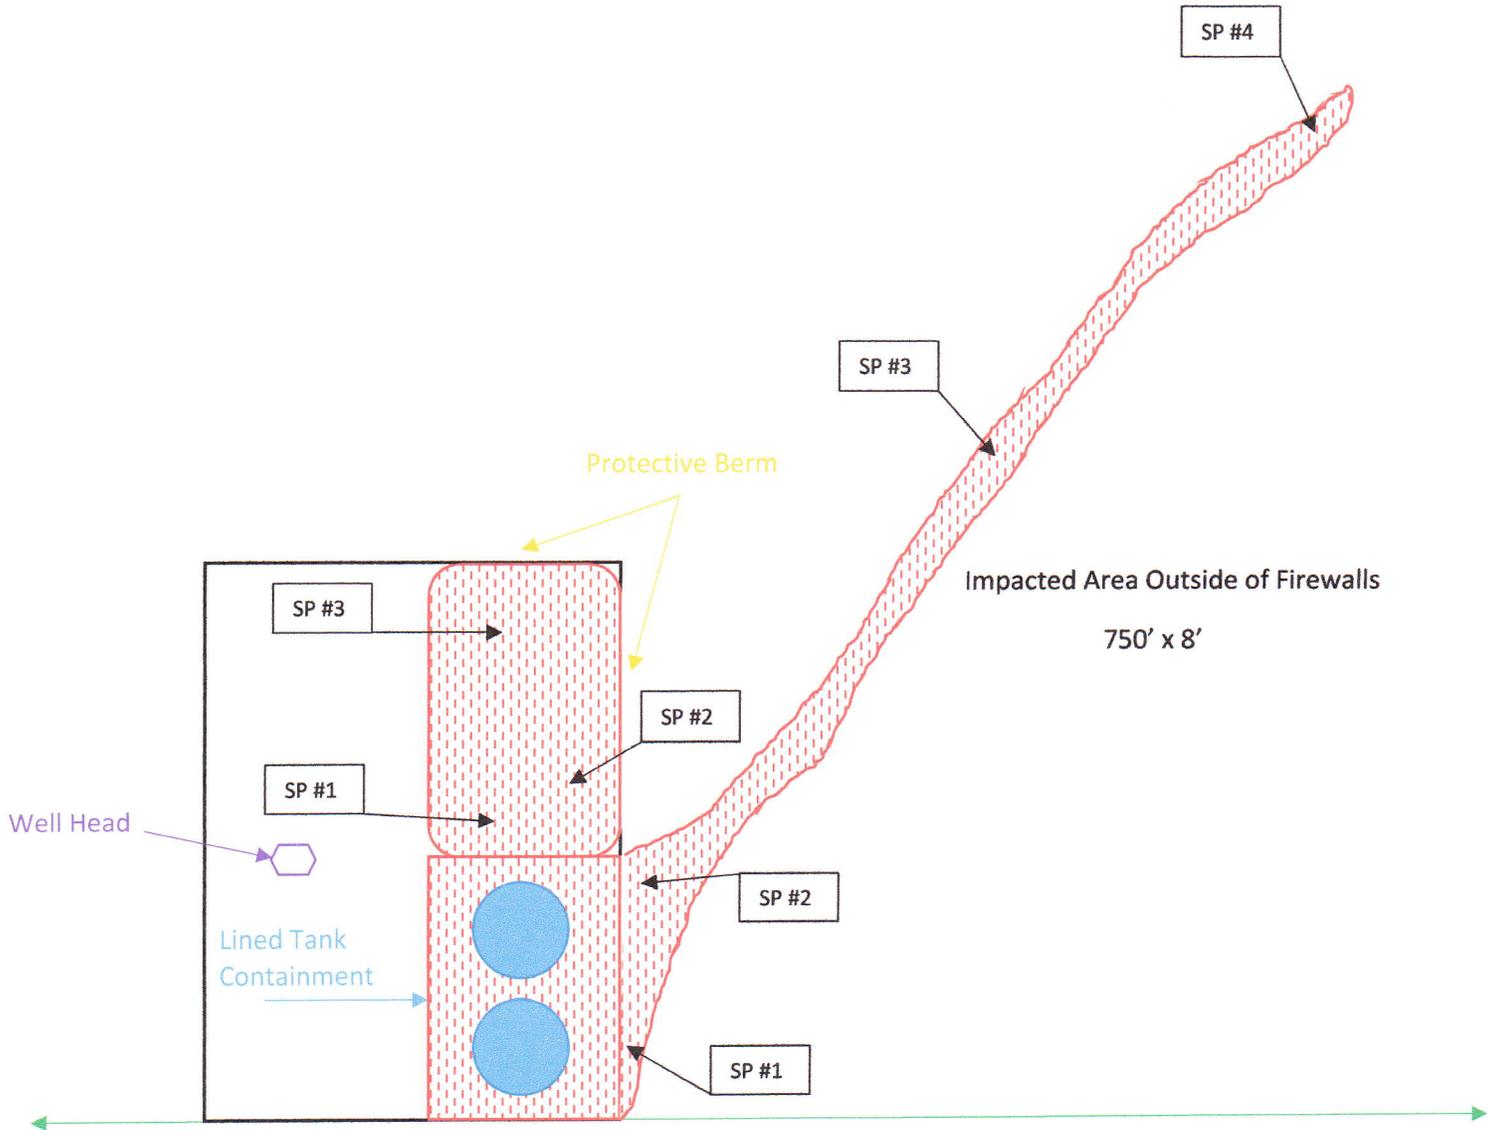
Grand Banks Energy (Cambrian Management) -Anderson Ranch Unit #16

Soil samples were obtained from three sample points on the pad and from four sample points in the pasture. (See attached lab analysis and corresponding sketch.) Lab results indicate closure limits have been reached for all sample points except for Sample Points #1 and #2 in the pasture. These two sample points are adjacent to the east wall of the battery which is the point of release into the pasture from the bermed location.

Indicates Impacted Area

I propose to continue the dig and haul operation at Sample Points 1-2 (in the pasture) until lab analysis indicates TPH levels have dropped to 5000ppm or less. At which point the lab analysis will be presented to NM OCD seeking closure. All impacted soil will be transported to a division approved facility for disposal. Please see the attached Revegetation Plan for proposed surface restoration.

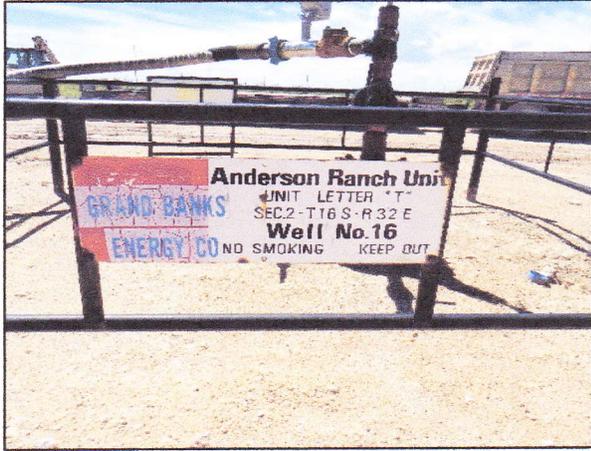
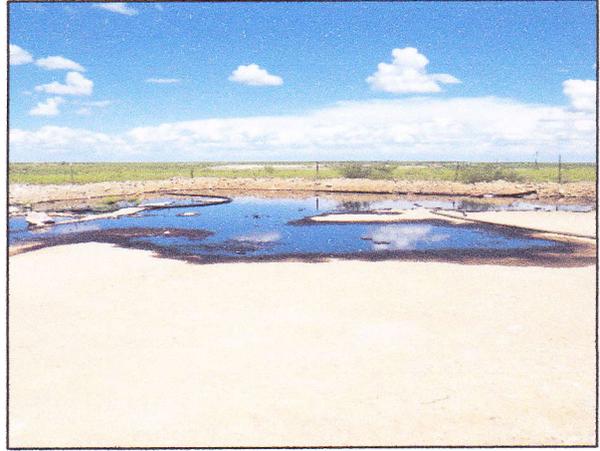
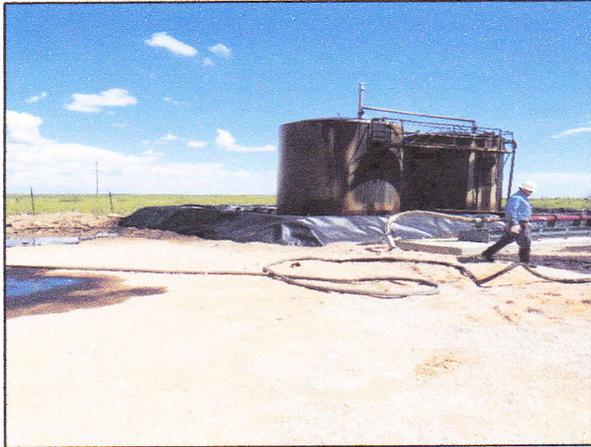
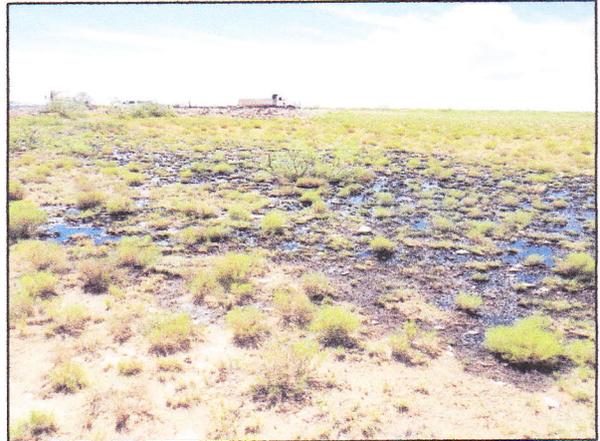
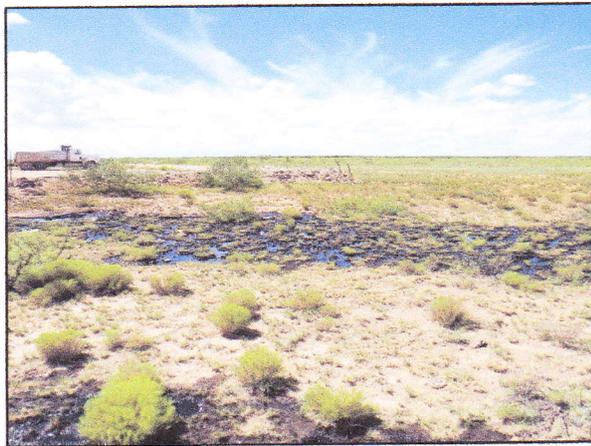
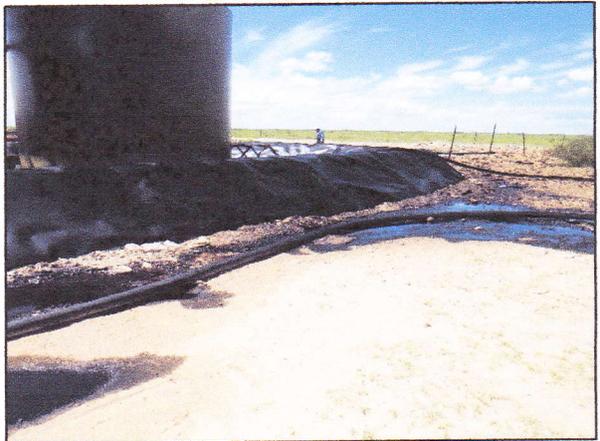
Cambrian Management (Grand Banks Energy) – Anderson Ranch Unit #16

Immediate upon discovery of the release, vacuum trucks were summoned to begin recovery of all free standing fluids along with roustabouts to steam clean the tanks and liner of the battery. Simultaneously, earth moving equipment was dispatched to the site to start remedial action. Due to the threat of incoming rains, excavation work of the impacted areas continued for the next three days. All impacted soils was transported to a division approved disposal facility.
