Marshall & Winston, Inc.
Loco Dinero 36 State 2H
Produced Water Spill (Some Oil)
Affected Area – 92,310 sq. ft. / 2.12 acres
GPS Coordinates: N32.444077 W103.465883

RE: Loco Dinero 36 State 2H Release - Lea County, New Mexico (OCD Case #1R-4526)

The following is a summary of the corrective action measures taken to date for remediating the produced water release off of the Loco Dinero '36' State 2H line:

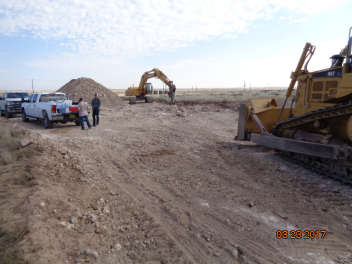
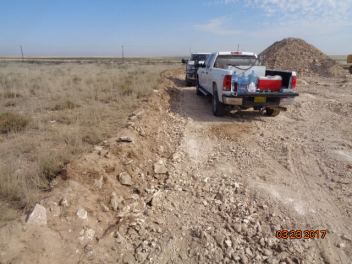
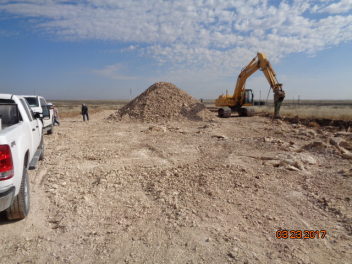
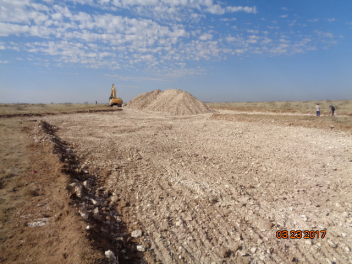
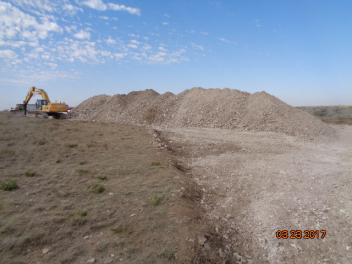
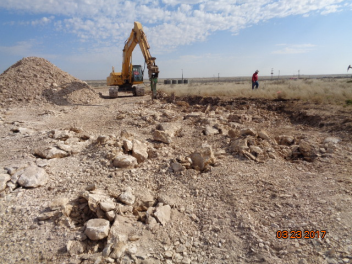
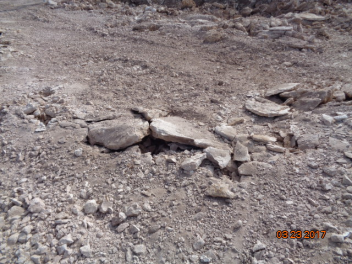
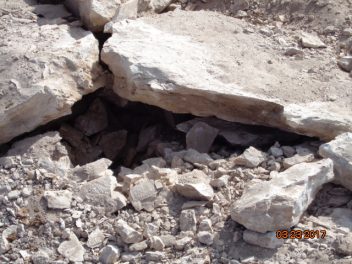
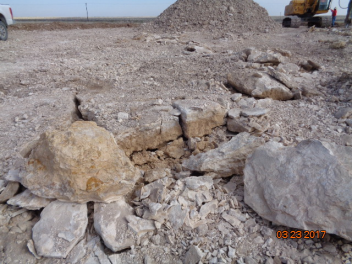
After meeting with the NMOCD on March 8, 2017 and receiving their directives, Marshall & Winston, Inc. representatives consulted with and directed a third party dirt contractor on March 13th in excavating and removing the affected soils that were the result of the produced water release off of the Loco Dinero '36' State 2H ruptured line. As excavation was being carried out at the release point and on the east and west pasture areas, on-site field testing was performed to verify the chloride content in the soil. Removal of the contaminated soils continued vertically until representative soil samples from the base of the excavation field tested at 250 ppm chloride or less. As requested by the OCD, split soil samples from the base of the excavation and at 10 feet below ground surface (bgs) were laboratory analyzed to confirm that the chloride content lab results were the same as the testing results we had been receiving on-site. Laboratory analysis confirmed the 250 ppm or less chloride content results (laboratory analysis attached). Field testing of the soil continued as the excavation and removal was performed to ensure the remaining soils were revealing acceptable levels. The affected areas on DCP's right-of-way were excavated by both hydrovac and by hand and the affected road areas were also excavated to the 4 inch depth that the OCD recommended on March 8th. As the excavation was continuing in the east pasture areas of this release, ongoing field testing was revealing a slightly higher chloride content result than we had previously received at midpoint. Previous field testing as well as laboratory analysis had already confirmed a <250 ppm chloride level at the 16 inch bgs depth and at the 10 foot bgs depth from a midpoint setting, however, various other base areas were now averaging 1,500 ppm chloride in the remaining soil that was available to retrieve and field test. The average depth of the soil that has been removed in this east affected pasture area is 18 inches bgs and the makeup of this 'bed' is approximately 90% rock and 10% soil. At this point in this east area, the dirt contractor is unable to penetrate the thick layer of rock that is

present at this depth (photos attached). With the chloride levels already reduced from the initial average of 12,300 ppm and the fact that we believe that breaking this protective layer of rock in this east area would not be beneficial to this situation, BCC, Inc. recommends seeking the approval from the OCD to stop the excavation at this 18 inch depth and proceed with the backfilling and revegetation of this site. After your review of this summary of events, please contact me with any questions you may have.
