CONOCOPHILLIPS

Wyatt #13
1RP-3461

Site Closure Report

API No. 30-025-01363

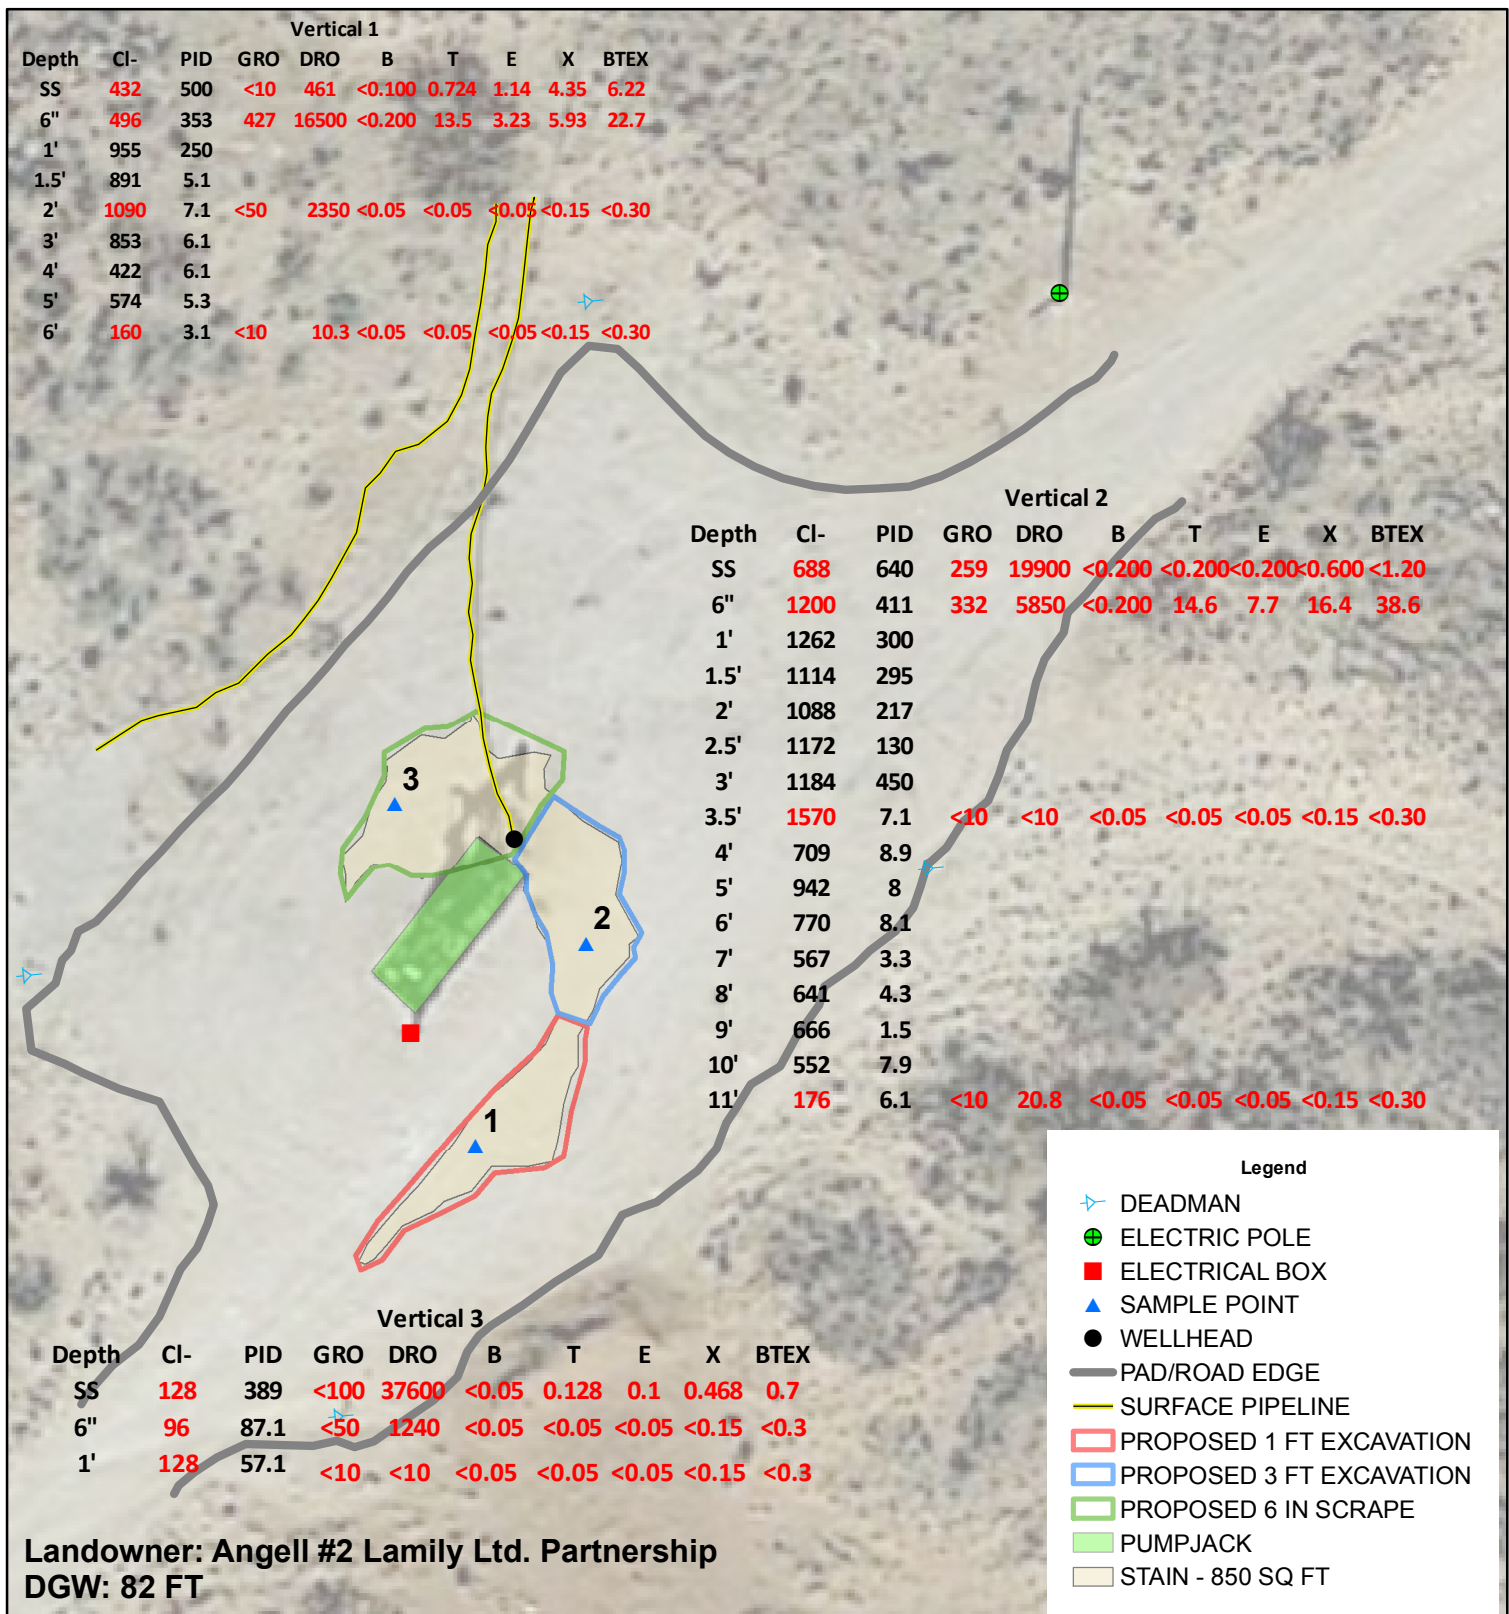
Figure 1

Samples Collected Summary

The release area around Point 1 was excavated down to 2 ft bgs, the release area around Point 2 was excavated down to 3.5 ft bgs and the release area around Point 3 were excavated to 1 ft bgs (Figure 1, Appendix D). One additional sample was collected on November 11, 2015 at Point 3 and sent to a commercial lab for analysis. At 1 ft bgs, Point 3 returned a chloride value of 128 mg/kg, a GRO, DRO and BTEX values of non-detect (Appendix B). Clean soil was imported to the site to backfill the excavation; sample analysis can be found in Appendix B.

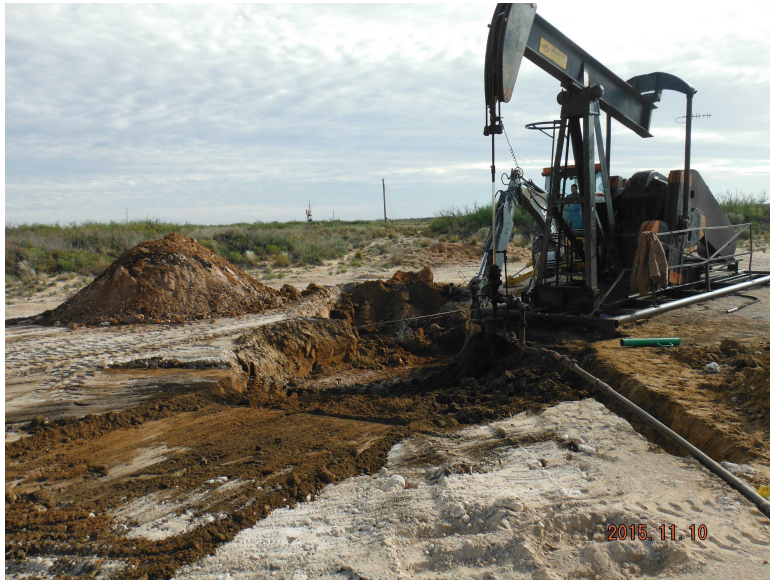
EXCAVATING FACING SOUTH 11-10-15

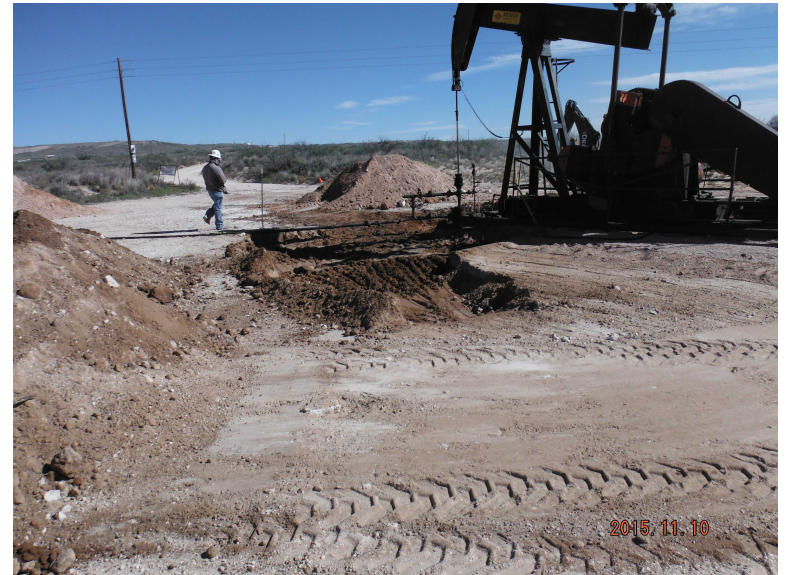
EXCAVATION FACING EAST 11-11-15

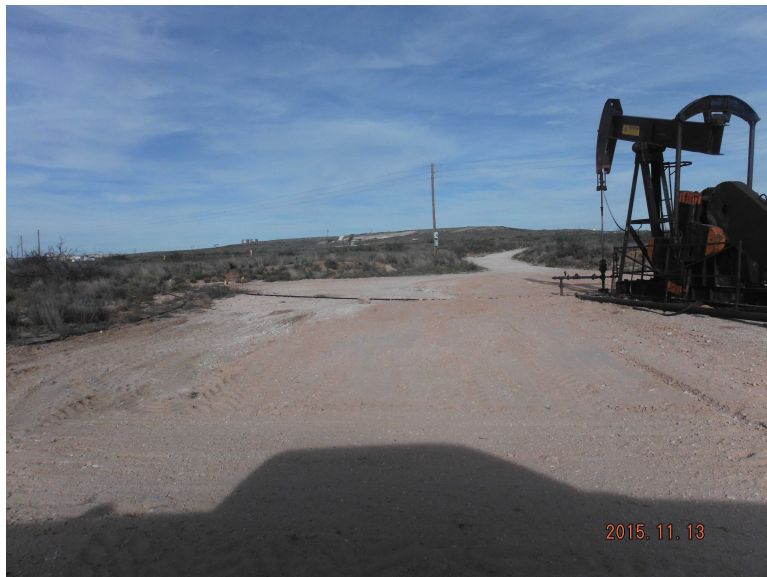
FINAL PHOTO FACING EAST 11-13-15

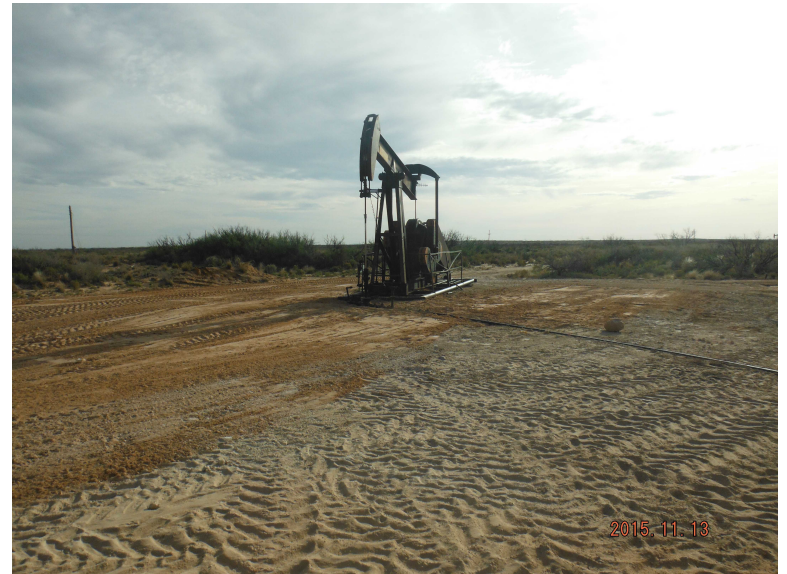
FINAL PHOTO FACING SOUTH 11-13-15
