Ruth Co SWD

1RP-4572-0

Delineation Report

Section 30, Township 18S, Range 39E

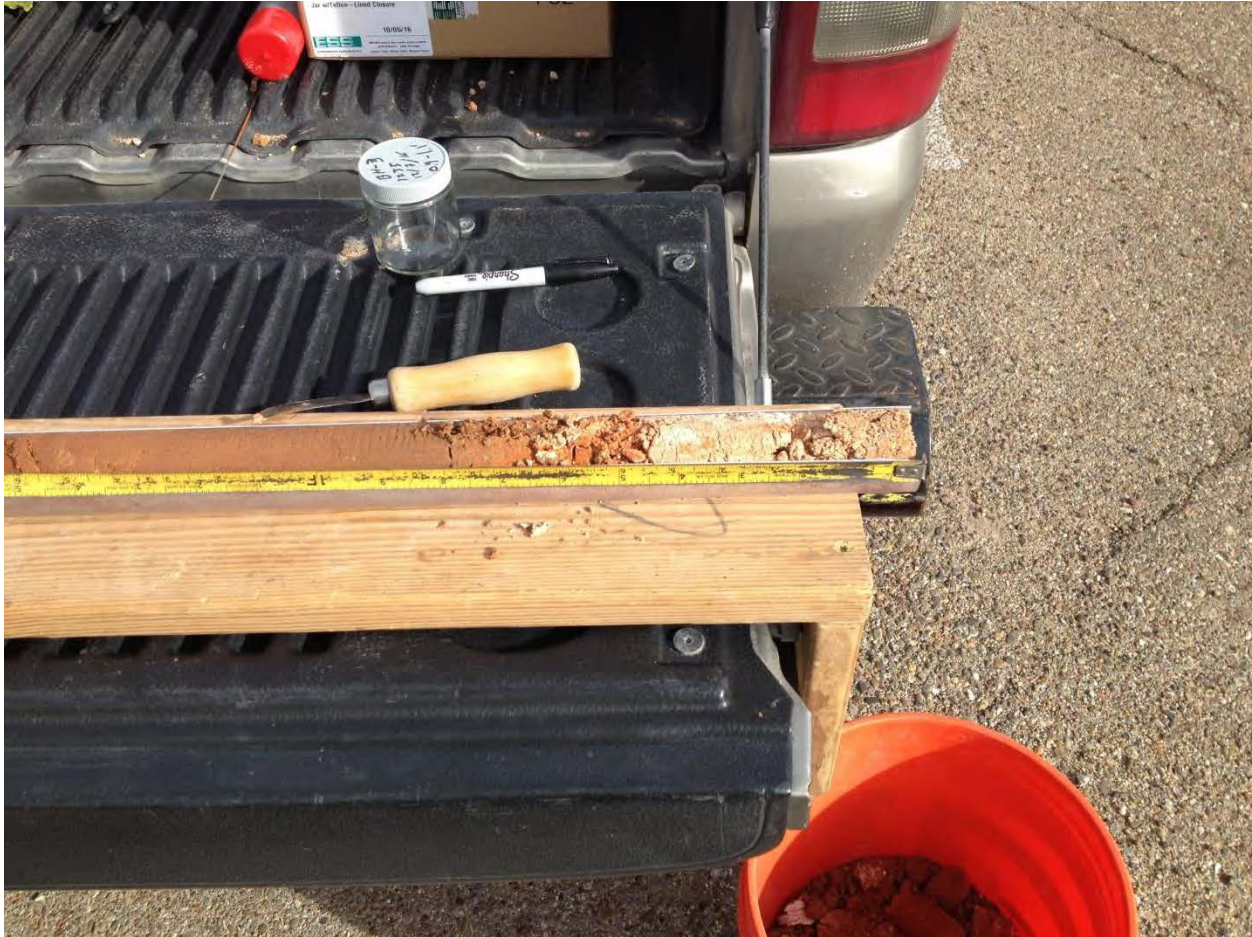
Figure 1. Borehole 3, top. White soil is mixture of sand and caliche at pad surface then a uniform fine-grained sand below. Soil sample for analysis to be taken at 1 foot (0.9-1.1 feet)

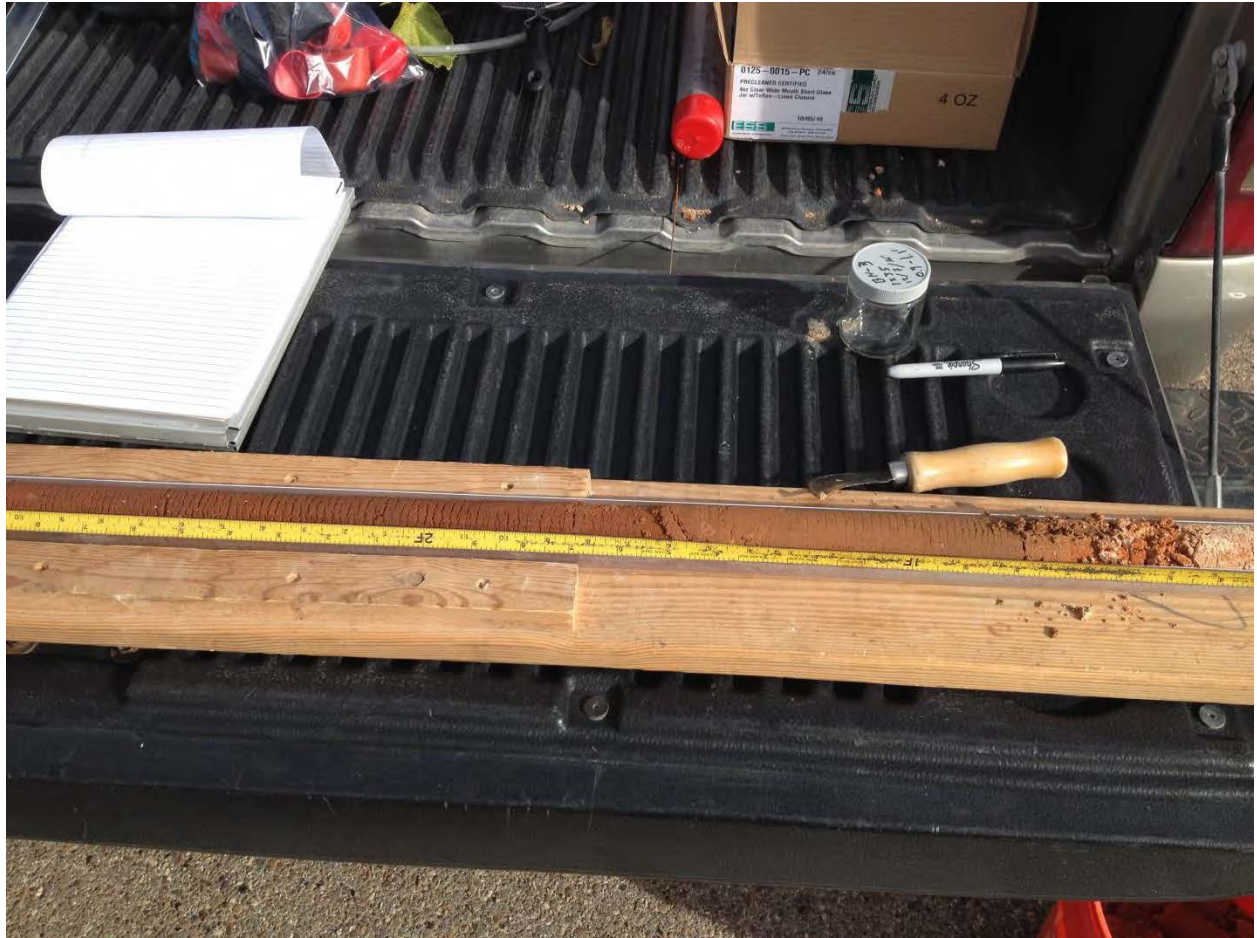
Figure 2. Borehole 3. Next sample to be taken at 2 feet (1.9-2.1 feet) then at 3 feet and at 4 feet.

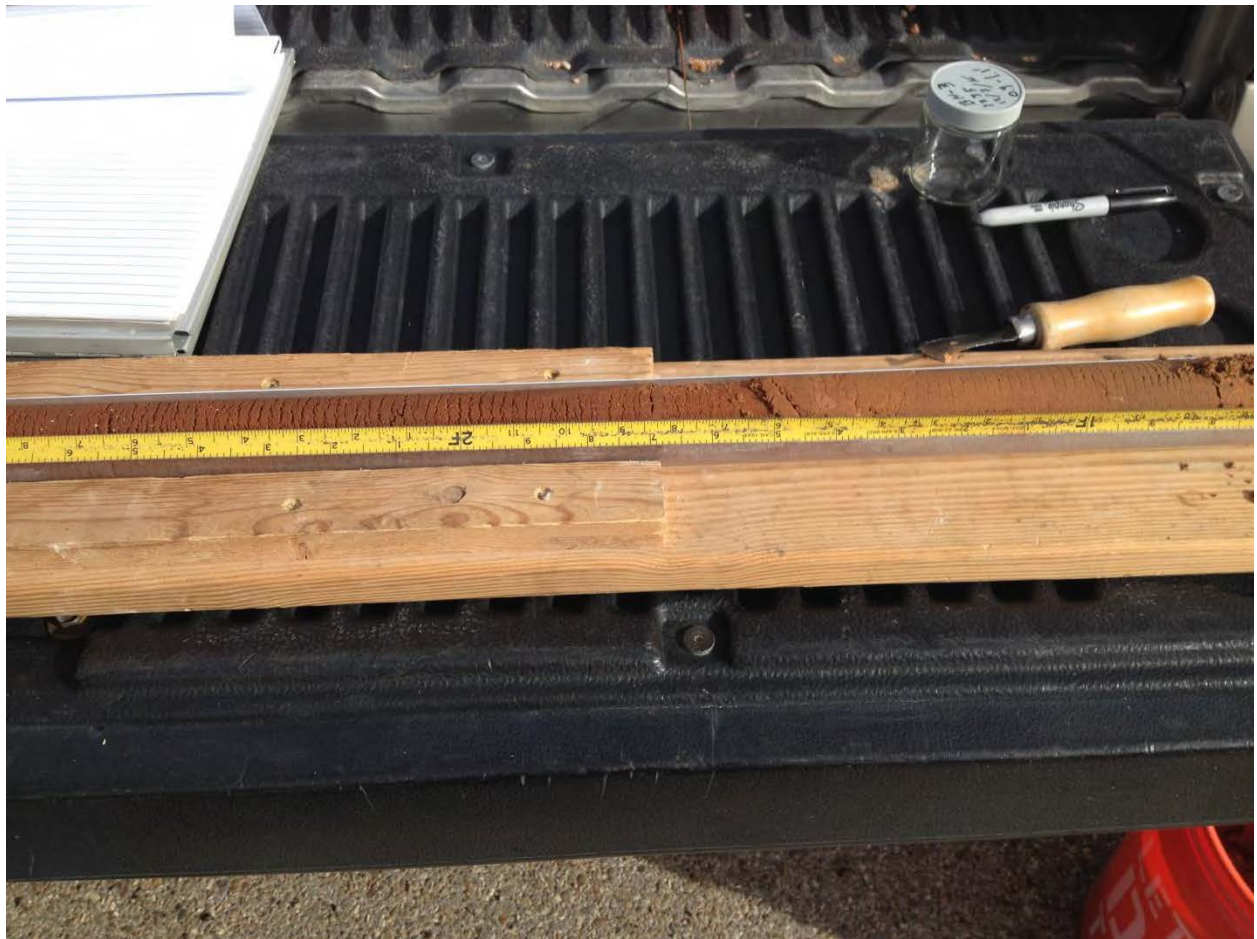
Figure 3. Close up of uniform sand at 2 feet.

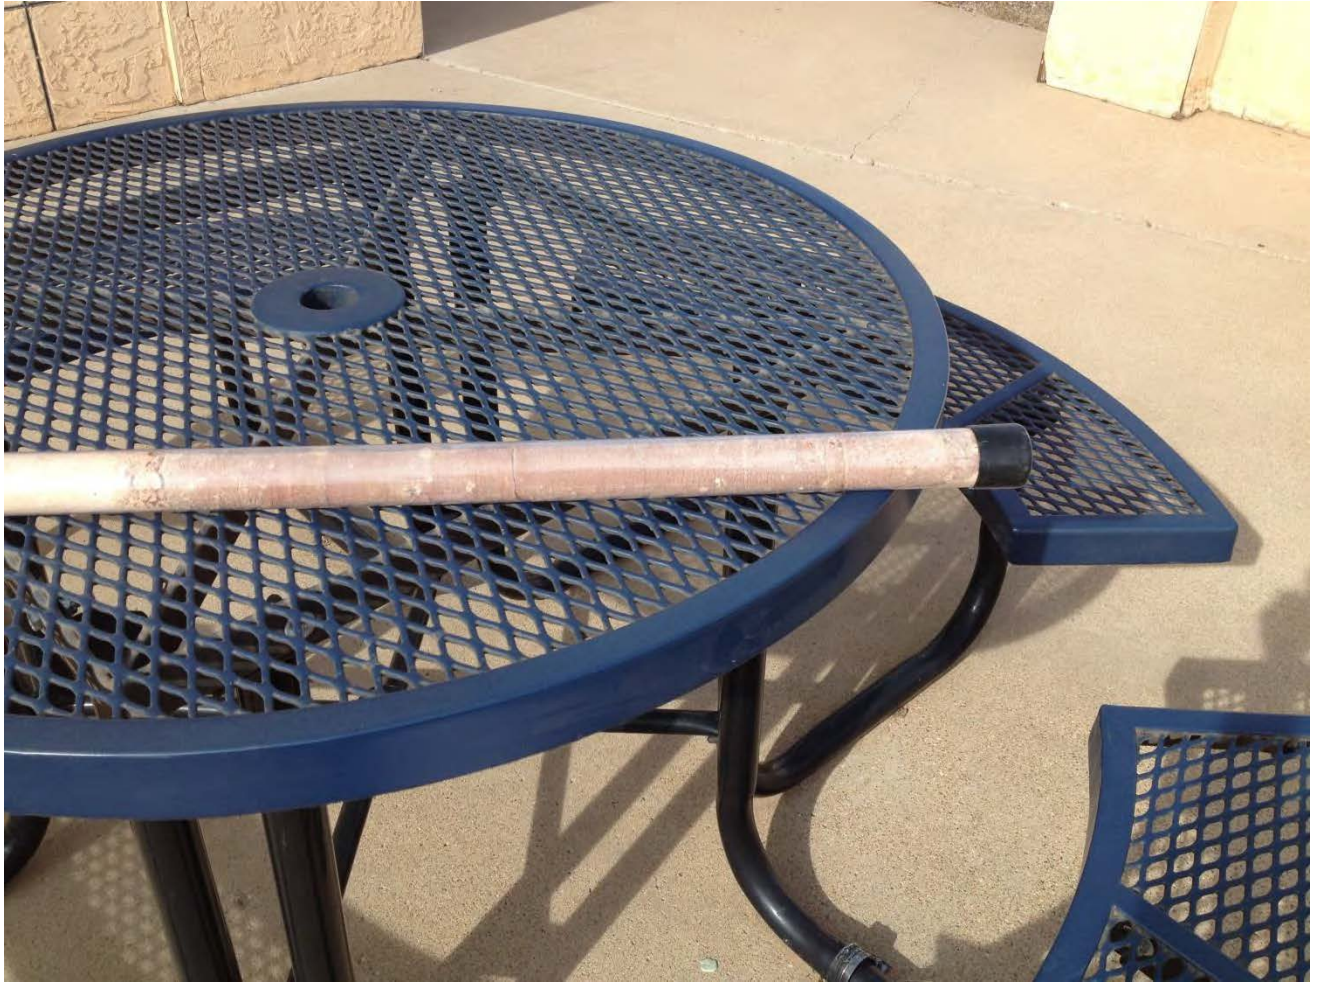
Figure 4. Core from 4 to 8 feet. Black cap is top of core, red is base. Sand at 4 feet grading to soft caliche at about 6 feet to base at 8 feet. Sample taken for analysis at 8 ft. Intermediate samples not to be tested unless sample at 4 feet shows contamination.

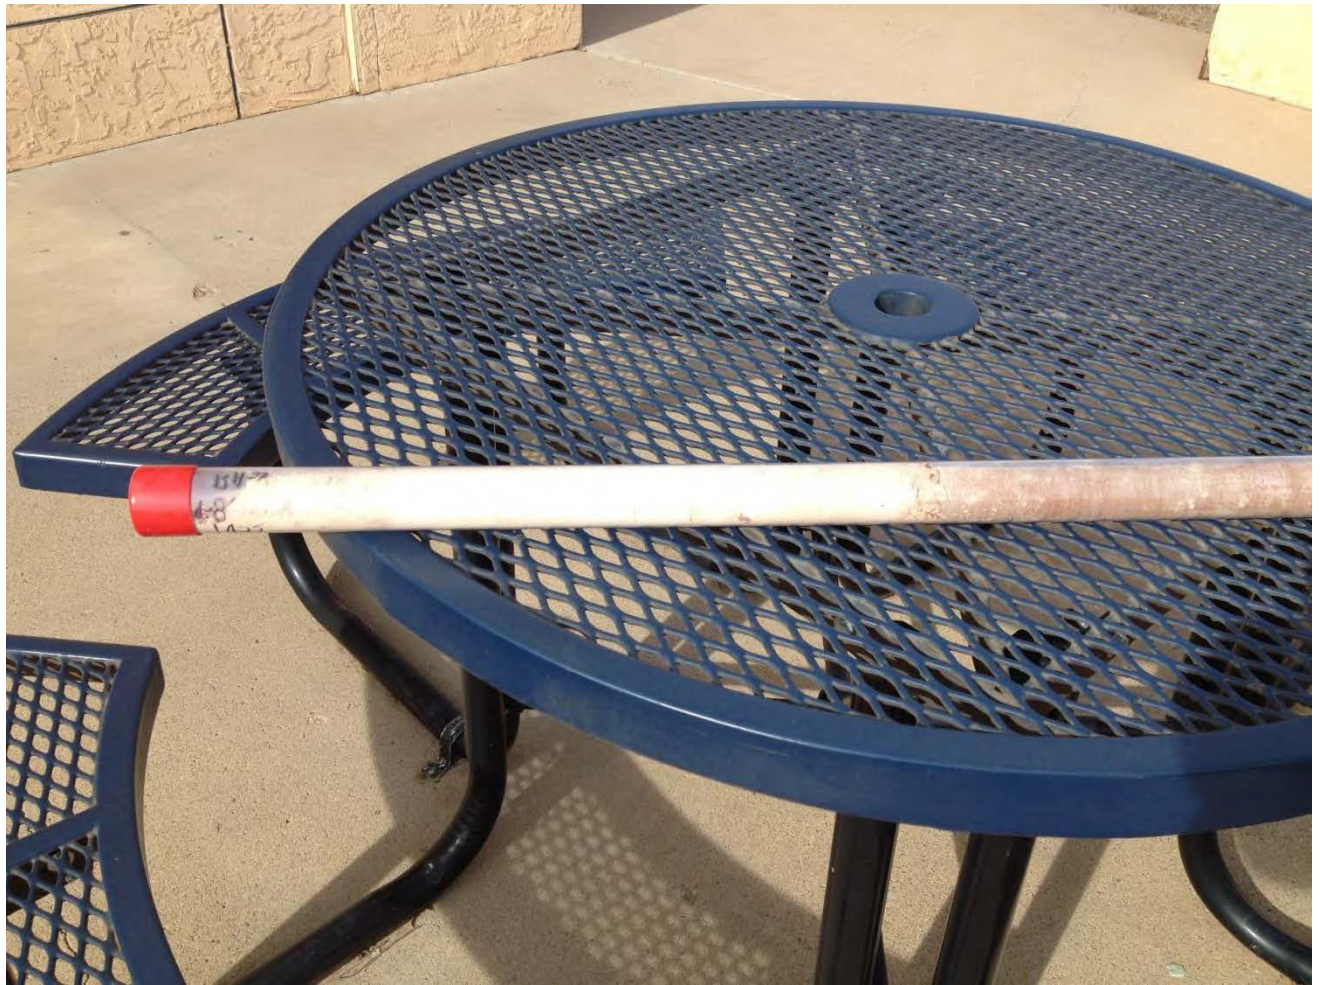
Figure 5. Core from 4 to 8 feet. Black cap is top of core, red is base. Sand at 4 feet grading to soft caliche at about 6 feet to base at 8 feet.

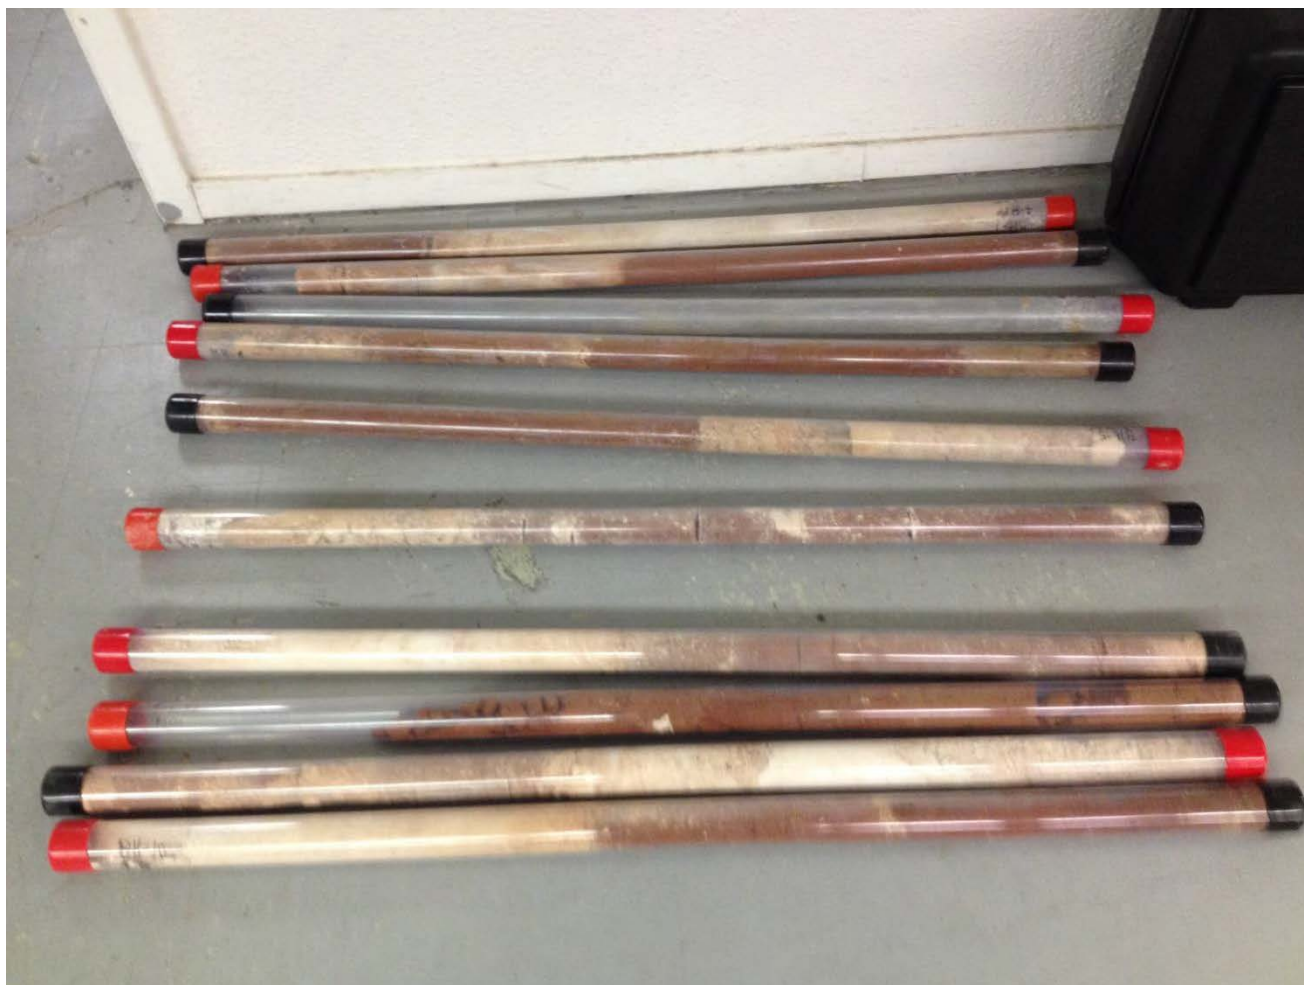
Figure 6. Untested 4 to 8 foot cores. After measurement and visual observations these will be discarded and not tested unless the 0 to 4 feet core shows contamination.

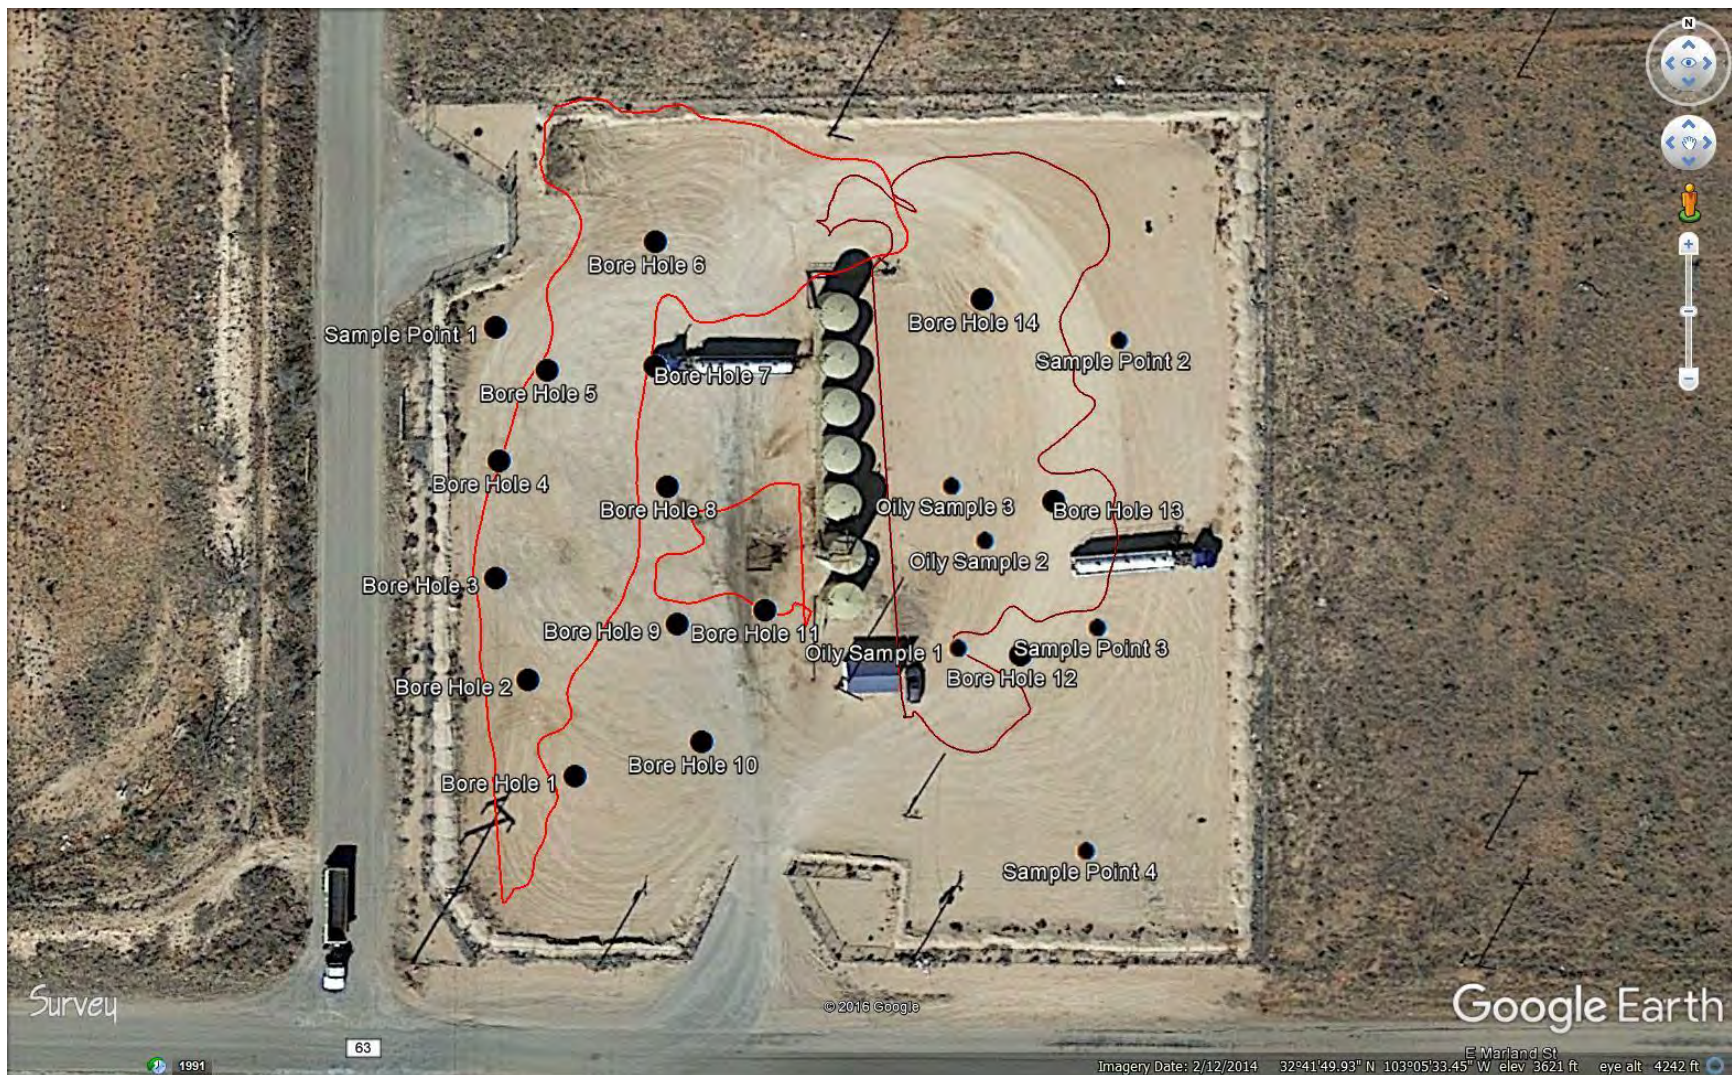
Site Map

Bore Hole
Sample Point
Oil Sample
High in Chlorides
High in TPH

Bore Hole # 10		
12/13/2016	CL	TPH
Depth ft'	ppm	ppm
BH-1'	592	<10.0
BH-2'	48	
BH-3'	64	
BH-4'	128	
BH-8'	32

Bore Hole # 11		
12/13/2016	CL	TPH
Depth ft'	ppm	ppm
BH-1'	2560	496
BH-2'	832	13.5
BH-3'	240	
BH-4'	272

Due to the depth to groundwater at this site, the entire area of impact will be excavated, placed into containment and cleaned through the RXSoil process. Pad site will be tested horizontally and vertically during excavation to ensure all contaminants have been removed to standards set by EMNRD. Clean material will then be backfilled and stabilized to operational standards.

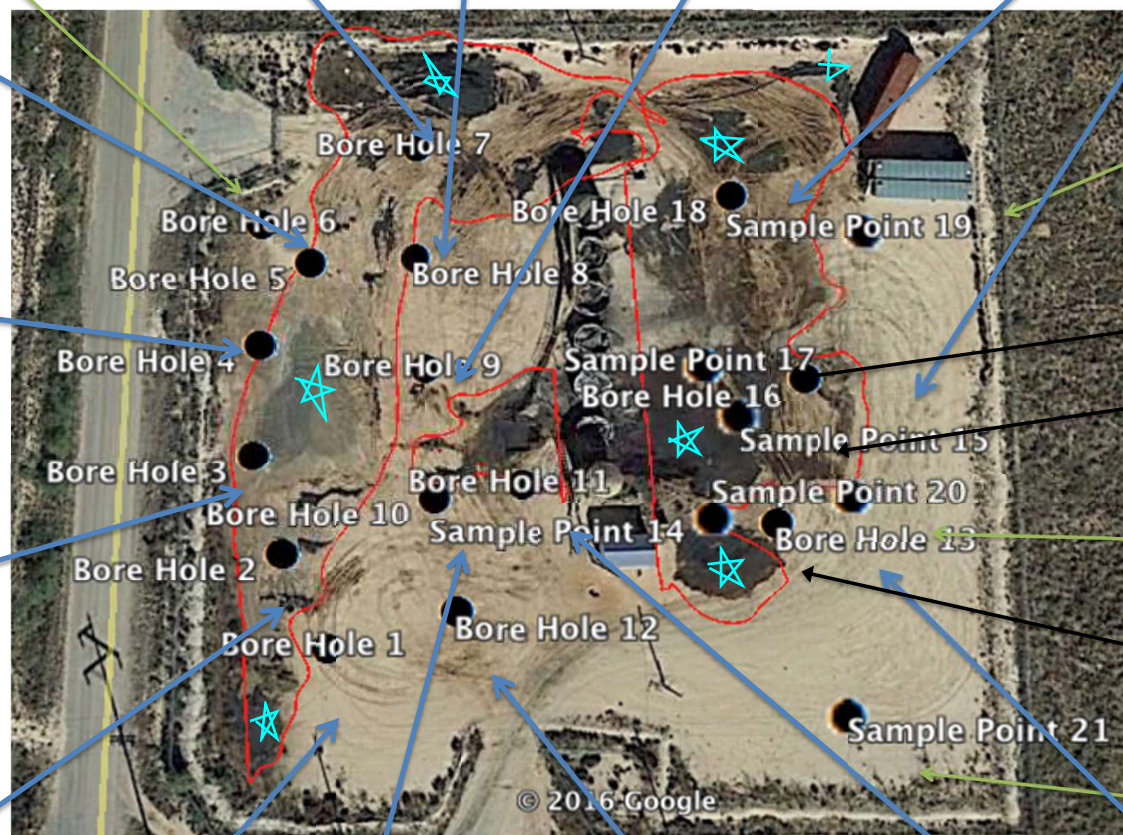
Bore Hole # 1		
12/13/2016	CL	TPH
Depth ft'	ppm	ppm
BH-1'	<16	<10.0
BH-2'	<16	
BH-3'	<16	
BH-4'	32	
BH-8'	48

Bore Hole # 9		
12/13/2016	CL	TPH
Depth ft'	ppm	ppm
BH-1'	1250	<10.0
BH-2'	96	
BH-3'	80	
BH-4'	48	
BH-8'	16
