Re: Remediation Summary and Permission to Backfill Request
A-14 Compressor Station (Below Ground Sump) Release (1RP-4635)
GPS: N 32.246183° W 103.402000°
Unit Letter "I", Section 6, Township 24 South, Range 35 East, NMPM
Lea County, New Mexico

TRC Environmental Corporation (TRC), on behalf of ETC Field Services, LLC (ETC) has prepared this Remediation Summary and Permission to Backfill Request (Request) for the A-14 Compressor Station (Below Ground Sump) Release Site (Release Site). The purpose of this Request is to provide documentation of remediation activities designed to advance the A-14 Compressor Station (Below Ground Sump) Release Site toward an NMOCD approved Site Closure Status. The legal description of the Release Site is Unit Letter "I", Section 6, Township 24 South, Range 35 East, NMPM, in Lea County, New Mexico. The GPS coordinates for the site are N 32.246183° W 103.402000°. The subject property is administered by the United States Bureau of Land Management (BLM). A Site Location Map, Site Details and Soil Sample Location Map, Site Details and Soil Sample Locations Maps, and Site Details and Confirmation Soil Sample Locations Map are provided as Figure 1, Figure 2, F

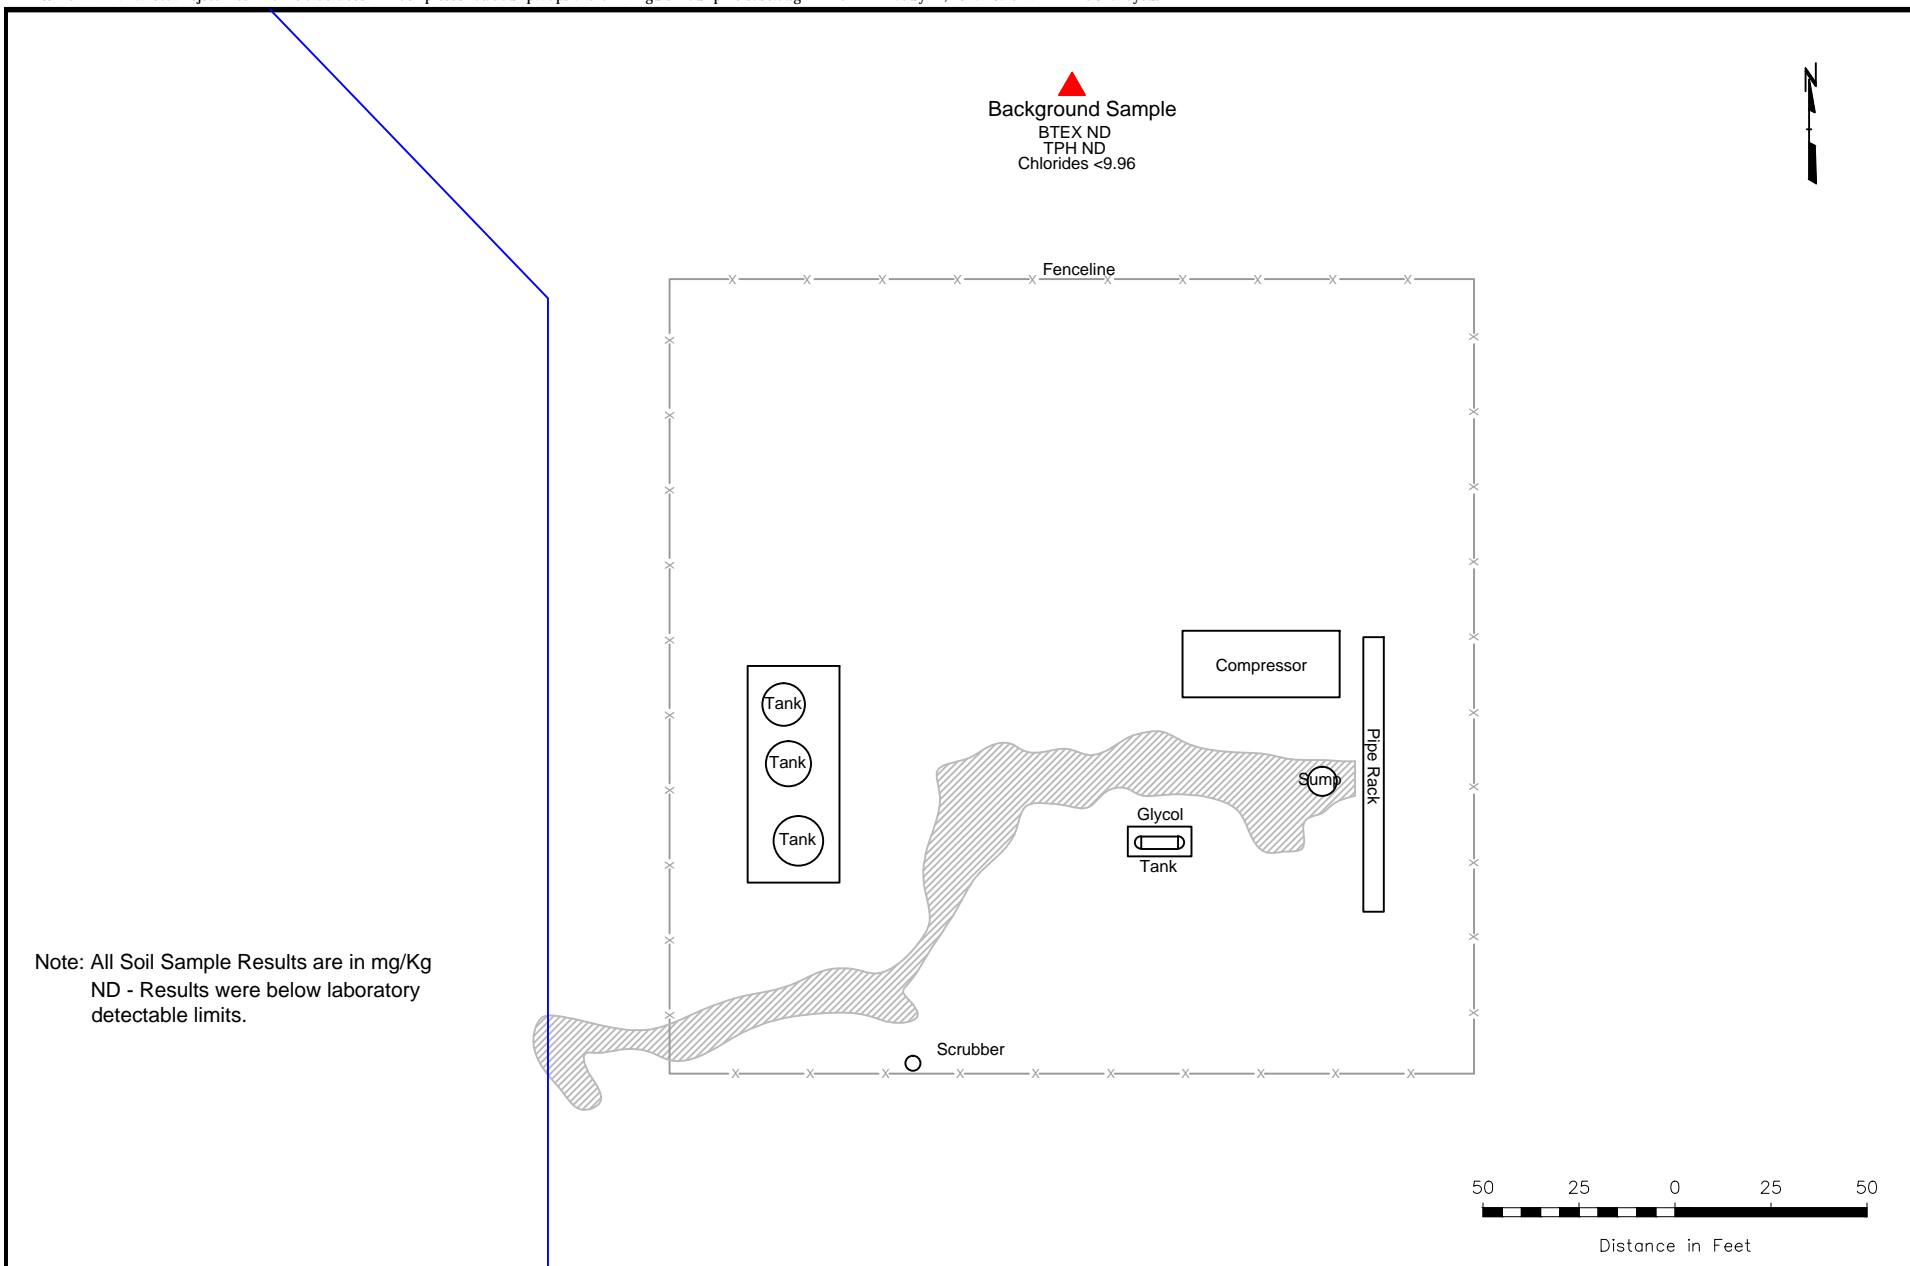
Figure 2
 Site Detail and
 Soil Sample Location Map
 ETC Field Services, LLC
 A-14 Compressor Station
 Sump Release
 Lea County, NM

On March 22 and March 23, 2017, TRC, on behalf of ETC, utilized a hand auger to collect eighteen (18) delineation soil samples (S-1 6" through S-7 6", S-1 1' through S-7 1', S-3 16", S-3 22", S-4 21", and S-4 2') from the surface soil stained area. The soil samples were submitted to Xenco Laboratories in Midland, Texas for determination of concentrations of BTEX using Method SW 846-8021B, Total Petroleum Hydrocarbons (TPH) using Method SW 846-8015M, and chloride using Method E-300.1. The analytical results indicated benzene and BTEX concentrations were less than the applicable laboratory Method Detection Limit (MDL), with the exception of soil sample S-3 22", which exhibited a BTEX concentration of 0.00322 mg/Kg which is below NMOCD regulatory guidelines. TPH concentrations ranged from less than the laboratory MDL for soil samples S-1 1', S-5 6", and S-7 1' to 17,531 mg/Kg for soil sample S-4 6". A review of laboratory analytical results indicated soil samples S-3 1' and S-4 6" exhibited TPH concentrations above NMOCD regulatory guidelines. Chloride concentrations ranged from less than the applicable laboratory MDL for soil samples S-2 6", S-2 1', S-5 6", S-5 1', S-6 6", S-6 1', S-7 6", S-7 6", and S-7 1' to 3,120 mg/Kg for soil sample S-4 6". A review of

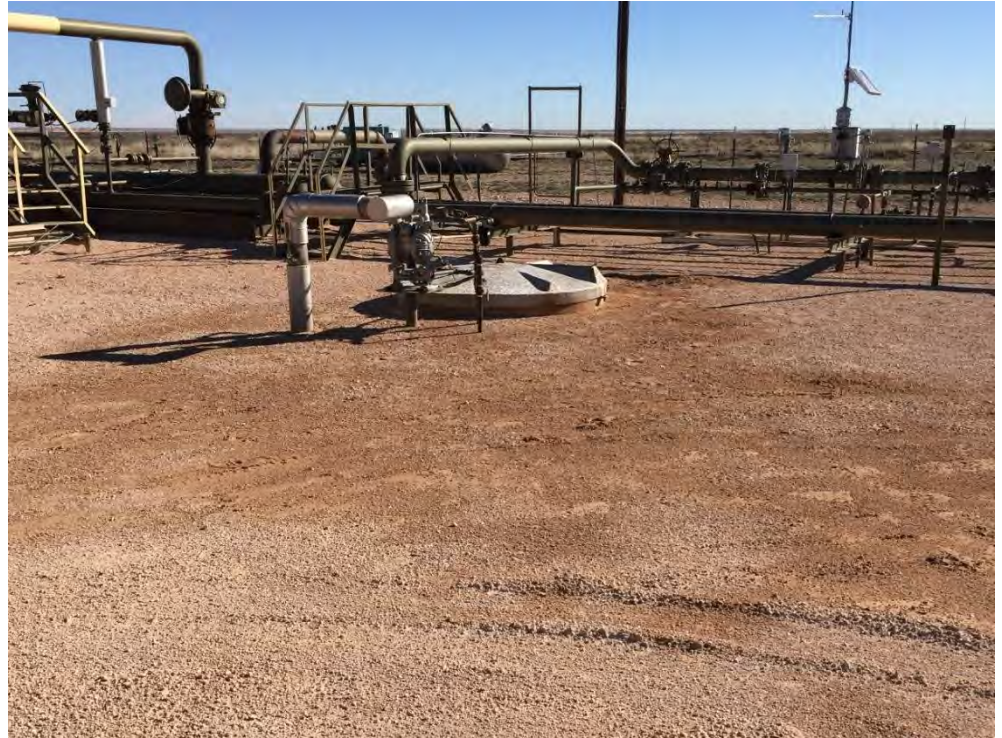
Description:
View of impacted area and below ground tank (sump) release point.

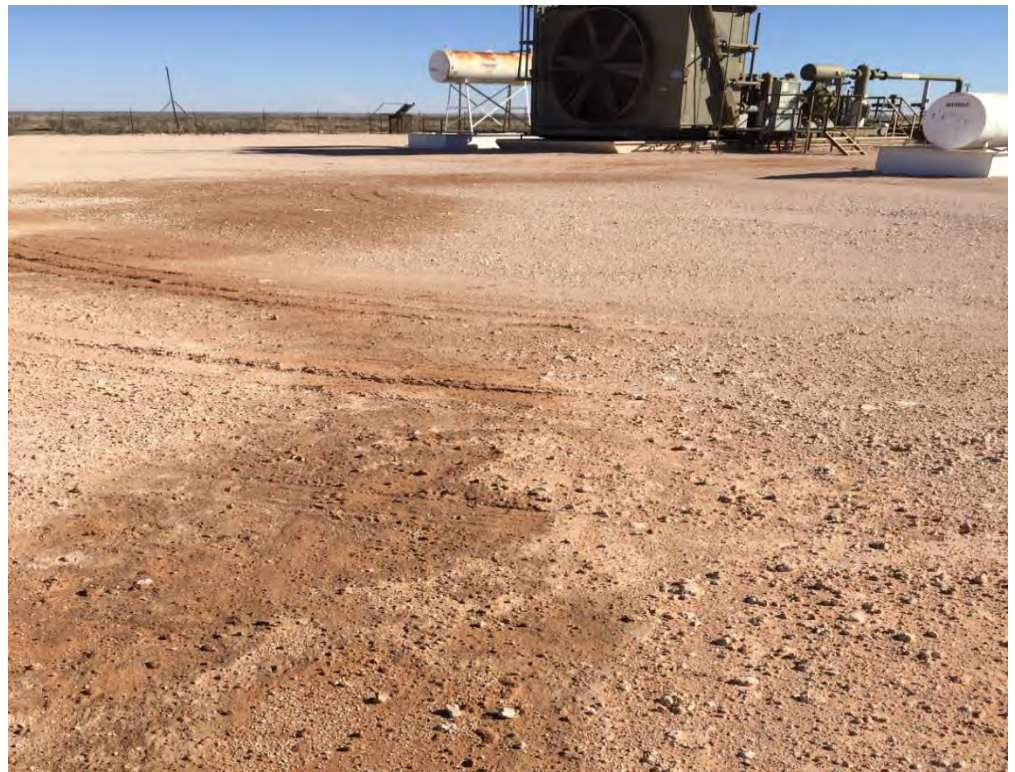
Photograph No. 2

Description:
View of impacted area. Sump is located toward the upper right of photo.

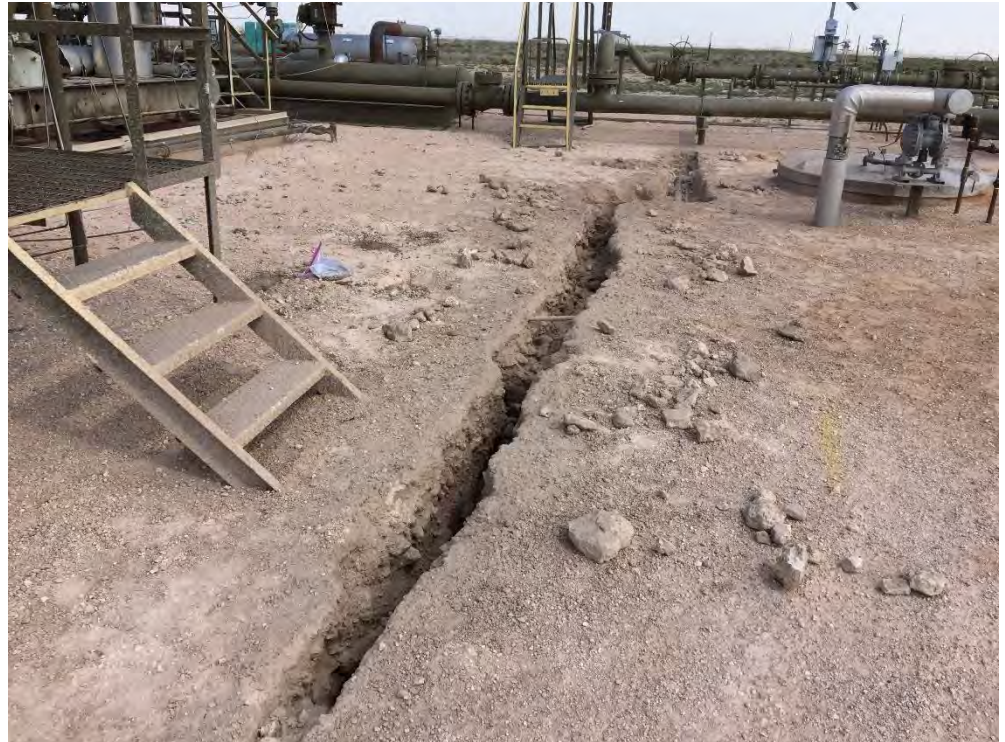
Description:
View of hydro-vac
trenches utilized to
locate
underground
equipment.

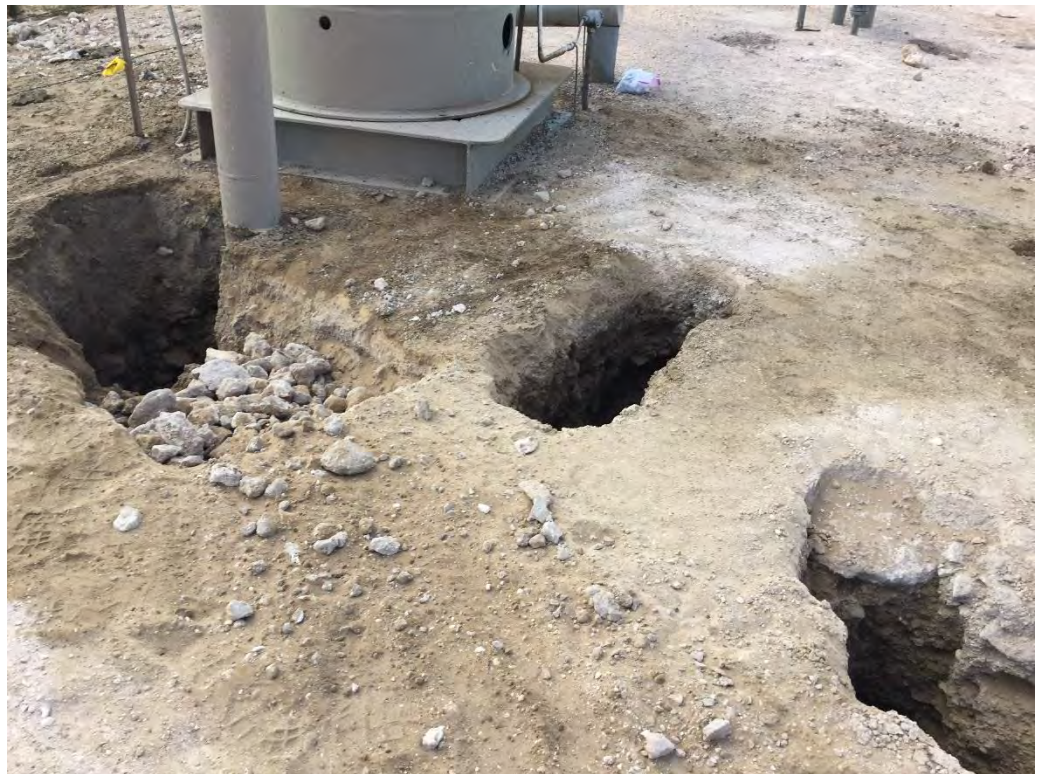
Photograph No. 4

Description:
View of hydro-vac
trenches utilized to
locate
underground
equipment.

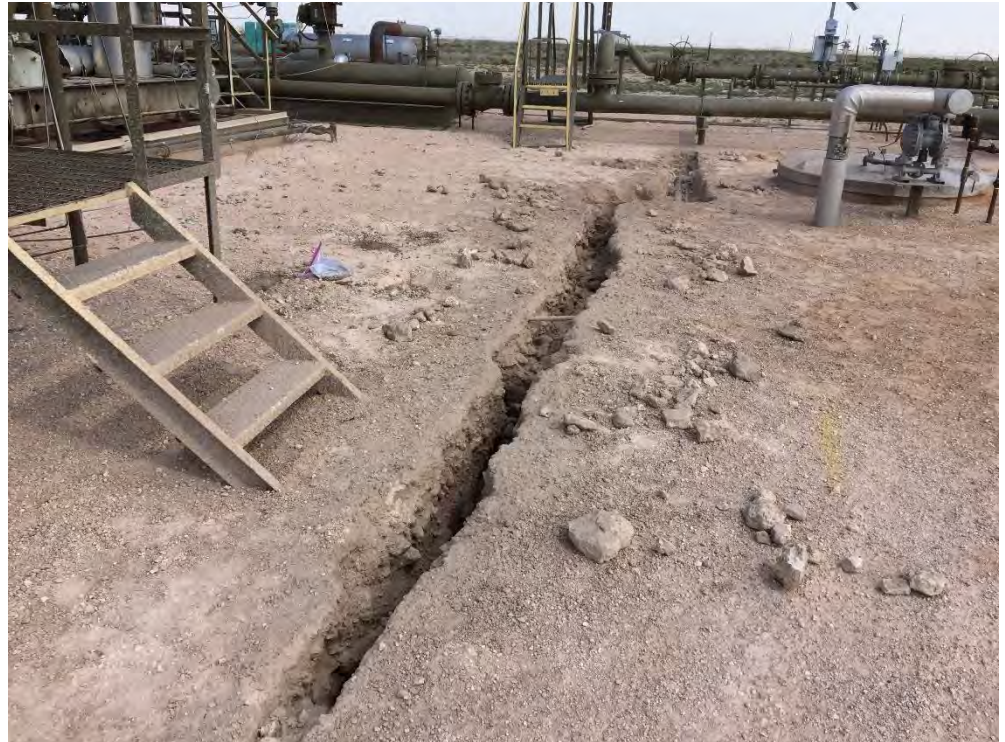
Description:
View of hydro-vac
trenches utilized to
locate
underground
equipment.

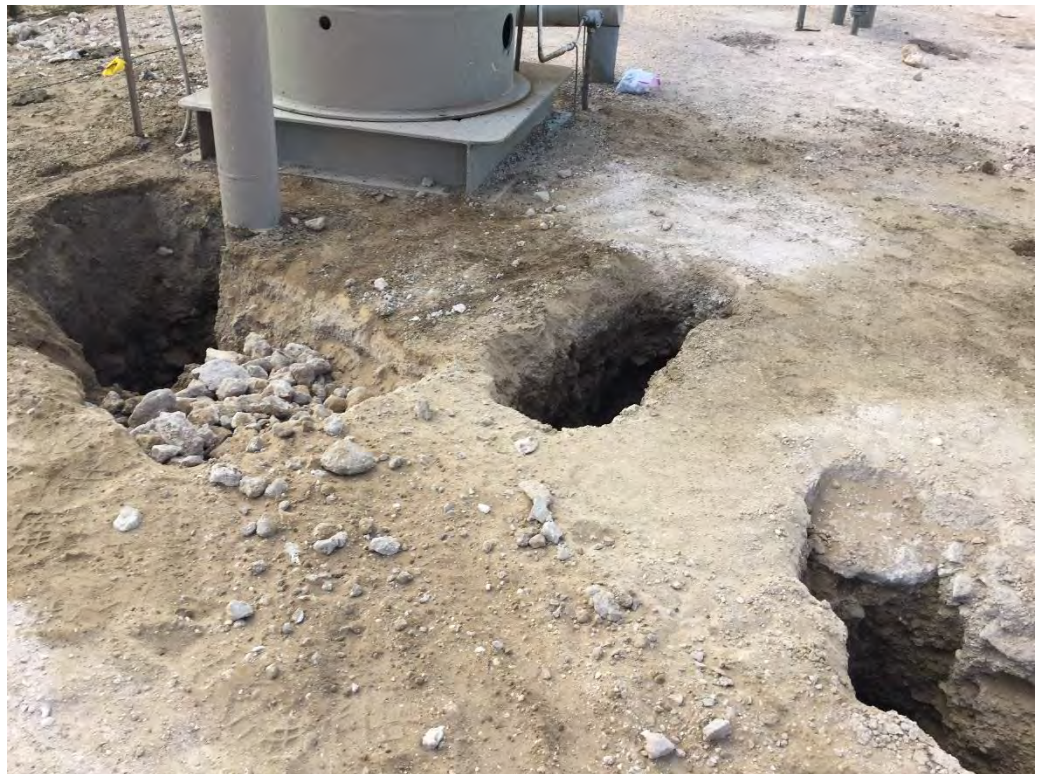
Photograph No. 6

Description:
View of hydro-vac
trenches utilized to
locate
underground
equipment.

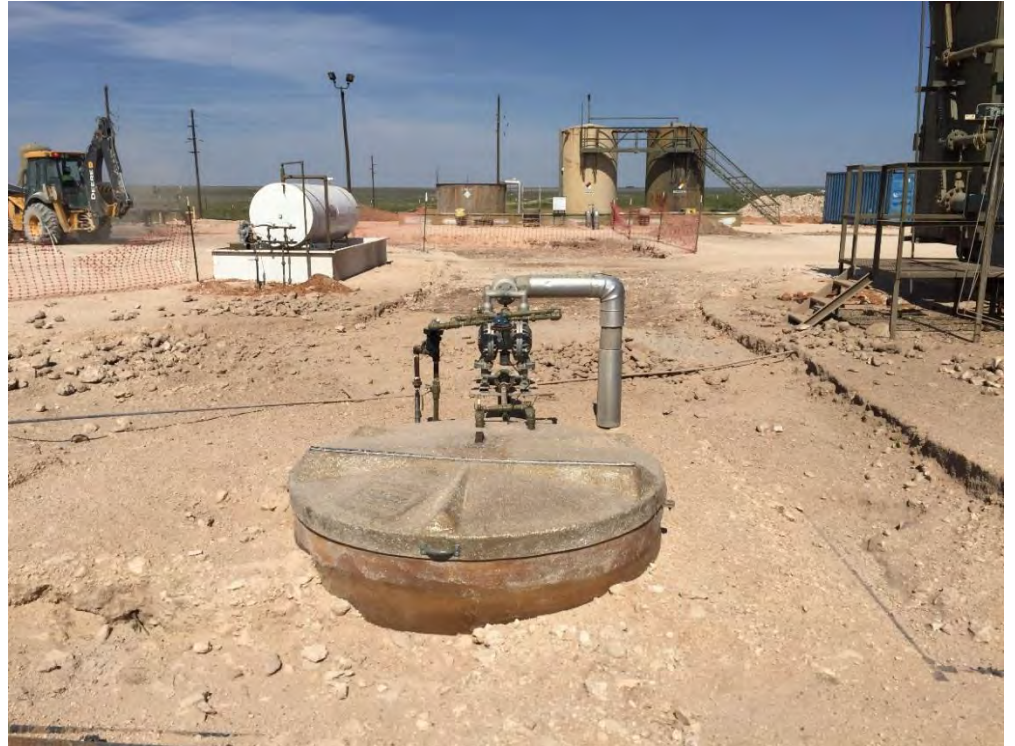
Description:
View of excavated
area.

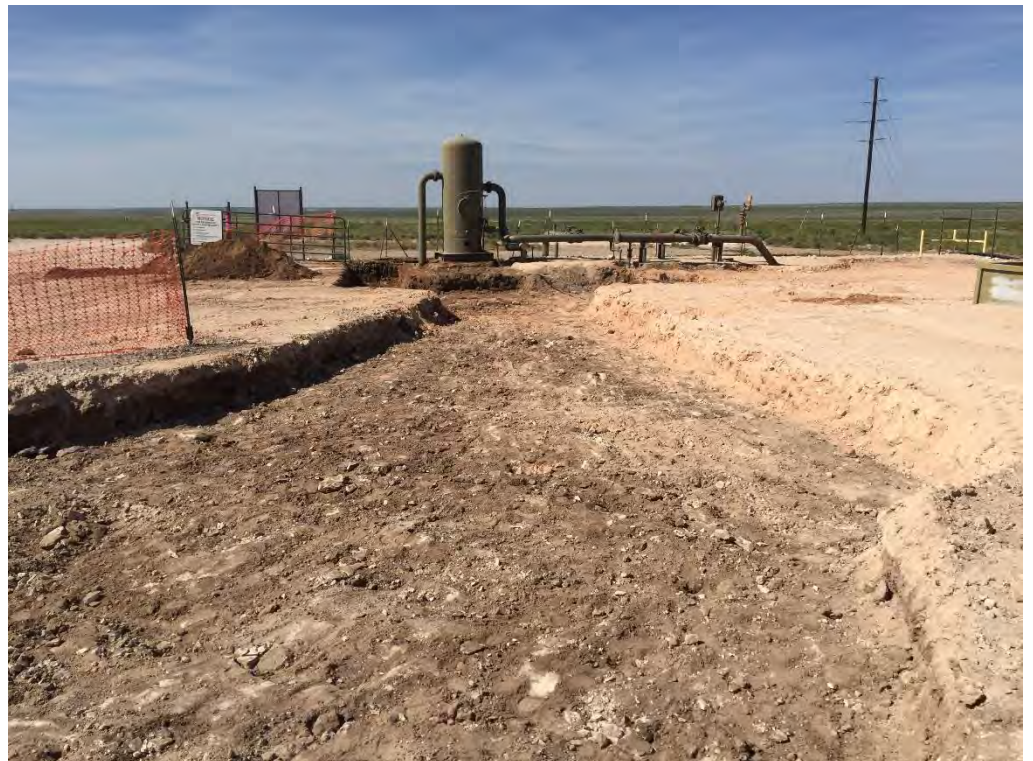
Photograph No. 8

Description:
View of excavated
area.

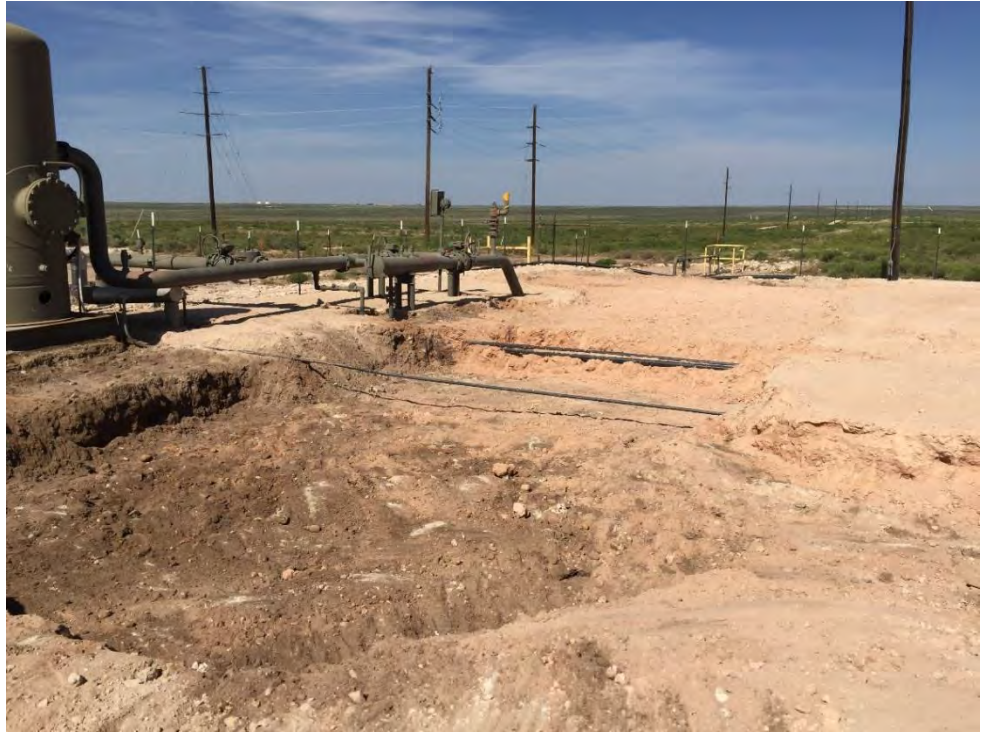
Description:
View of excavated
area.

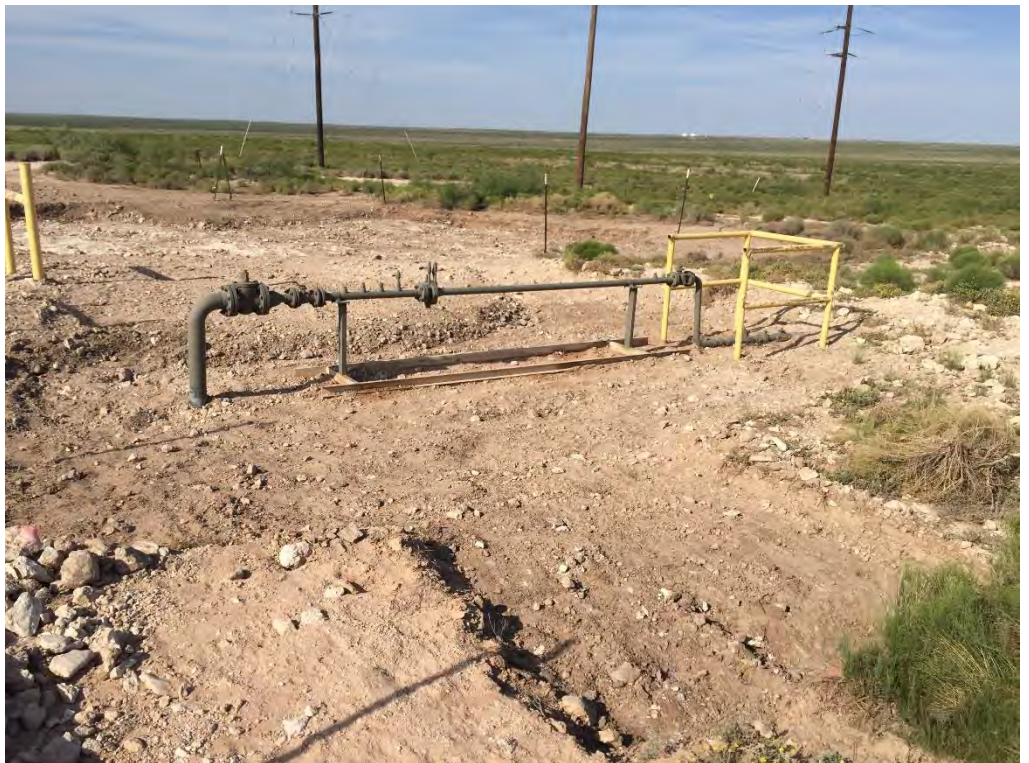
Photograph No. 10

Description:
View of excavated
area.
