Re: Closure Request
Fullerton 16 Inch (1RP-4499)
ETC Field Services LLC
Site Location: Sec. 35, T 21-S, R 37-E
(Lat 32.42832N°, Long -103.1396W°)
Lea County, New Mexico

On behalf of ETC Field Services LLC (ETC), GHD Services, Inc. (GHD) is requesting that no further action status be granted for the Fullerton 16 Inch (hereafter referred to as the "Site").

Re: Remediation Summary Report Fullerton 16 Inch (1 RP-4499) ETC Field Services LLC

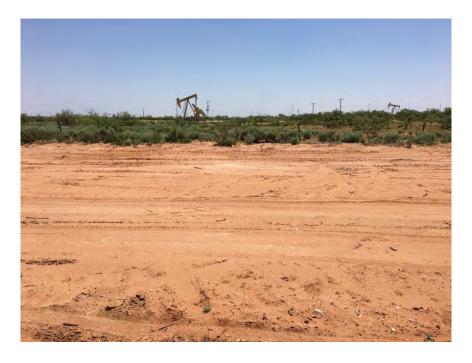
Photo 1 - Backfilled area

- Backfilling of the excavation with clean fill material and wheel compacting to grade.
- Fertilizing and reseeding of the disturbed area with an appropriate seed mix. BLM #2 grass mix was used.

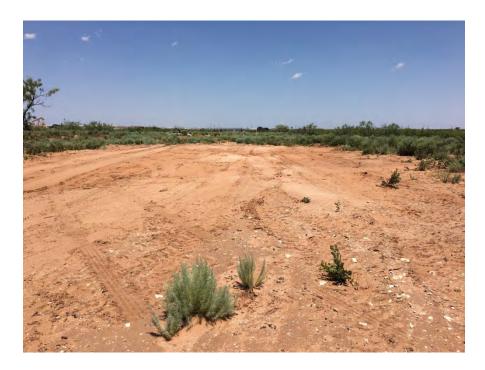
Photo 2 - Backfilled area

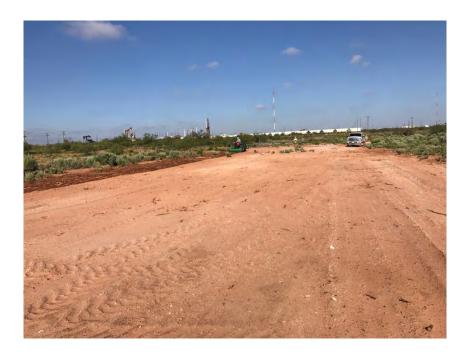
Photo 3 - Re-seeding

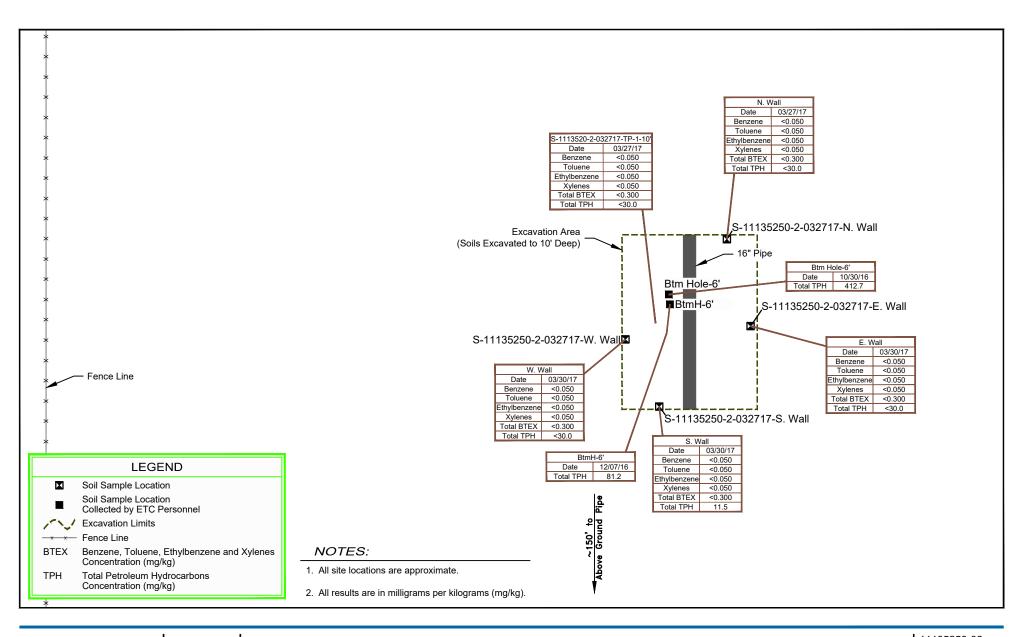
FIGURE 2

Confirmation soil samples were collected and submitted to Cardinal Laboratories for laboratory analysis. Samples were collected from the base of the excavation and the four walls (see Figure 2). The soil samples were analyzed for BTEX by EPA Method 8021 and TPH by EPA Method 8015 full range (Table 1). Laboratory analytical data can be found in Appendix B. Based on the low concentrations that were observed during the initial sampling (see above), the confirmation samples were not analyzed for chloride.

The final dimensions of the excavation were measured at 14 feet wide by 18 feet long by 10 feet deep. Only one sample (S-1113520-2-032717-S. Wall) contained a detectable Analyte above the laboratory reporting limit. This sample contained a TPH diesel range organics concentration of 11.5 mg/kg which is below the RRAL. Initial bottom of excavation soil samples did not contain chloride concentrations above the RRAL and thus, the confirmation samples were not analyzed for chloride.

SOIL SAMPLE LOCATION

Confirmatory soil samples collected from the base of the excavation at a depth of 10 ft bgs, and the four walls (see Figure 2) were submitted for laboratory analysis. The laboratory analytical results are below the RRALs for the constituents that were analyzed. Based on the laboratory results, GHD recommends the following:
