## PROJECT SUMMARY

10215A1 4.5 inch steel Gas Pipeline  
Lea County, New Mexico  
1RP 4511

**September 1, 2017**

**DCP Midstream**  
**10215A1 4.5 inch Steel Gas Pipeline** 1RP 4511  
NESE Section 18, Township 22 South, Range 33 East  
Lea County, New Mexico

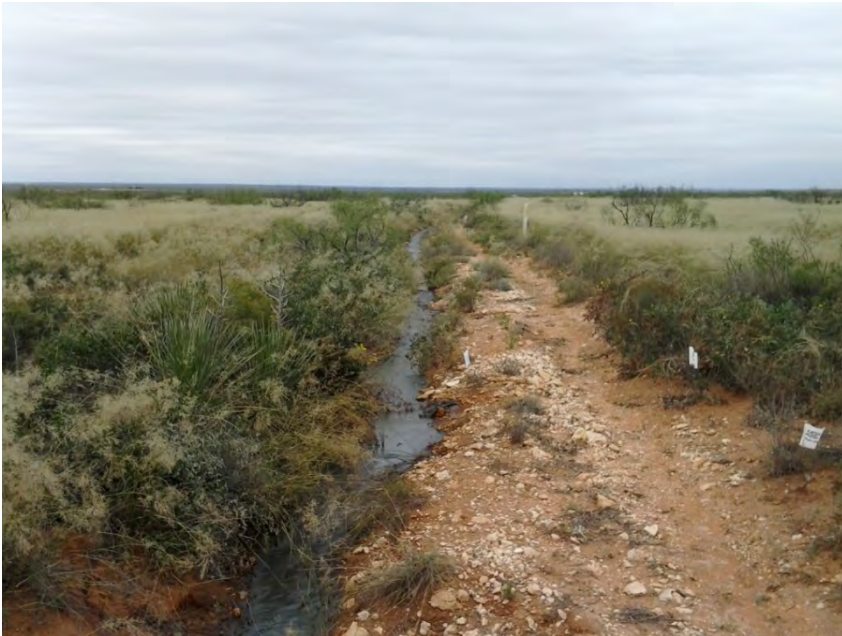
11/09/2016

On November 9, 2016, the leak was discovered in the pipe resulting in 8 bbls condensate released, the line was depressurized and repaired. Tasman personnel were on site on August 2, 2017 to assess the release. The release area was GPS mapped (Figure 1) and samples were collected, the samples were field tested for chlorides and organic vapors, and representative samples were taken to a commercial laboratory for analysis (Appendix A) and photographed (Appendix B).

Initial Leak

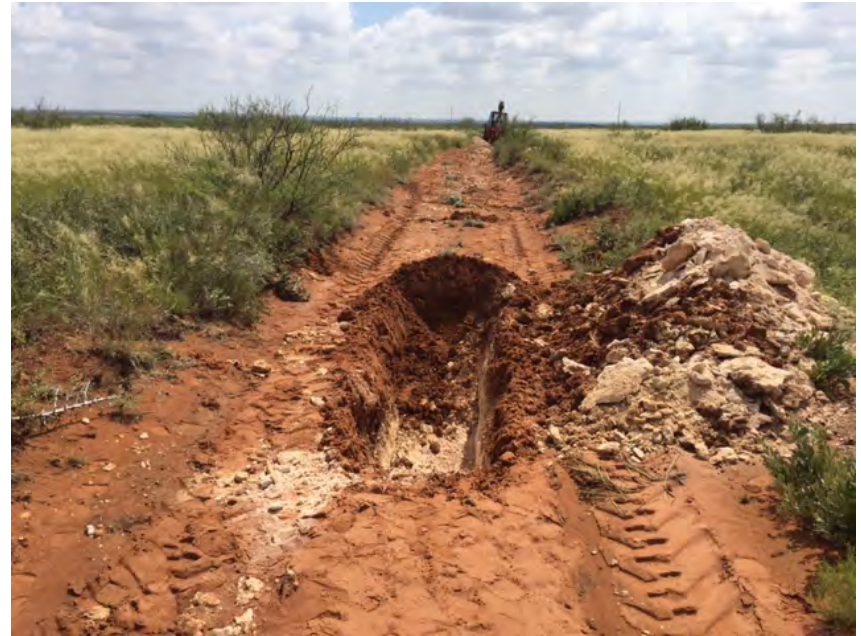
8/02/2017

Vertical #4, facing west

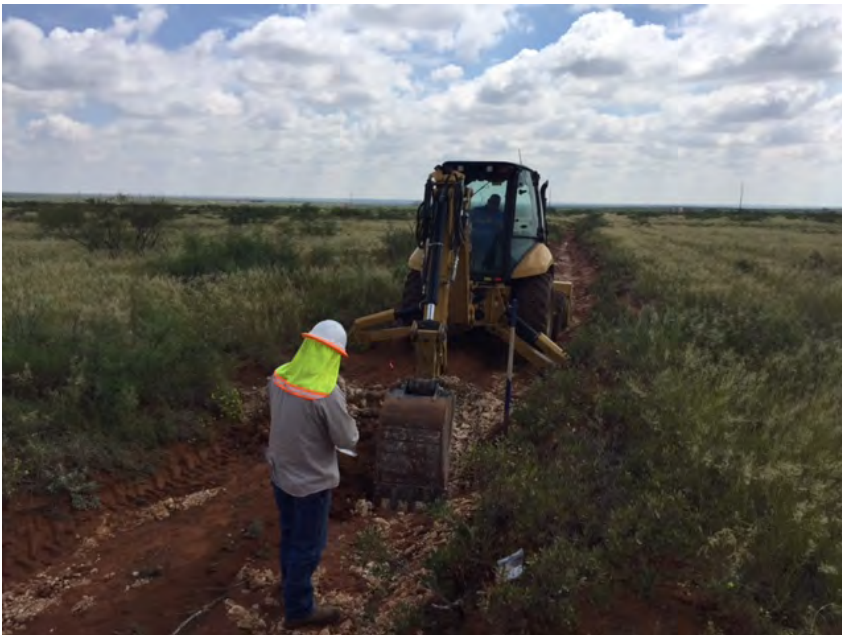
8/02/2017

Excavating Vertical #4, facing west

Approximately 130 cubic yards of contaminated soil were exported and disposed of at Lea Land.

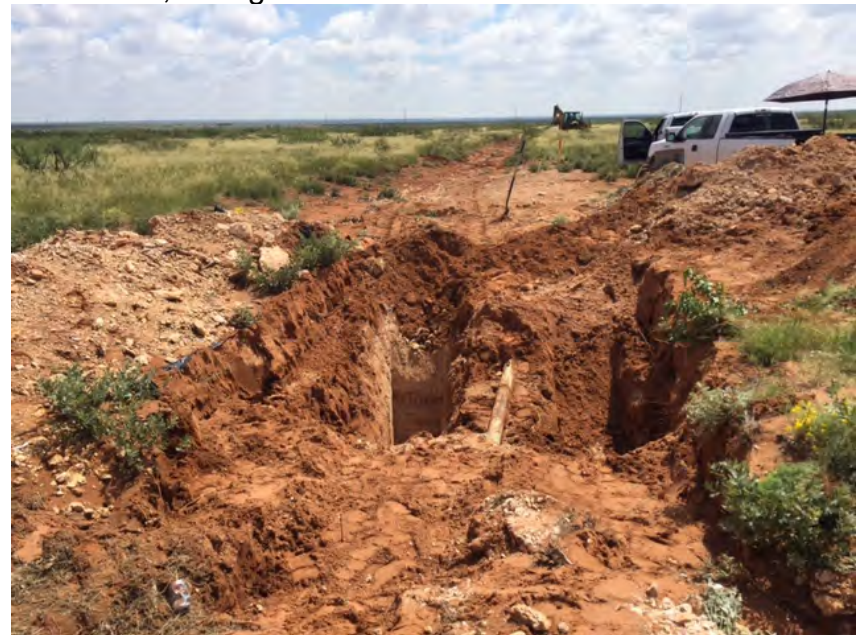
8/02/2017

Vertical #1 at source, facing east
