Re: Work Plan for Site Characterization
State OG SWD No. 2 Release
Bagley North Oil Field, Lea County, New Mexico
NW1/4 SW1/4, Sec. 9, T11S, R33E
NMOCD Case No. 1R-4703

On behalf of Jay Management, LLC (Jay Management), Timberwolf Environmental, LLC (Timberwolf) prepared this work plan for site characterization at the State OG SWD No. 2 Facility (Site) to assess impacts related to a recent release. The Site is located in the Bagley North Oil Field approximately 5.1 miles east-southeast of Caprock, Lea County, New Mexico (Figures 1 through 3). The release response actions, initial site assessment, and the site characterization work plan are discussed below.

Proposed Work Plan for Site Characterization

PHOTOGRAPHIC LOG

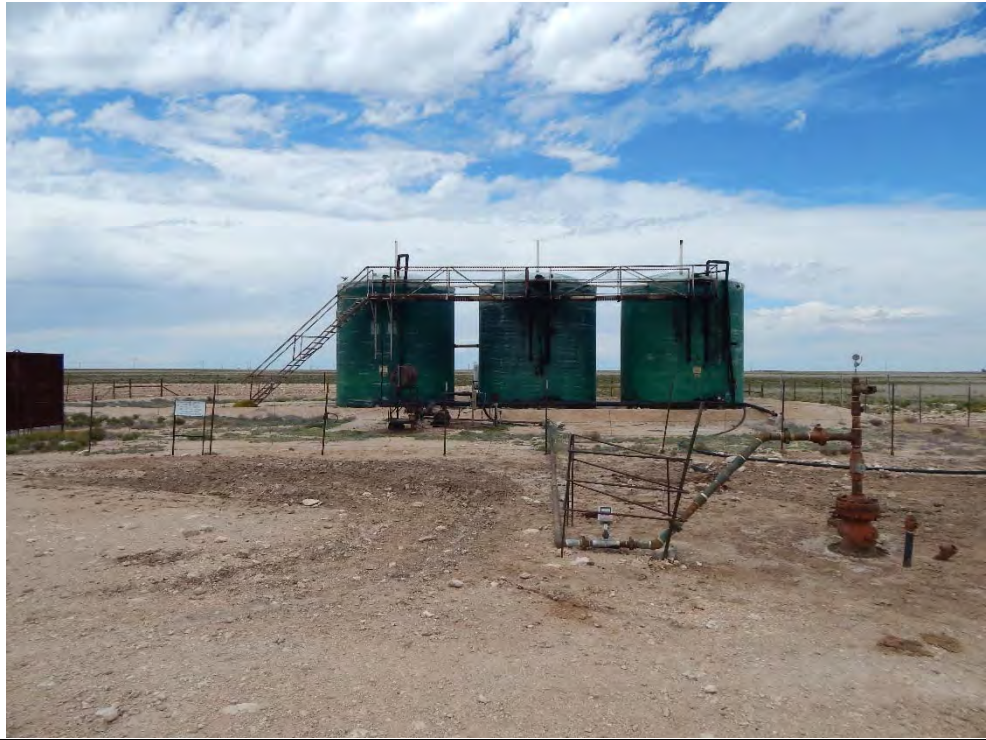
| Photo No.: 1 | | | |

| Comments: View of the State OG SWD No. 2 well, tank battery, and injection pump. | | | |

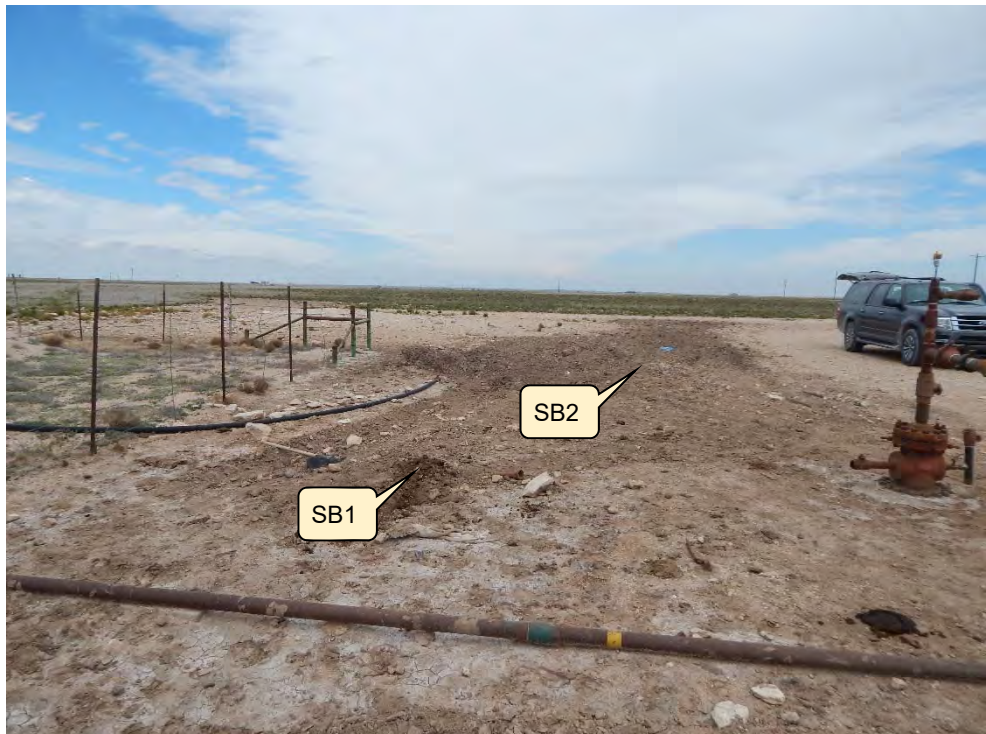
| Photo No.: 2 | | | |

| Comments: View of tilled impacted soils within the spill area. Note SB1 and SB2 sample locations. | | | |

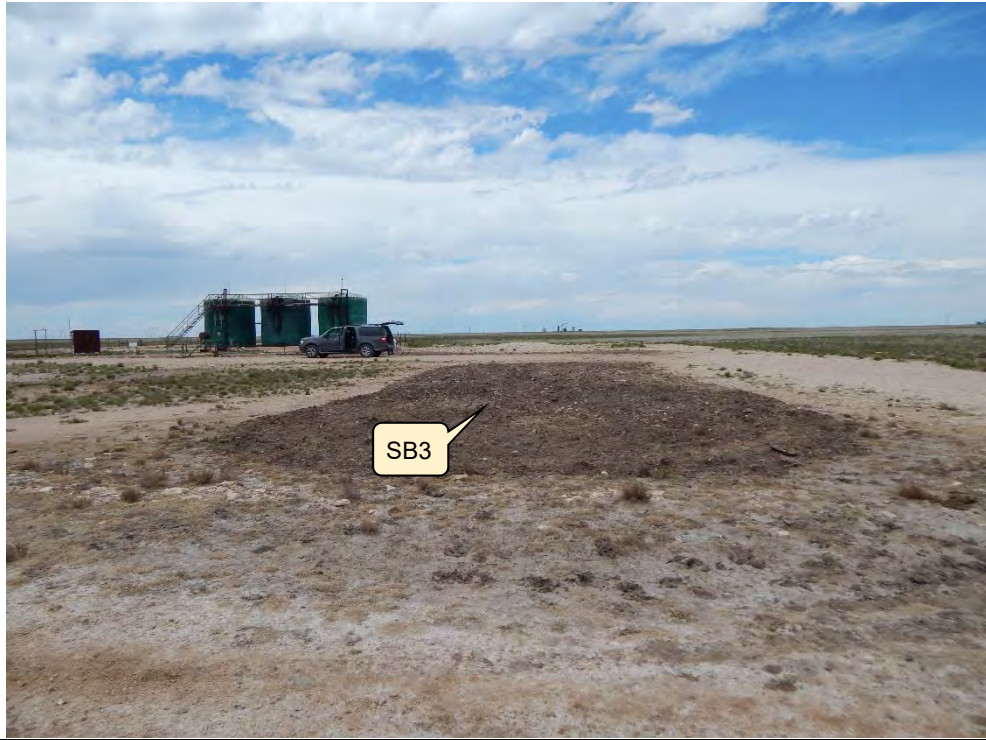
| Photo No.: 3 | | | |

| Comments: View of tilled impacted soils within the spill area. Note SB3 sample location. | | | |

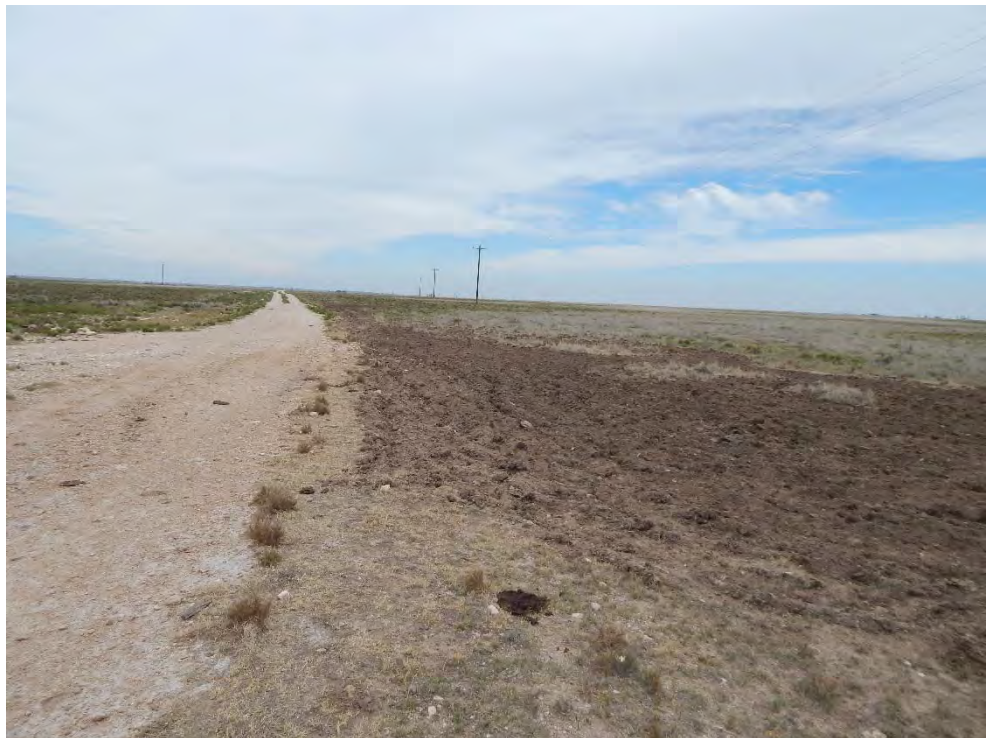
| Photo No.: 4 | | | |

| Comments: View along the lease road and tilled impacted soils within the spill area. | | | |
