July 31, 2017

**Re: Release Characterization Report and  
Proposed Remediation Work Plan  
Yates State #2 Tank Battery  
NMOCD Case No. 1R-4587  
Lea County, New Mexico**

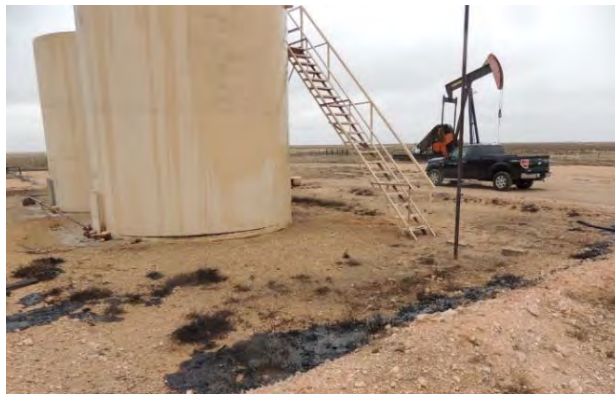
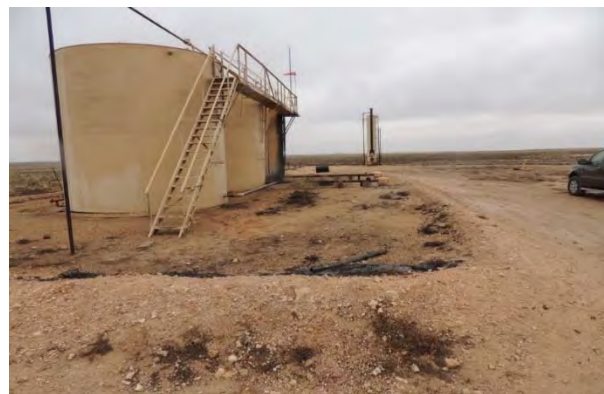
Enviro Clean Cardinal, LLC (ECC) has been retained by RAM Energy Resources (RAM) to conduct a release characterization at RAM's Yates State #2 Tank Battery (Site) located in Unit H, Section 16, Township 12 South, Range 38 East of Lea County, New Mexico (geographical coordinates 33.2793N, 103.0945W) and to prepare a proposed work plan to remediate the Site. The Site is approximately two miles west of the New Mexico/Texas state line and 13 miles east-northeast of Tatum, New Mexico. The Site location and topographical features are shown on the attached **Figure 1**. The Yates State #2 wellhead and tank battery are collocated on the Site as shown on the photograph below and **Figure 2** (photographs taken from southeast corner and east side of tank battery, respectively).
