Re: VGSAU 148 Soil Assessment and Delineation Report

Soil Assessment and Delineation Activities Report

VGSAU #148

Produced Water Release

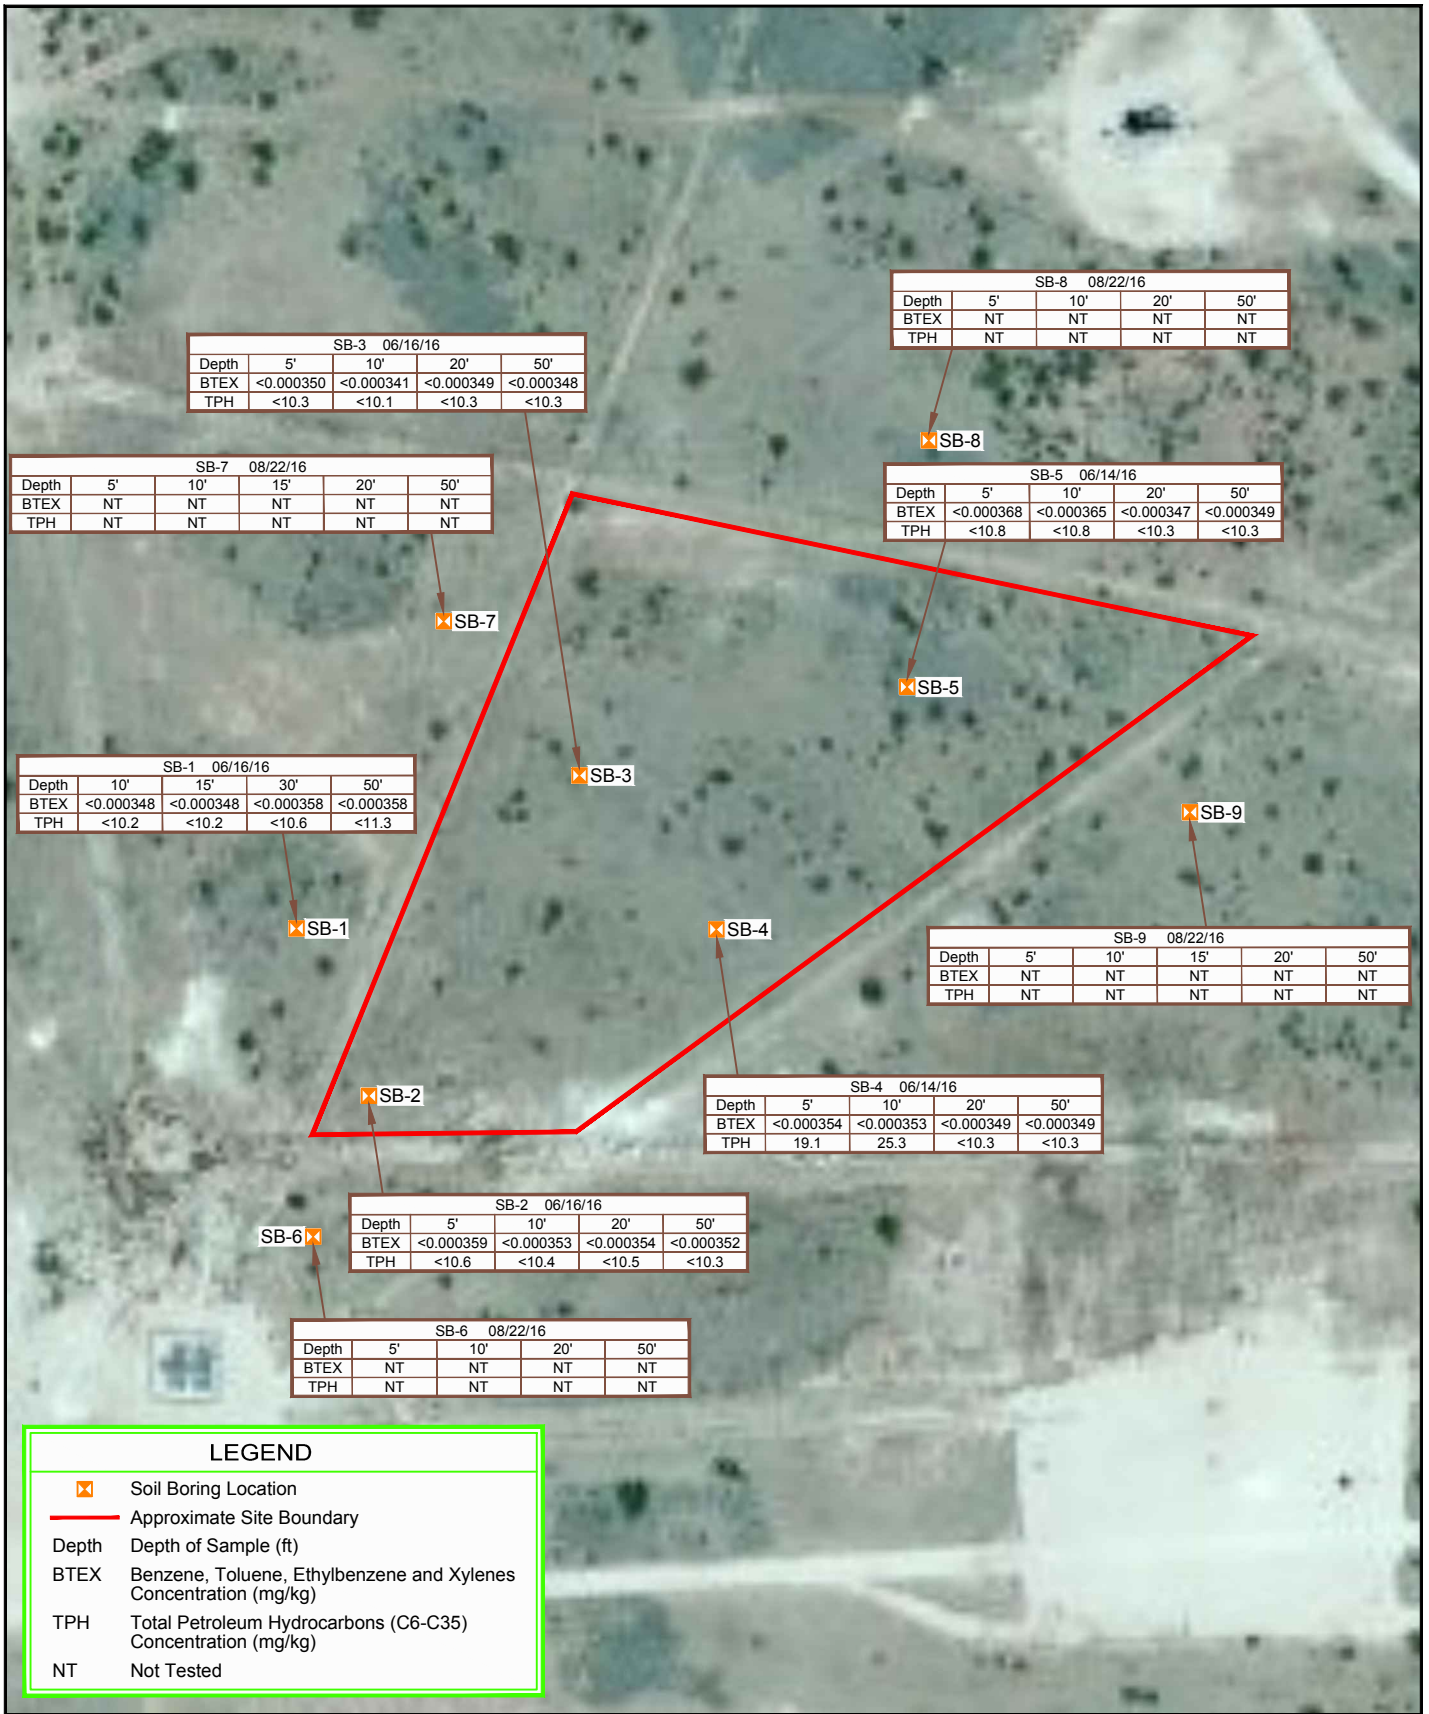
CHLORIDE CONCENTRATION MAP **FIGURE 2**

Analytical results are summarized in Table 1. Chloride results are presented on Figure 2, and BTEX-TPH results are presented on Figure 3. Analytical reports are provided in Appendix C.
