NMOCD APPROVED
REMEDATION SUMMARY
AND
SITE CLOSURE
FOR THE
RHOMBUS UNION STATE COM 1
1RP-4671

REFERENCE: NMOCD APPROVED SOIL REMEDIATION WORK PLAN FOR
INCIDENT 1RP-4671 RHOMBUS UNION STATE #1 LEA COUNTY,
NEW MEXICO

NMOCD APPROVED SOIL REMEDIATION WORK PLAN FOR INCIDENT 1RP-4671

FRONTIER FIELD SERVICES LLC
RHOMBUS UNION STATE COM # 1
SECTION 32, TOWNSHIP 18S, RANGE 34E
LEA COUNTY, NEW MEXICO

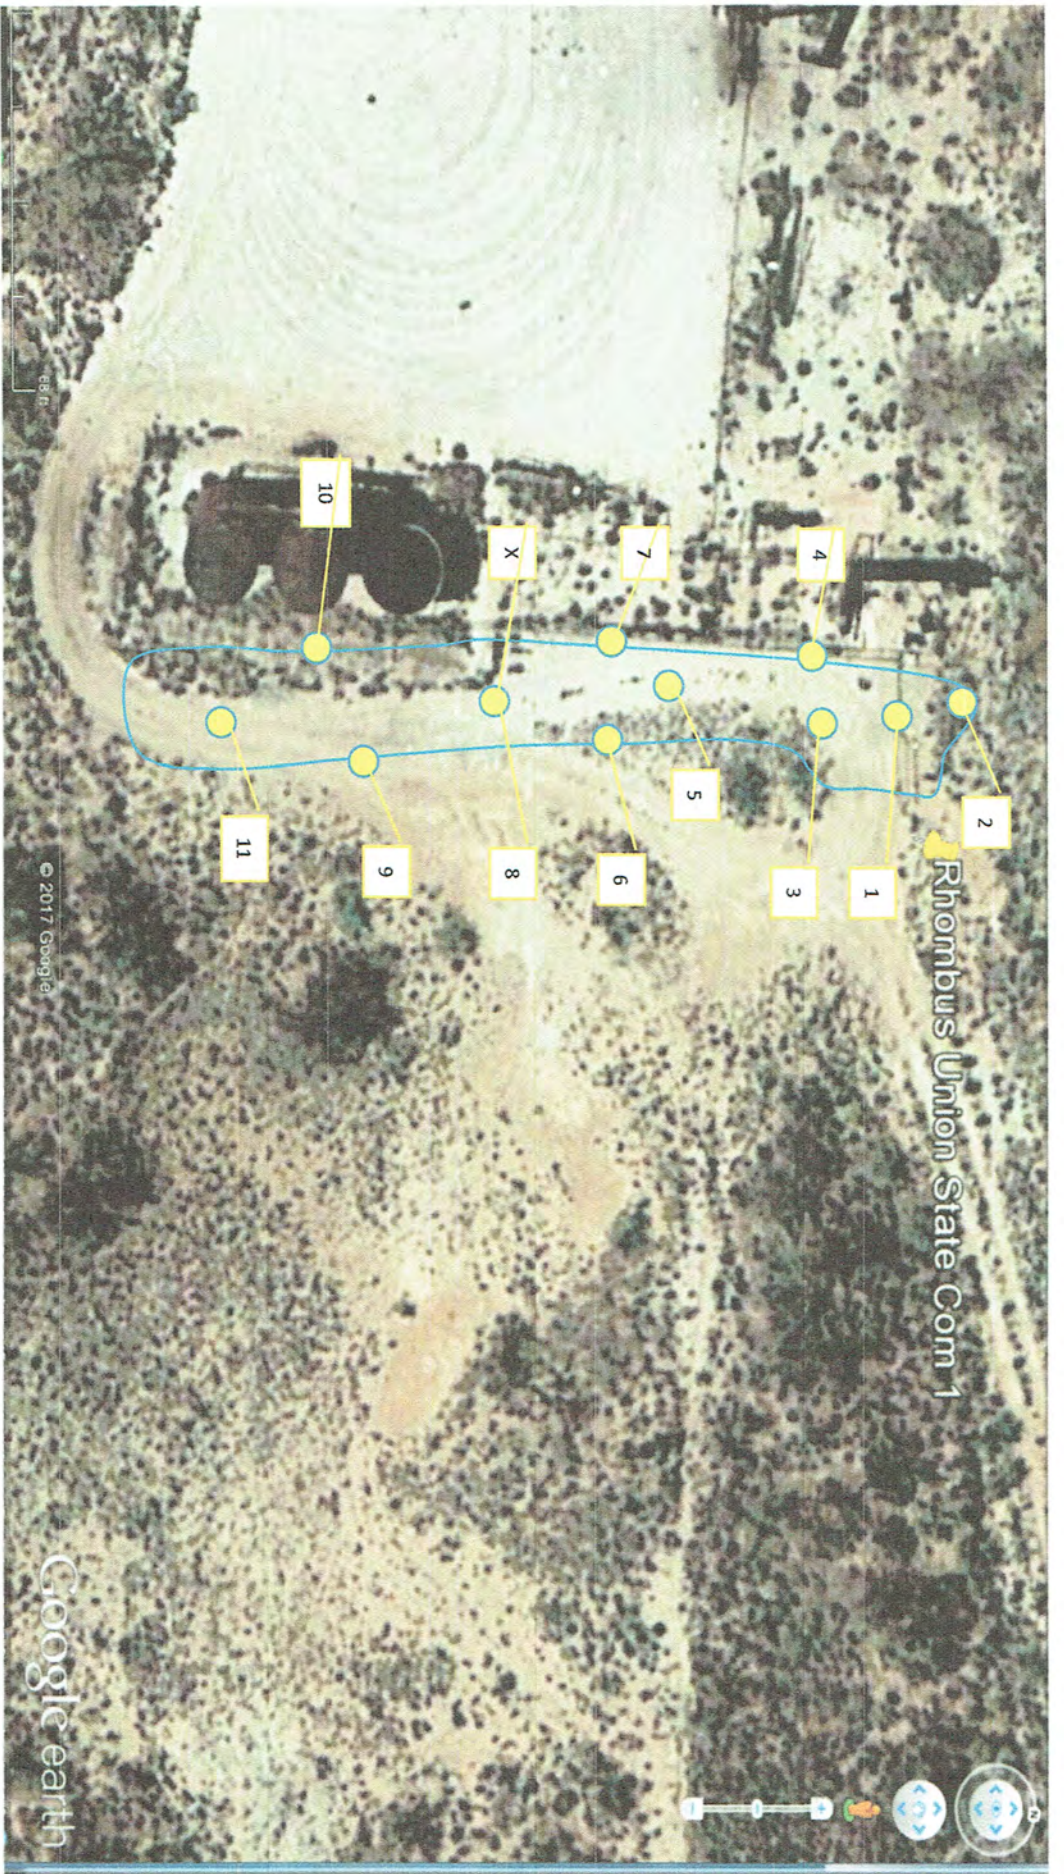
On May 19, 2017, samples were collected from 12 locations to a depth of approximately 2.5 to 3.0 feet bgs., as illustrated on Figure 2 and Figure 3, by Frontier EHS Group. All samples were collected and processed according to NMOCD soil sampling procedures. The laboratory samples were sent under chain-of-custody protocols to Cardinal Labs in Hobbs, NM for analysis for Benzene and Total BTEX using EPA Method 8021B, DRO and Extended DRO, GRO by EPA Method 8015M, and total Chlorides using EPA Method SM4500CI-B. The Analytical results are summarized in Table 2 and Table 3.

Detailed Site and Sample Map
Rhombus Union State Com 1
UL D 18S 34E

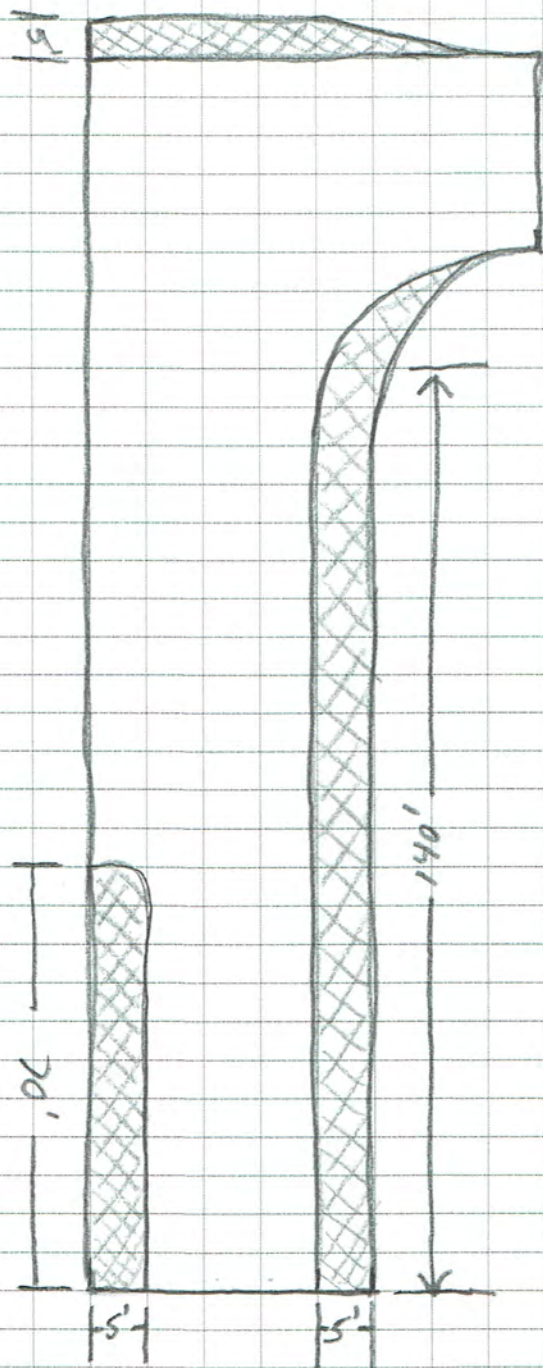
The chloride affected area(s) resulted in an additional 5400 cubic feet of delineated impacts. The chloride samples were collected over a period from June 26, 2017 to July 6, 2017, to reach the NMOCD acceptable chloride limits of ≤ 600 ppm. (Figure 3). All analytical results are provided in Appendix A. On July 7, 2017, all sample locations met the NMOCD chloride standard of ≤ 600 ppm. Analytical Chloride results are summarized in Table 3. A 20 mil liner will be laid before backfilling of any clean soil begins.

Below Ground Surface (bgs)

$$\begin{array}{r}
 20 \times 5 \times 4 = 1400 \\
 140 \times 5 \times 5 = 3500 \\
 20 \times 5 \times 5 = 500 \\
 \hline
 5400
 \end{array}$$

$$\begin{aligned}
 &H^2 / 27 \\
 &= \sqrt{200} \text{ Cubic Yards}
 \end{aligned}$$

PROJECTS: IRP-4671 Rhombos
Chloride Delamination
Frontier Field Services

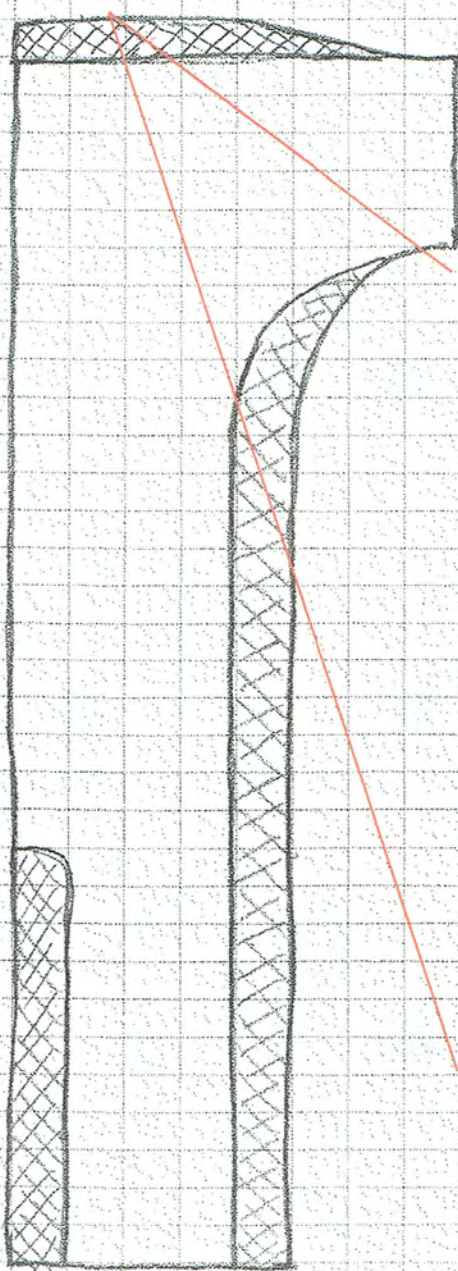
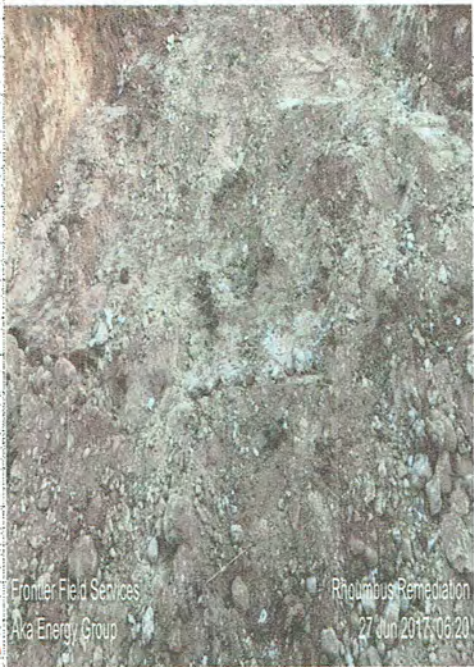
Final Chloride Sample # 2

Frontier excavated additional soil from the Sample #2 location on June 27th and then resampled, with samples collected from the surficial soil (Sample 2-A) as well as 2.5 feet bgs (Sample 2-B) and five (5) feet bgs (Sample 2-C). All samples were reported below the chloride cleanup level of 600 mg/kg, and no additional excavation or sampling is proposed at this location as five (5) feet of soil which meet the chloride cleanup level has been demonstrated (Samples 2-A, 2-B and 2-C collected on June 27th).

2-A Surface @ 80 ppm

2-B 2.5 feet bgs @ 112 ppm

2-C 5 feet bgs @ 576 ppm

Soil + Calcic MIF

PROJECTS: IRP - 4671 Rhombus Final Chloride Sample #2 Frontier Field Services	DESIGNER: EHS Group	
	SCALE: N/A	DATE: June 27, 2017

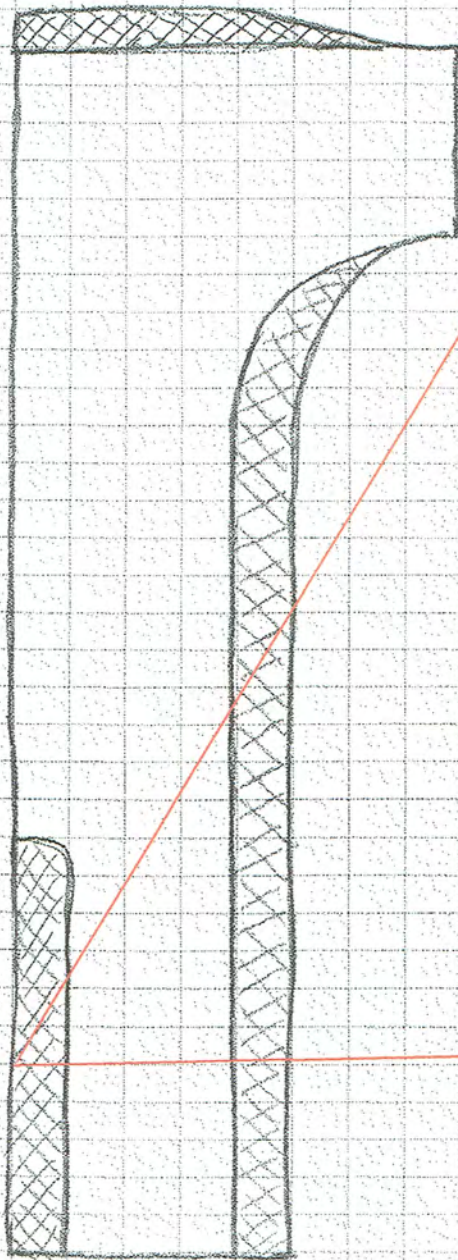
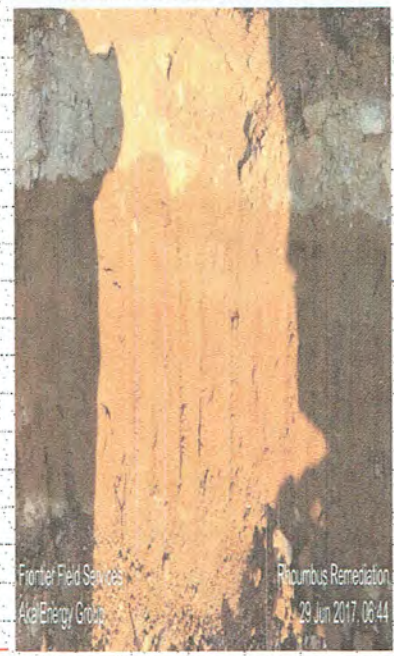
Final Chloride Sample # 10

Frontier excavated additional soil from the Sample #10 location on June 27th and 28th and then resampled on June 29th, with samples collected from the surficial soil (Sample 10-A) as well as two (2) feet bgs (Sample 10-B) and four (4) feet bgs (Sample 10-C). All samples were reported below the chloride cleanup level of 600 mg/kg, however, as five (5) feet of soil below the chloride cleanup level has not been demonstrated, Frontier proposes collecting an additional sample from this location at five (5) feet bgs.

10-A Surface @ 208 ppm

10-B 2 feet bgs @ 80 ppm

10-C 4 feet bgs @ 112 ppm

Soil/Catch mixed

PROJECTS: IRP - 4671 Rhombus Final Chloride Sample #10 Frontier Field Services	DESIGNER: EHS Group SCALE: N/A DATE: June 29, 2017
---	---

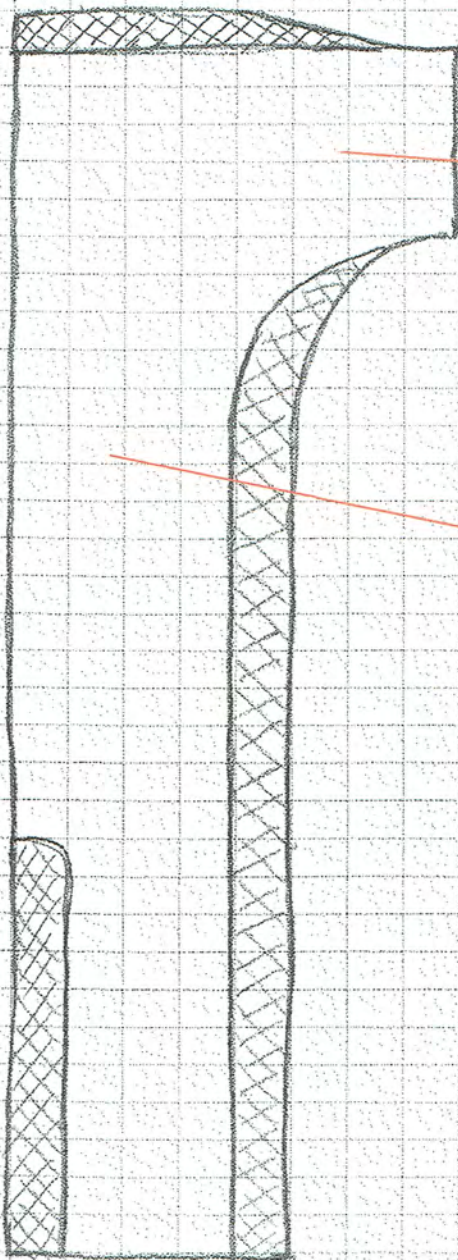
Frontier excavated additional soil from the Sample #5 location on June 27th and 28th and then resampled. The sample collected from five (5) feet bgs on June 29th (Sample Repeat #5) was reported below the applicable chloride cleanup level. Frontier proposes collecting an additional sample from this location at ten (10) feet bgs to demonstrate that there is five (5) feet of soil that meets the permissible chloride level.

Leak Location

Sample # 5 - 5.5 feet bgs @ 480 ppm

PROJECTS: IRP - 4671 Rhombus
Final Chloride Sample # 5
Frontier Field Services

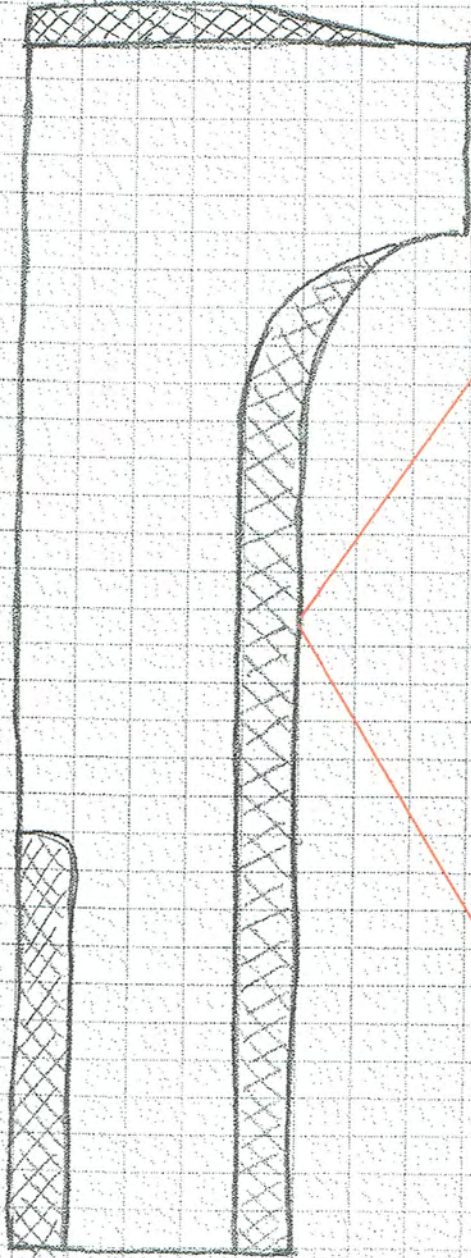
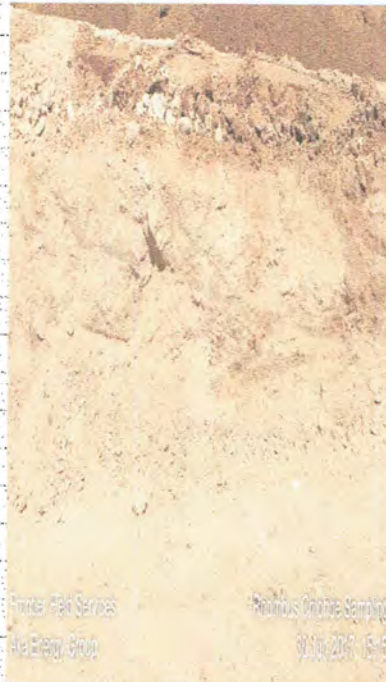
Final Chloride Sample # 6

Frontier excavated additional soil from the Sample #6 location between June 27th and 29th and then resampled on June 30th, with samples collected from the surficial soil (Sample 6-A) as well as 2.5 feet bgs (Sample 6-B) and five (5) feet bgs (Sample 6-C). All samples were reported below the chloride cleanup level of 600 mg/kg, and no additional excavation or sampling is proposed at this location as five (5) feet of soil which meet the chloride cleanup level has been demonstrated (Sample 6-A, 6-B and 6-C collected on June 30th).

2-A Surface @ 384 ppm

2-B 2.5 feet bgs @ 464 ppm

2-C 5 feet bgs @ 208 ppm

PROJECTS: 1RP-4671 Rhombus
Final Chloride Sample #6
Frontier Field Services

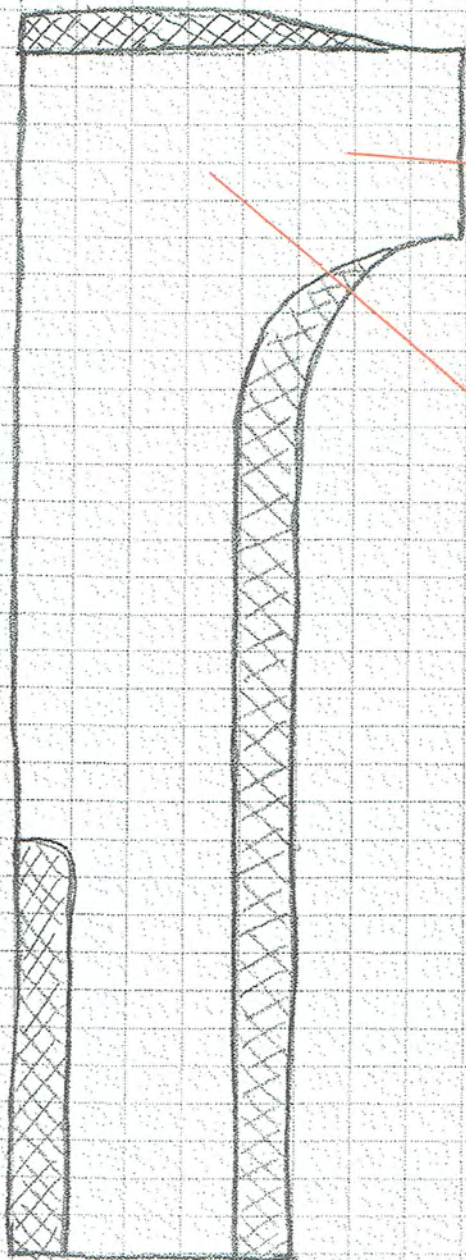
Frontier excavated additional soil to a depth of seven (7) feet bgs from the Sample #1 location on June 27th - 29th, and then resampled. The final sample collected on July 6th was reported below the applicable chloride cleanup level. Frontier proposes collecting an additional sample from this

Leak Location

Sample # 1 - 7 feet bgs @ 80 ppm

PROJECTS: IRP - 4671 Rhombus
Final Chloride Sample # 1
Frontier Field Services

location at 12 feet bgs to demonstrate that there is five (5) feet of soil that meets the permissible chloride level.
