Soil Assessment Report

New Mexico East State NCT-1 007

Wellhead Release

089861 | Report No 2 | November 2016

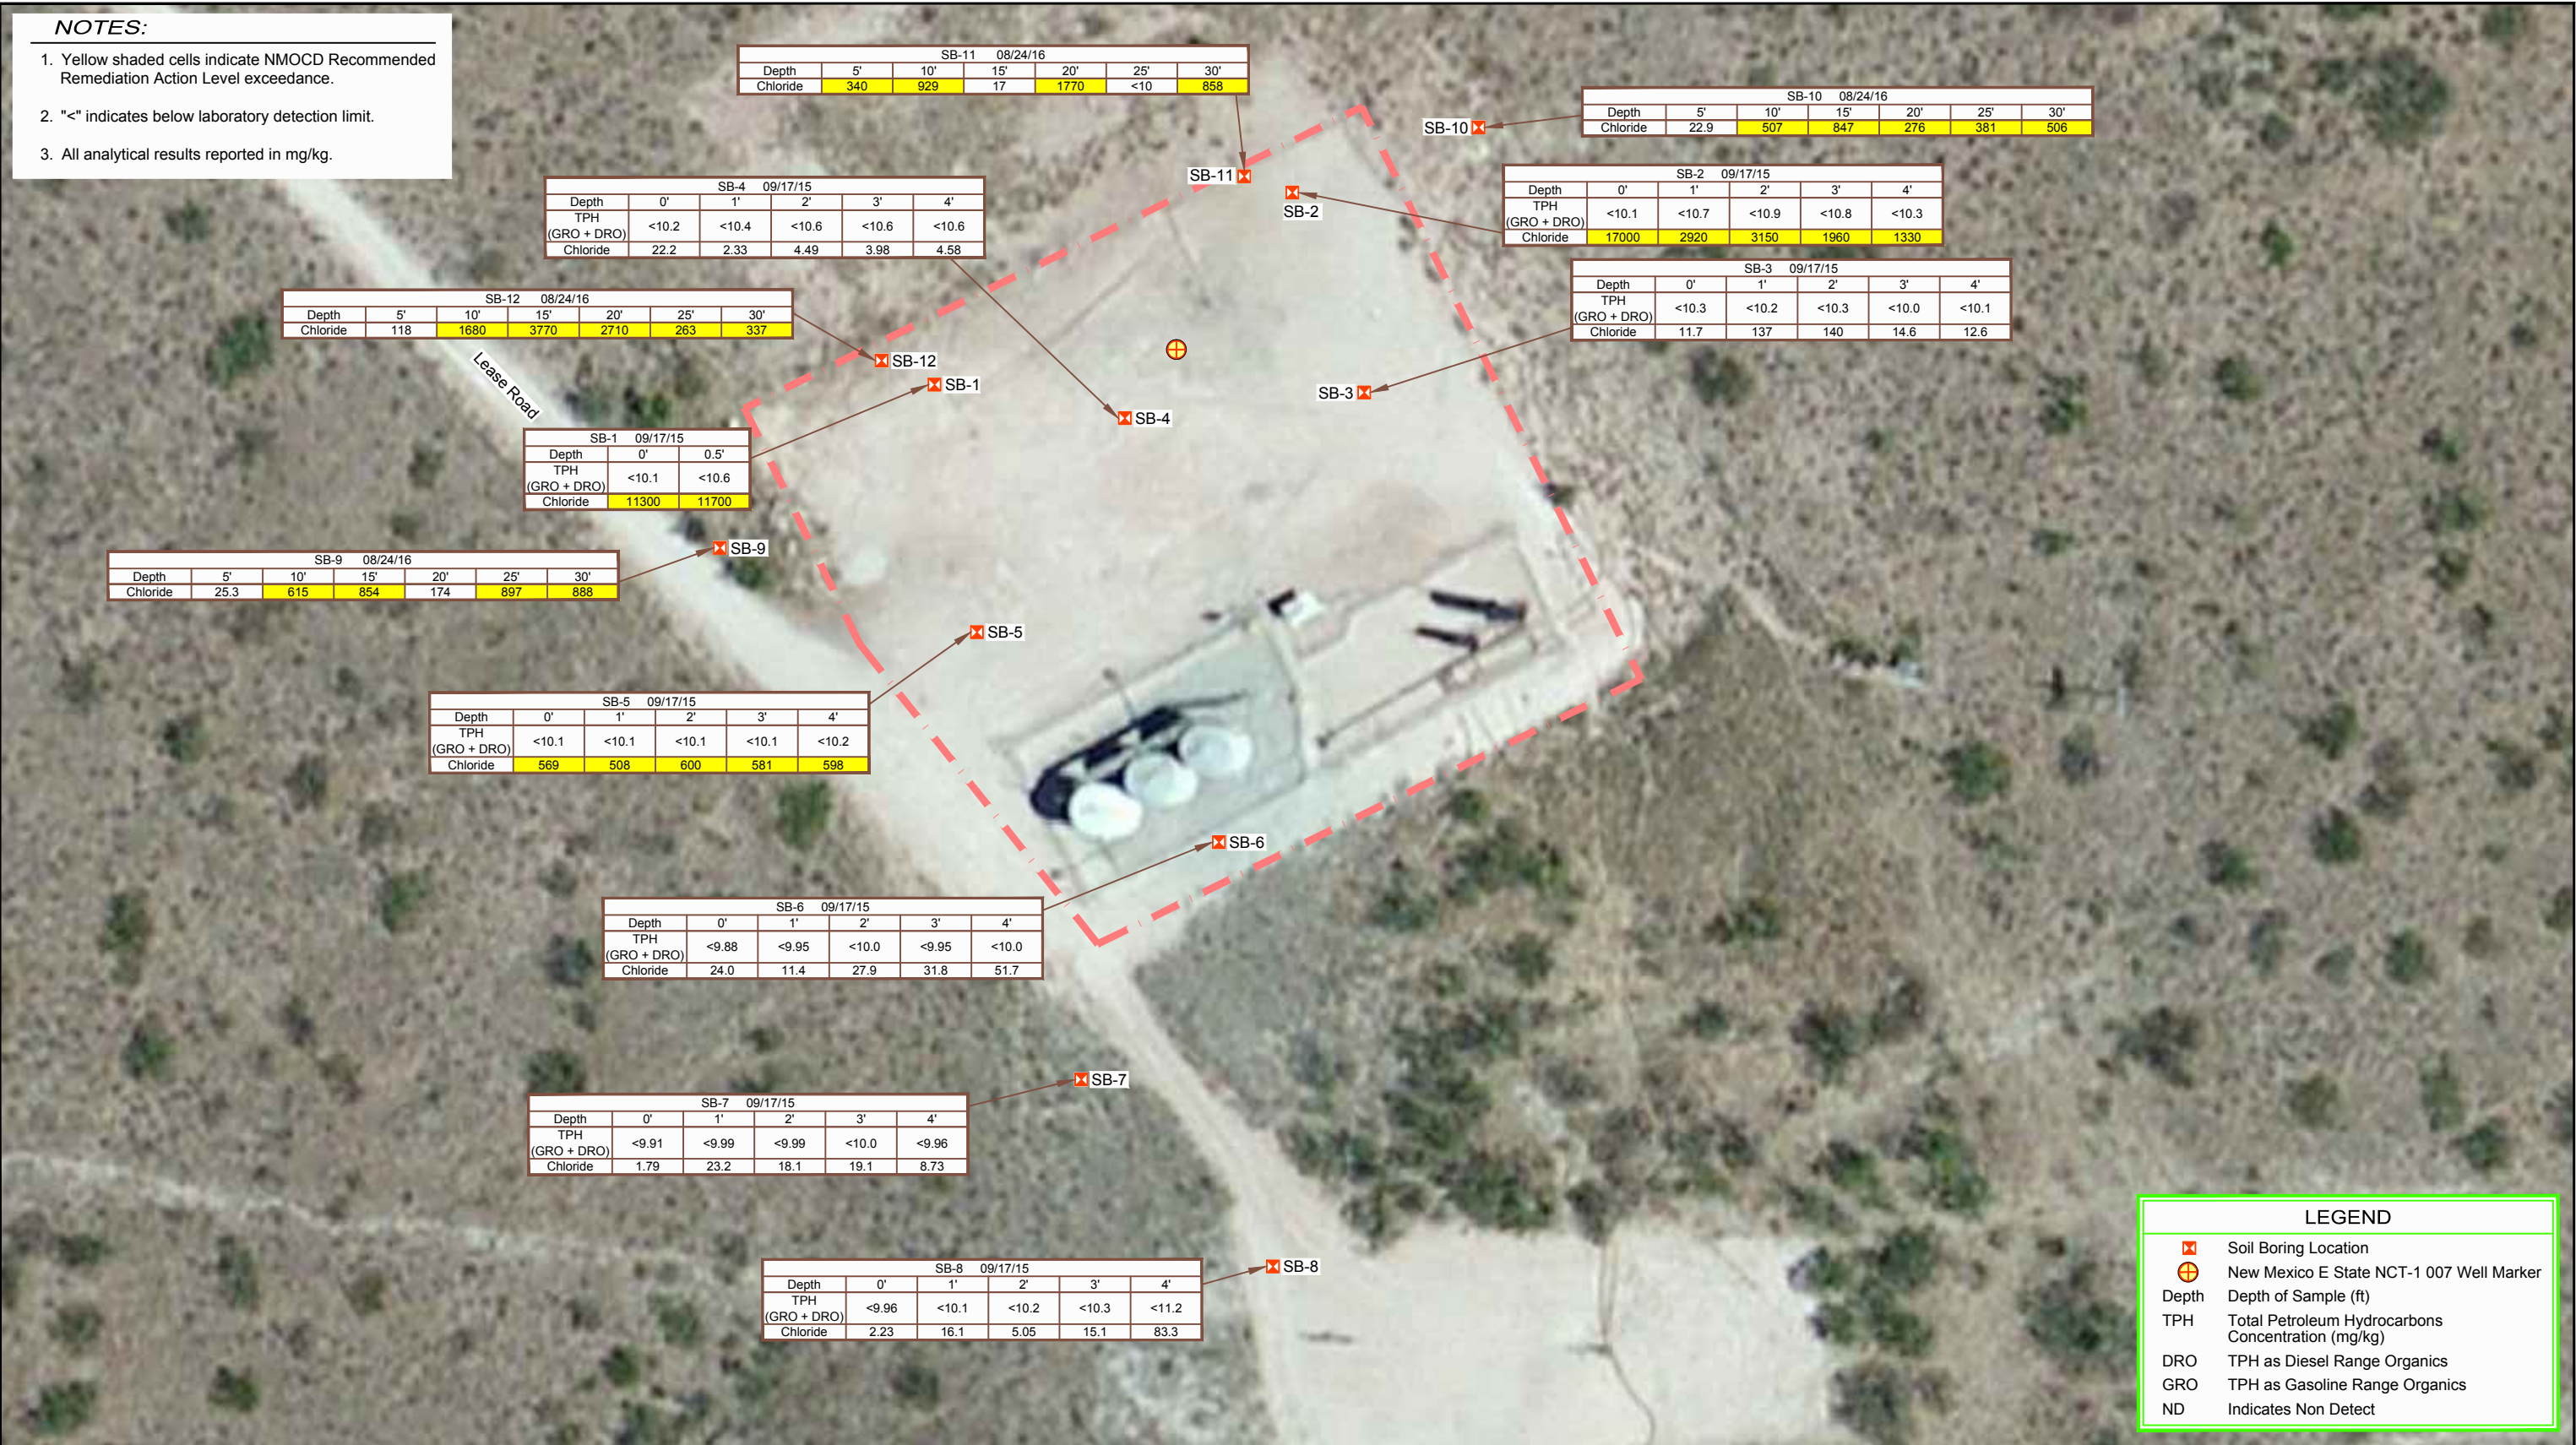
FIGURE 3

Analytical results are summarized in Table 1 and the distribution of analytical results is presented in map view on Figure 3. TPH concentrations in all hand auger borings (SB-1 through SB-8) are below the Site RRAL (100 mg/kg) and reporting limits. Chloride concentrations in hand auger borings SB-1, SB-2, and SB-5 exceeded the RRAL (250 mg/kg, see Figure 3).

Chloride concentrations in the deeper borings installed in 2016 (SB-9 through SB-12) exceeded the RRAL in most intervals sampled down to the total depths of 30 feet bgs. Chloride concentrations in deep samples range up to 3,770 mg/kg (SB-12, 15') and exceeded the RRAL in all samples collected at total depth.

SITE DETAILS AND ANALYTICAL RESULTS MAP

On September 17, 2015, GHD mobilized to the Site to begin soil boring activities. Eight hand auger borings (SB-1 through SB-8) were advanced across the Site on September 17, 2015. The borings were advanced to 4 feet bgs, except SB-1 which encountered refusal at 0.5 feet bgs. Site details and boring locations are shown on Figure 3.

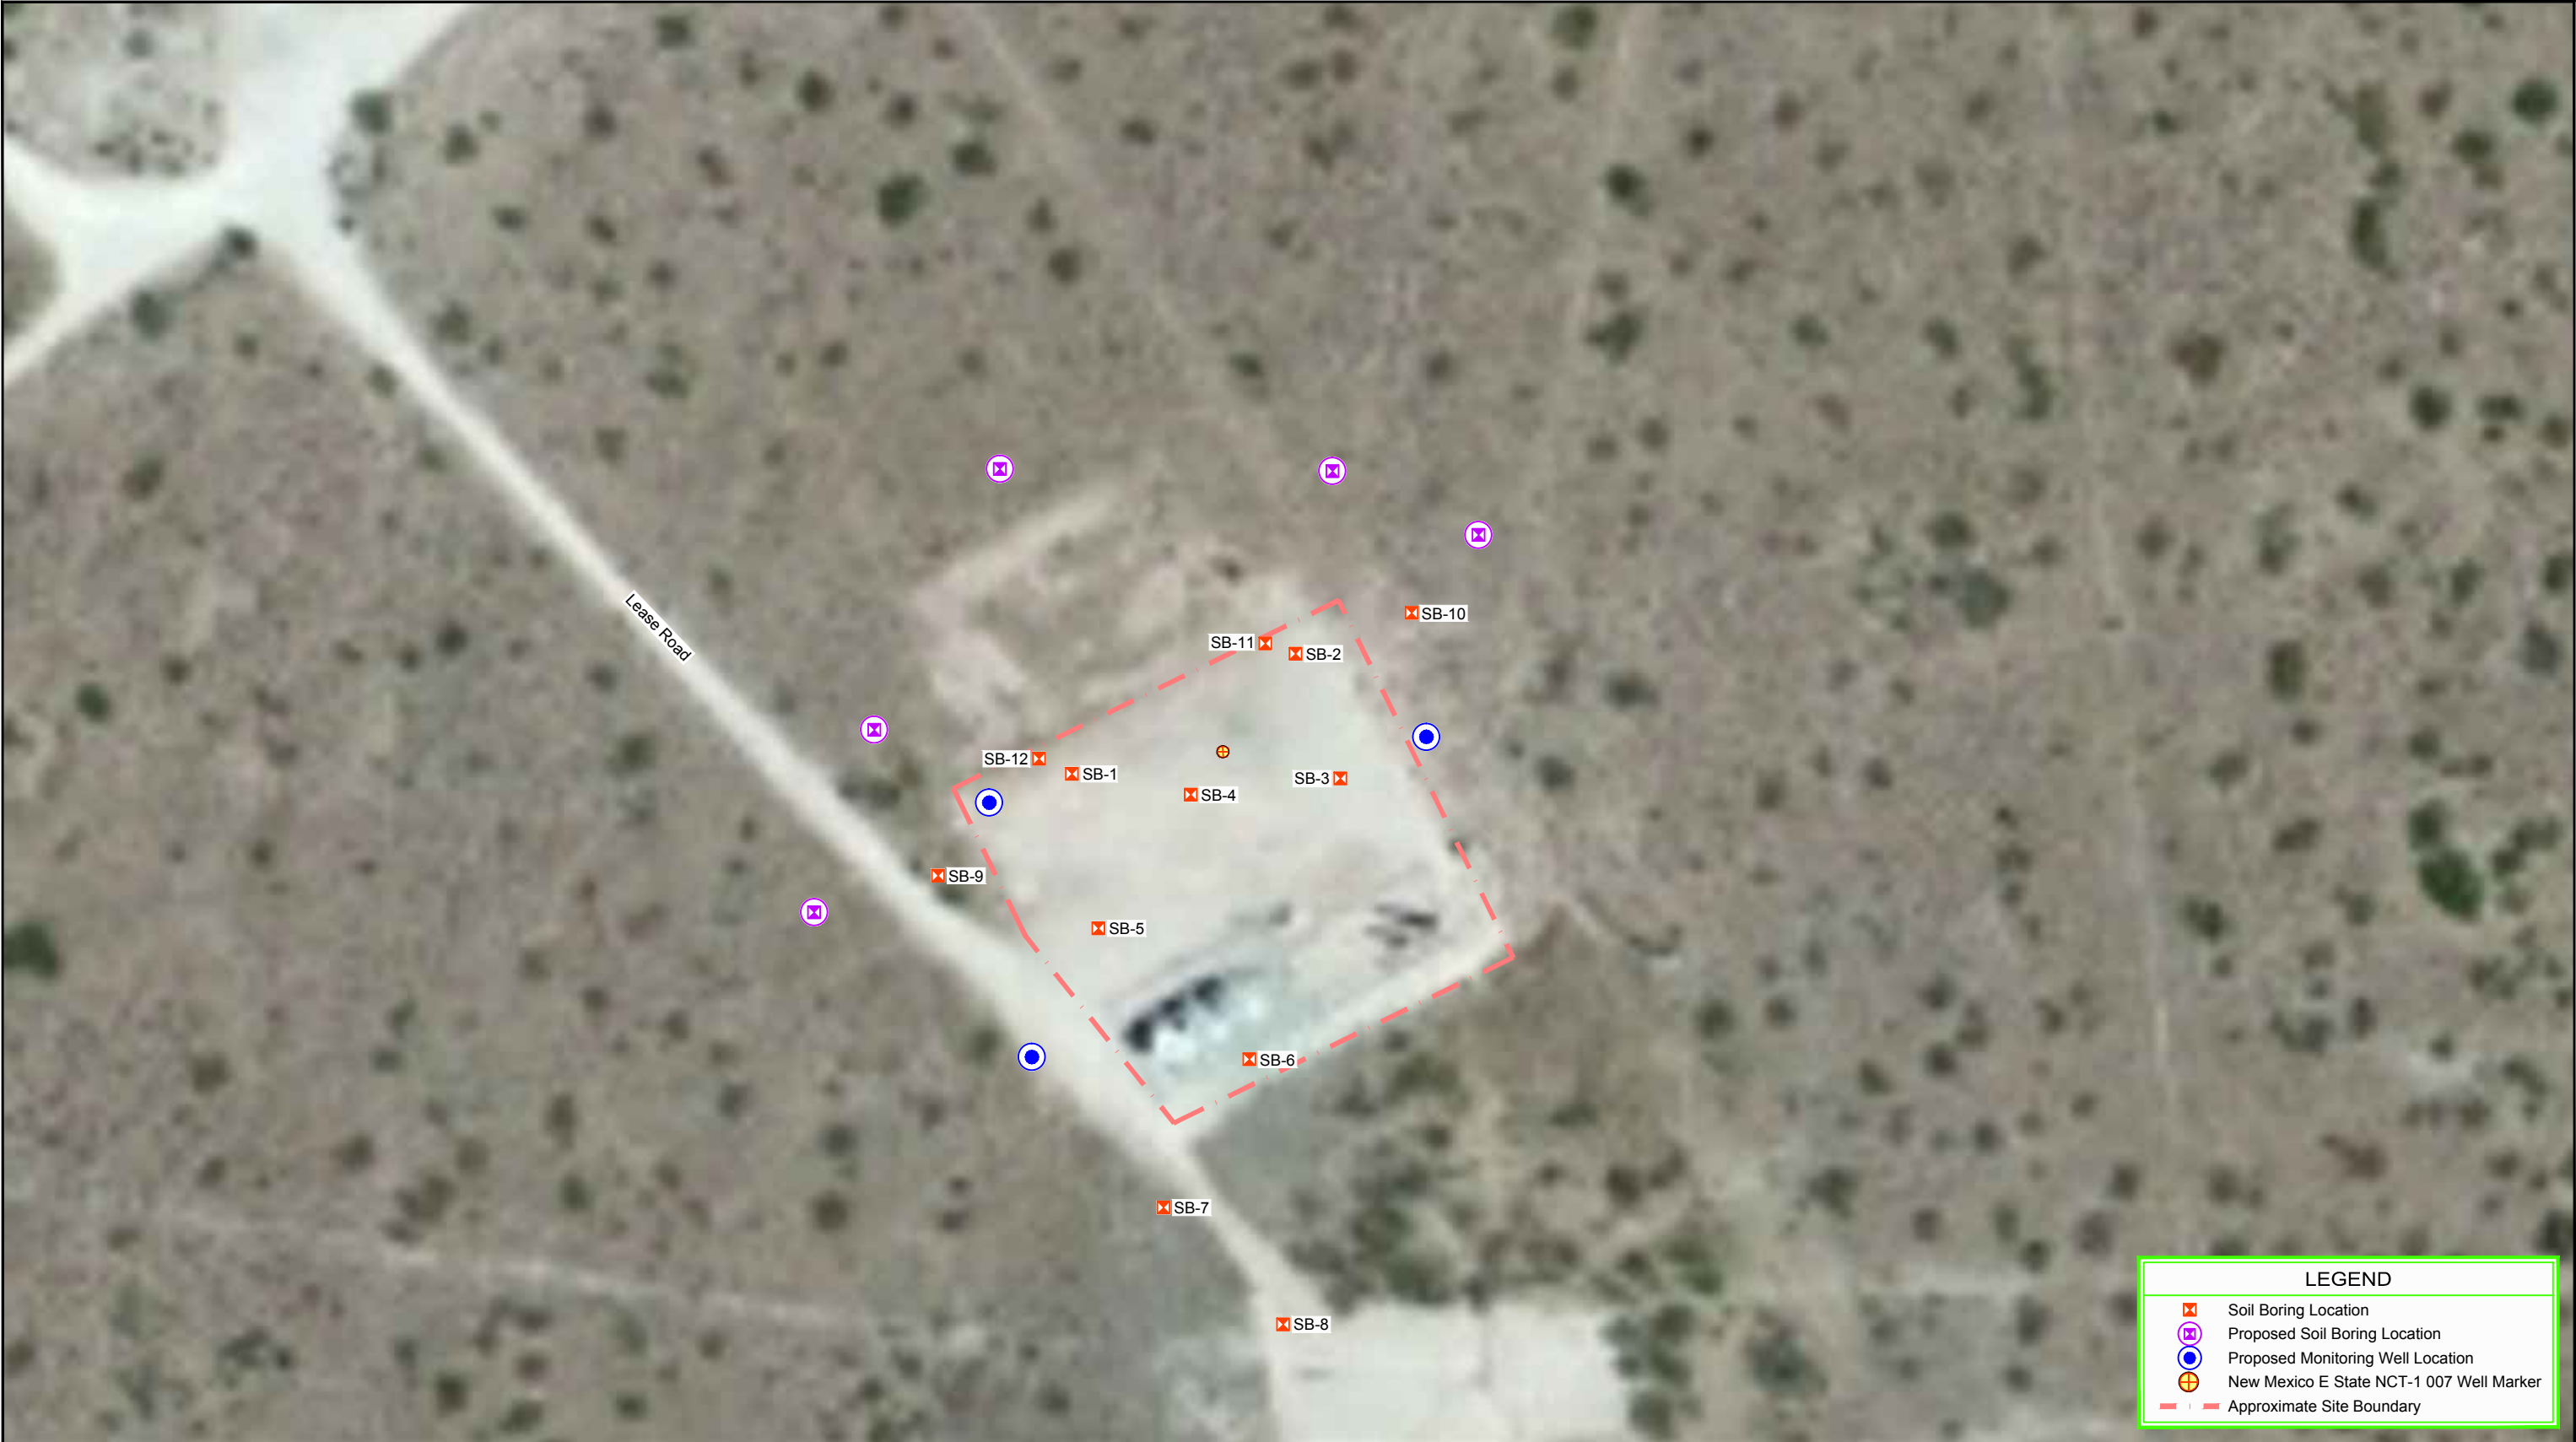
GHD proposes to advance five (5) additional soil borings and three (3) monitoring wells in the northern, western and eastern portions of the Site (Figure 4). Field screening of soil cuttings for chlorides will be performed to guide drilling activities, and the terminal depth of each boring will be based on these field screening results. The following outlines basic project details that will be completed by GHD and GHD subcontractors.
