1RP-4166
REMEDIATION CONFIRMATION REPORT
LMPSU #286 Flowline
Crude Oil Spill
Lea County, New Mexico

LAI Project No. 17-0175-19

January 9, 2018

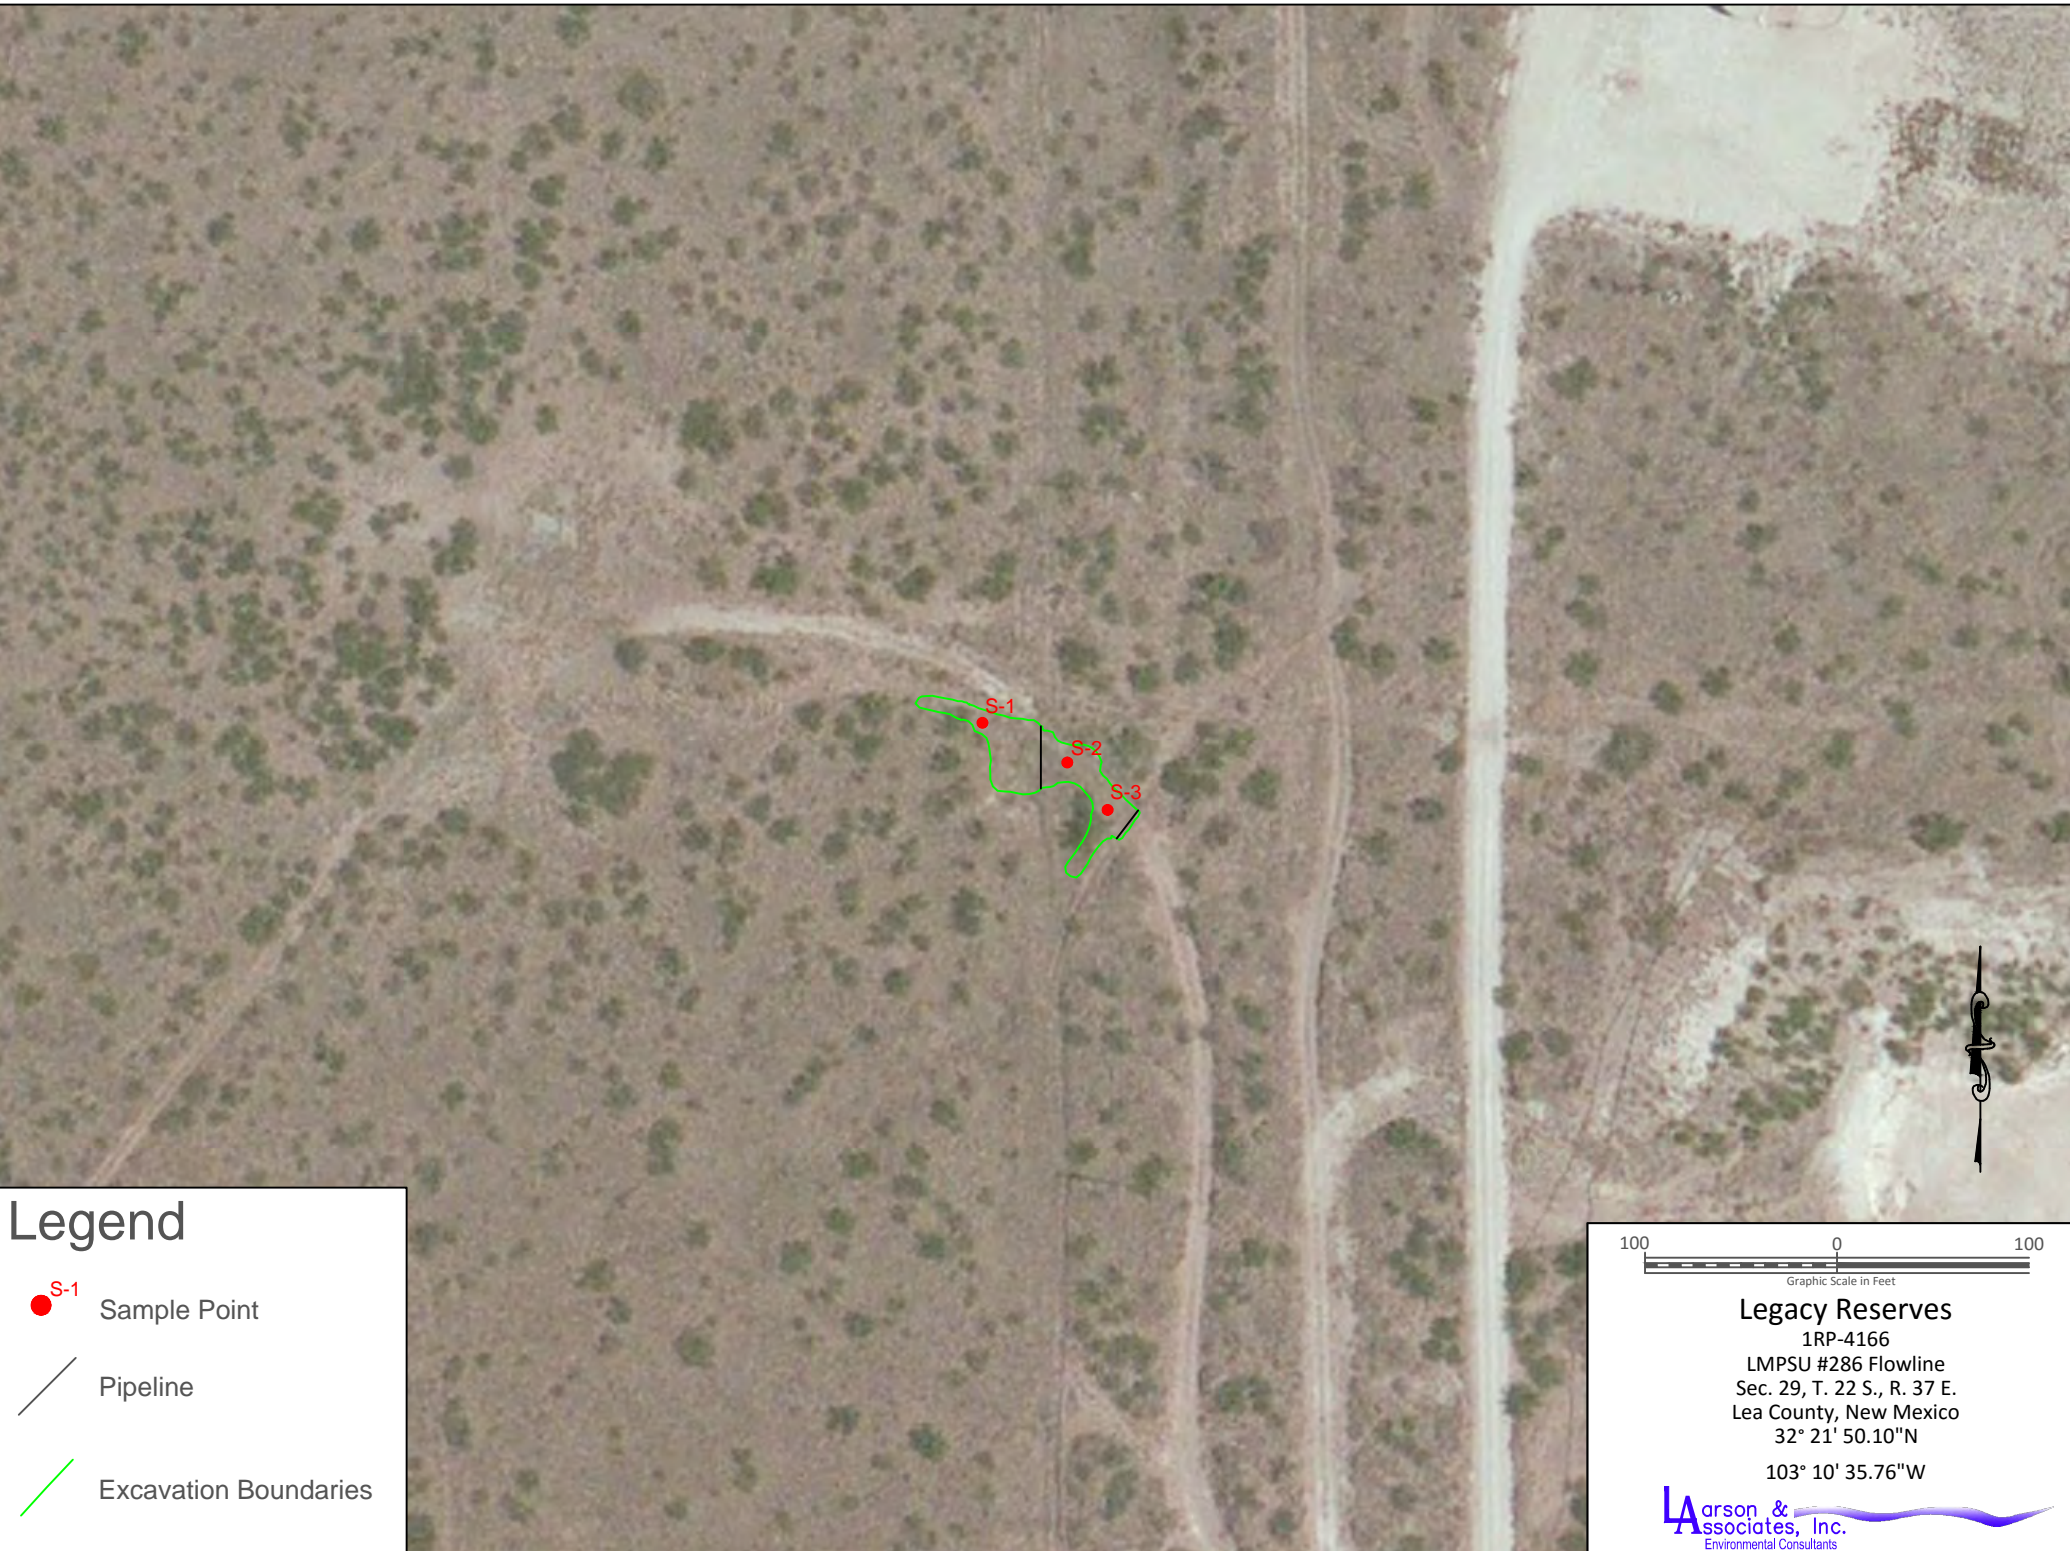
Figure 2 - Aerial Map

On January 5, 2018, LAI collected soil samples at three (3) locations (S-1 through S-3) in the bottom of the excavation. The samples were collected with a stainless steel hand auger at 1 foot intervals to depth of approximately 7 feet bgs (S-1), 10 feet bgs (S-2) and 4 feet bgs (S-3) or until caliche was reached. Additional samples were collected at a depth of 2 feet bgs from both side walls opposite of each samples, as well as the east and west sidewall. The samples were delivered under chain of custody and preservation to Permian Basin Environmental Lab (PBEL) in Midland Texas. The upper samples were analyzed for BTEX and TPH by EPA SW-846 8021B and 8015M, respectively. All samples were analyzed for chloride by EPA Method 300. BTEX and TPH reported below the RRALs in all samples. Chloride reported below the delineation limit (600 mg/Kg) in all samples. Appendix D presents photographs.

Legacy believes no additional soil remediation is necessary and requests approval to fill the excavation to approximately 1 foot bgs with caliche and to surface with top soil. The surface will be seeded to New Mexico State Land Office requirement. A final report to include photographs and final C-141 will be submitted to OCD and SLO upon completion of the work.

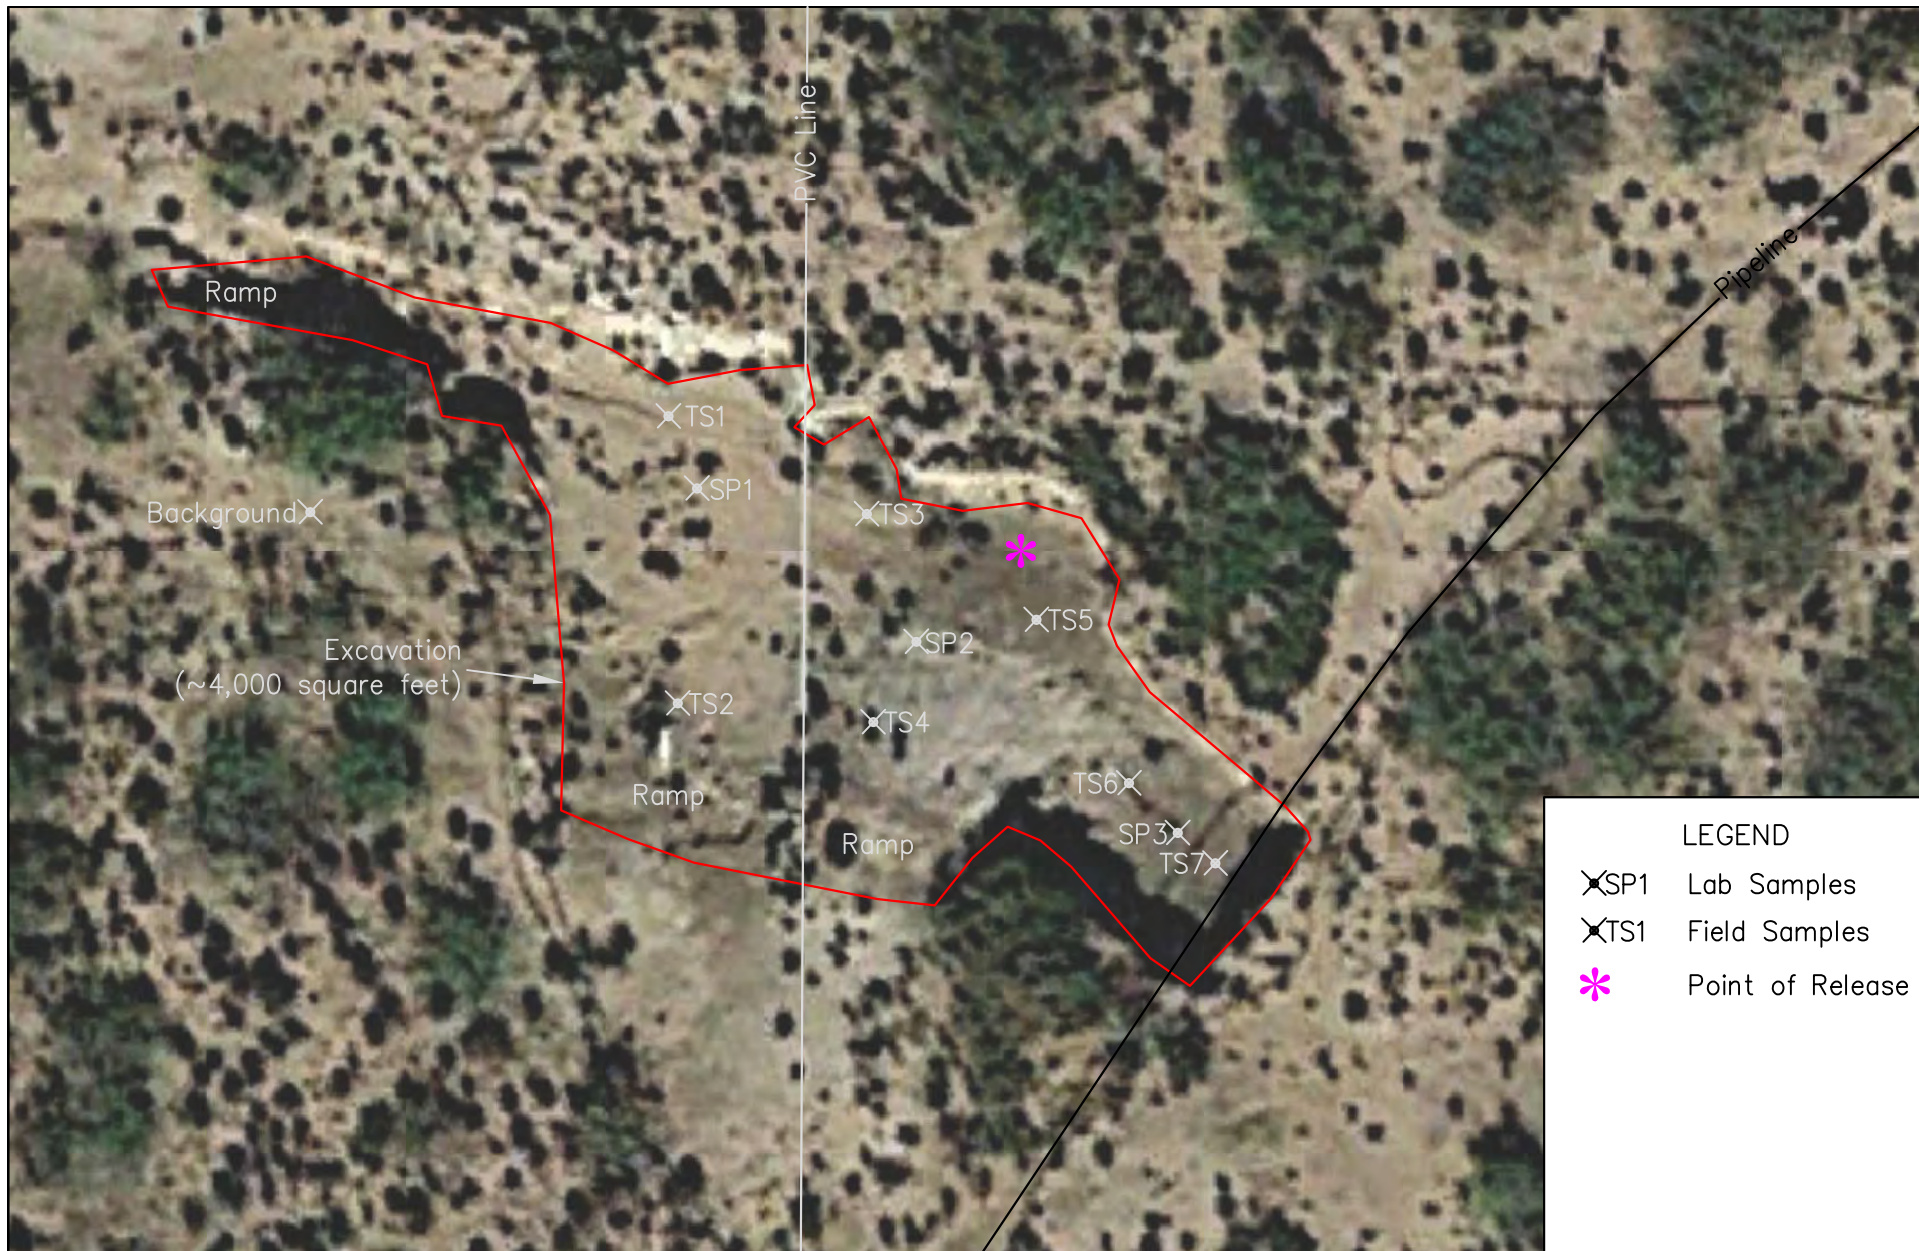
Figure 3 Sample/Site Map Legacy, L.P. LMPSU #286 Flowline	Lea County, New Mexico SE 1/4 of NE 1/4, Sec. 29, T22S, R37E N 32° 21' 50.01" W 103° 10' 35.76" Elevation: 3,355 feet amsl	DWG By: D Dominguez July 2017		REVISED:

The fluid spread to the west of the flowline approximately 125' into pasture area consisting of approximately two feet of topsoil atop caliche (reference *Figure 3*).

On January 22, 2014 EPI personnel mobilized on site to collect soil samples to determine the vertical extent of contamination. A total of ten soil samples were collected from seven sample locations; TS1 – TS7. All ten samples were field tested for chlorides. Field testing indicates elevated chlorides between three and sixteen feet bgs (reference *Figure 3* and *Table 2*).

On January 23, 2014 EPI personnel collected soil samples for laboratory analysis. A total of four soil samples were collected from four sample locations; SP1 – SP3, background. All samples were sent to Cardinal Labs in Hobbs, New Mexico, for testing. Laboratory analytical results indicate that Benzene, BTEX, TPH, and Chloride concentrations at depth of sample collection, are below NMOCD RRALs (reference *Figure 3* and *Table 2*).

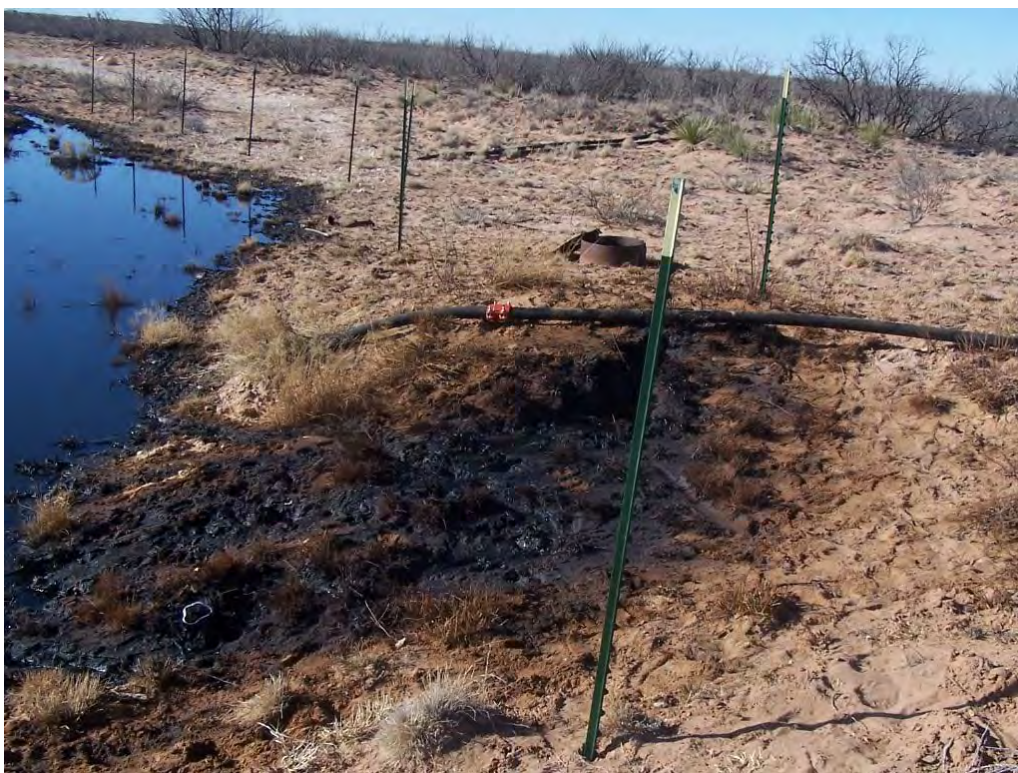
Photograph #2- Looking across release area toward release point.

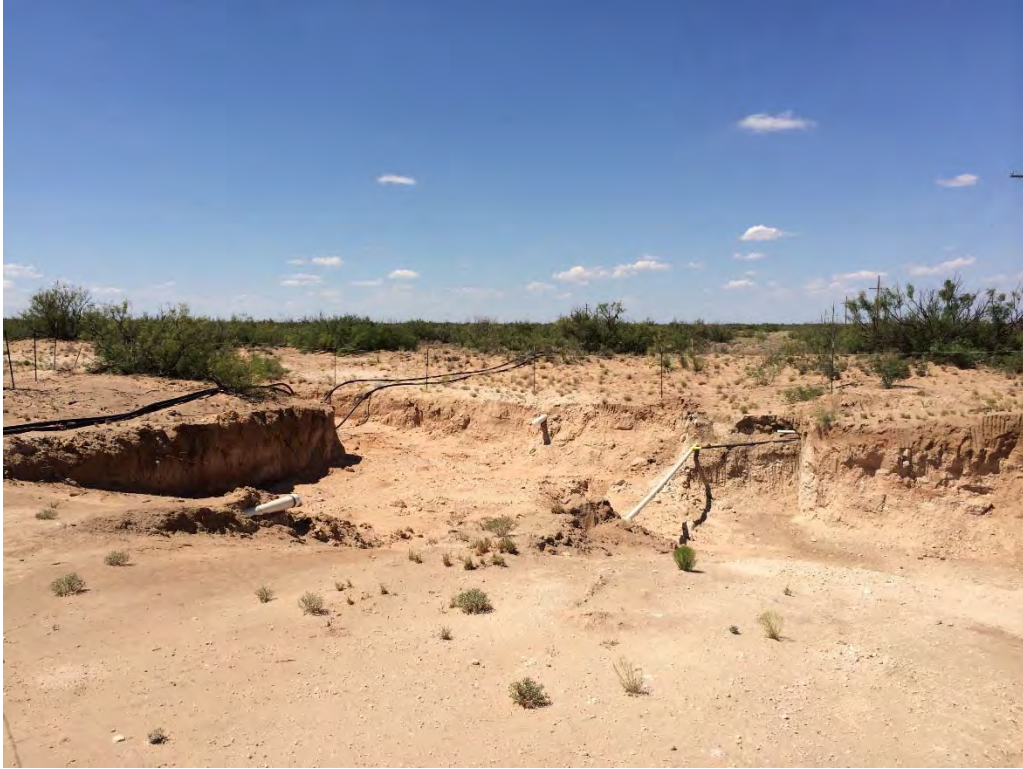
Photograph #5- Looking across excavated area.

In January 2014, in conjunction with sampling activities, the release area was excavated to approximately four feet bgs at the west end and approximately eight feet bgs at the east end. All contaminated soil was hauled to a state approved disposal facility.

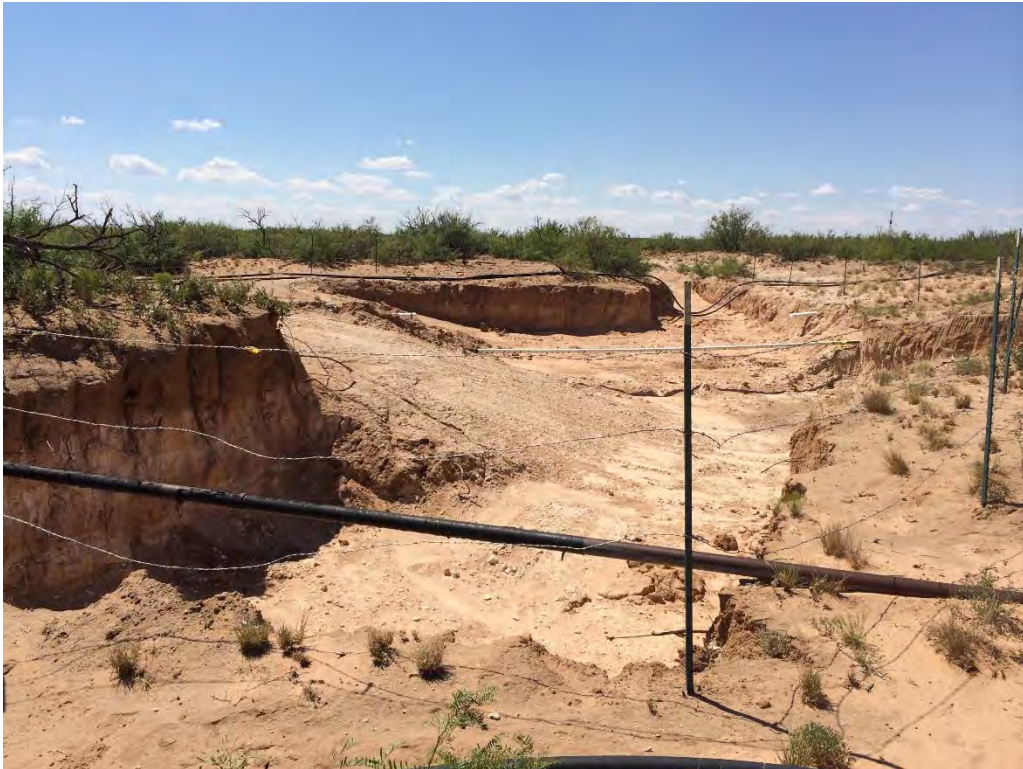
Photograph #6- Looking across excavated area.

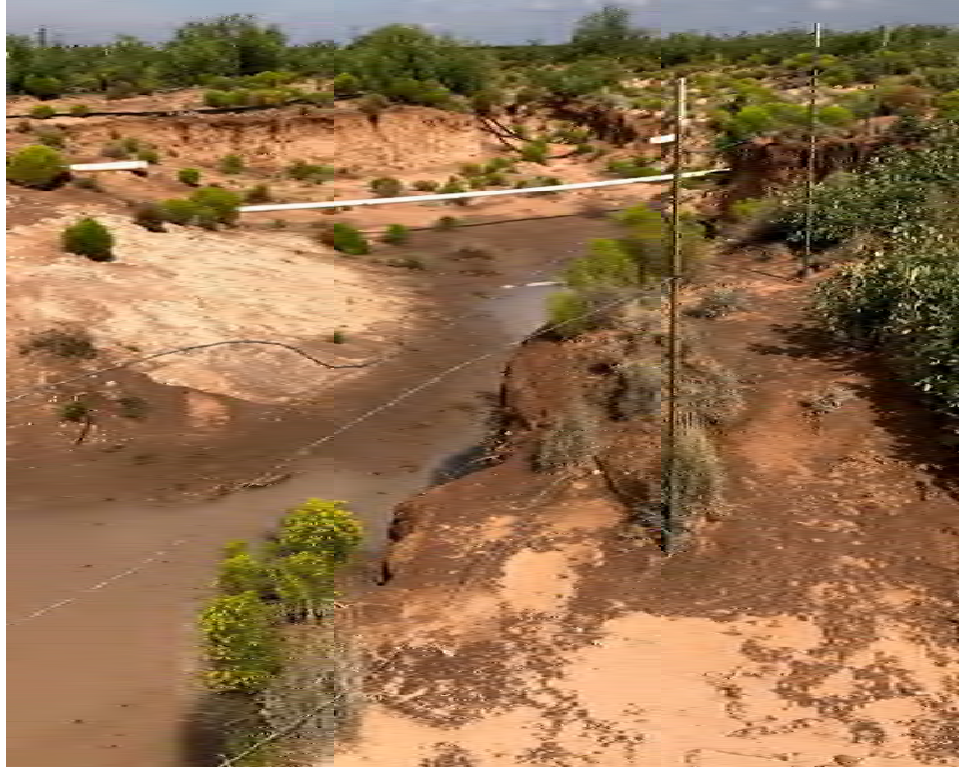
Photograph #7- Current state of excavation

Taking into consideration the age of the release, the open excavation, and field testing indicating elevated chlorides, EPI proposes to install a twenty-mil poly-ethylene liner in the excavation floor then backfill with clean soil to finish grade. As the depth of the excavation varies along the length of the excavation, caliche will be used as backfill to within three feet of ground surface, at which point topsoil will be used as backfill to finish grade.

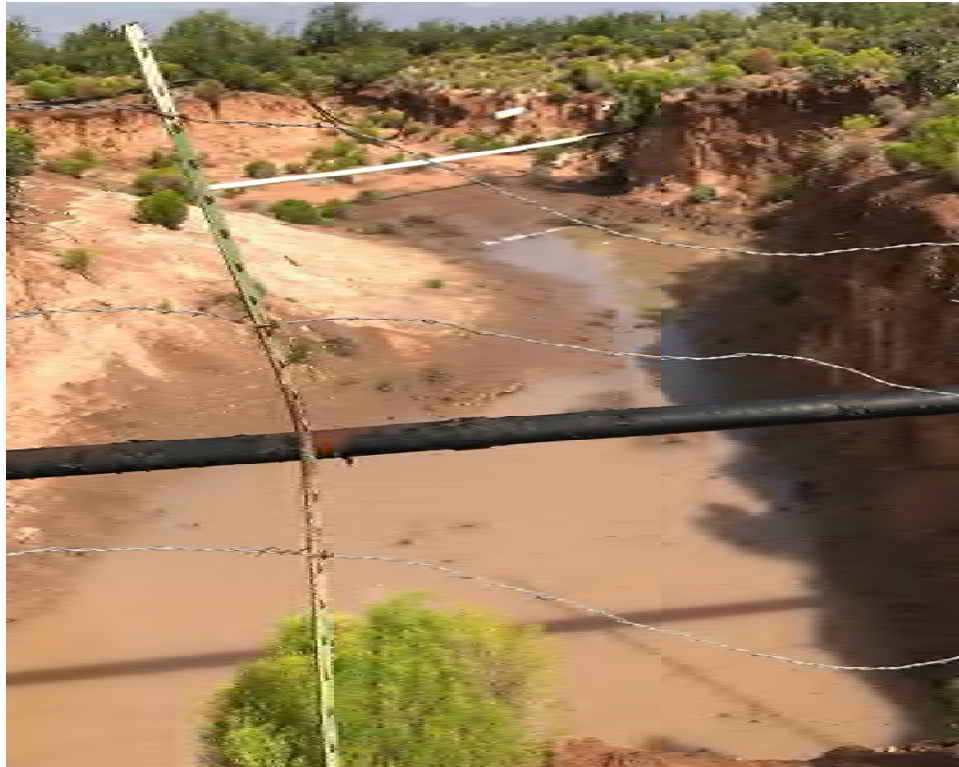
Photograph #8- Current state of excavation

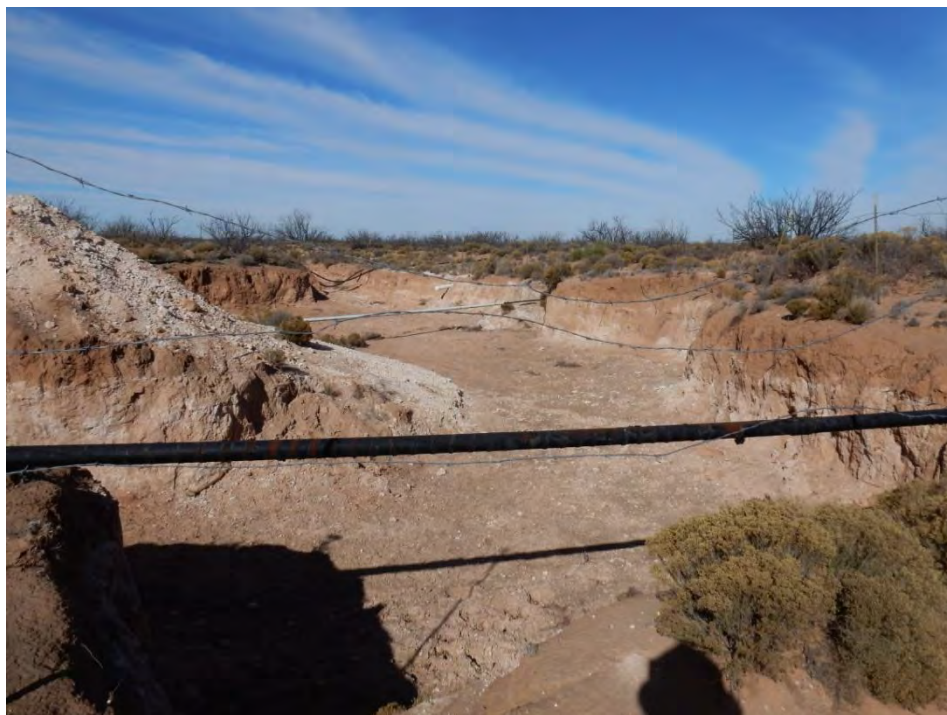
Excavation Viewing West, January 5 ,2018

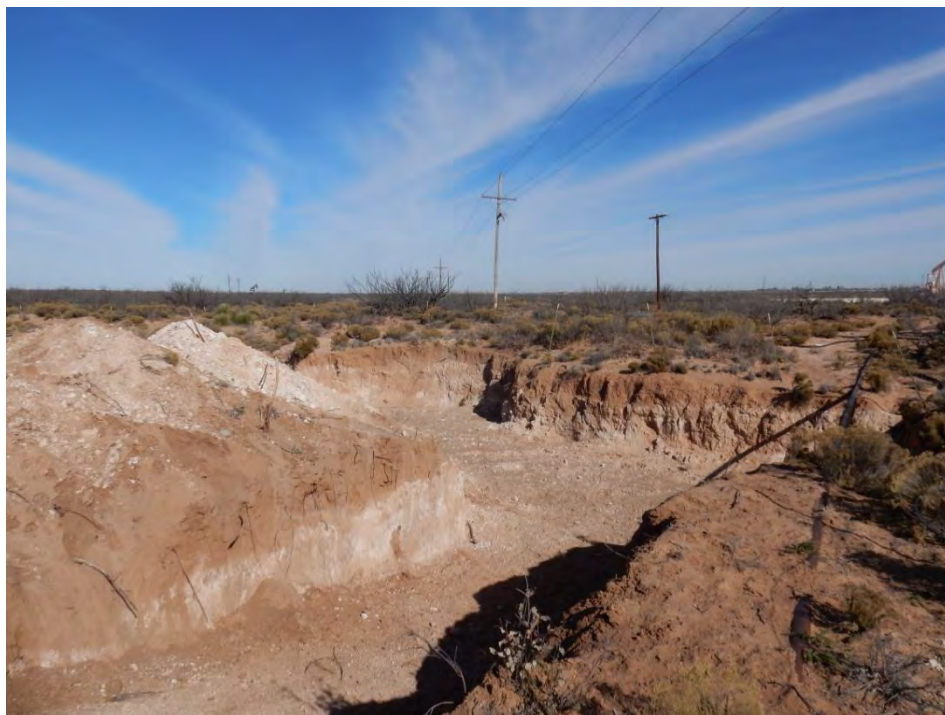
Excavation Viewing North, January 5, 2018

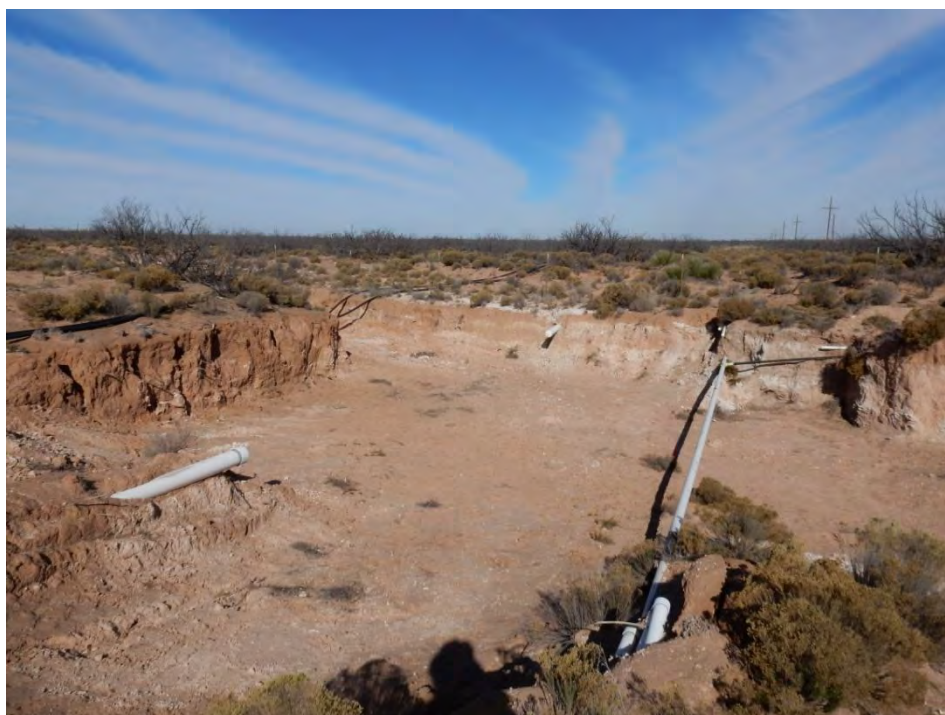
Excavation Viewing North, January 5, 2018

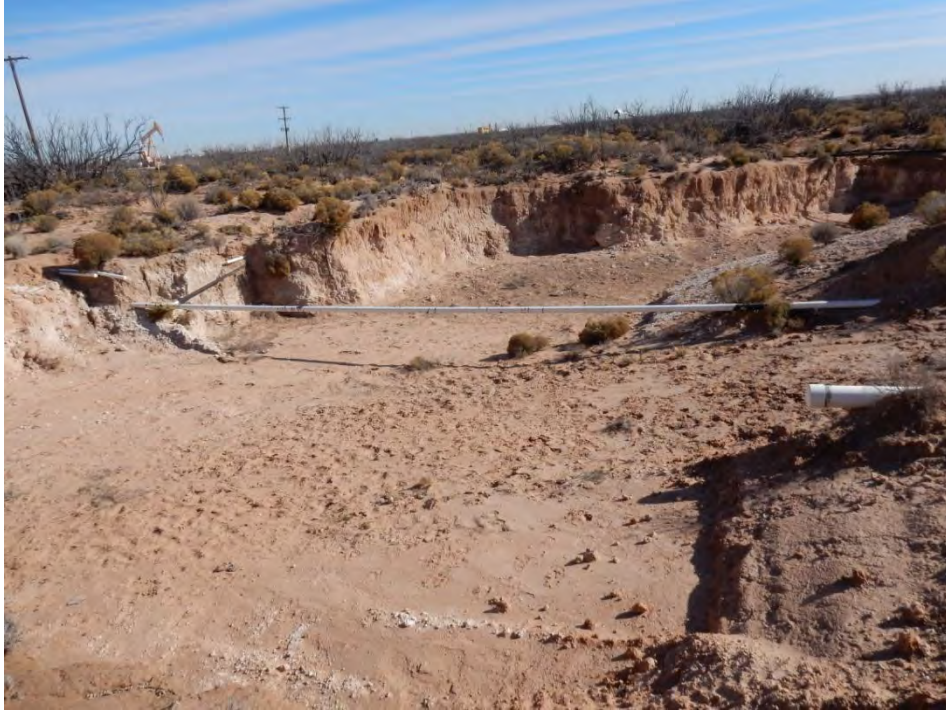
Excavation Viewing East, January 5, 2018
