REMEDIATION WORK PLAN

**Concho Operating, LLC.
Azores Federal #002H
Lea County, New Mexico
Unit Letter "O", Section 29, Township 24 South, Range 32 East
Latitude 32.1816673, Longitude -103.6935196
1RP-4149**

April 2017

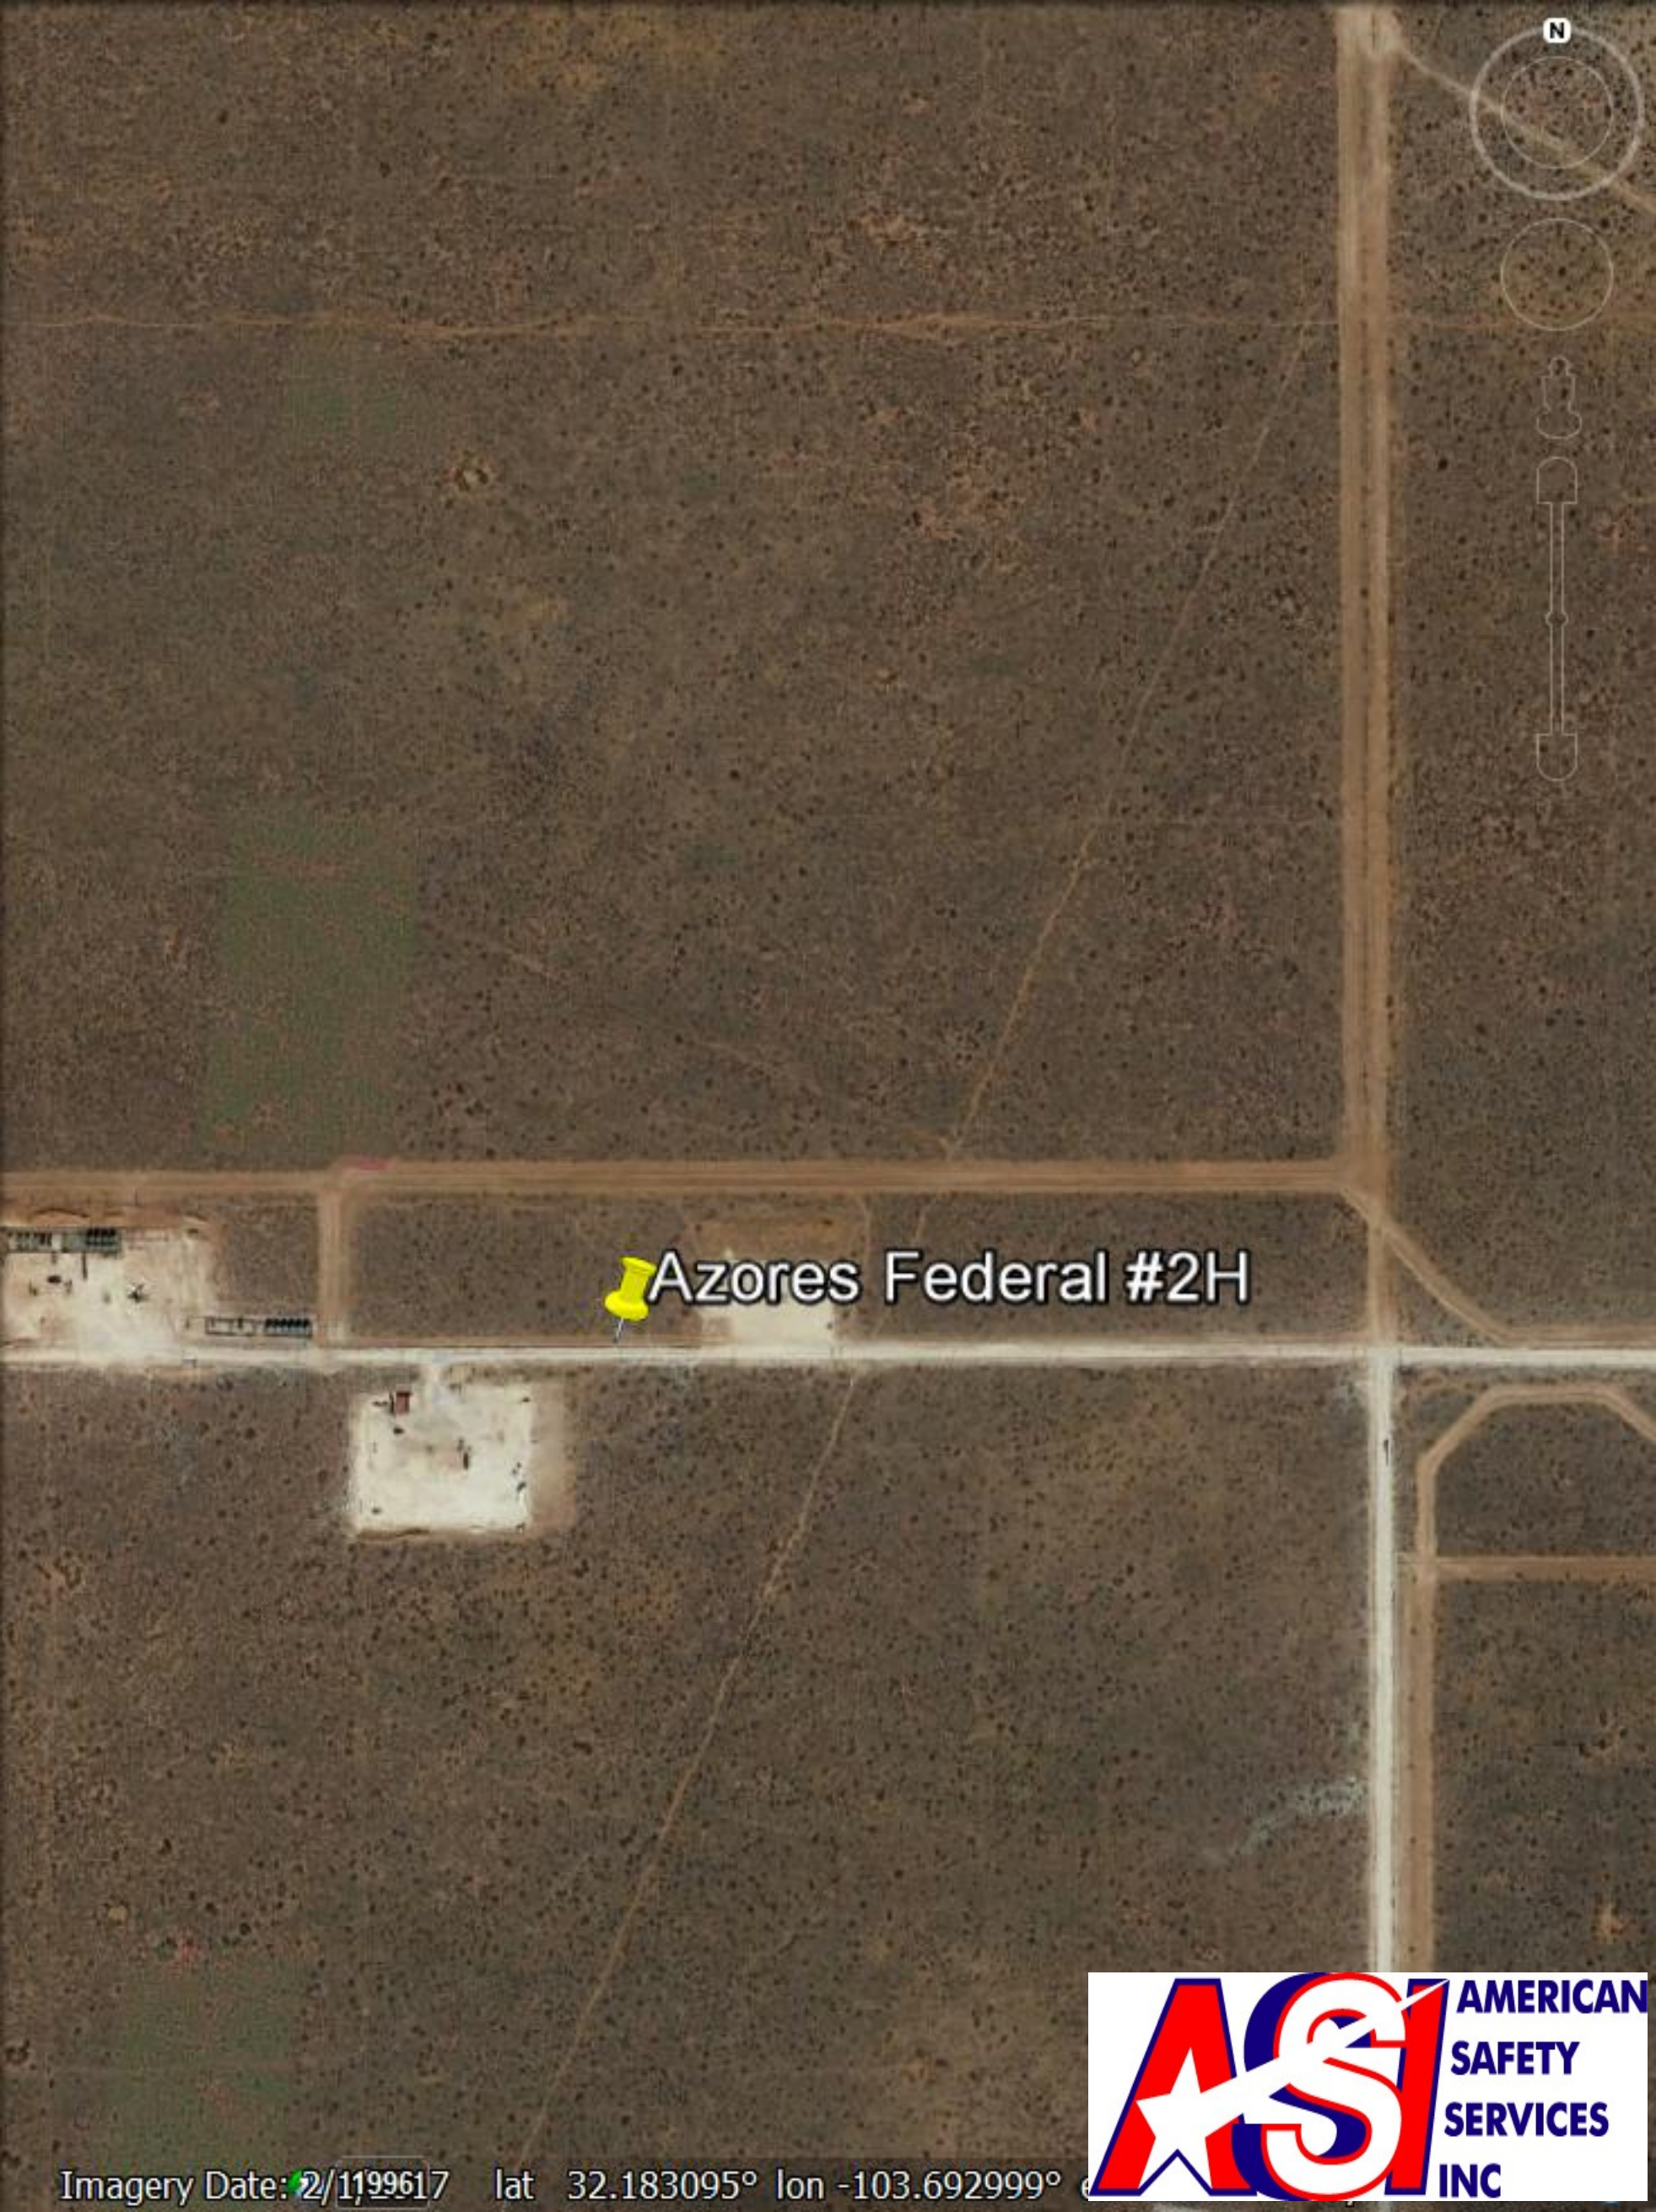
Azores Federal #002H

Released: 15 bbls Produced Water
Recovered: 3 bbls Produced Water
32.1816673, -103.6935196

Figures 3 and 4 are Site Diagrams that indicate the approximate location of the confirmation soil boring locations in relation to pertinent land features and general Site boundaries, which is included in Appendix A.

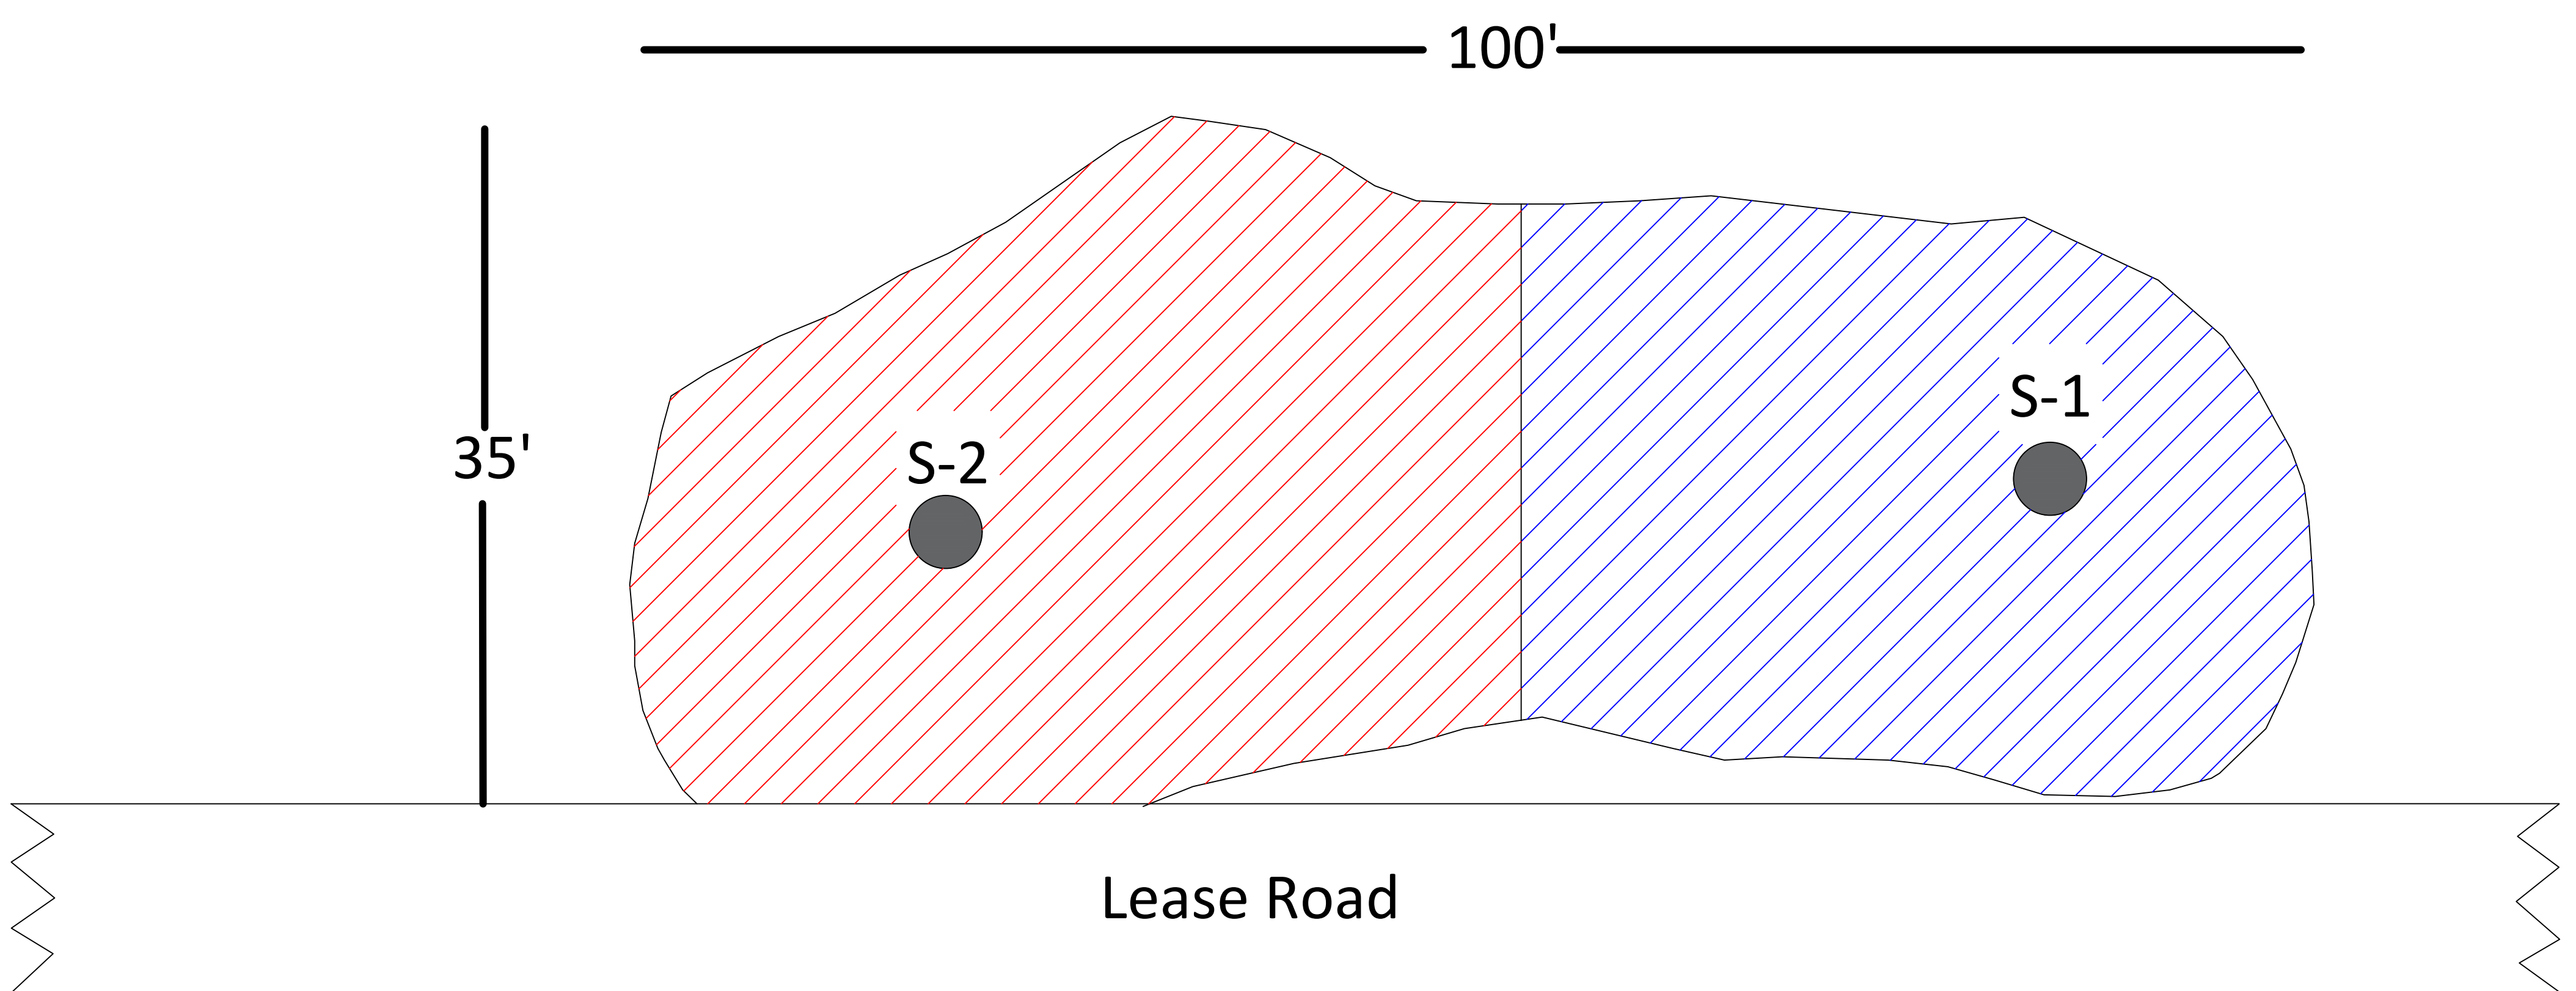
FIGURE 4
**Proposed Excavation
Areas**

— Excavate 6'
-

— Excavate 6' with liner
-

— Sample Point

Based on the analytical data, COG and ASSI propose to remove the impacted material as presented in Table 1. The area adjacent to and around soil boring S1 will be excavated to a depth of approximately six (6) foot bgs. Following excavation operations, a plastic liner will be installed at the bottom of the excavation on top of the excavation floor. The area adjacent to and around soil boring S2 will be excavated to a depth of approximately six (6) foot bgs. All material removed by mechanical means from both excavations will be stockpiled onsite and subsequently removed (hauled away) offsite to a proper disposal facility under appropriate manifest. The excavated areas will be backfilled to grade with clean material and the surface grade contoured to the surrounding landscape.
