Re: Proposed Closure Strategy – West Boiler Sump
Energy Transfer Company's Jal #3 Gas Plant
Section 33, Township 24 South, Range 37 East
Lea County, New Mexico

**FIELD ACTIVITIES SUMMARY AND
BELOW-GRADE TANK CLOSURE REQUEST**

**ETC FIELD SERVICES, LLC
West Boiler Sump
Lea County, New Mexico
UNIT LTR "L", Section 33, Township 24 South, Range 37 East, NMPM
Latitude 32.17374° North, Longitude 103.17375° West
NMOCD Reference No. GW-010**

December 2017

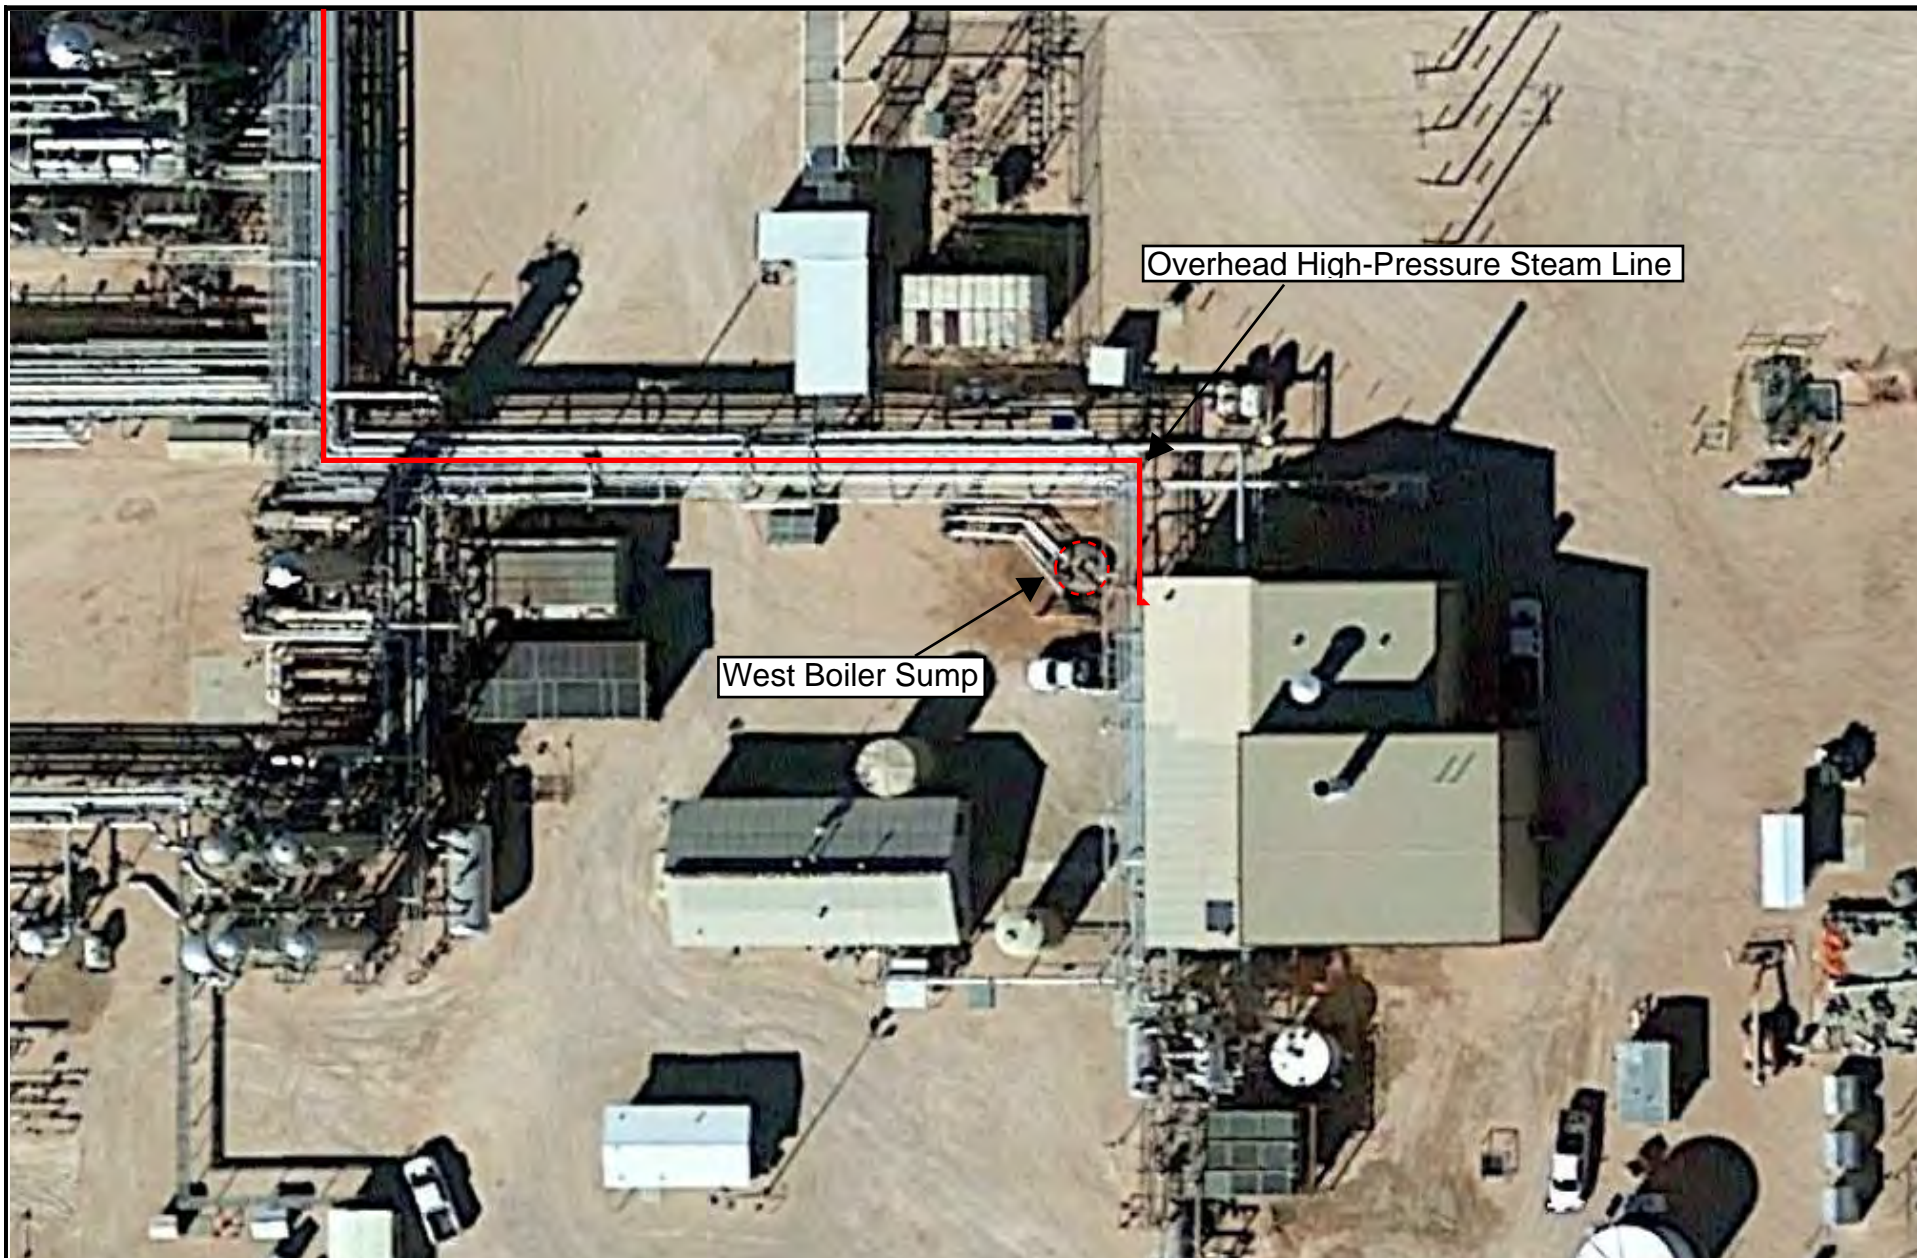
Attachement #2

Below-Grade Tank
High-Pressure Steam Line

Site Diagram
ETC Field Services, LLC
Jal #3 BGTs
Lea County, NM

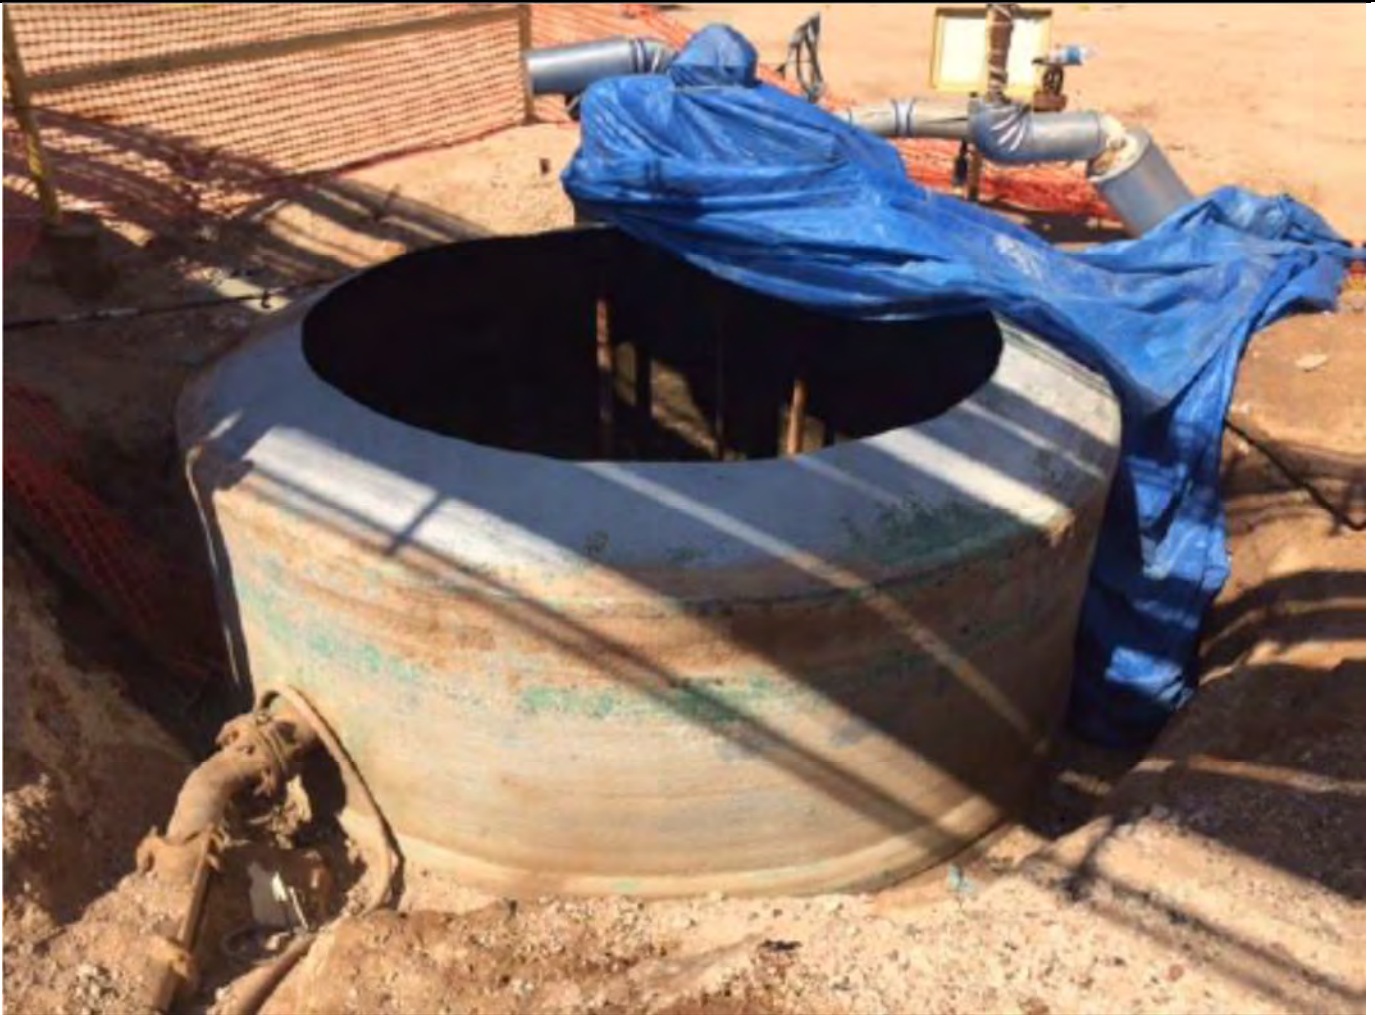
Photo 2: View of the West Boiler Sump after cutting top off, facing southwest.

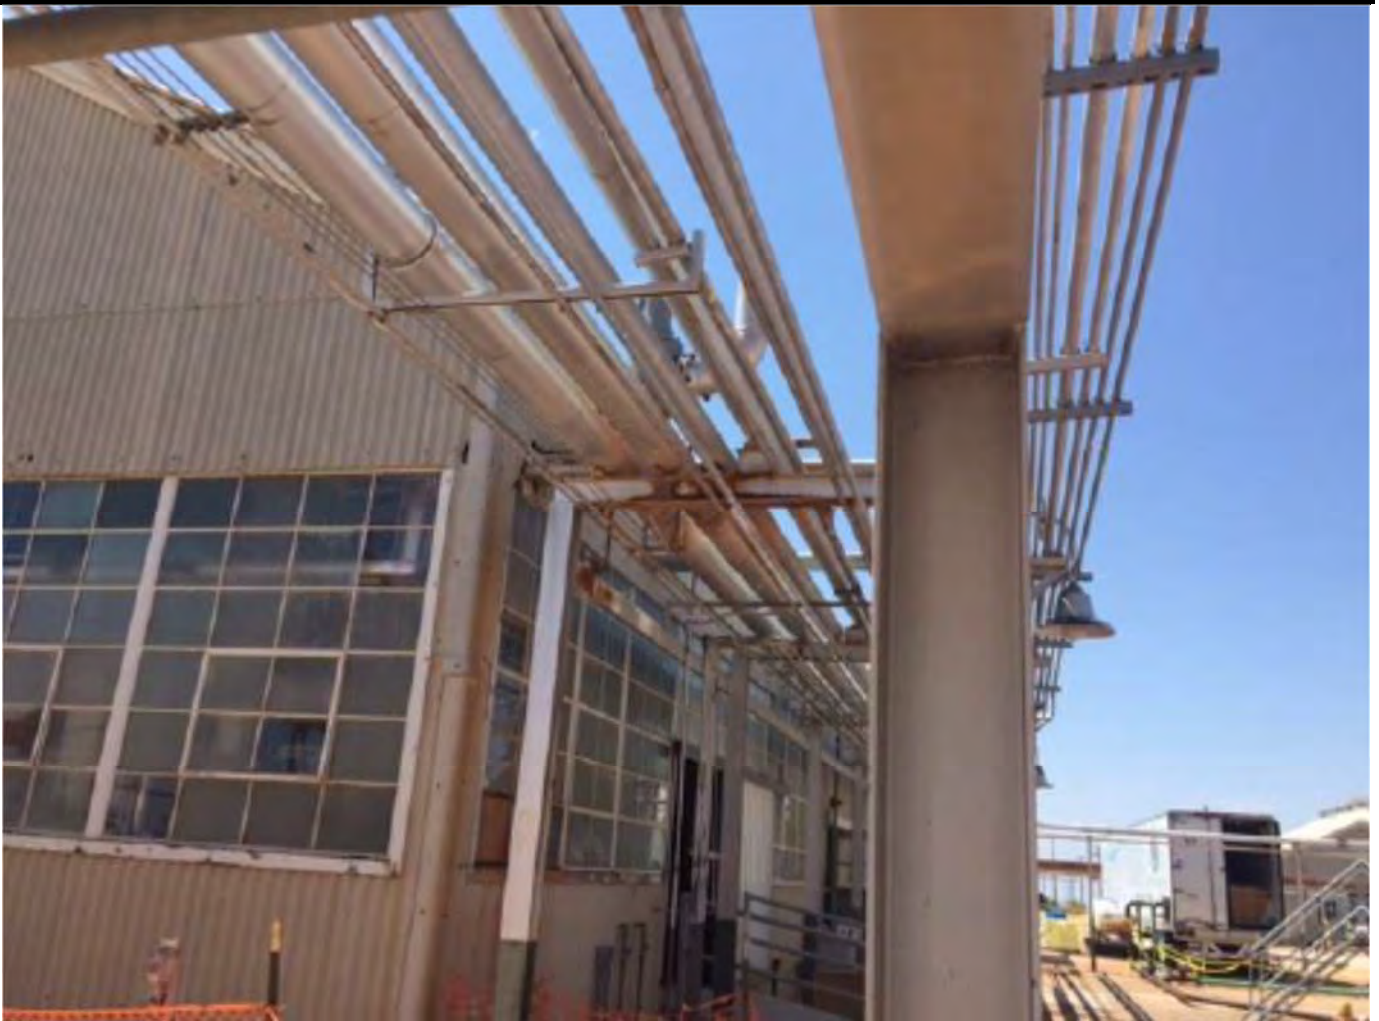
Photo 8: View of affected pipe rack support and associated utilities, included the high pressure steam line, facing south.

ETC maintains removing the West Boiler Sump from its current location poses a risk to human health and safety due to its proximity to the mechanical building and multiple above and below ground utilities, particularly the plant's main high pressure steam line, which is located on an adjacent pipe rack. A preliminary visual inspection of the floor and side of the tank from the surface and accounts from ETC personnel who have entered the BGT to conduct tank cleaning activities suggest the fiberglass BGT's integrity has not been compromised. A hydrostatic test, detailed inspection and/or the collection of soil samples would be necessary to confirm these.

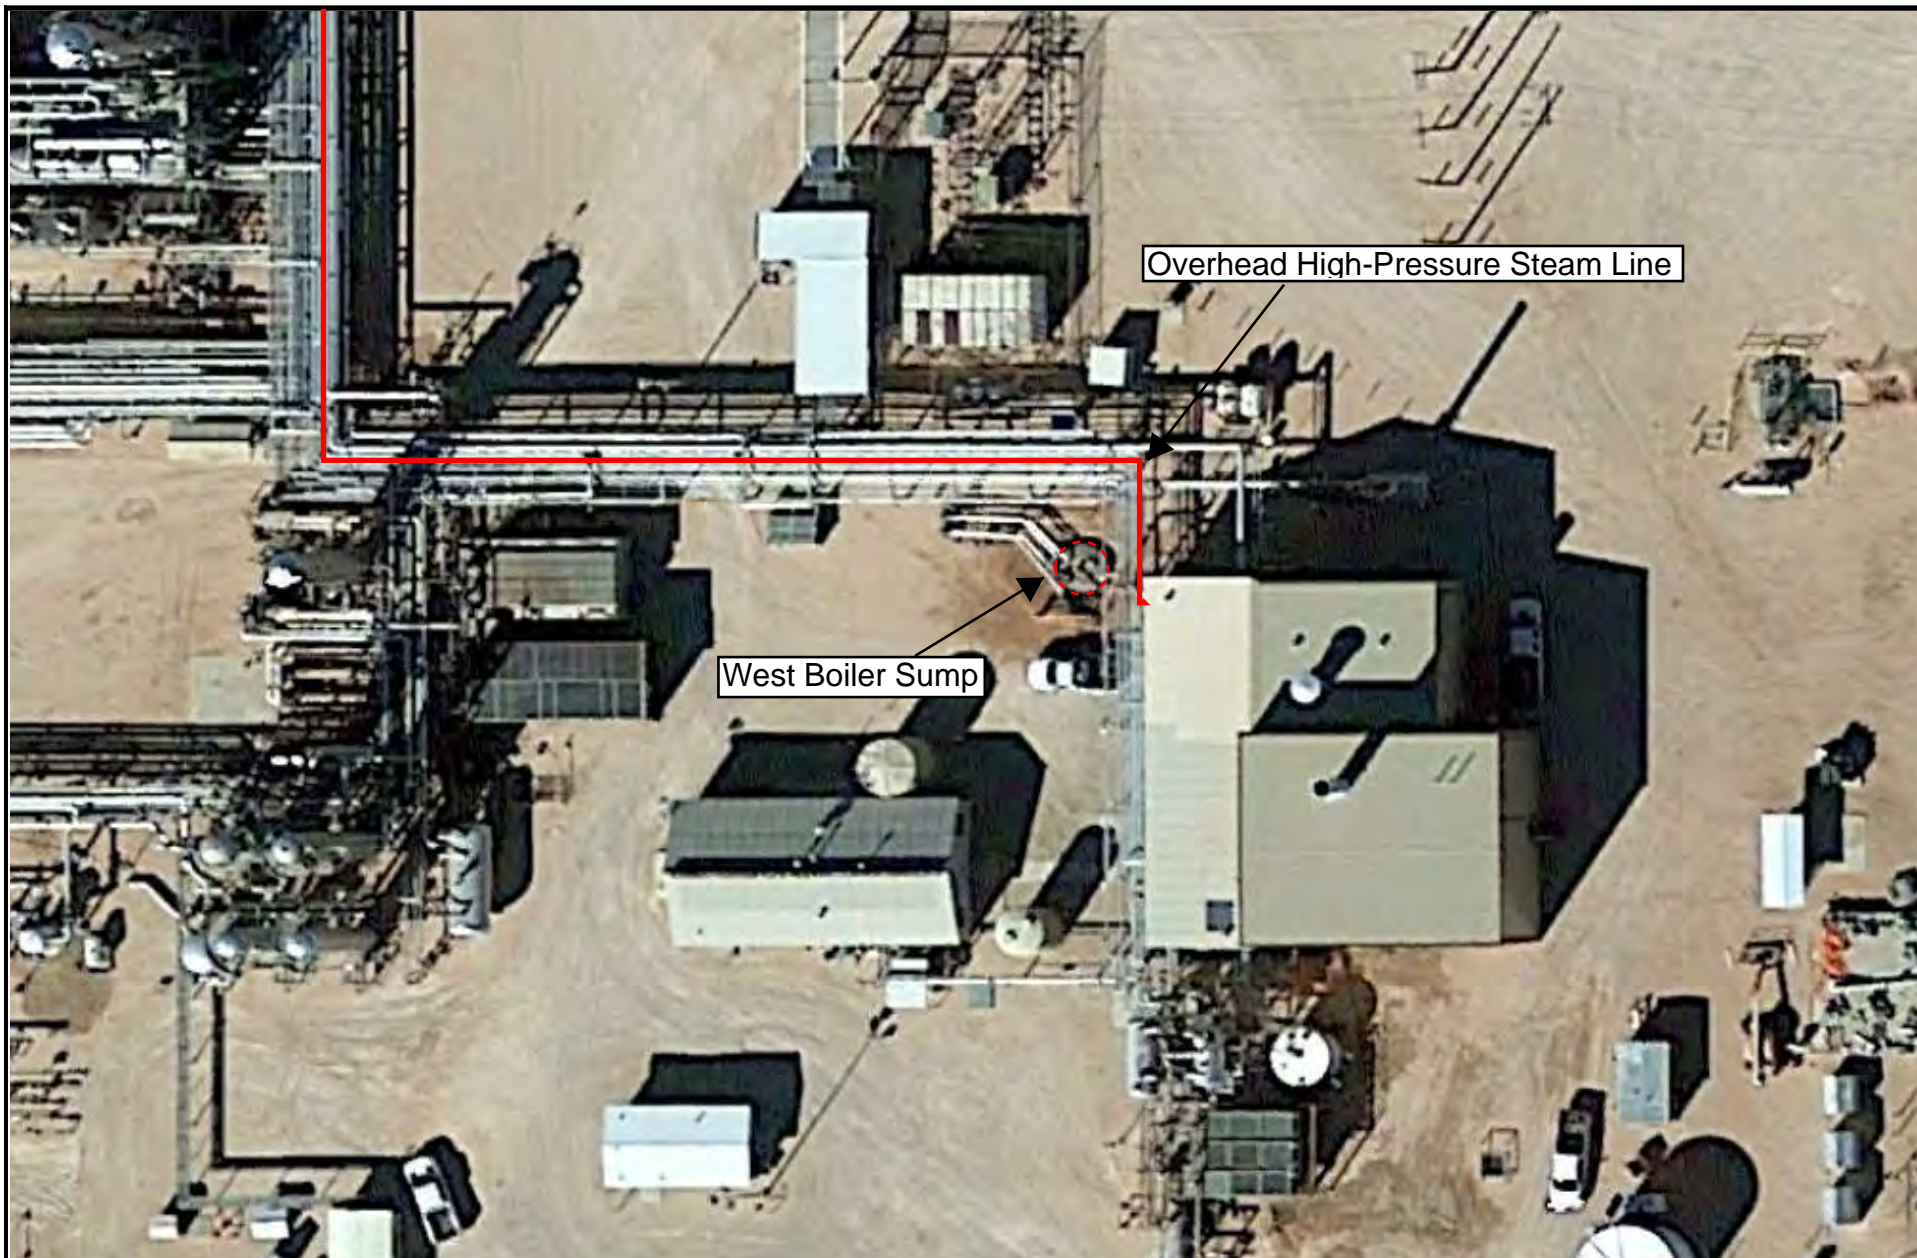
Figure 2

Below-Grade Tank
High-Pressure Steam Line

Site Diagram
ETC Field Services, LLC
Jal #3 BGTs
Lea County, NM

This BGT is located in the south-central portion of the plant in a highly congested area as you will see on the attachment #2 site diagram. The removal of the West Boiler Sump from its current location poses a risk to human health and safety due to its proximity to the mechanical building and the multiple above and underground utilities pipelines surrounding the BGT. One of our biggest concerns is the plants high pressure steam line, which is located on an adjacent pipe rack directly above the BGT. If this high pressure steam line was to be impacted it could cause serious injuries and possible death to anyone in the vicinity of that area due to not only the high pressure of the steam-line but also from the heat associated with the steam-line.

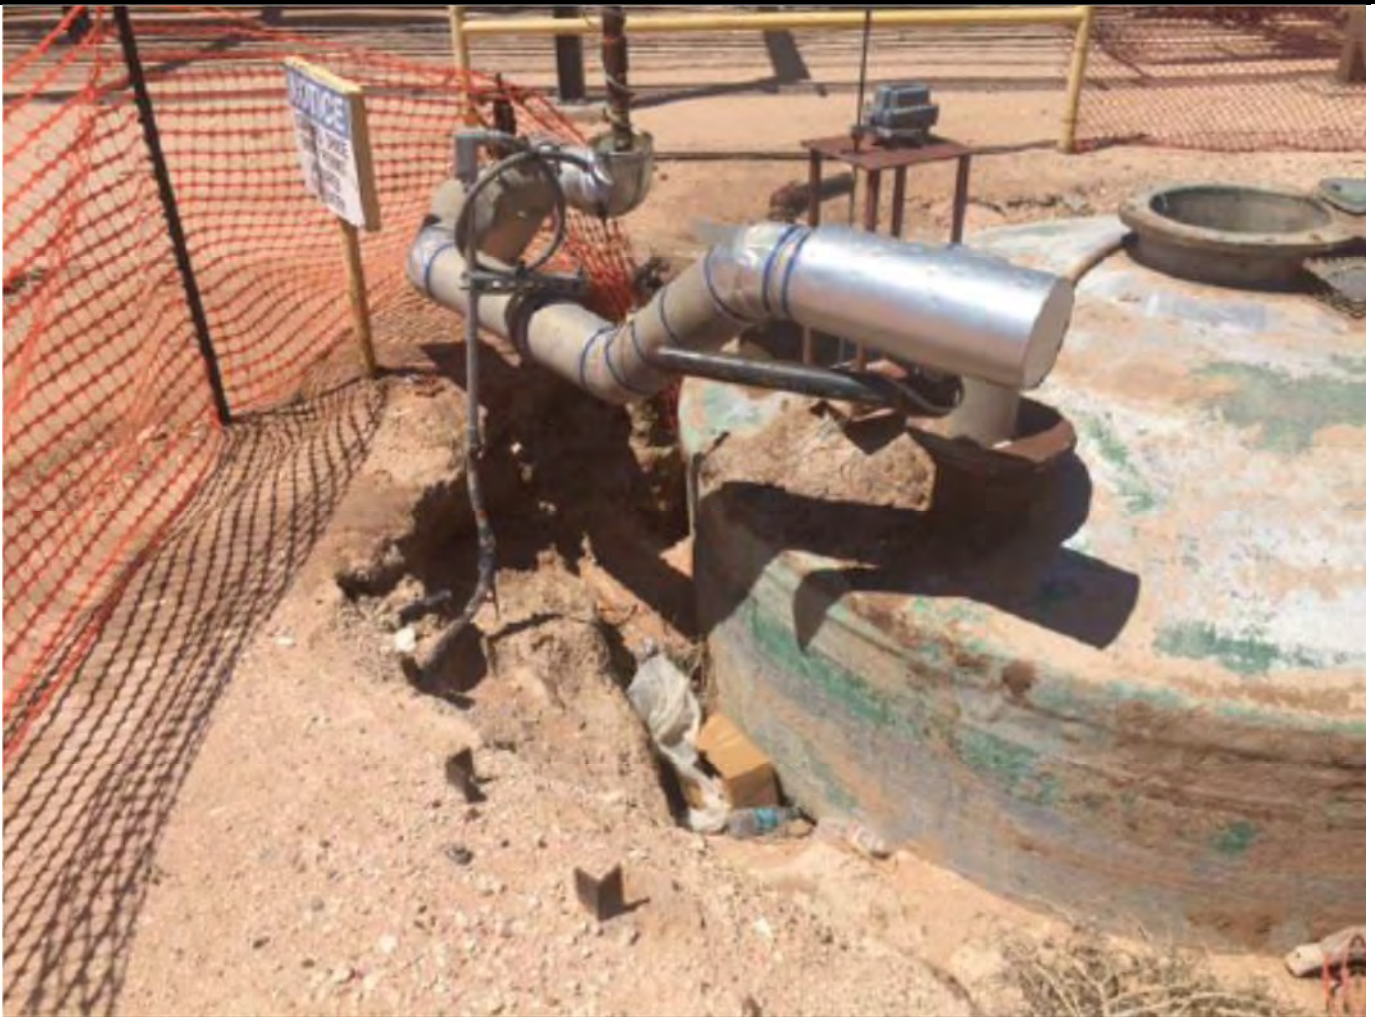
Photo 1: View of the West Boiler Sump prior to cutting the top off, facing north.

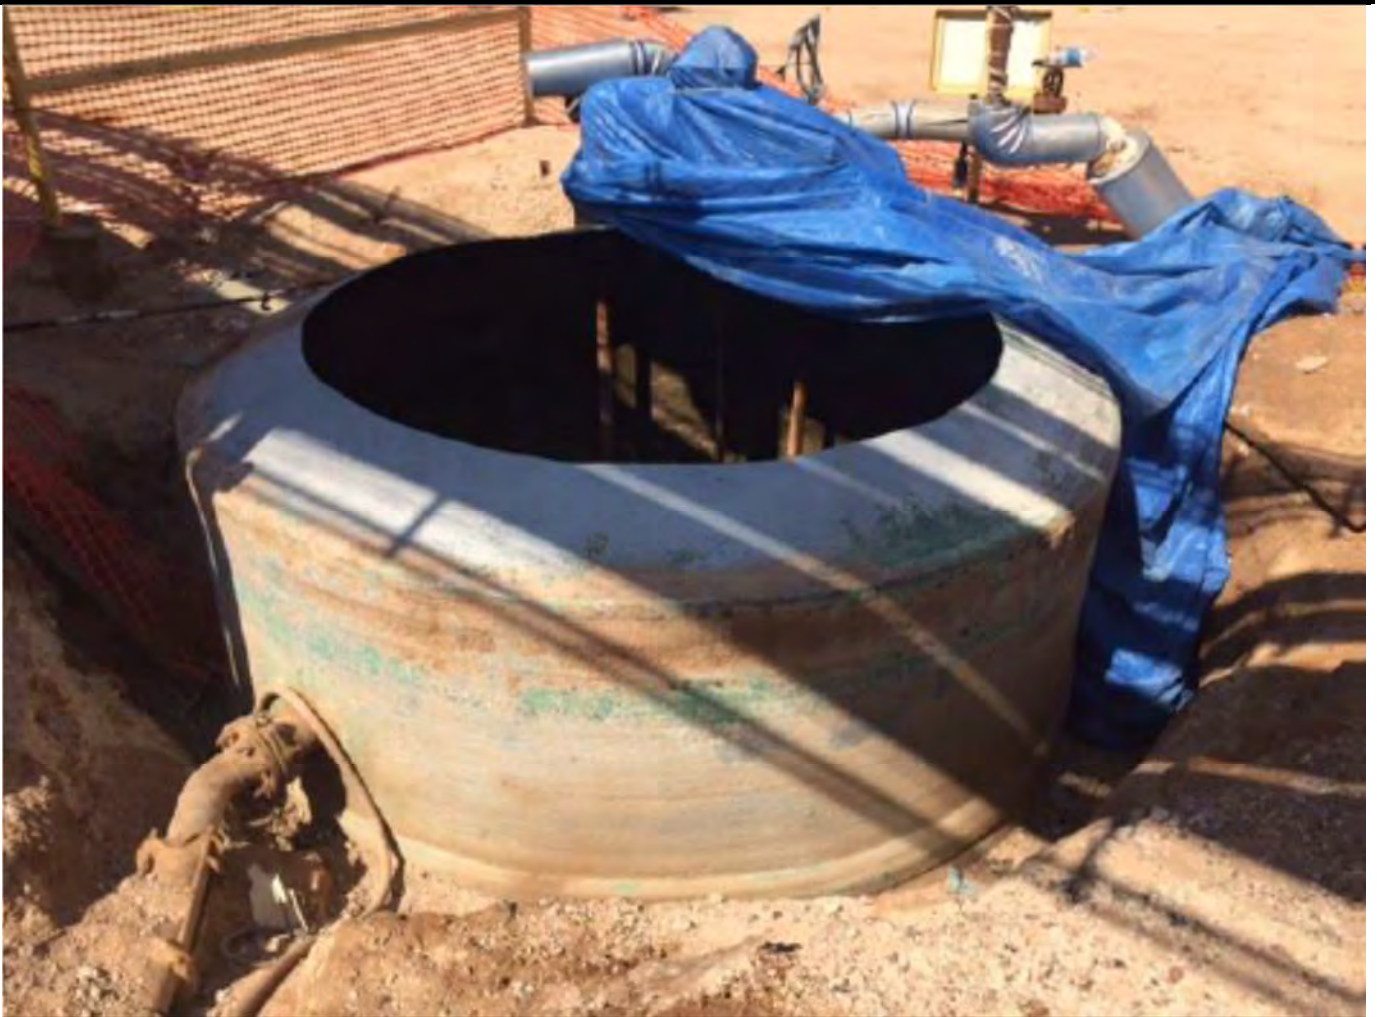
Photo 2: View of the West Boiler Sump after cutting top off, facing southwest.

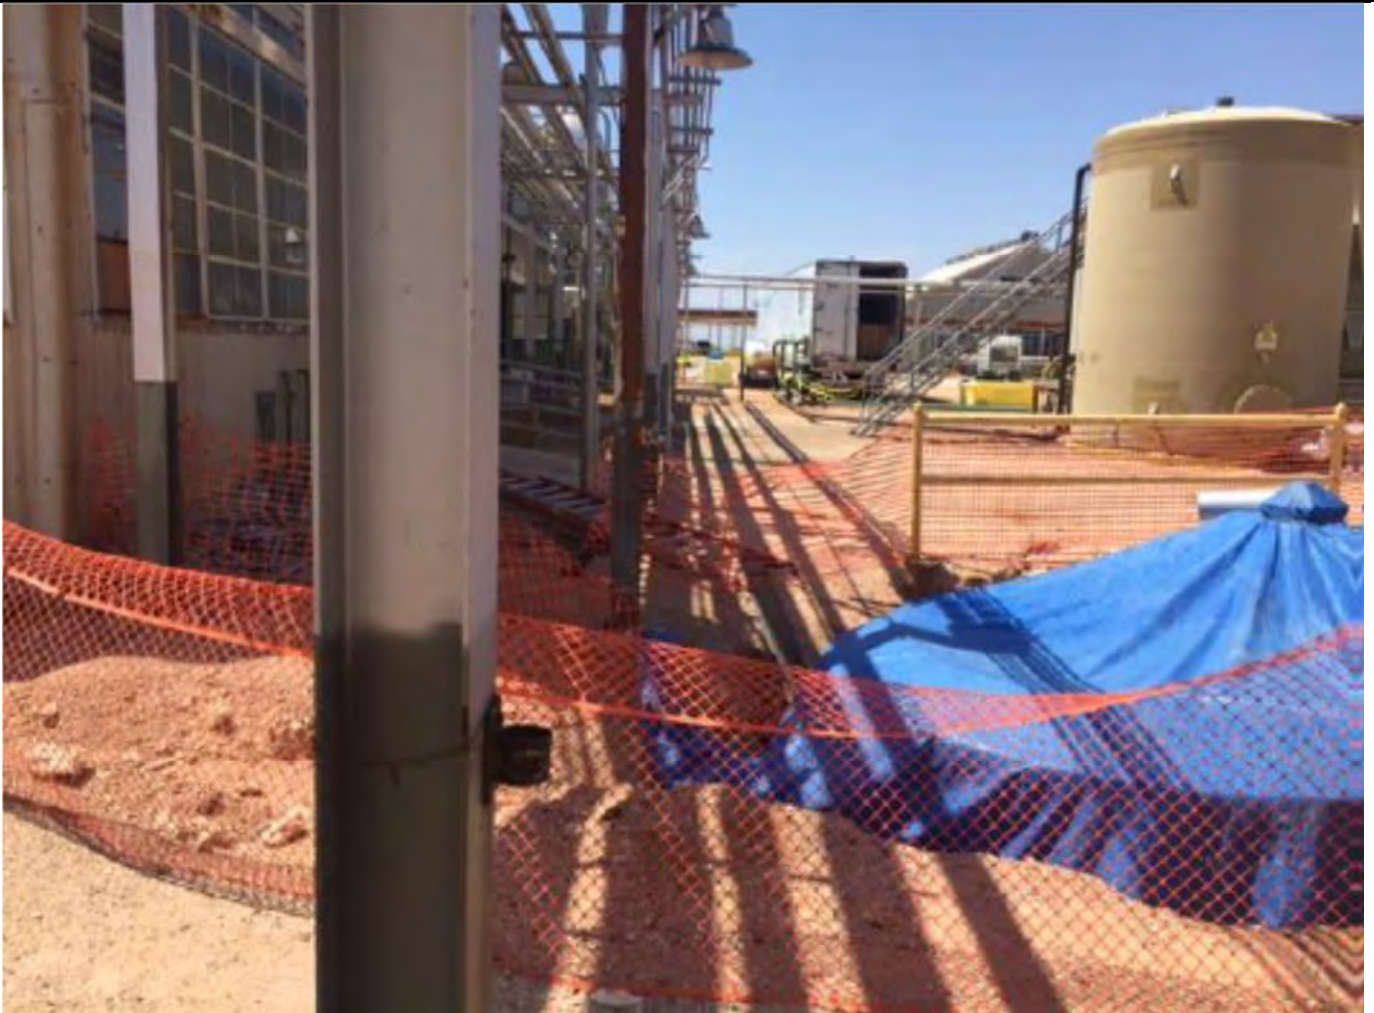
Photo 3: View of the West Boiler Sump and affected utilities and proximity to pipe rack, facing south.

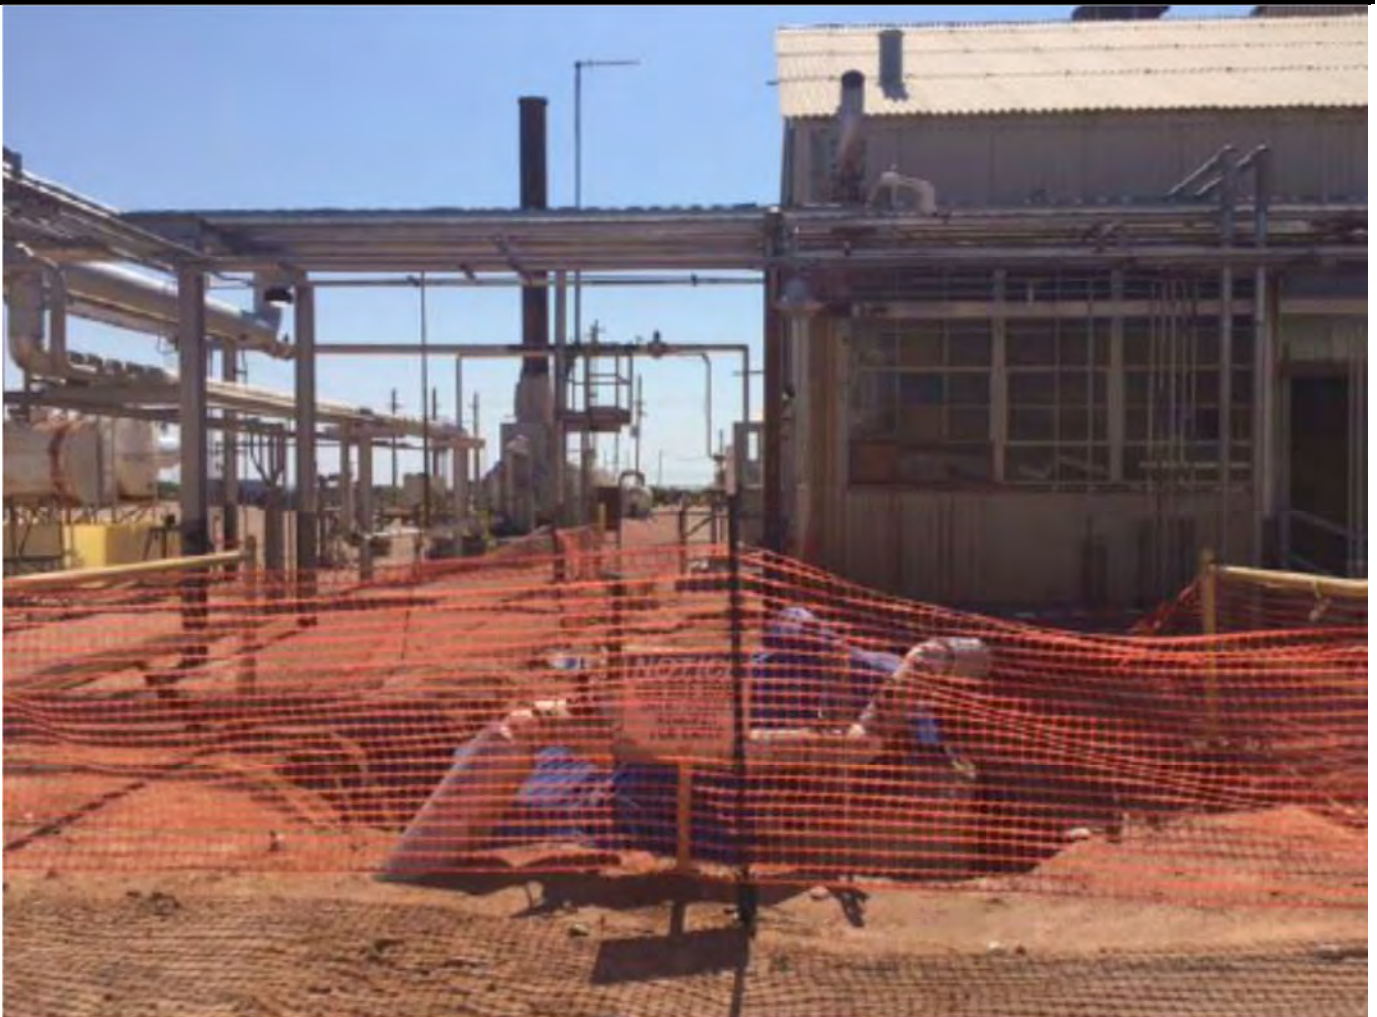
Photo 4: View of the West Boiler Sump, affected utilities, proximity to pipe rack and mechanical building, facing east.

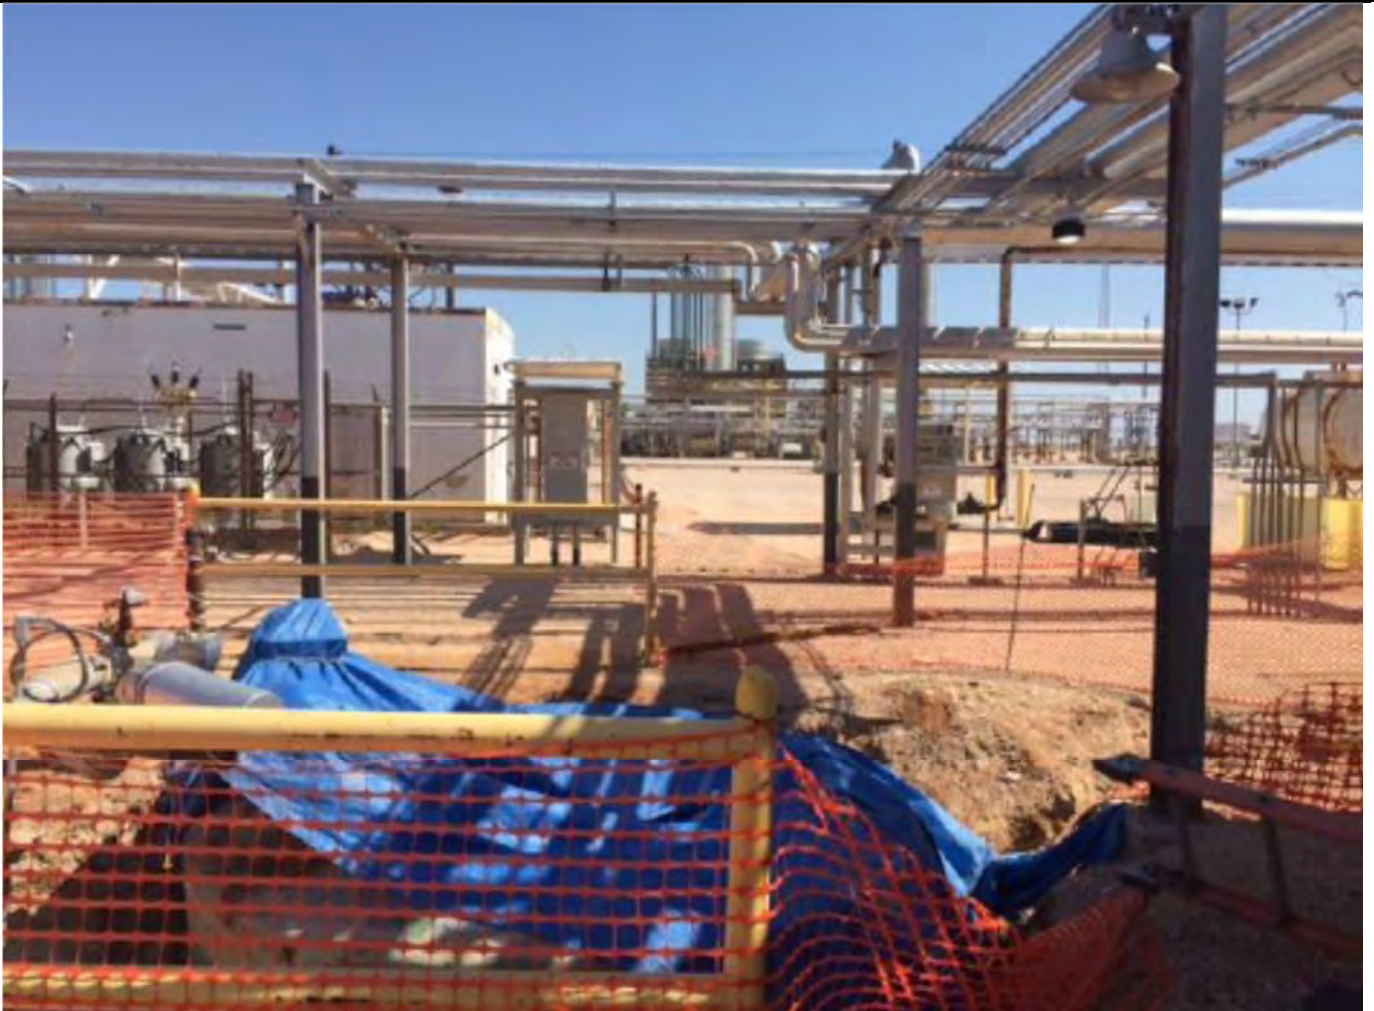
Photo 5: View of the West Boiler Sump and affected utilities and proximity to pipe rack support (east side), facing north.

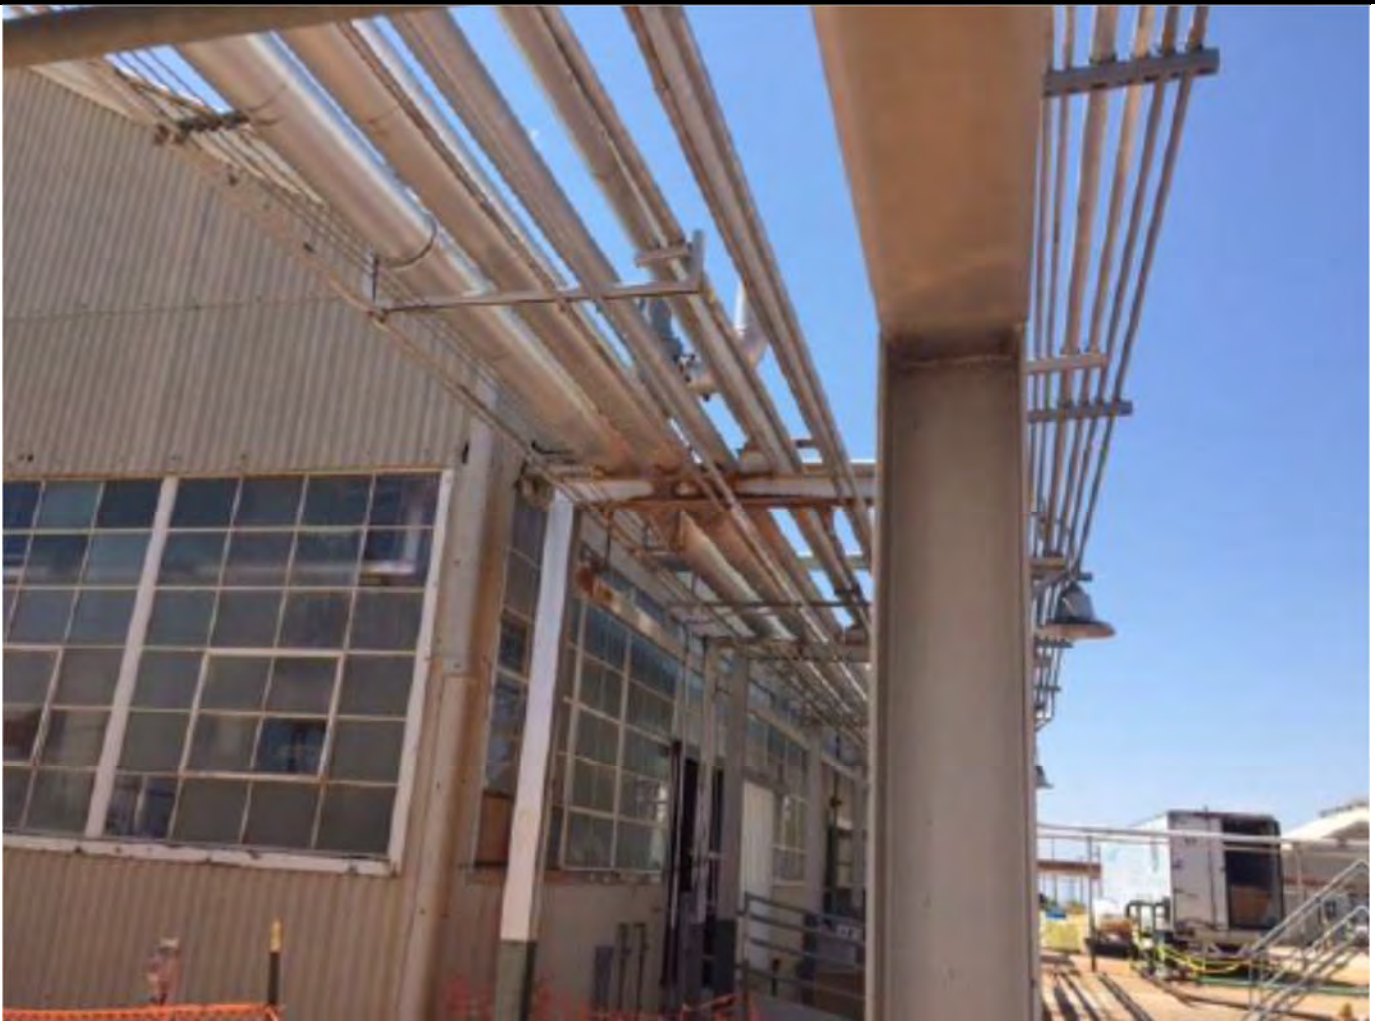
Photo 6: View of affected pipe rack support and associated utilities, included the high pressure steam line, facing south.
