Re: Proposed Closure Strategy – West Boiler Sump
Energy Transfer Company's Jal #3 Gas Plant
Section 33, Township 24 South, Range 37 East
Lea County, New Mexico

**FIELD ACTIVITIES SUMMARY AND
BELOW-GRADE TANK CLOSURE REQUEST**

**ETC FIELD SERVICES, LLC
West Boiler Sump
Lea County, New Mexico
UNIT LTR "L", Section 33, Township 24 South, Range 37 East, NMPM
Latitude 32.17374° North, Longitude 103.17375° West
NMOCD Reference No. GW-010**

December 2017

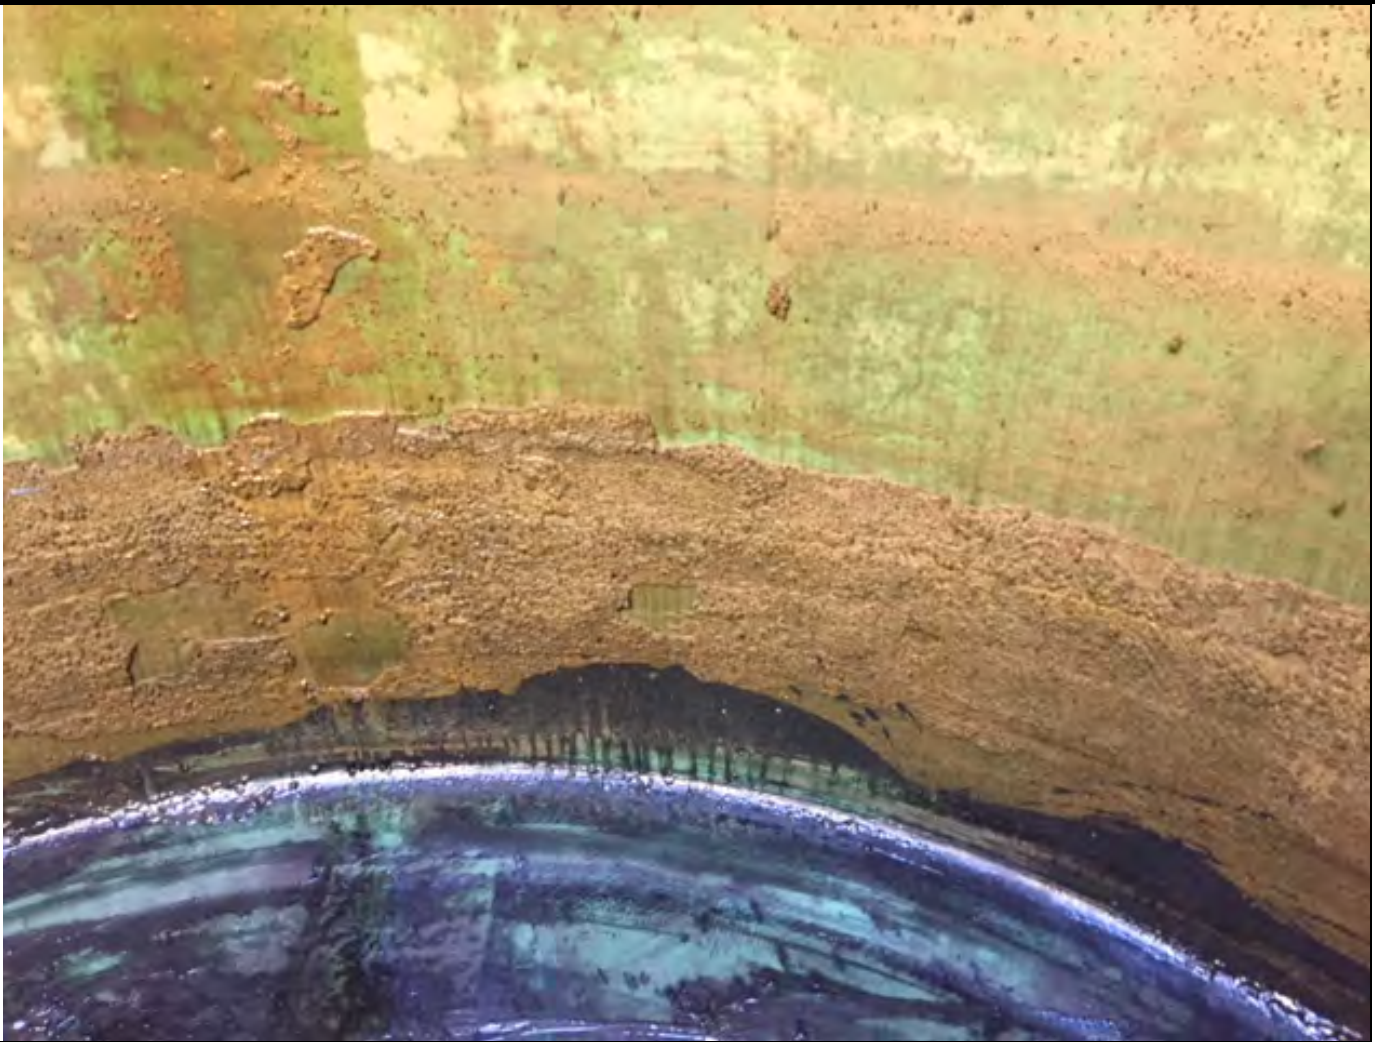
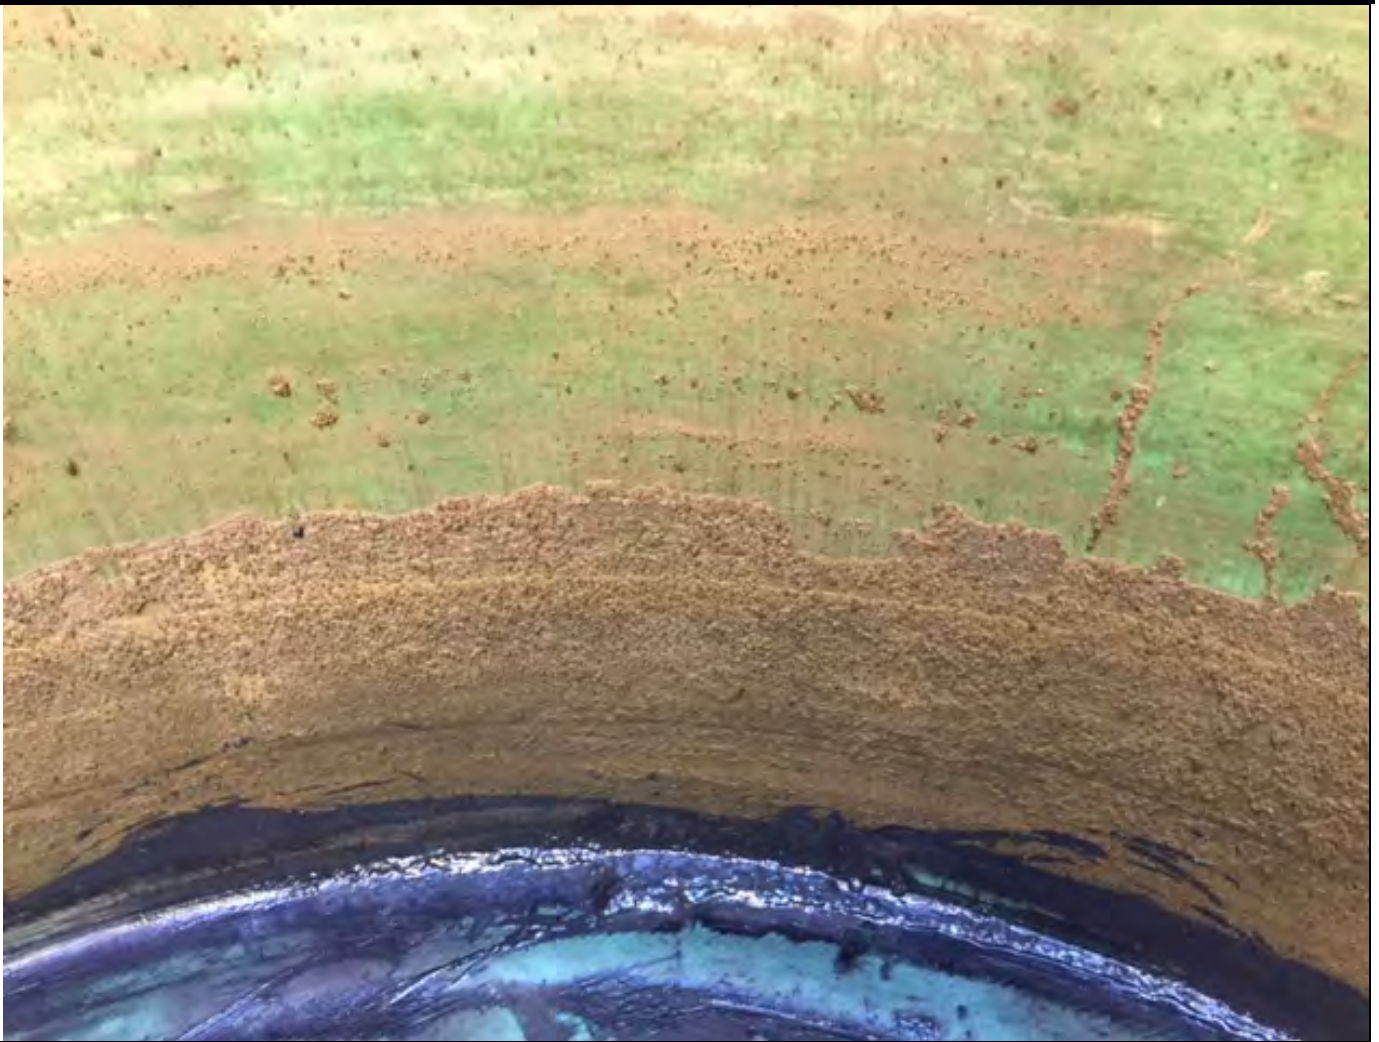
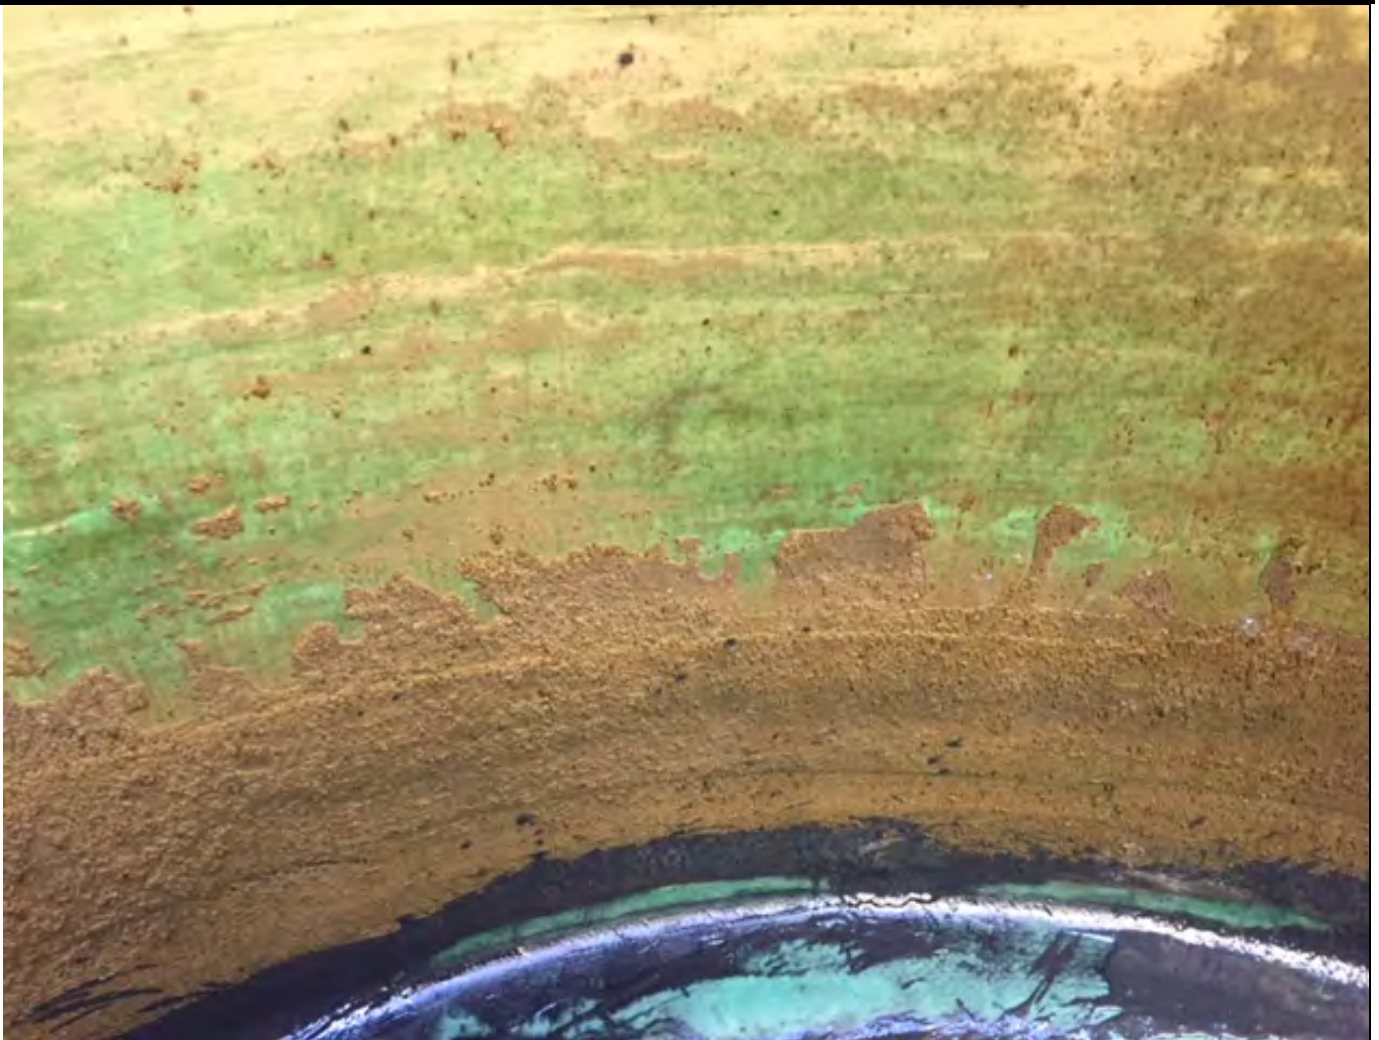
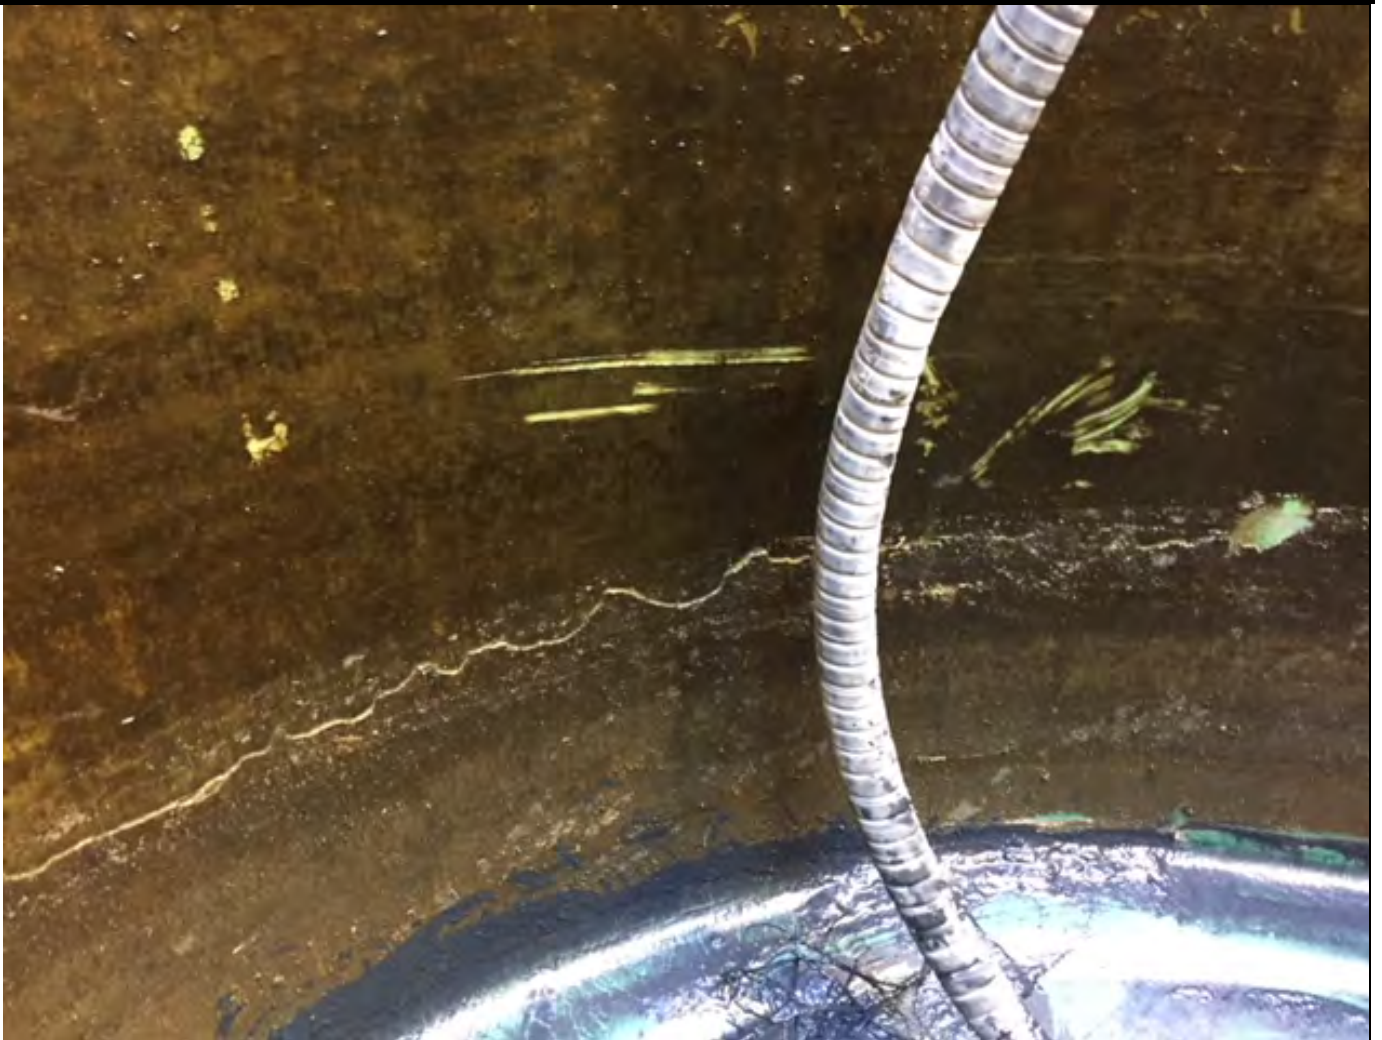
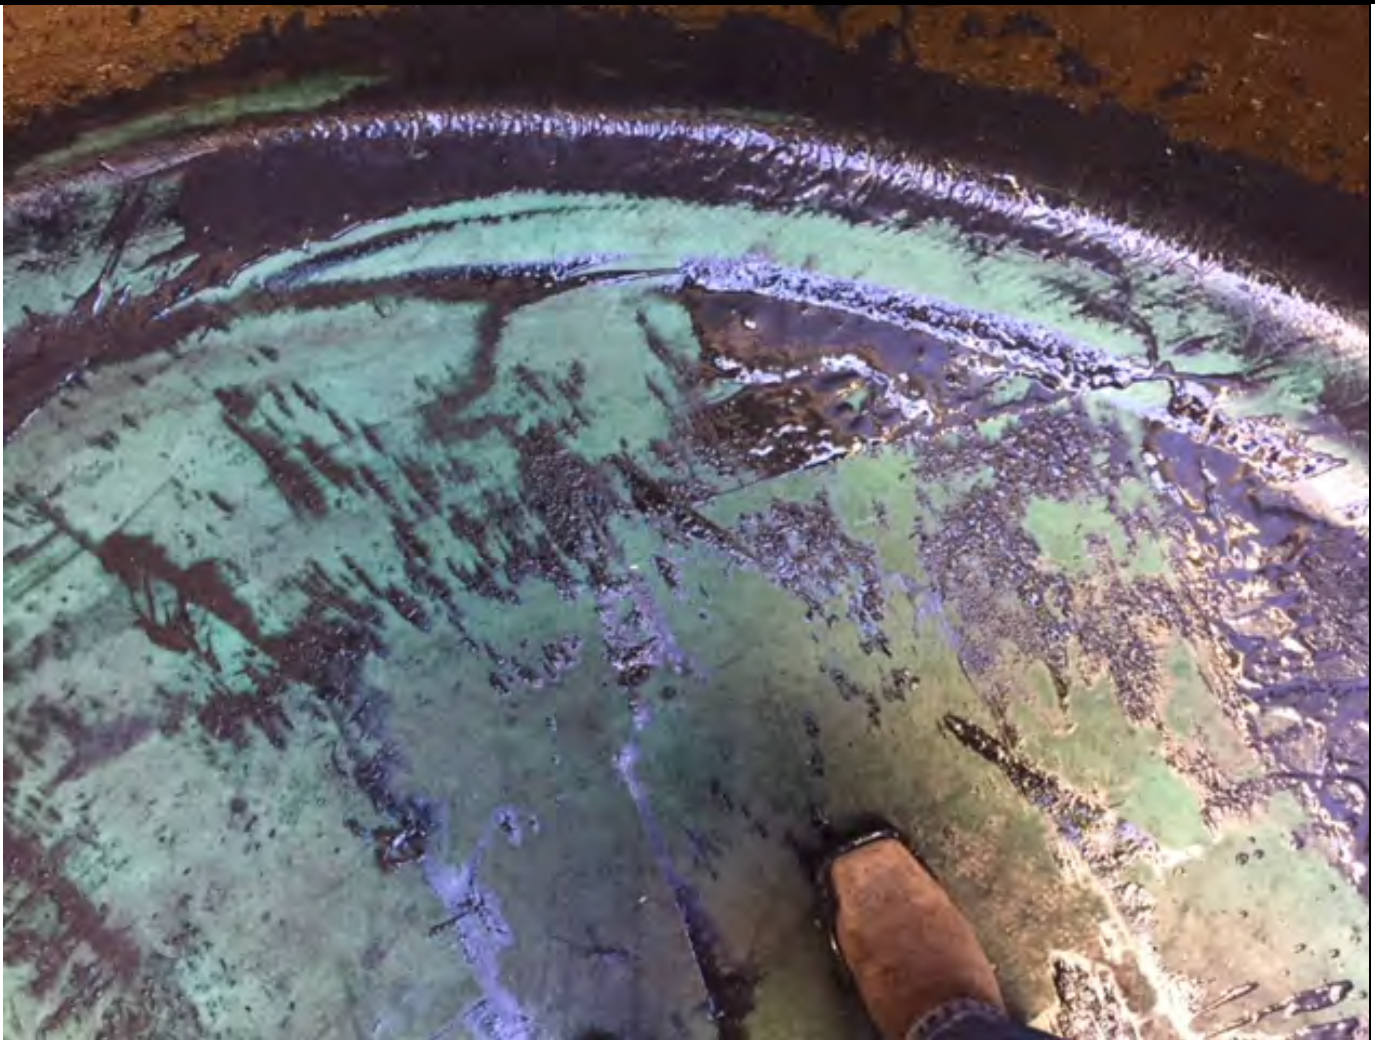
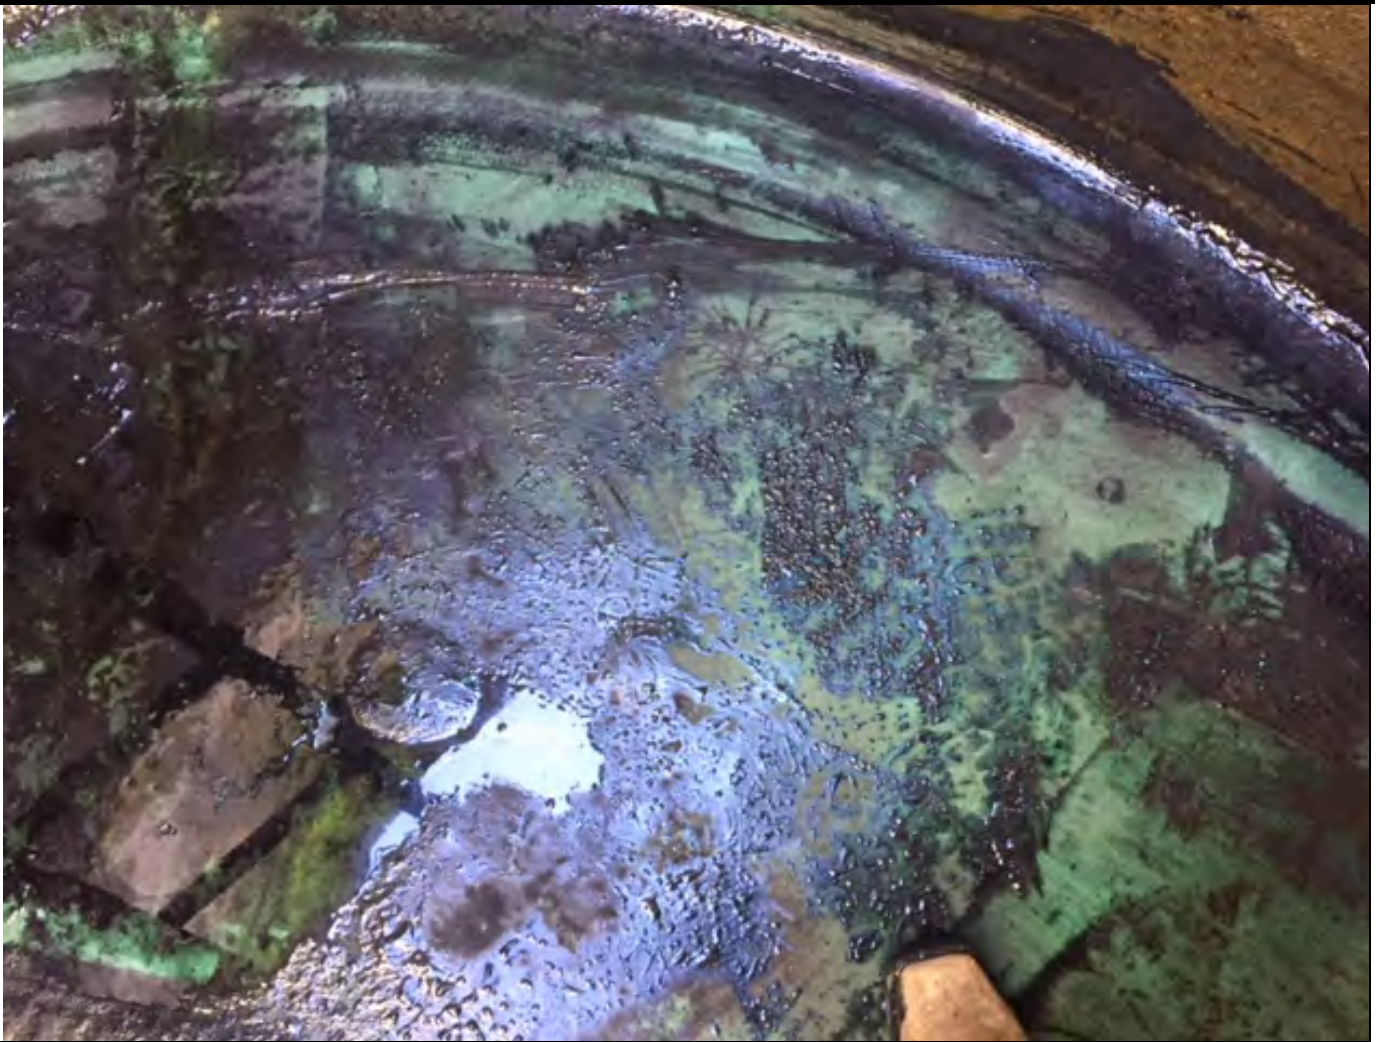
On November 15, 2017, representatives and contractors of ETC, conducted a visual inspection of the West Boiler Sump in an effort to determine if evidence of a release was present. The visual inspection included checking the floor, sides, seams and inlets for evidence of potential failures. During the visual inspection, the fiberglass tank appeared to be intact and no evidence of release were noted.

Photo 7: View of the interior of the West Boiler Sump.

Photo 8: View of the interior of the West Boiler Sump.

Photo 9: View of the interior of the West Boiler Sump.

Photo 10: View of the interior of the West Boiler Sump.

Photo 11: View of the interior of the West Boiler Sump.

Photo 12: View of the interior of the West Boiler Sump.

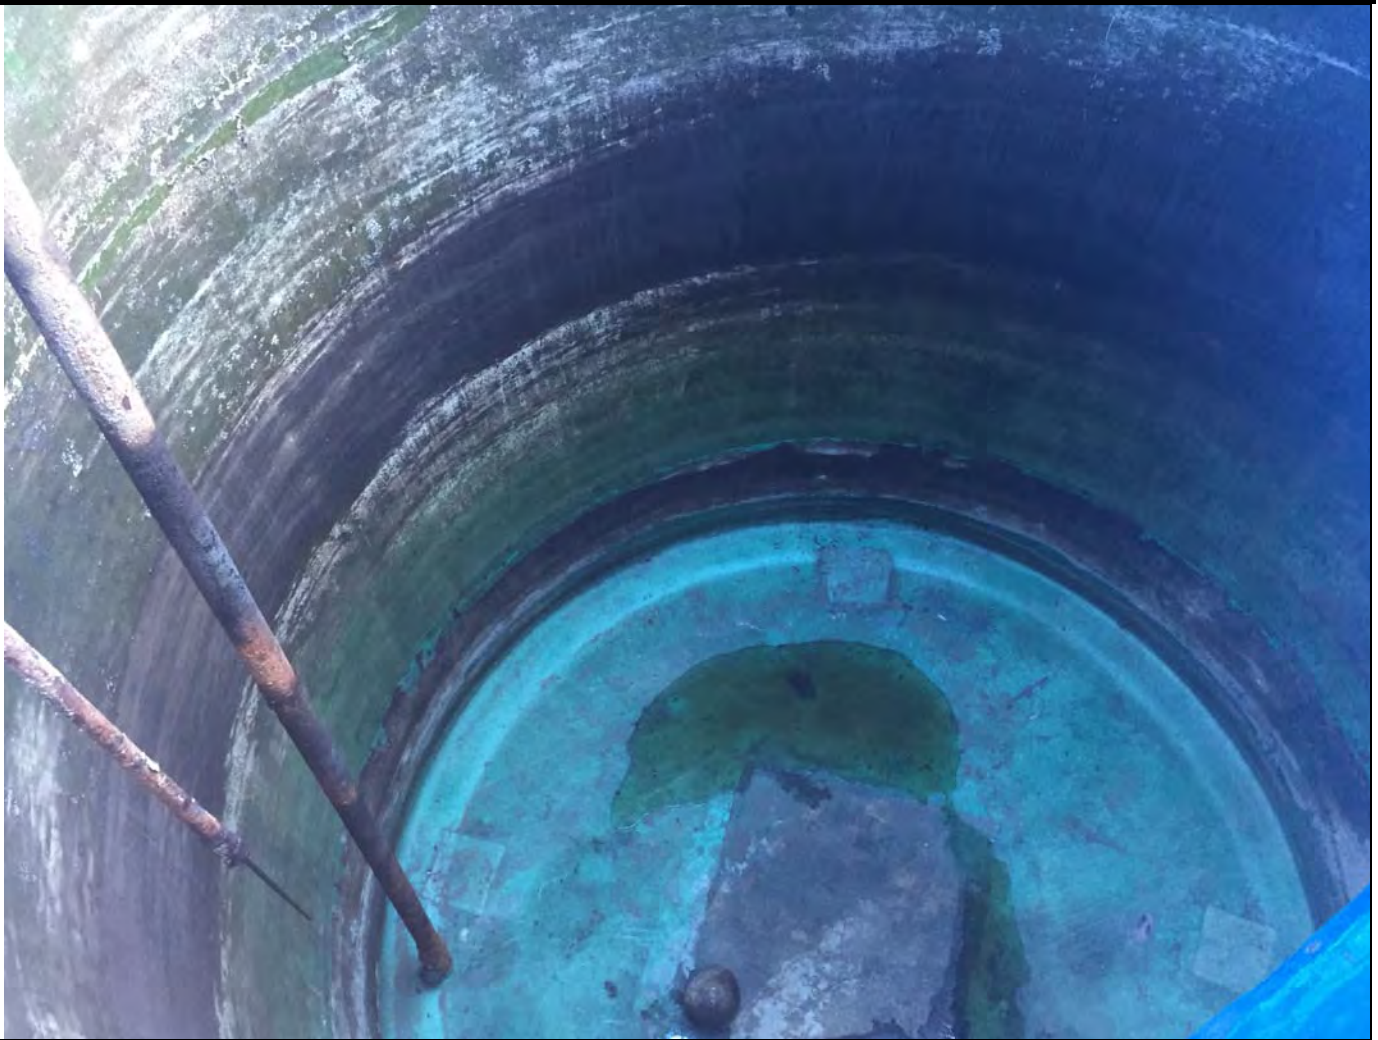
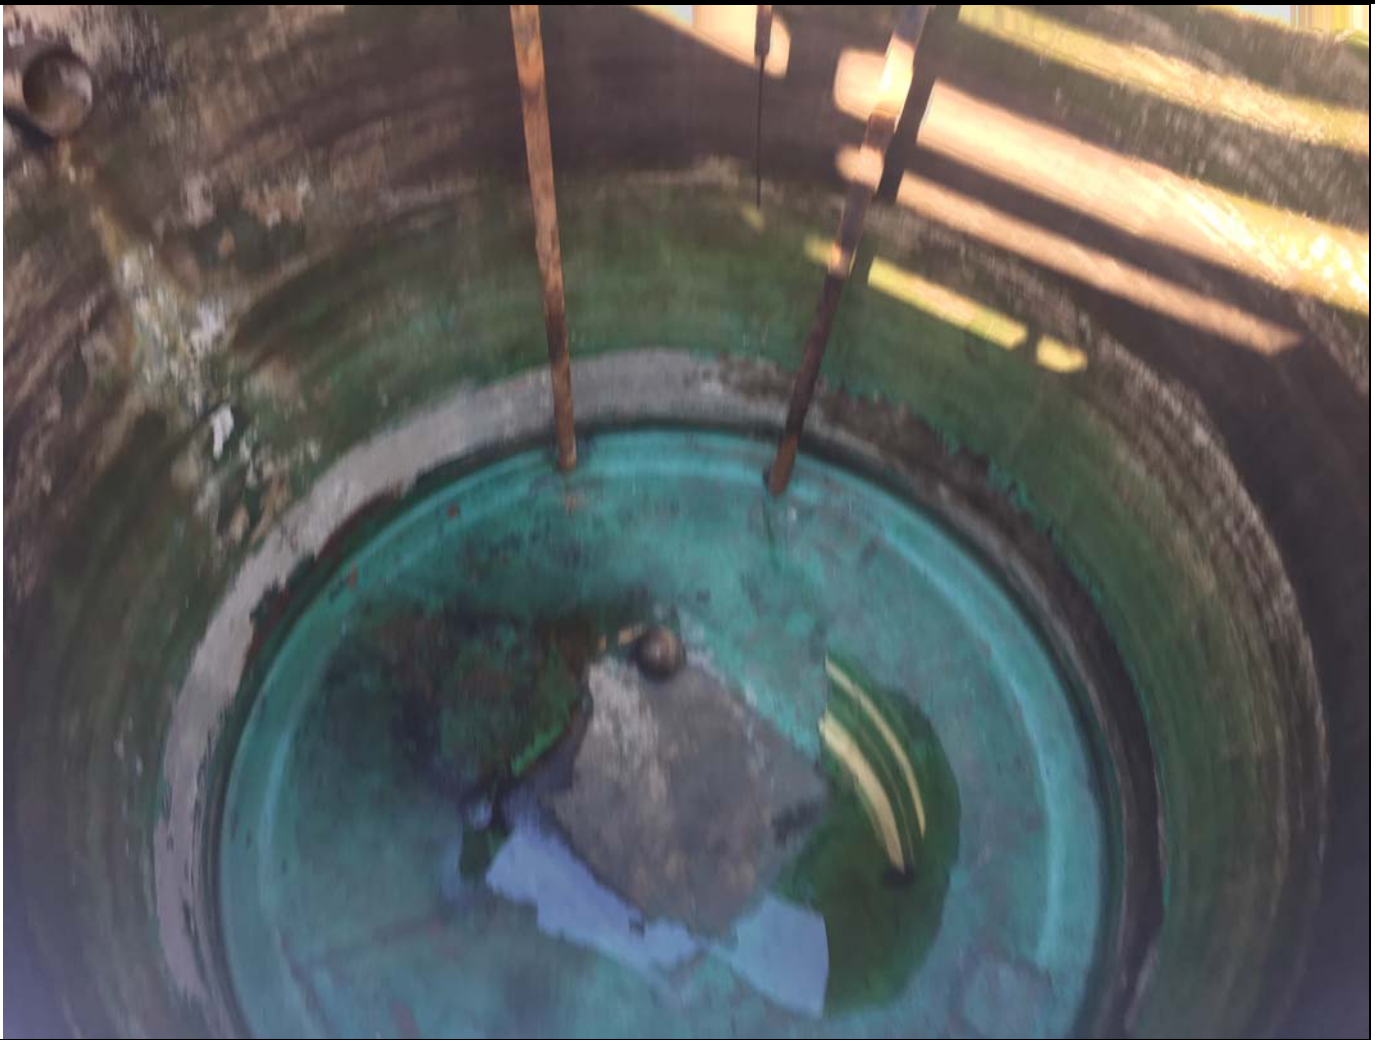
disposal well. Upon removing any remaining liquids, the BGT was cleaned utilizing a steamer. A photographic log is provided as Appendix A.

Photo 13: View of the interior of the West Boiler Sump after cleaning activities.

Photo 14: View of the interior of the West Boiler Sump after cleaning activities.

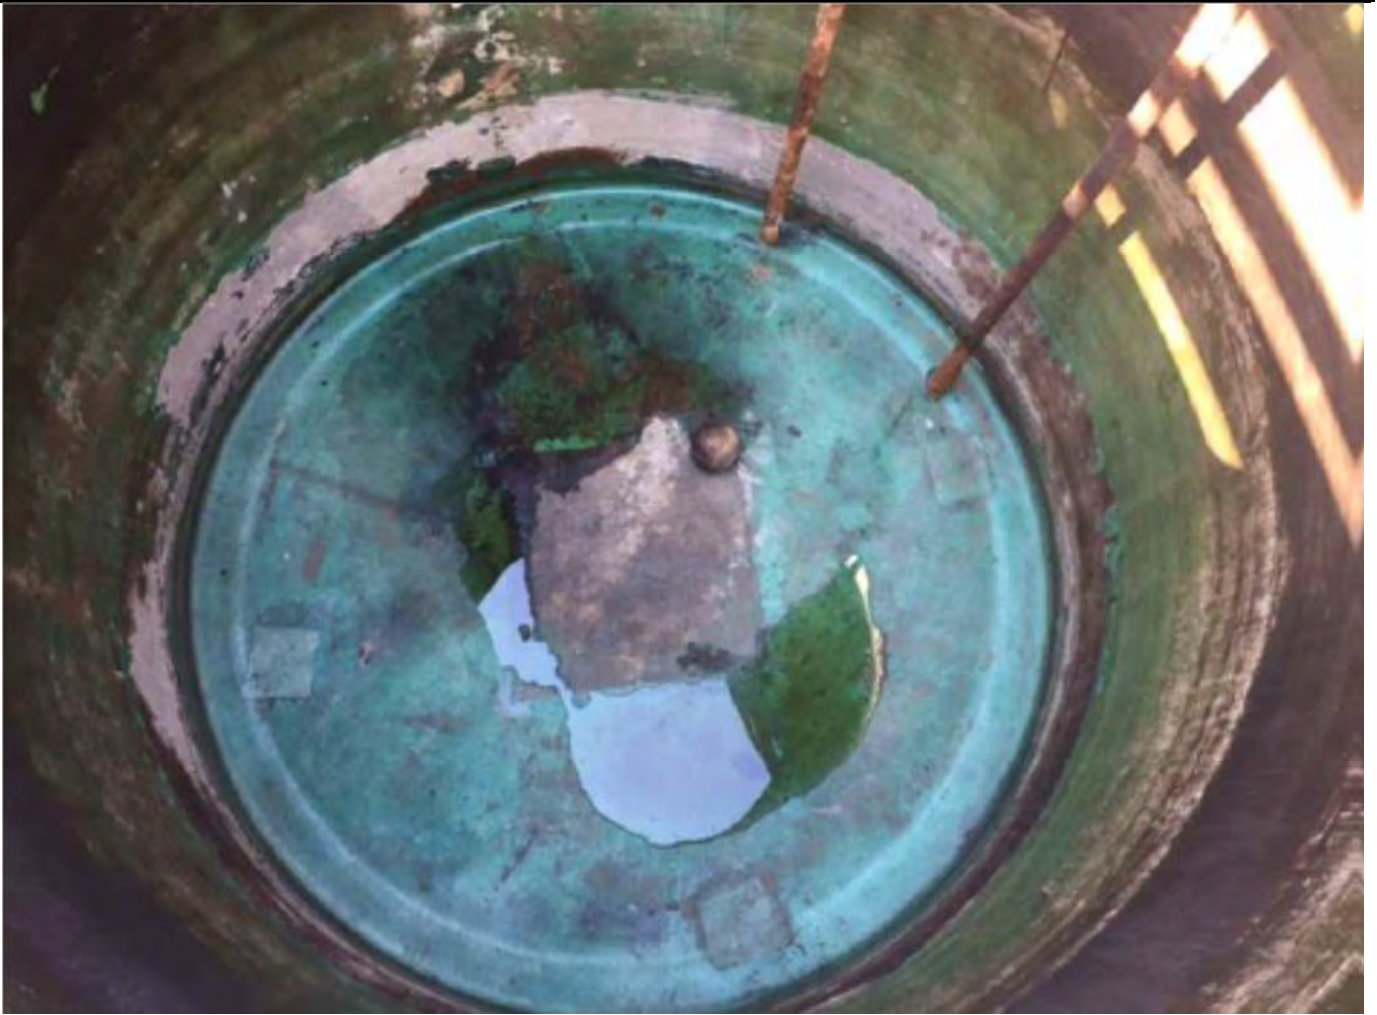
Photo 3: View of the interior of the West Boiler Sump after limited cleaning activities.

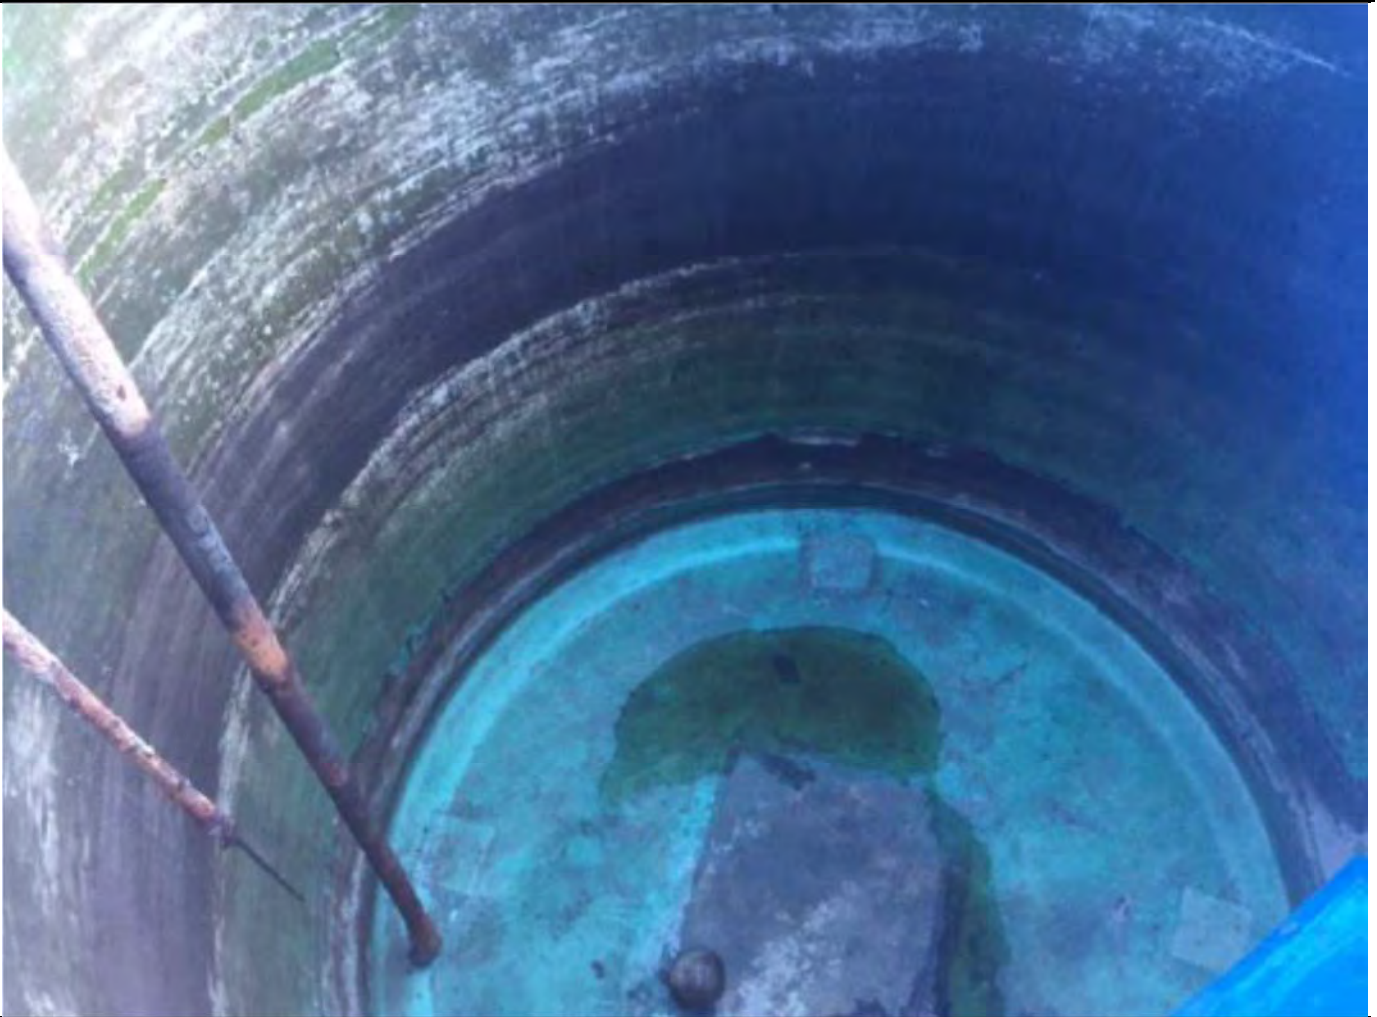
Photo 4: View of the interior of the West Boiler Sump after limited cleaning activities.

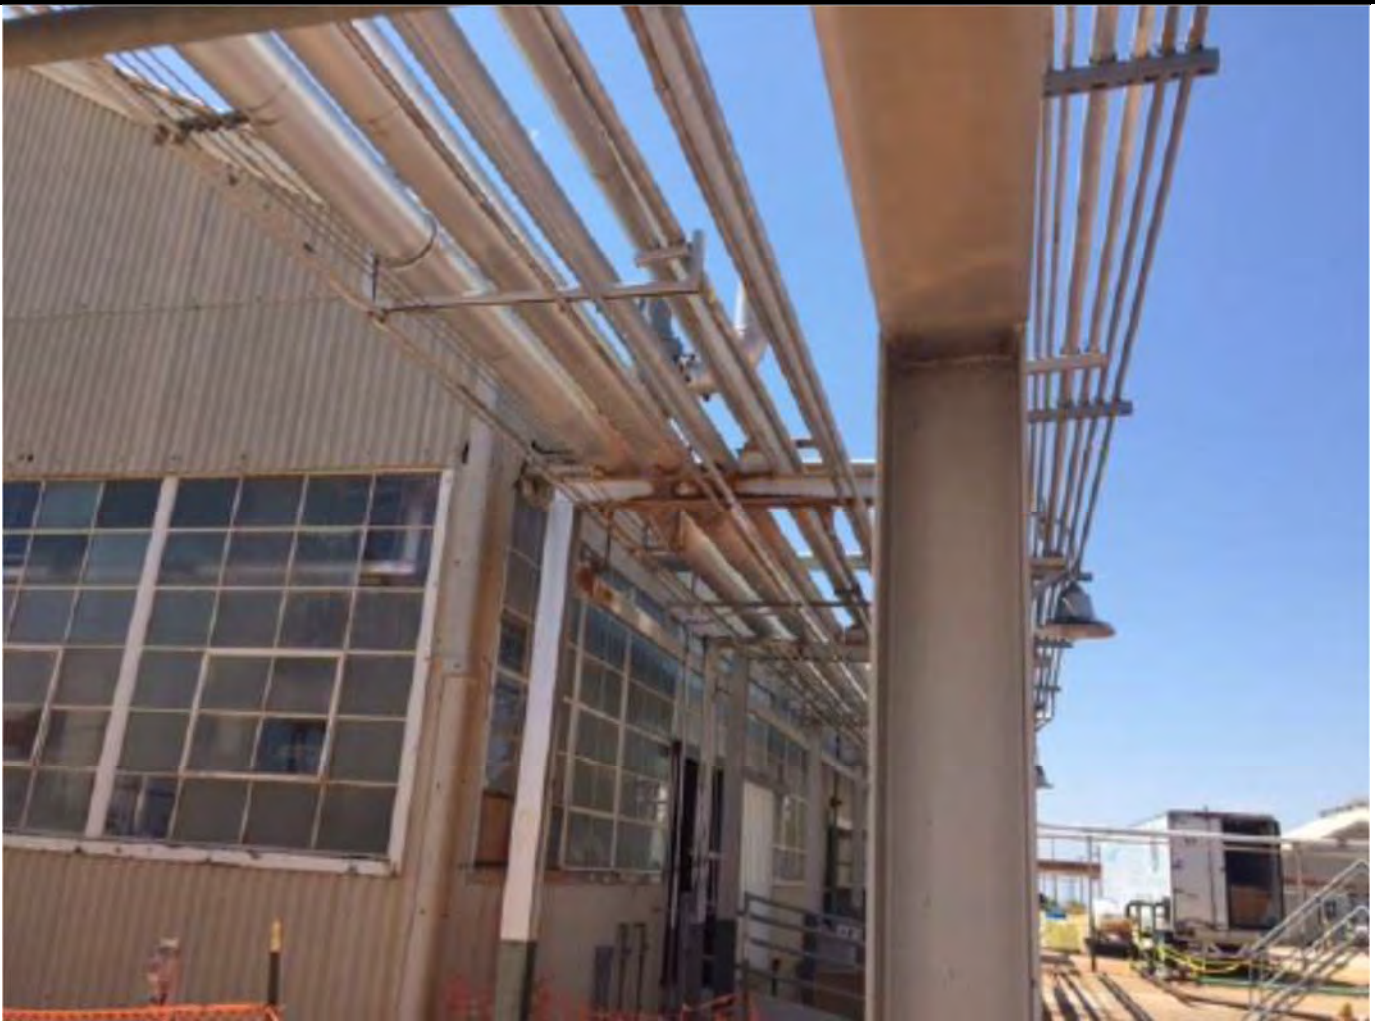
Photo 8: View of affected pipe rack support and associated utilities, included the high pressure steam line, facing south.

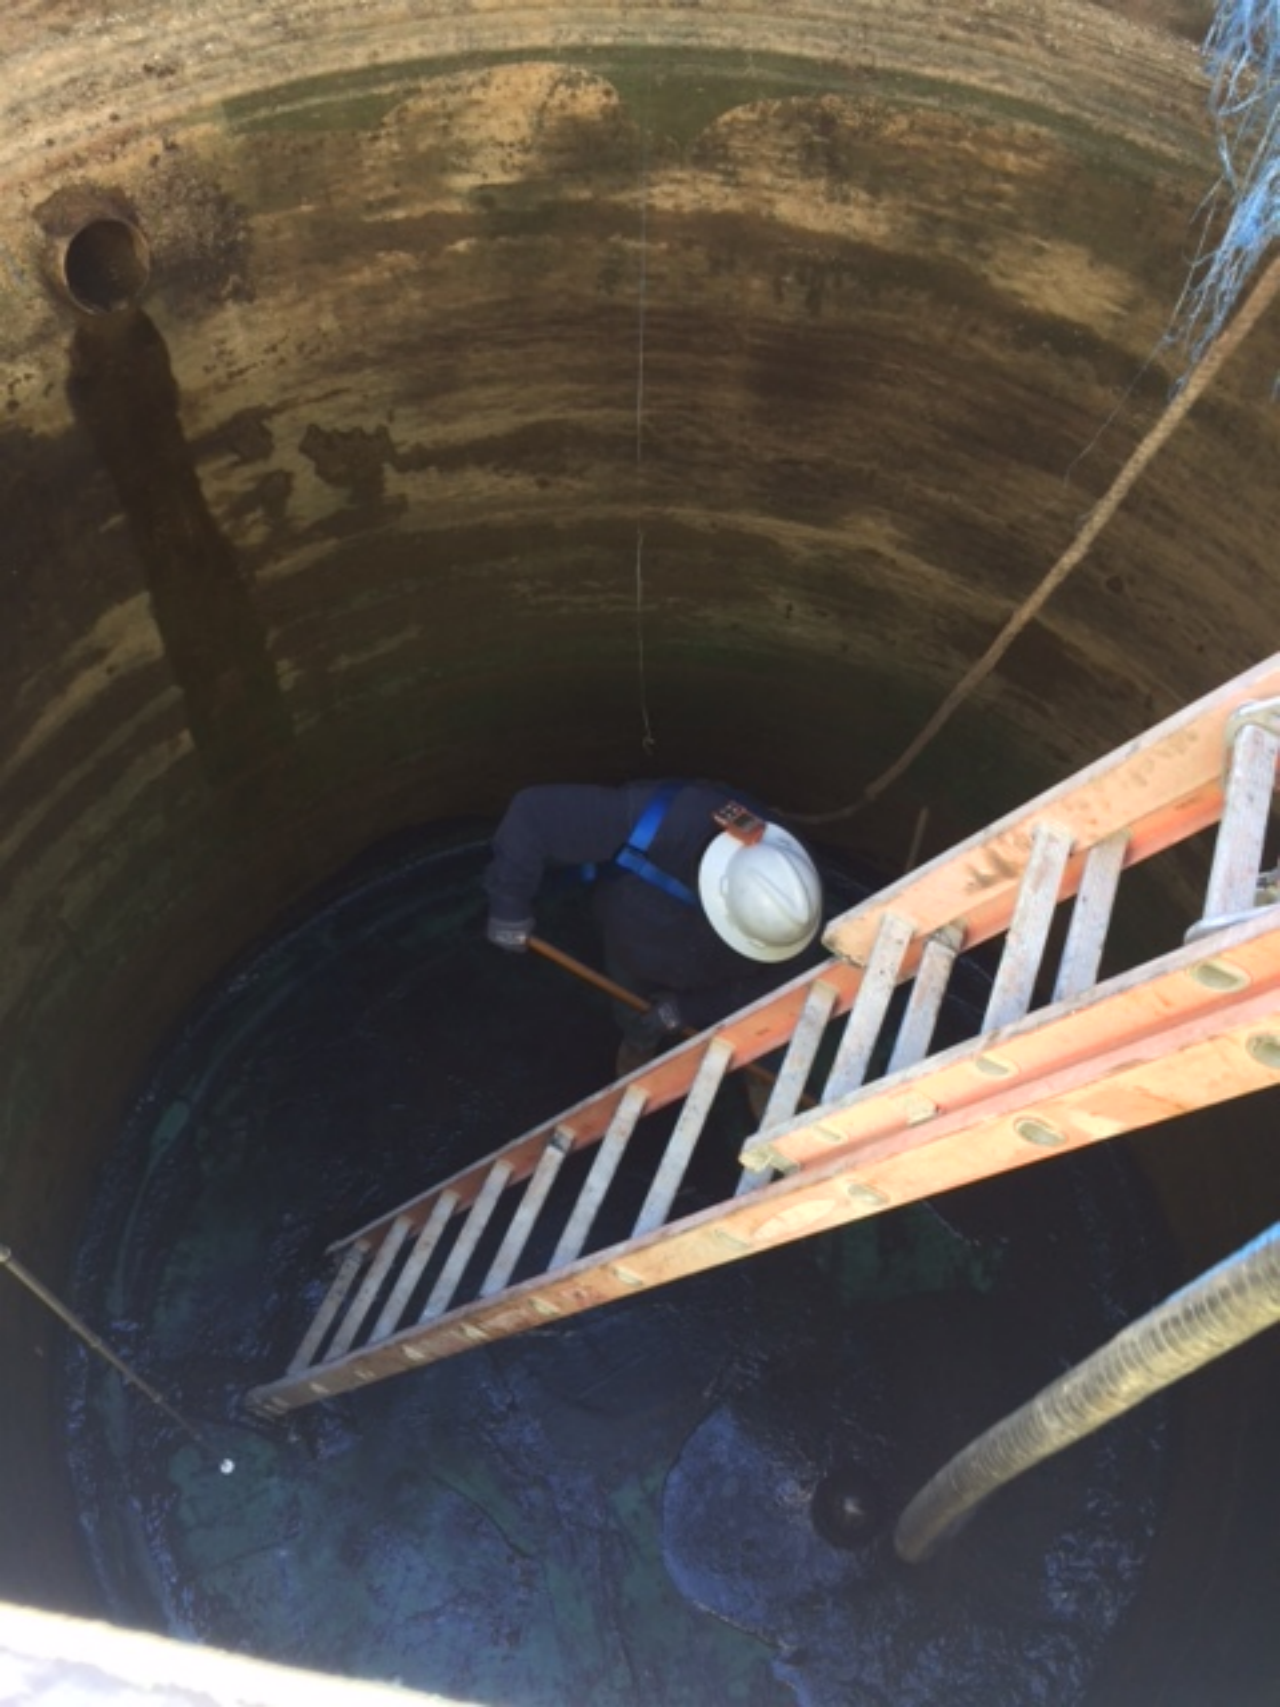
Merryman Const Co.
Backfilled West Sump @
Jal #3 plant. Liner was
added to top of fiberglass
tank. Remaining shown
backfilled with top soils

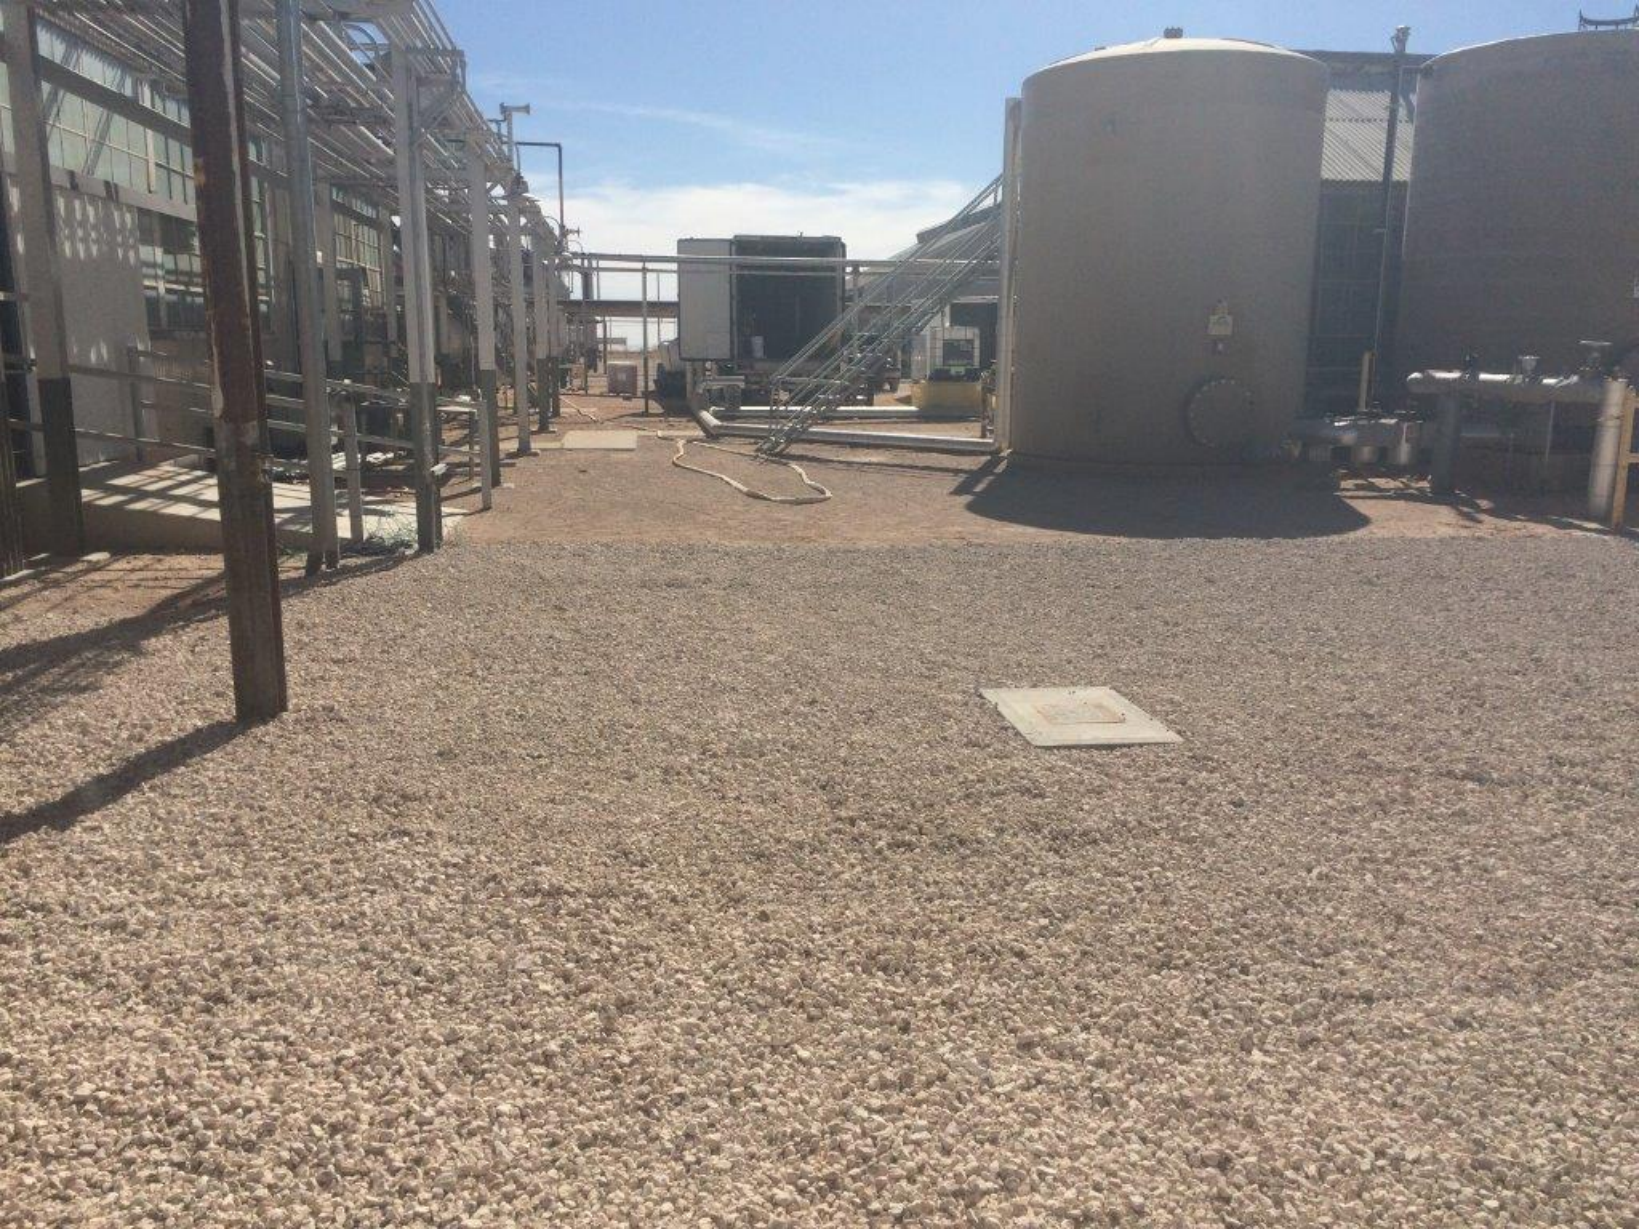
WESTER
BOILER
SUMP
BURIED
BELOW
