**1RP-1568, 1RP-1711 & 1RP-4231
DELINEATION PLAN
J.M. Denton Battery
Produced Water And Crude Oil Spill
Lea County, New Mexico**

LAI Project No.
17-0175-02
17-0175-03
17-0175-23

January 8, 2018

Prepared by:
Larson & Associates, Inc.
507 North Marienfeld Street, Suite 205
Midland, Texas 79701

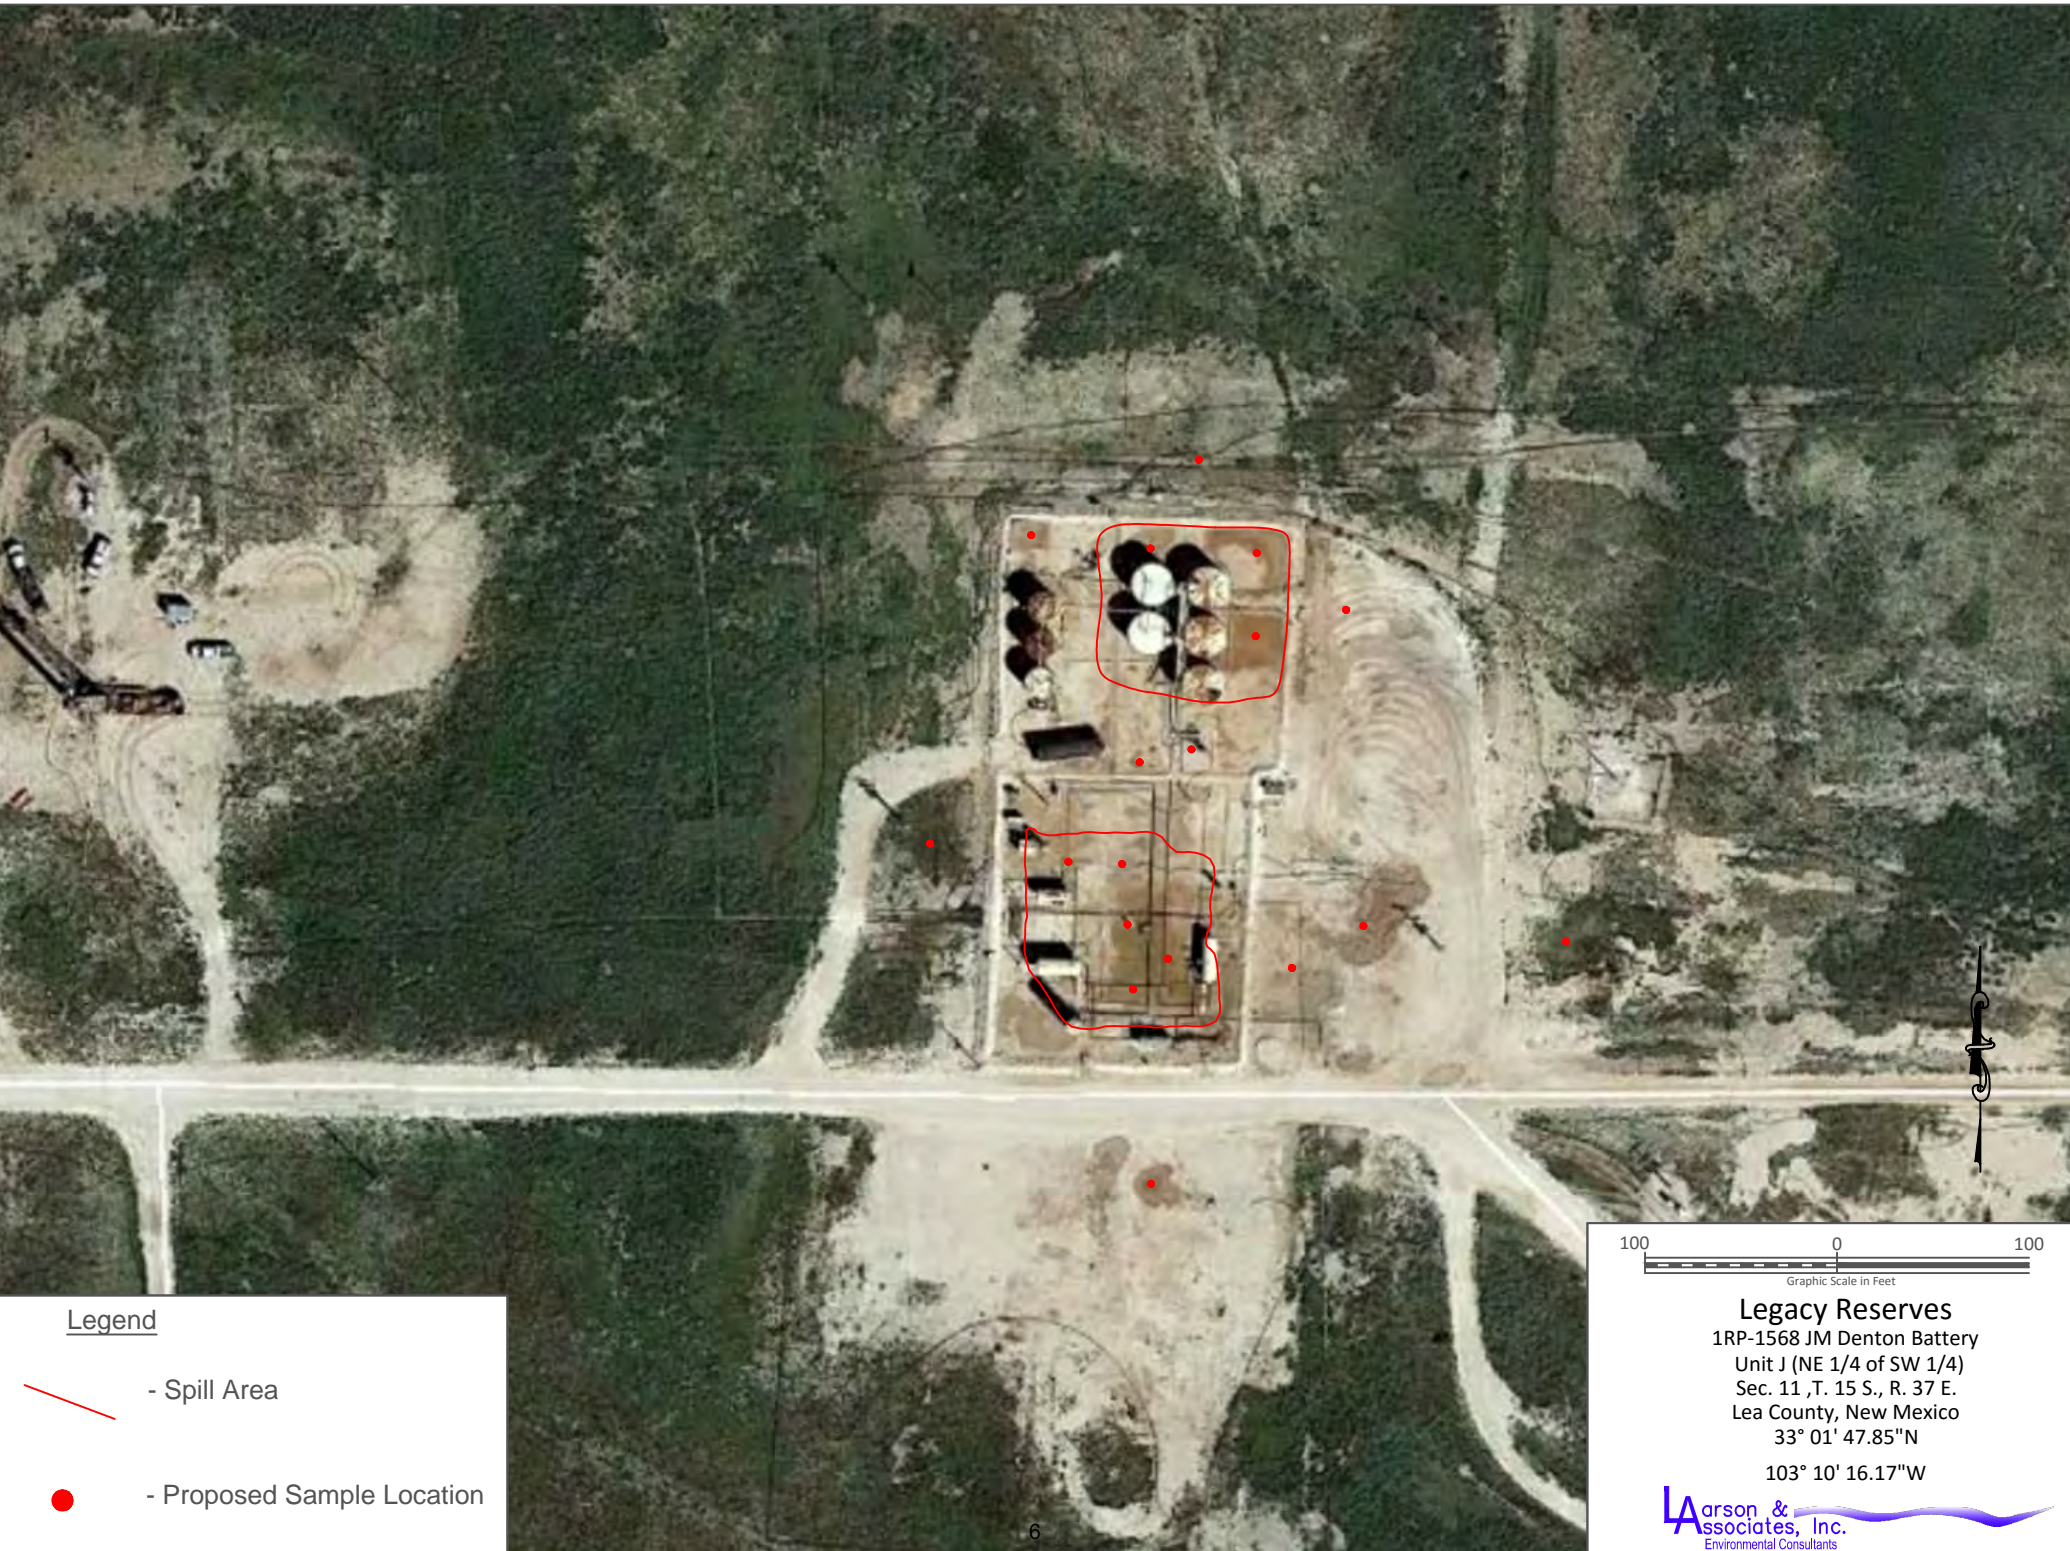
Figure 3 - Aerial Map

- Spill Area

- Proposed Sample Location

Larson & Associates, Inc. (LAI) has prepared this delineation plan on behalf of Legacy Reserves Operating, LP (Legacy) for submittal to the New Mexico Oil Conservation Division (OCD) District I for two produced water spills (1RP-1568 and 1RP-4231) and crude oil spill (1RP-1711) at the J.M. Denton Battery (Site) located in Unit J (NE/4, SW/4), Section 11, Township 15 South, Range 37 East, in Lea County, New Mexico. The geodetic position is North 33.02996 and West -103.17116. Figure 1 presents a topographic map. Figure 2 presents an aerial map.

on subsurface conditions. Additional samples will be collected in each cardinal direction (north, south, east and west) of the spill area at the same depth intervals for horizontal delineation. The soil samples will be delivered under chain of custody and preservation to XENCO Laboratories (XENCO) in Midland, Texas, and analyzed for benzene, toluene, ethylbenzene and xylenes (BTEX), total potential hydrocarbons (TPH), including gasoline range organics (GRO), diesel range organics (DRO) and oil range organics (ORO) and chloride by EPA SW-846 Methods 8021B, 8015M and 300 respectively. Pending laboratory results, further delineation may be required to reach cleanup level standards. Figure 3 presents a site map showing proposed soil sample locations. Appendix C presents photographs.

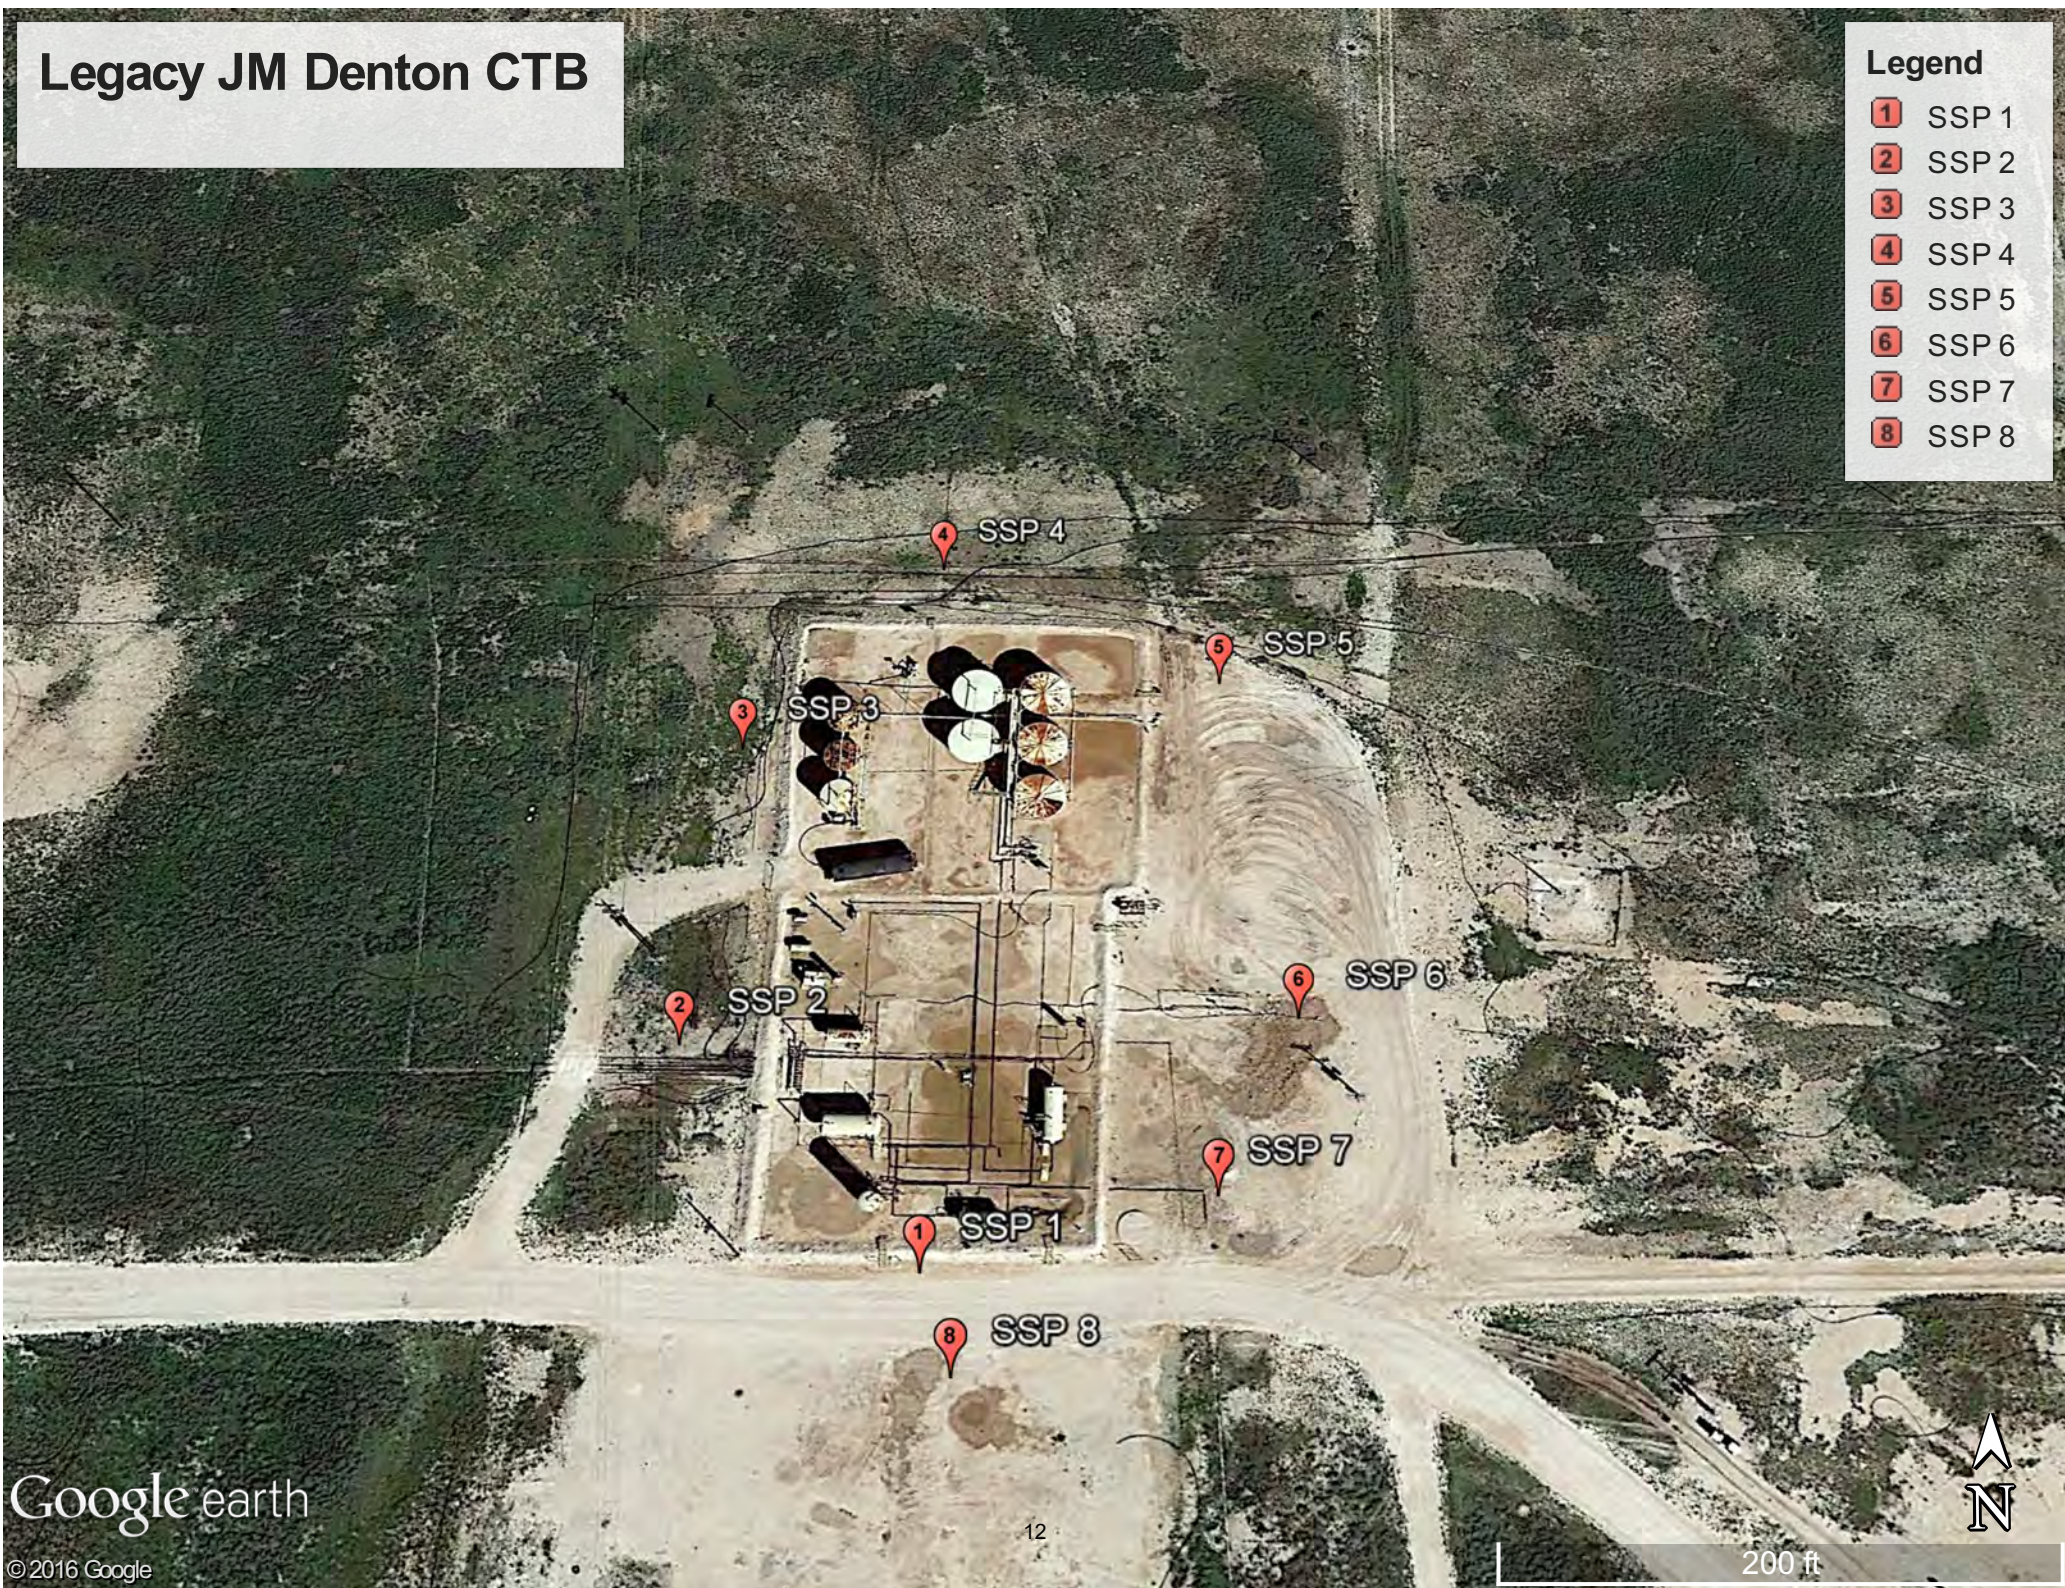
Legacy JM Denton CTB

- 1 SSP 1
- 2 SSP 2
- 3 SSP 3
- 4 SSP 4
- 5 SSP 5
- 6 SSP 6
- 7 SSP 7
- 8 SSP 8

On August 23, 2016, Environmental Plus, Inc. (EPI) collected soil samples from eight (8) locations (SSP1 through SSP8) outside of the firewall. The samples were collected at the surface (0' bgs) and to a depth of 6 inches bgs. The samples were analyzed for chloride by titration method. The following samples reported chloride levels above 600 mg/Kg:

- SSP1, 0' (4,000 mg/Kg)
- SSP1A, 6" (1,600 mg/Kg)
- SSP2A, 6" (2,400 mg/Kg)
- SSP3A, 6" (720 mg/Kg)
- SSP5, 0' (1,360 mg/Kg)
- SSP6, 0' (2,000 mg/Kg)
- SSP7 0' (4,000 mg/Kg)
- SSP7A 6" (2,000 mg/Kg)
