Report Type: Closure Report 1RP-4294

Site:	Red Hills North Unit #102					
Company:	EOG Resources, Inc.					
Section, Township and Range	Unit P	Sec. 1	T 25S	R 33E		
Lease Number:	API No. 30-025-32748					
County:	Lea					
Release GPS:	32.15297° N			103.51925° W		
Surface Owner:	Federal					
Mineral Owner:						
Directions:	From intersection of HWY 128 & Delaware Basin Rd in Rural Lea county, travel west on 128 for 1.4 mi, turn south onto Vaca Lane for 2.2 mi, turn east onto lease road for 0.7 mi, turn south onto lease road for 1.95 mi, turn west onto lease road for 0.8 mi to location.

RE: Closure Report - EOG Resources, Inc, Red Hills North Unit #102, Unit P, Section 1, Township 25S, Range 33E, Lea County, New Mexico, 1RP-4294

On behalf of EOG Resources, Inc (EOG), Tetra Tech submits the following Closure Report for the Red Hills North Unit #102 (site) located in Section 1, Township 25 South, Range 33 East, Lea County, New Mexico. The spill site coordinates are N 32.15297°, W 103.51925°. The site location is shown on Figures 1 and 2.

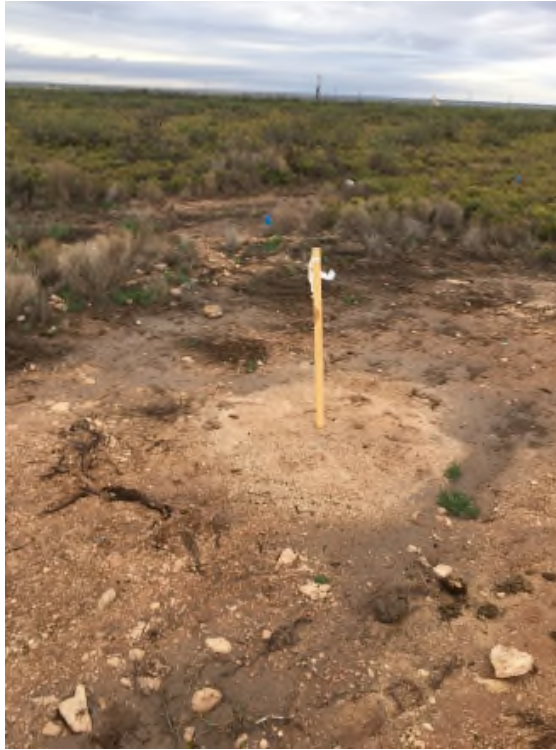
View West – Area of BH-1

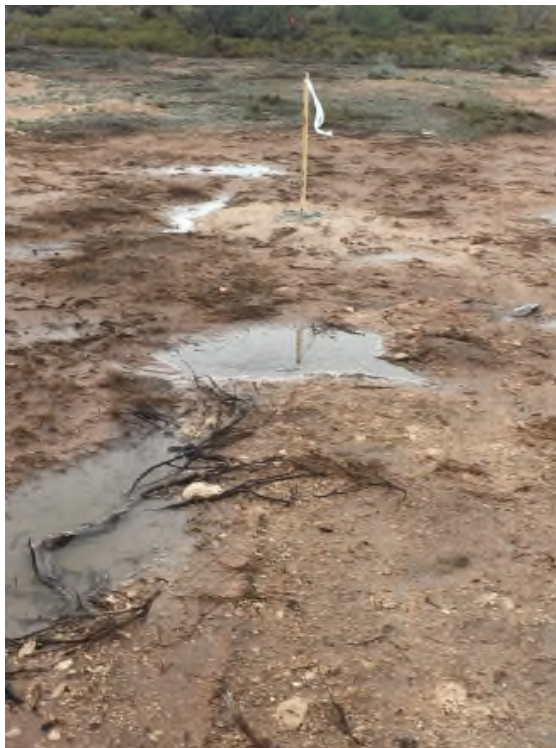
View West – Area of BH-2

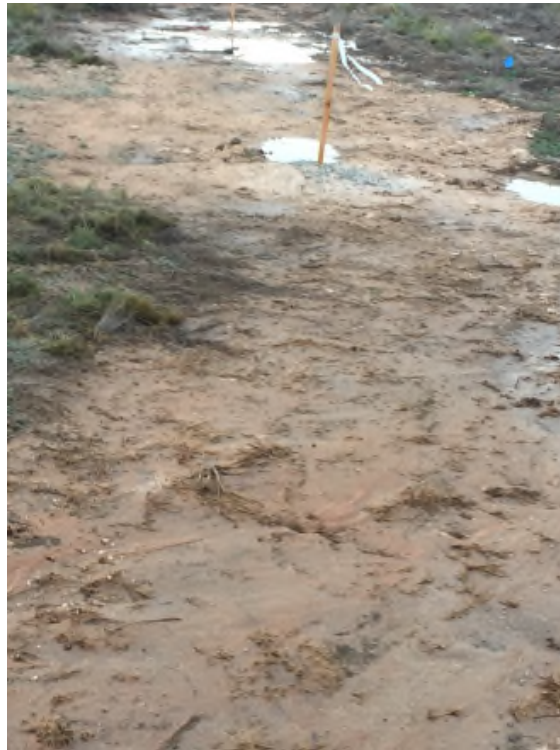
View South – Area of BH-3

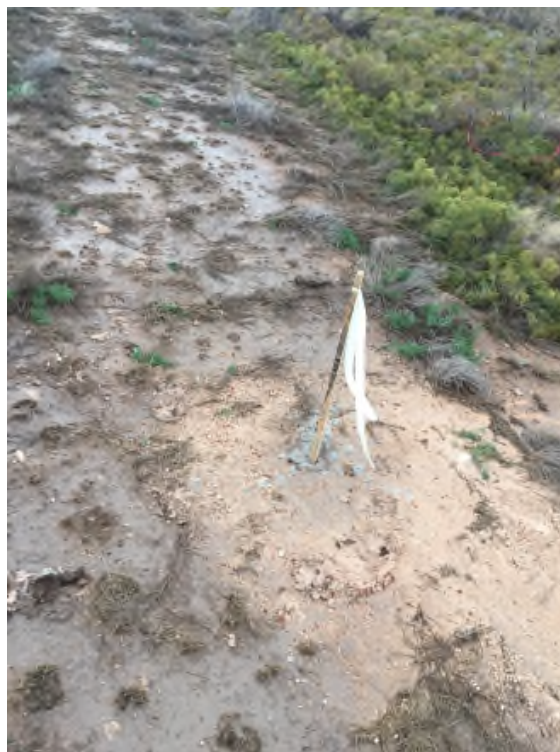
View West – Area of BH-4

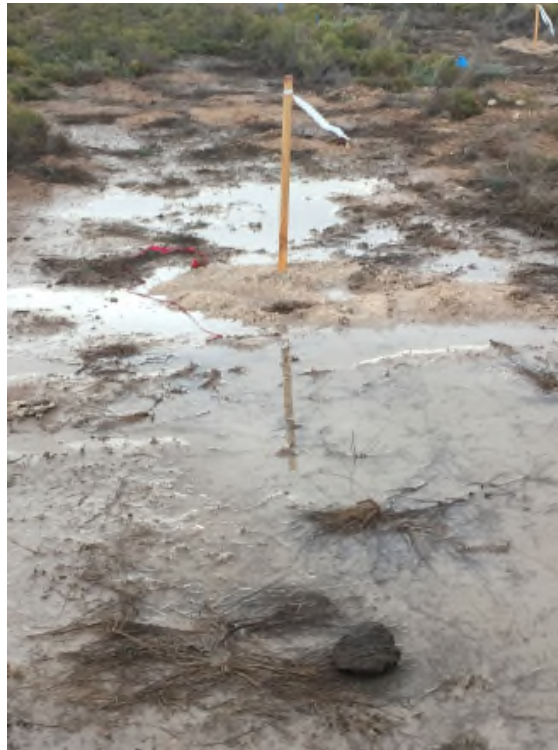
View West – Area of BH-5

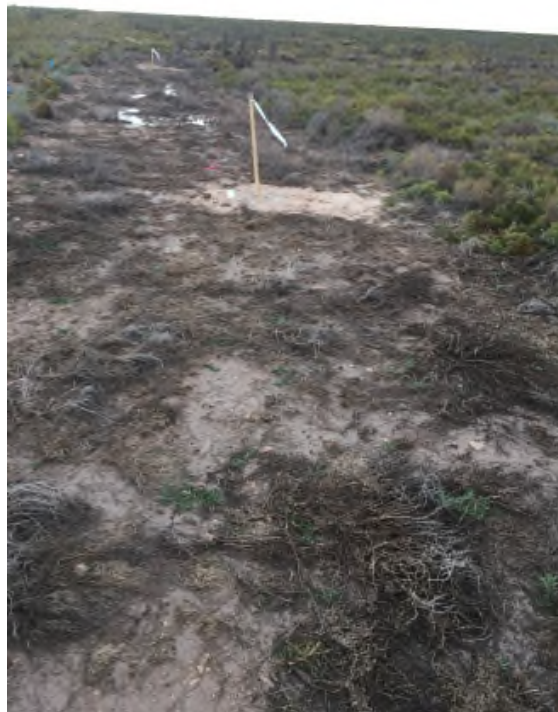
View East – Areas of BH-6 and BH-7

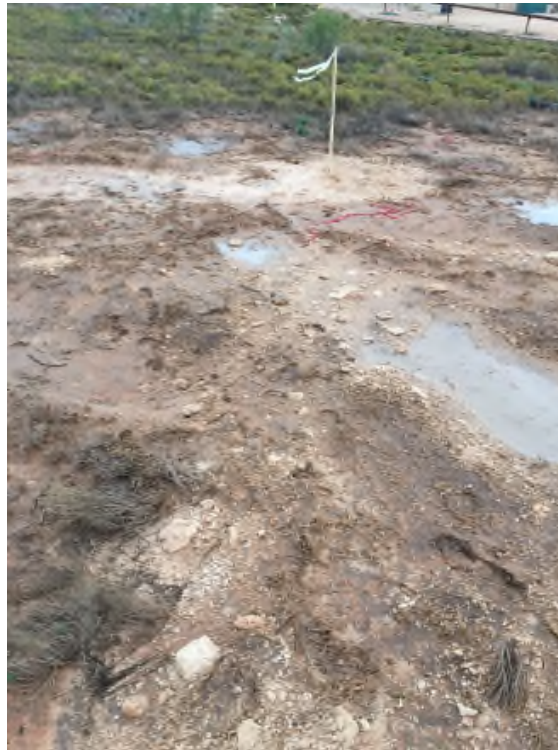
View North – Area of BH-8

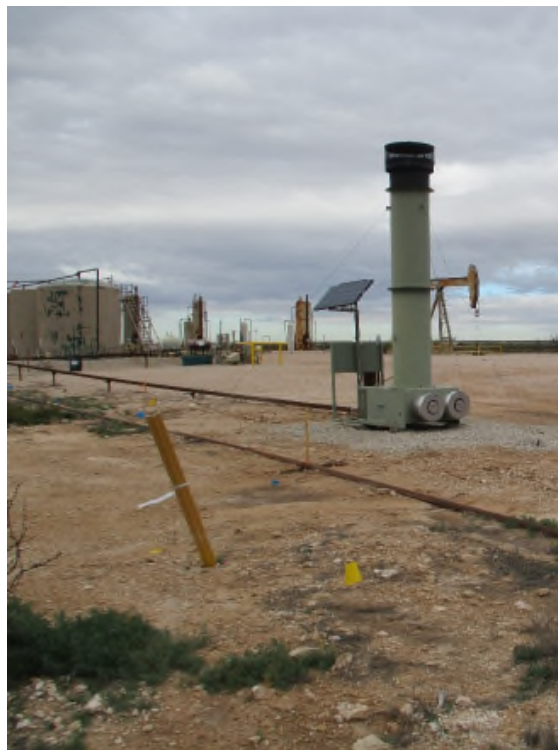
View Northwest – Area of BH-9

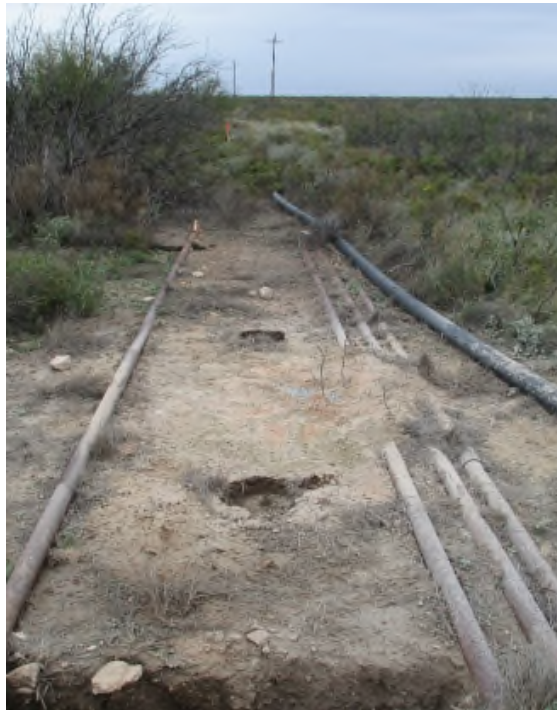
View East – Area of BH-10

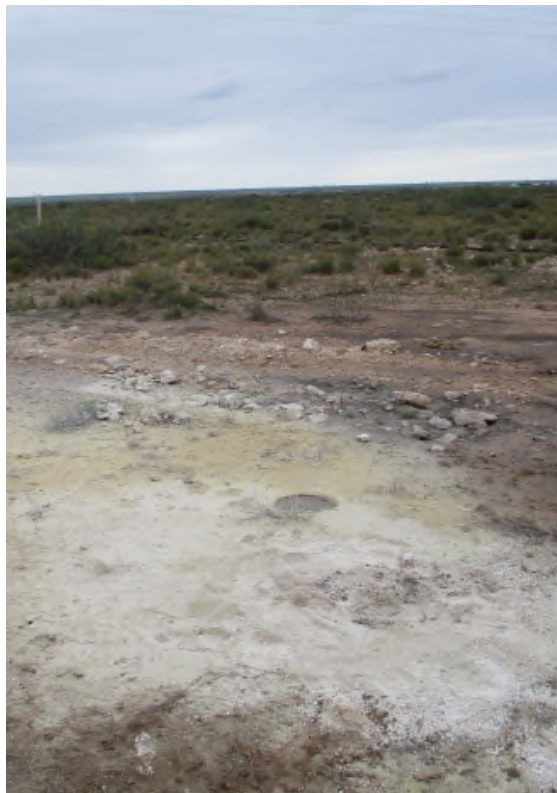
View South – Area of BH-11

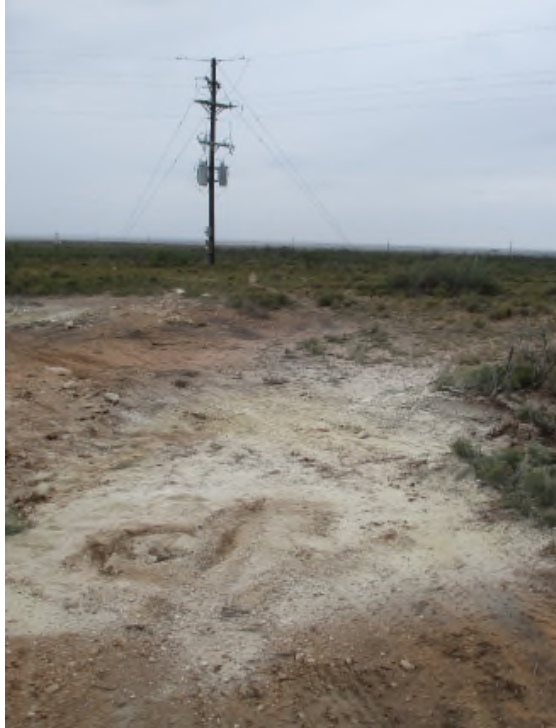
View South – Area of BH-12

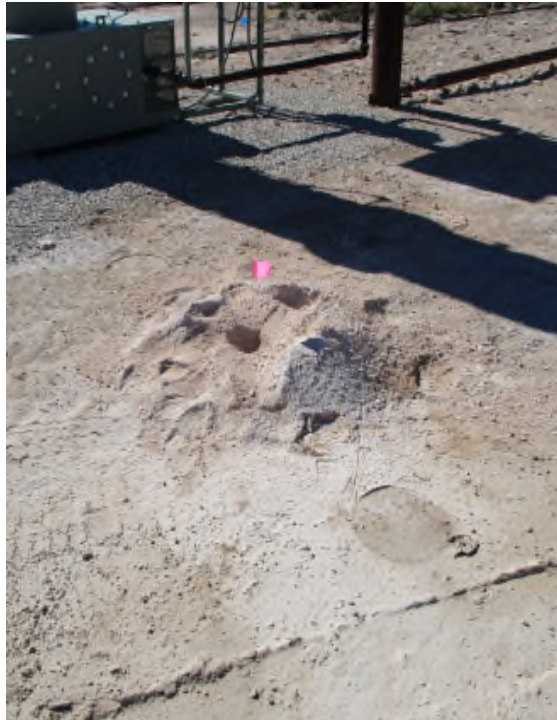
View South – Area of BH-1

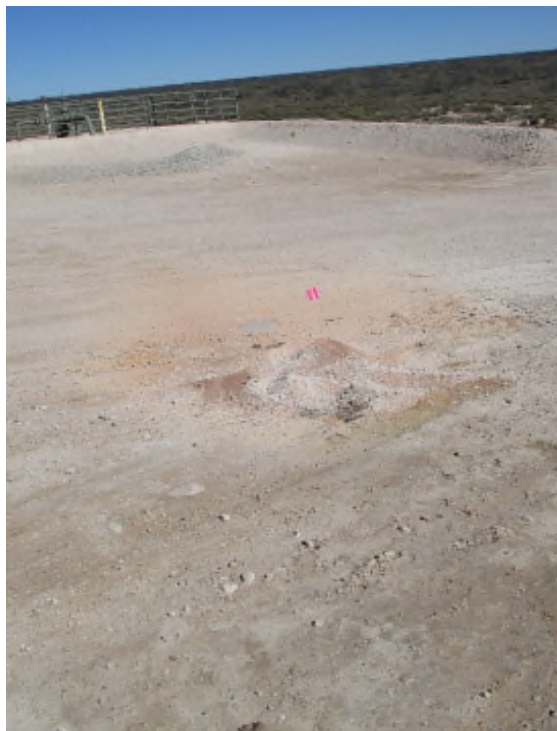
View North – Area of BH-2

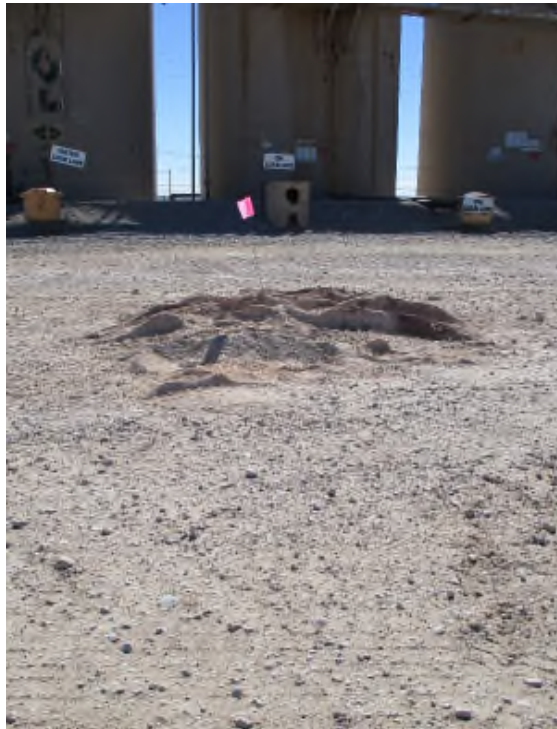
View South – Area of BH-3

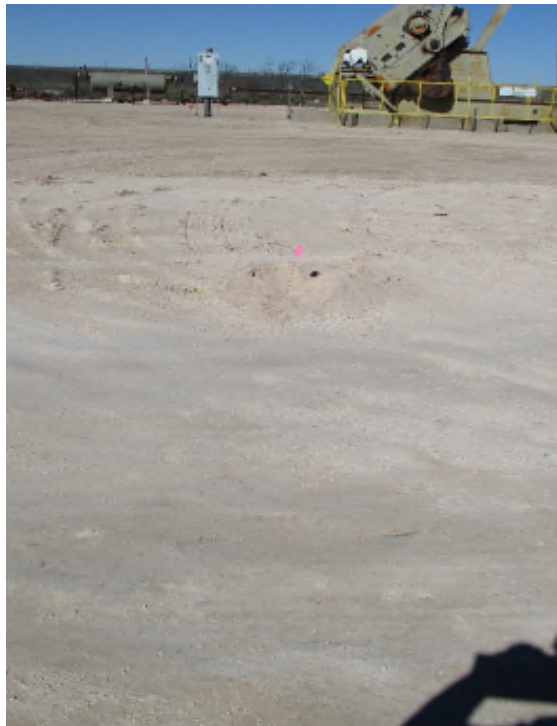
View North – Area of BH-4

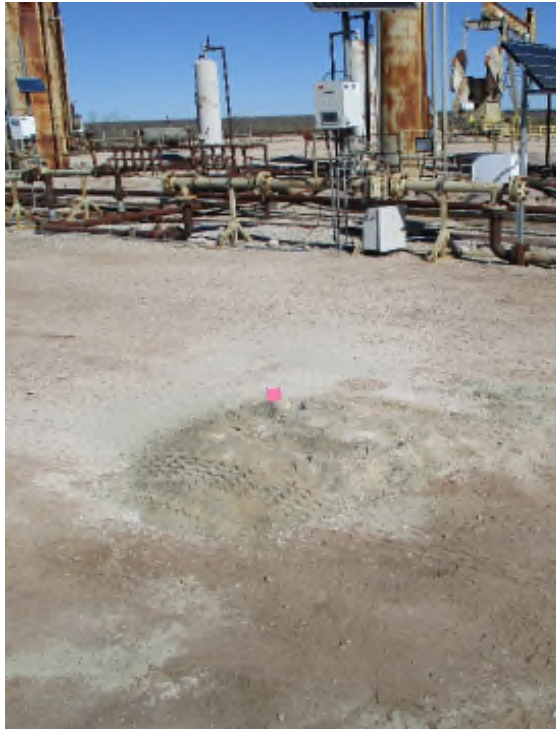
View East – Area of BH-5

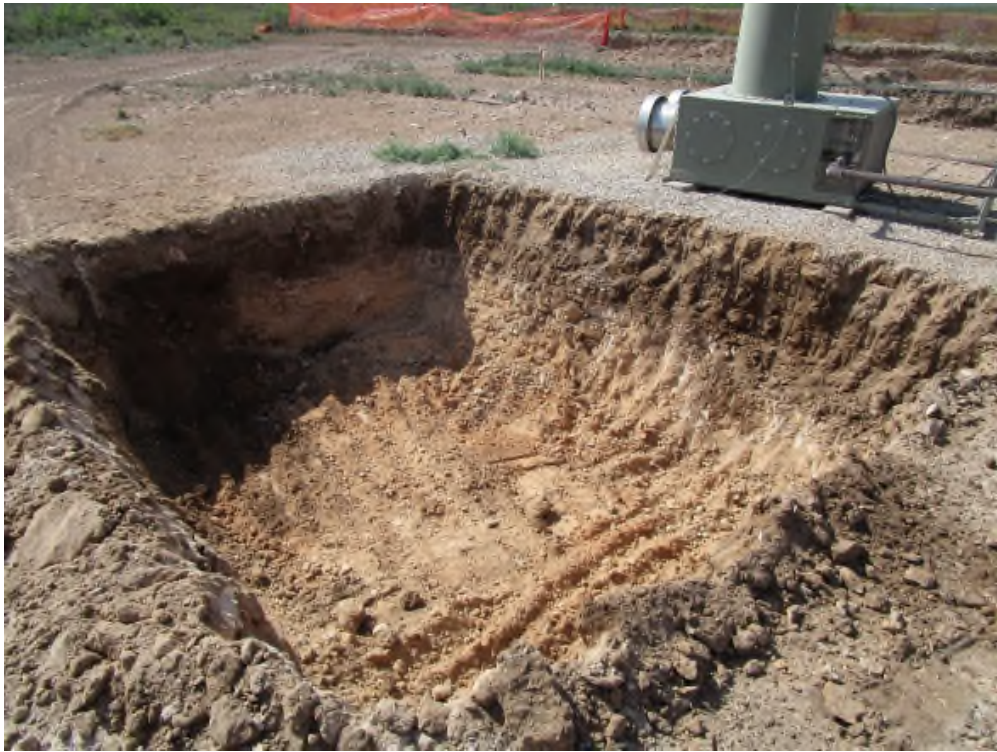
View West – Area of BH-1 Vent

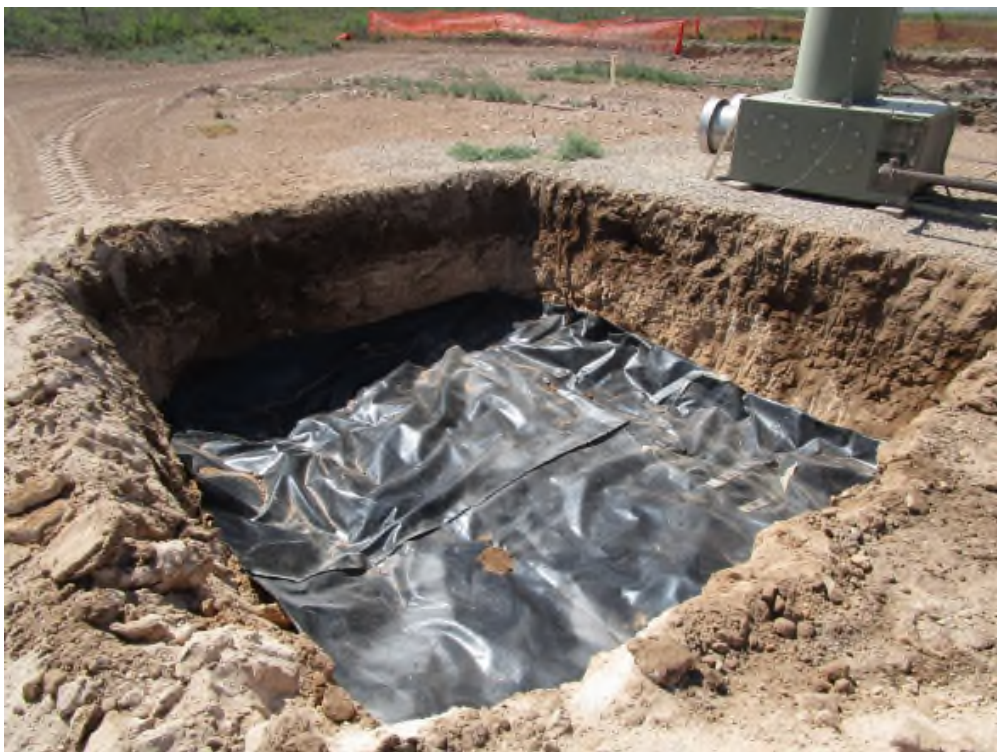
View West – Excavated and Lined Area of BH-1

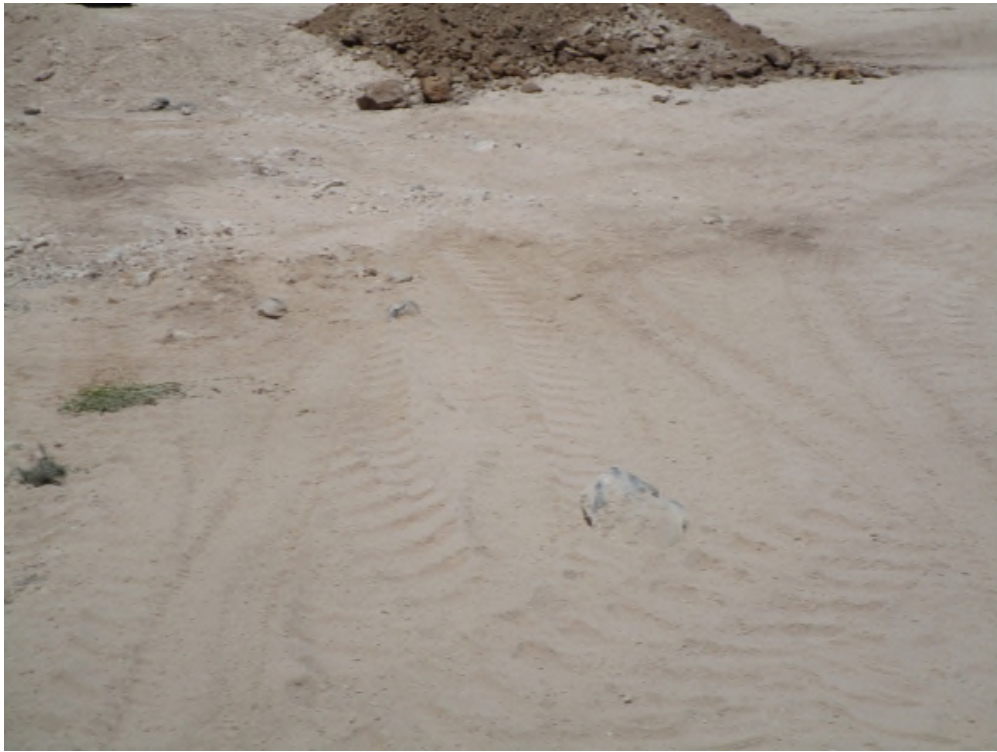
View East – Backfilled Area of BH-1

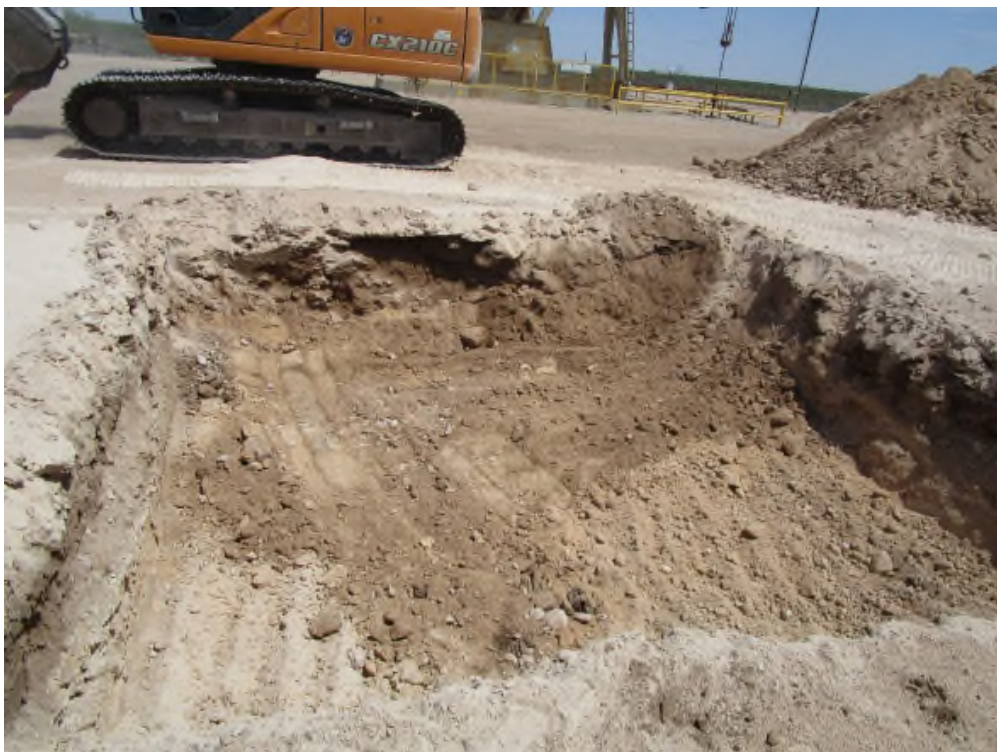
View North – Excavated Area of BH-4

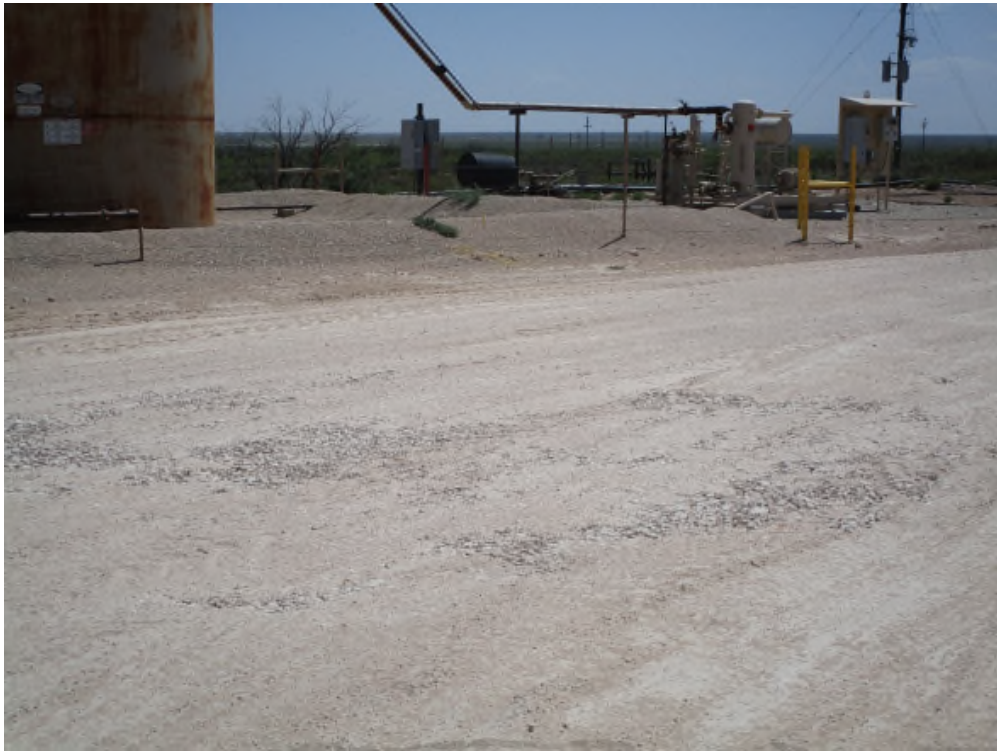
View East - Backfilled Area of Bh-4

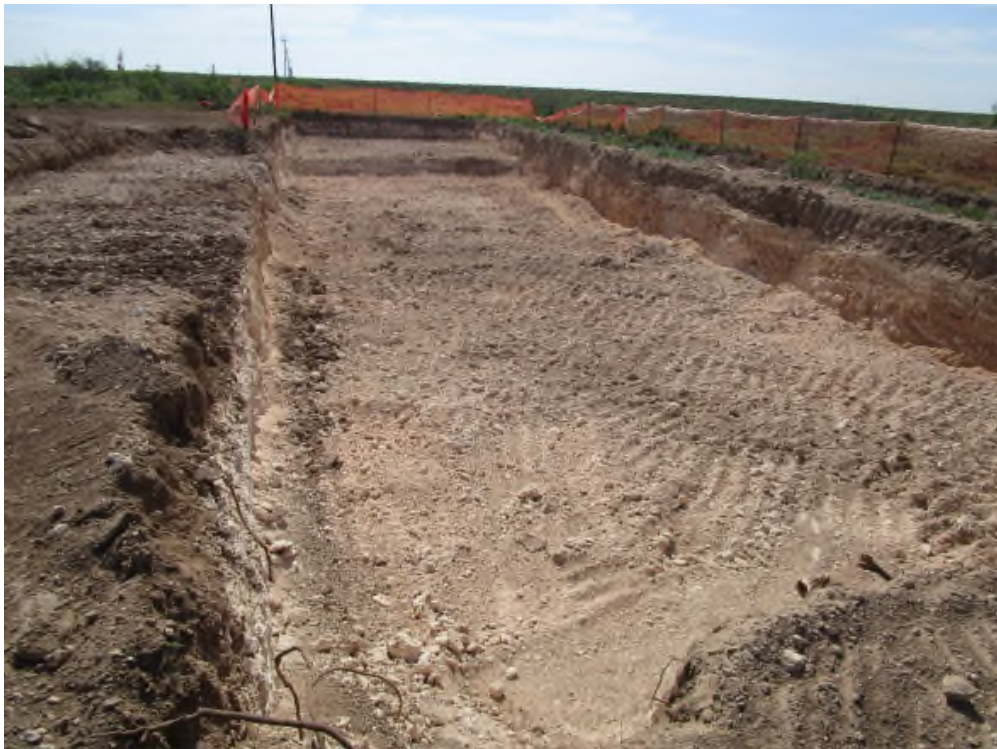
View West – Excavated Areas of Bh-1 And BH-2

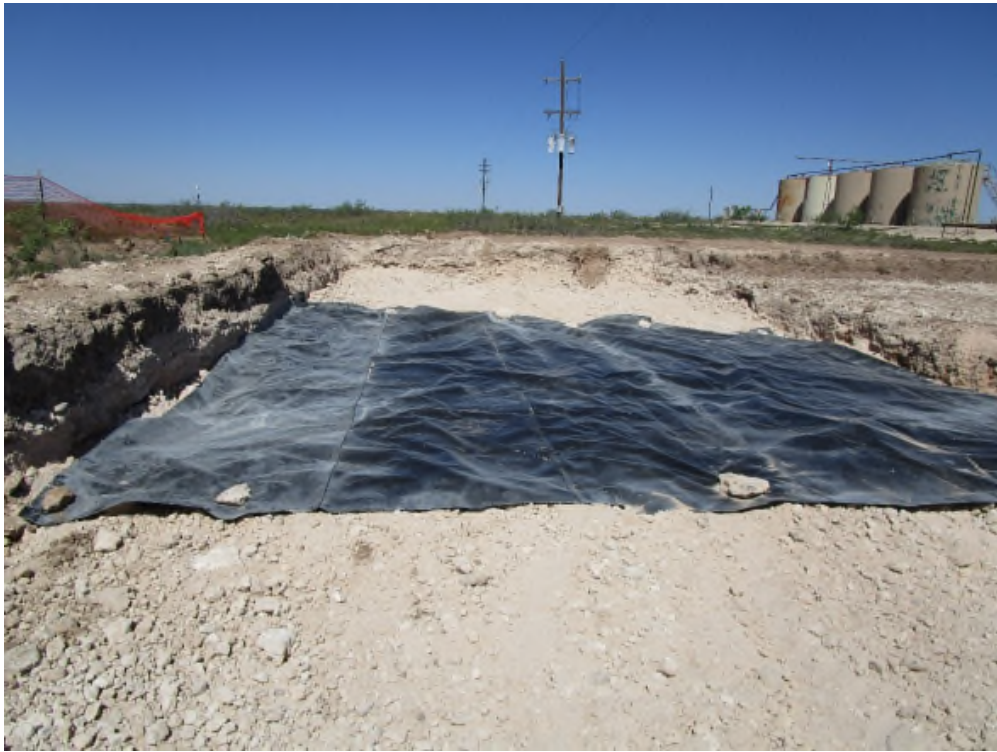
View west – Lined Area of BH-2

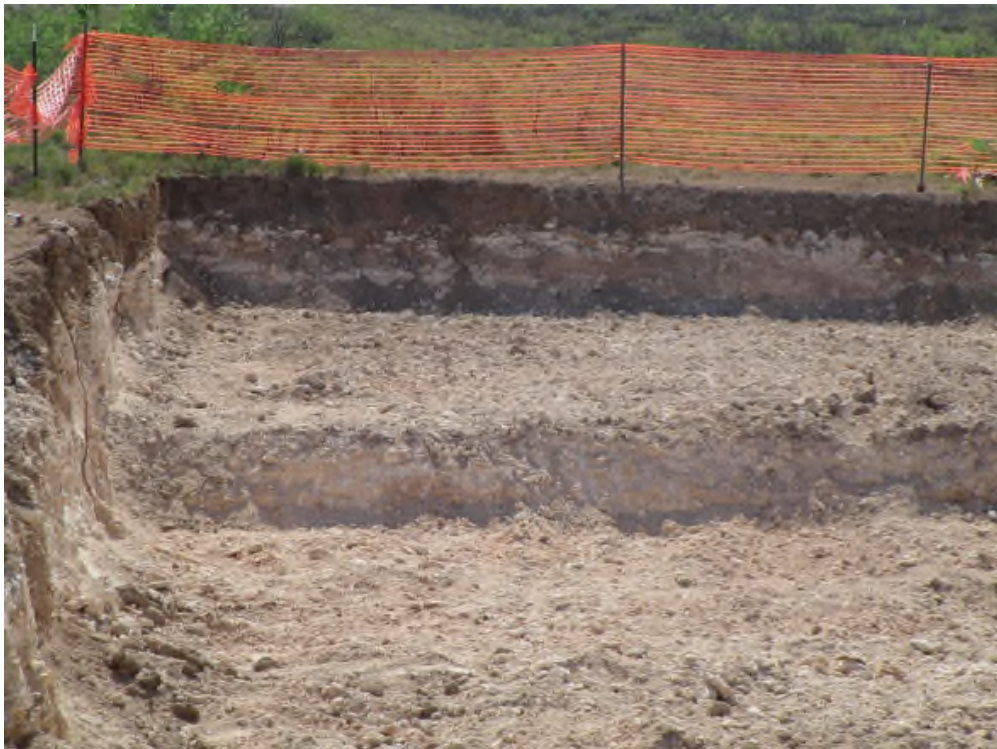
View East –Excavated Areas of BH-3 and BH-4

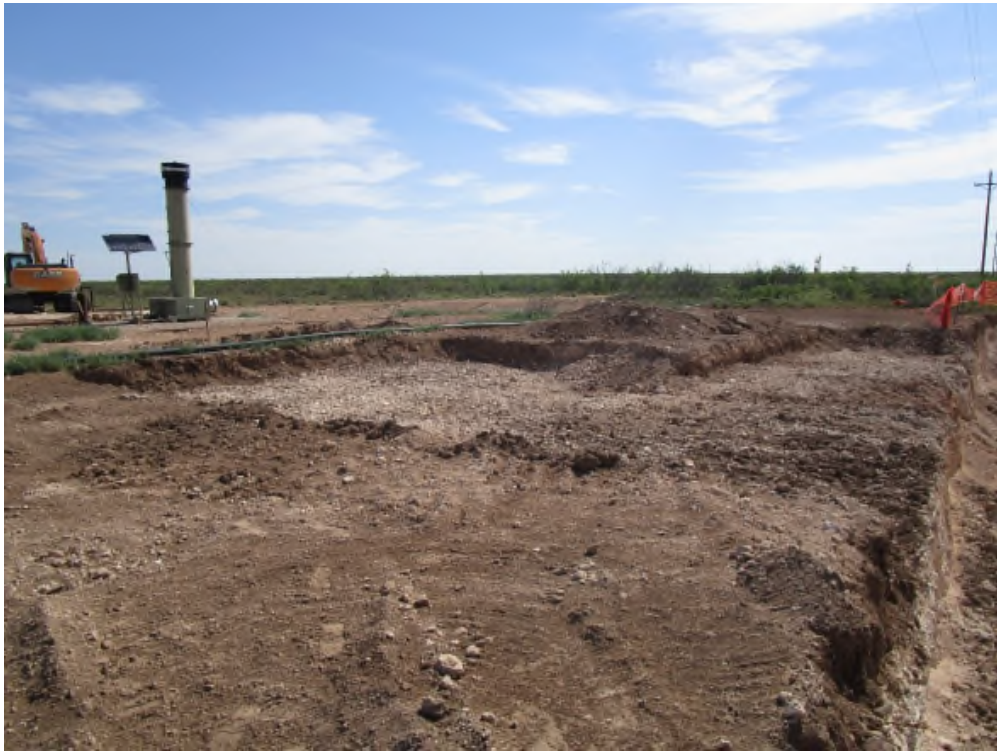
View East – Excavated Areas of BH-8

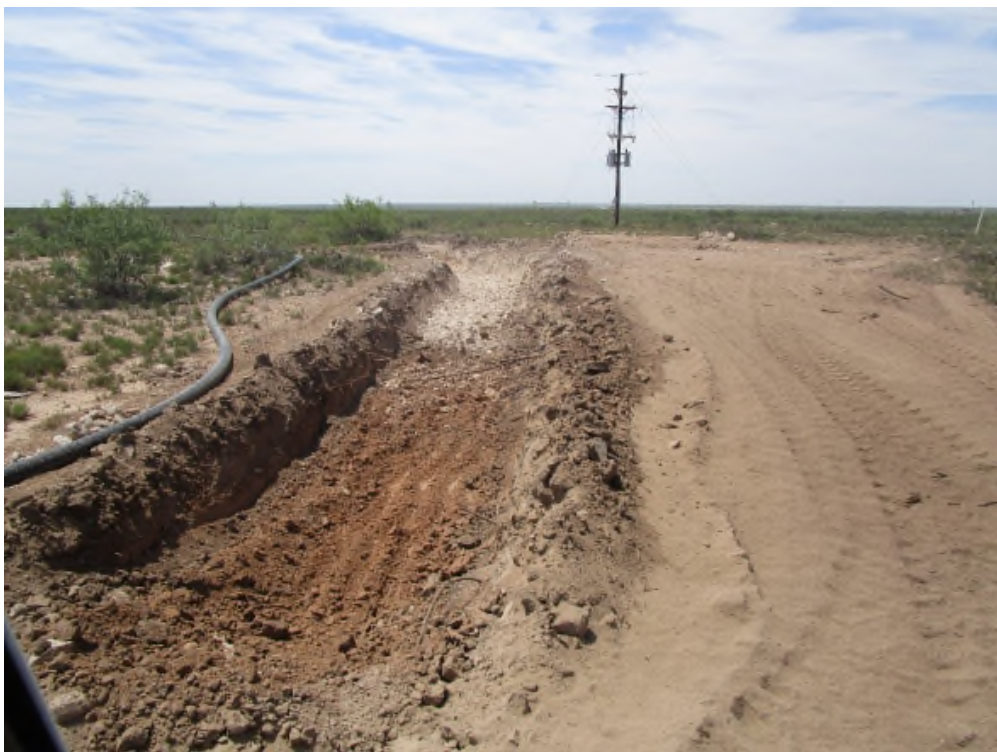
View South – Excavated Area of BH-12

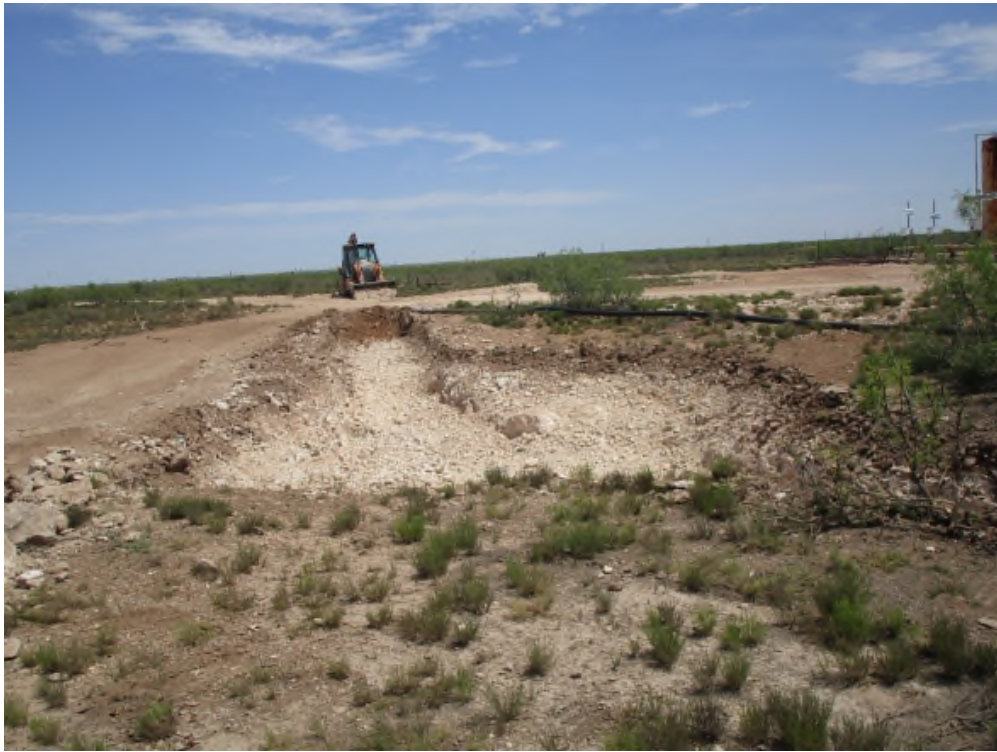
View North – Excavated Areas of BH-11

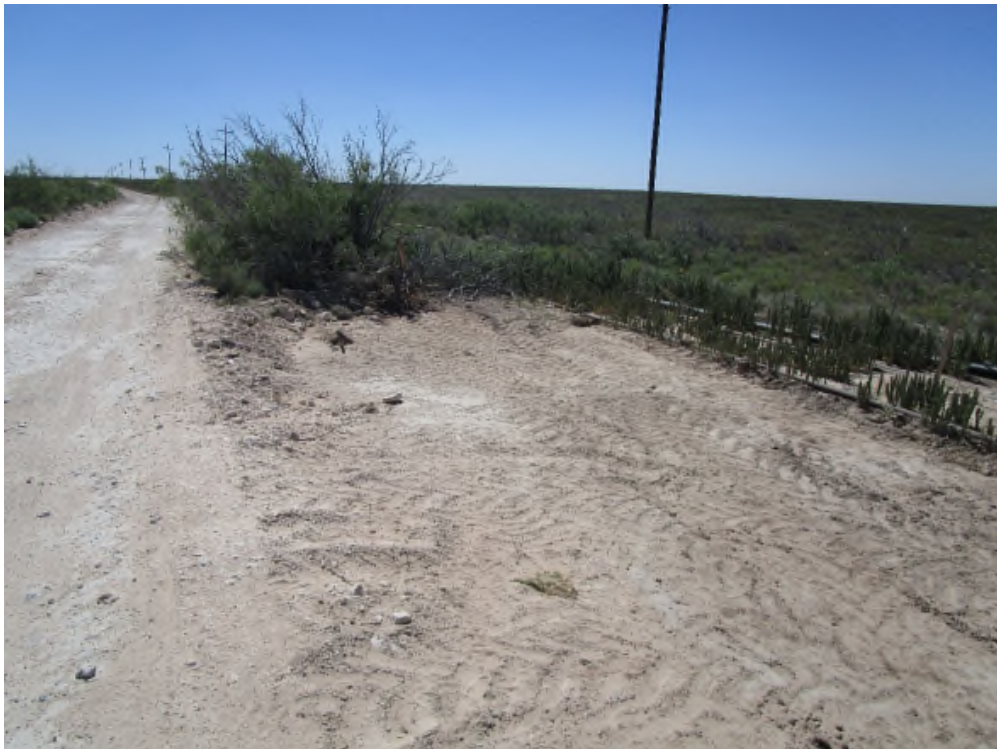
View East – Excavated Areas of BH-10

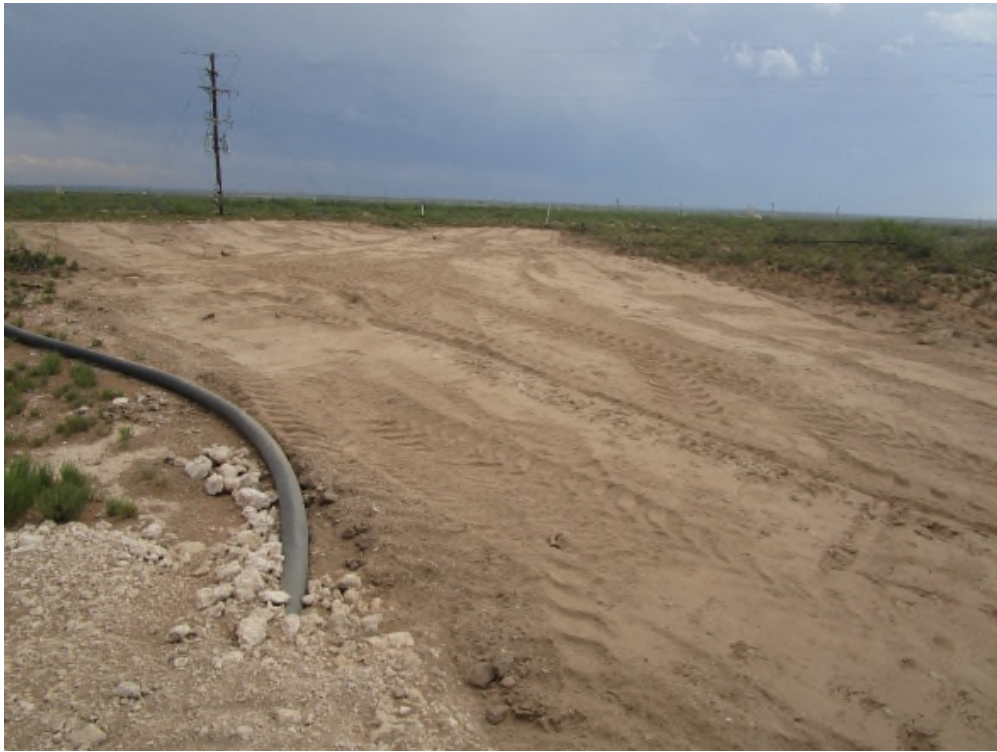
View South – Backfilled Areas of BH-11 and BH-12

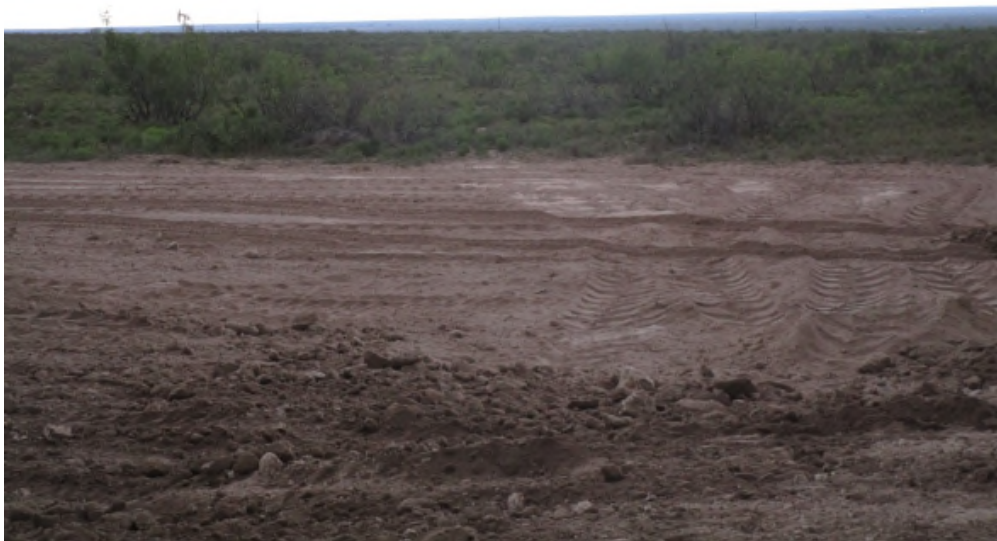
View South – Backfilled Areas of BH-1, BH-2 and BH-5

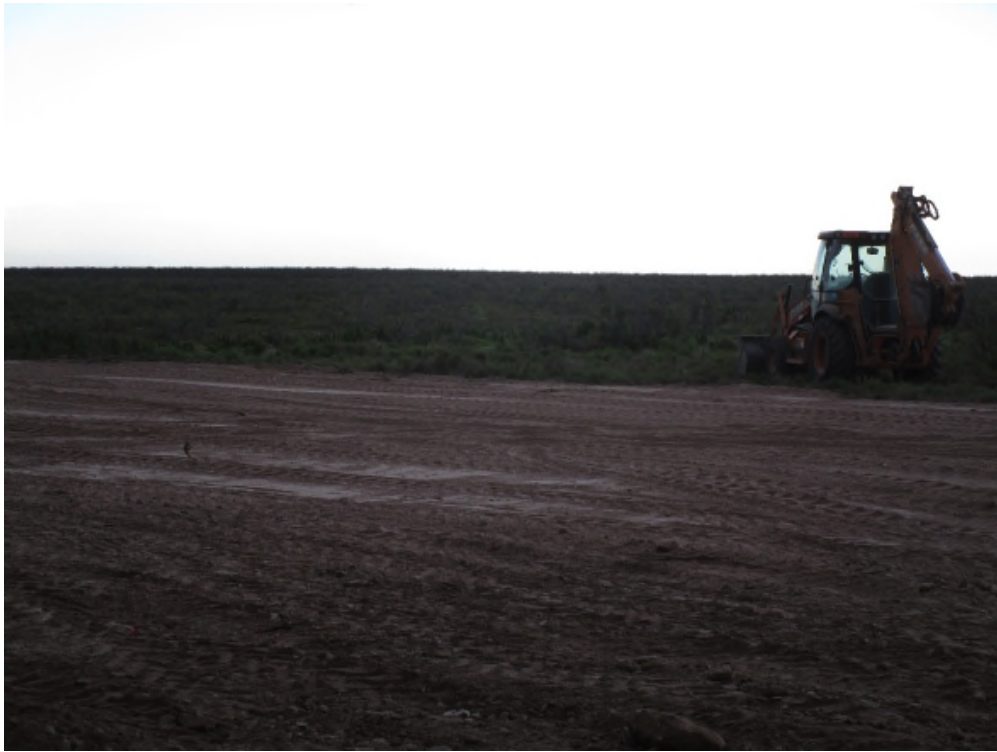
View South – Backfilled Areas of BH-3 and BH-6

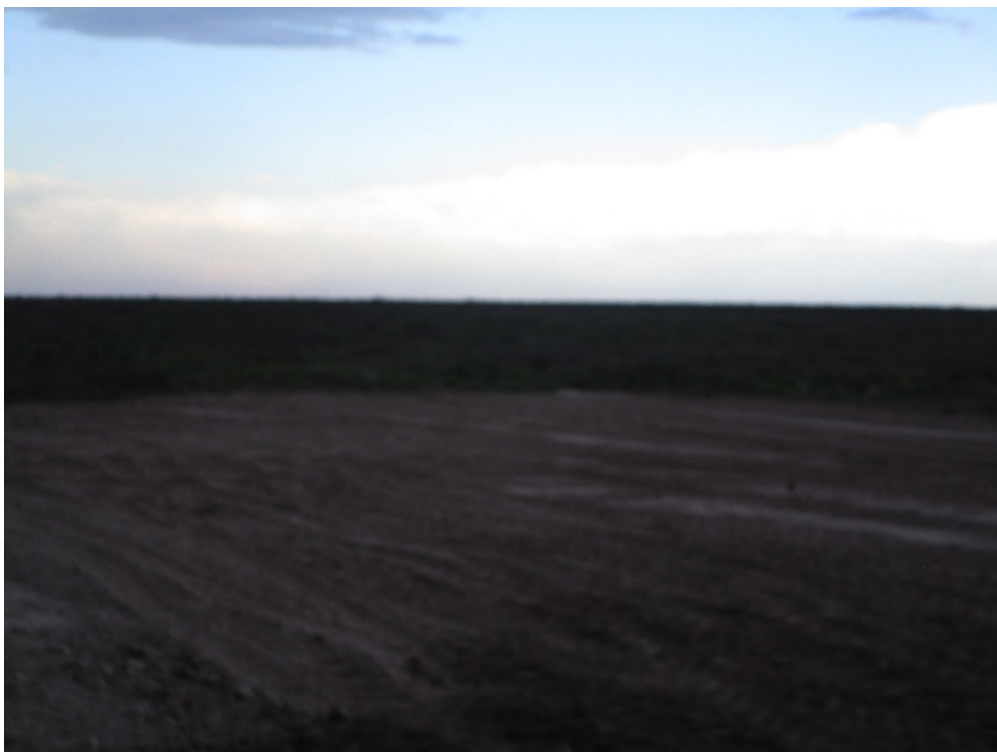
View East – Backfilled Areas of BH-4

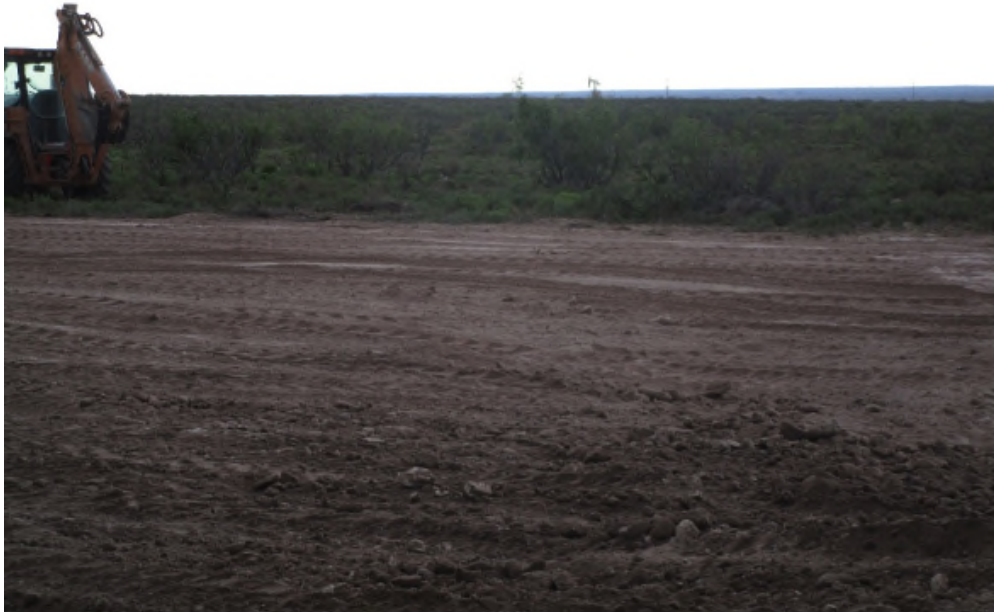
View South – Backfilled Areas of BH-1 and BH-8

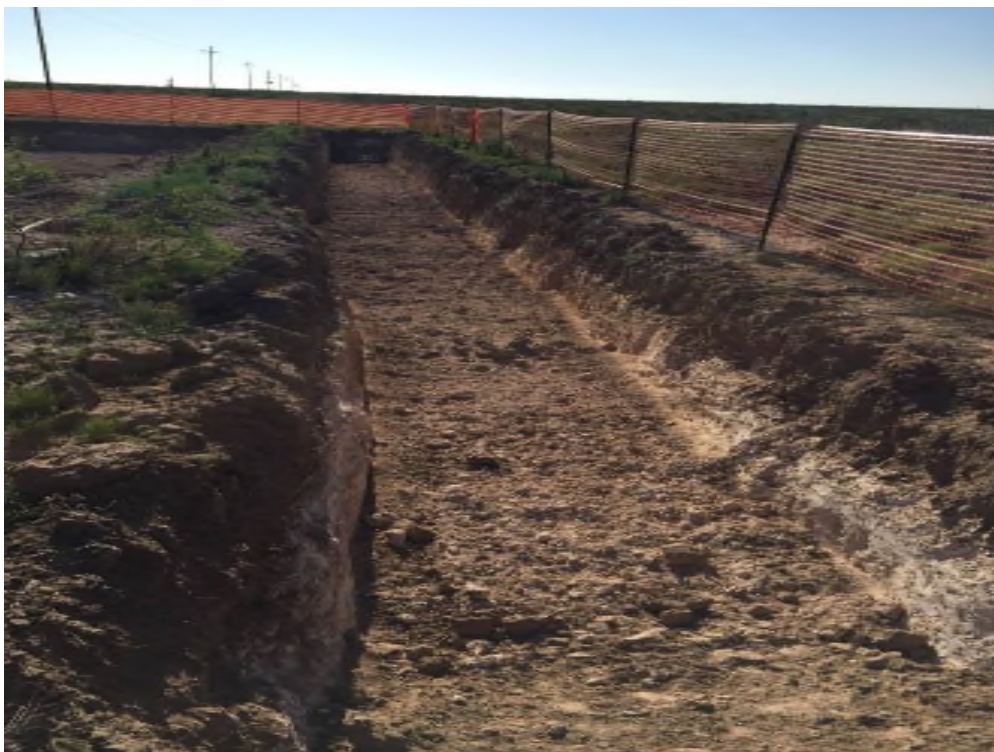
East View – Excavated Areas of BH-5 and BH-6
