**1RP-4575, 1RP-4641, 1RP-4764
DELINEATION PLAN
Rainer State #1
Produced Water and Crude Oil Spills
Lea County, New Mexico**

LAI Project No. 17-0175-41

February 22, 2018

Prepared for:
Legacy Reserves Operating, LP
303 West Wall Street, Suite 1300
Midland, Texas 79701

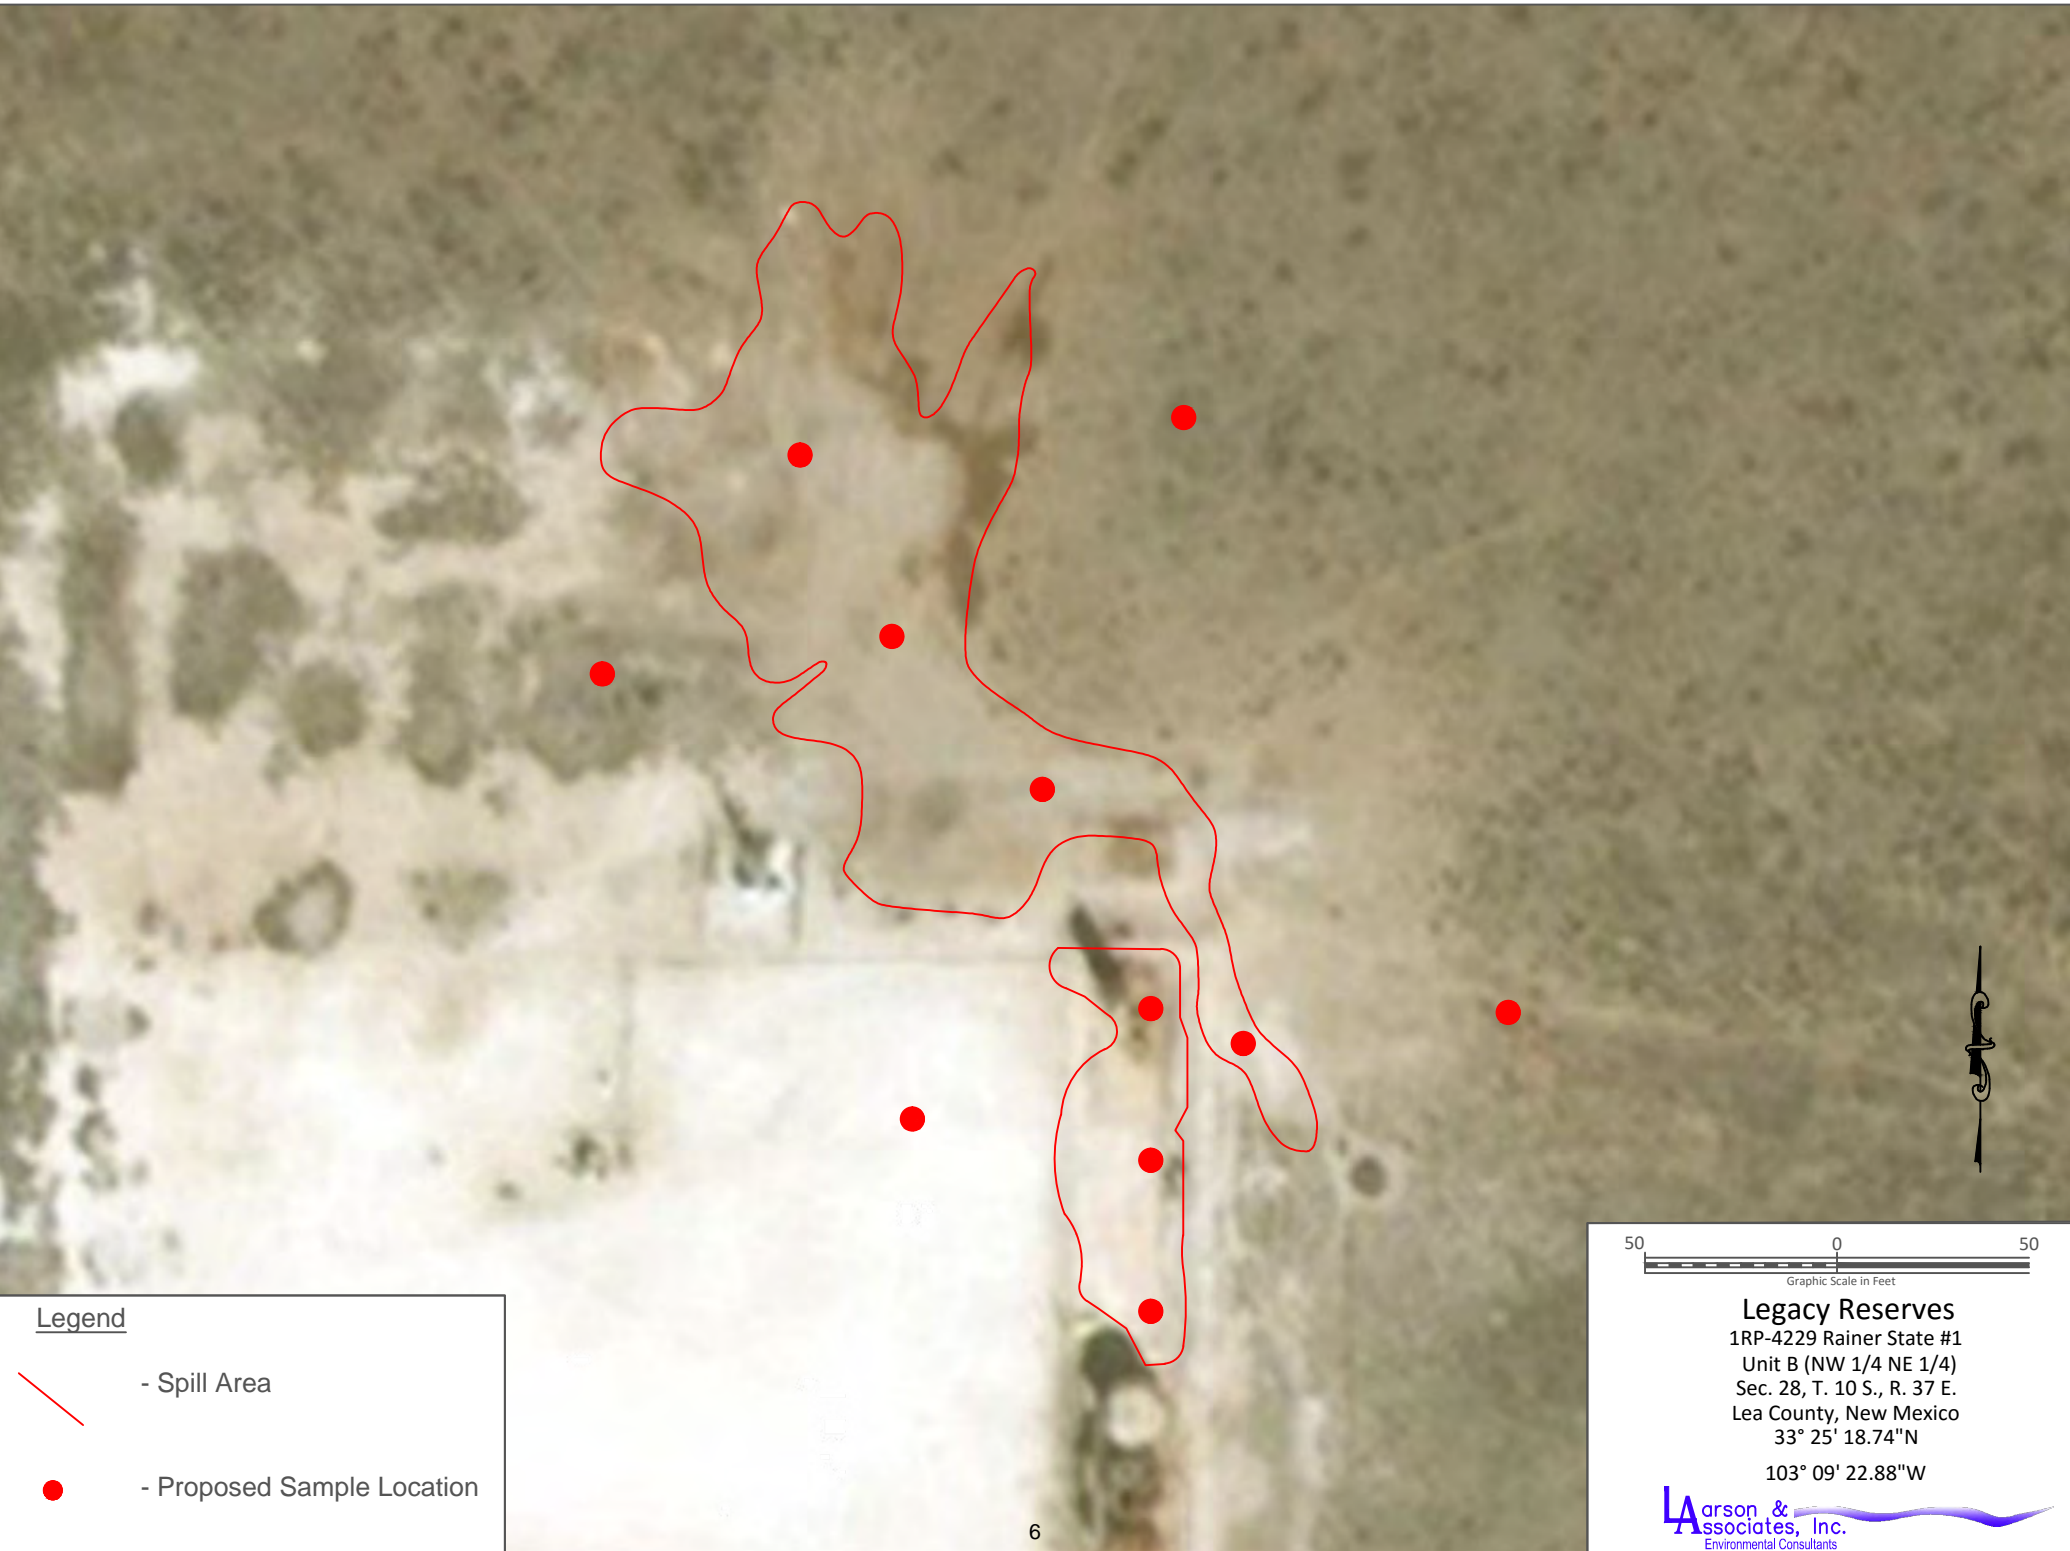
Figure 1 - Topographic Map

Larson & Associates, Inc. (LAI) has prepared this delineation plan on behalf of Legacy Reserves Operating, LP (Legacy) for submittal to the New Mexico Oil Conservation (OCD) District I for three (3) spills, including two (2) produced water spills and a crude oil spill, at the Rainer State #1 (Site) located in Unit B (NW/4, NE/4), Section 28, Township 10 South, Range 37 East in Lea County, New Mexico. The geodetic position is North 33° 25' 18.74" and West -103° 09' 22.88". Figure 1 presents a topographic map. Figure 2 presents an aerial map.

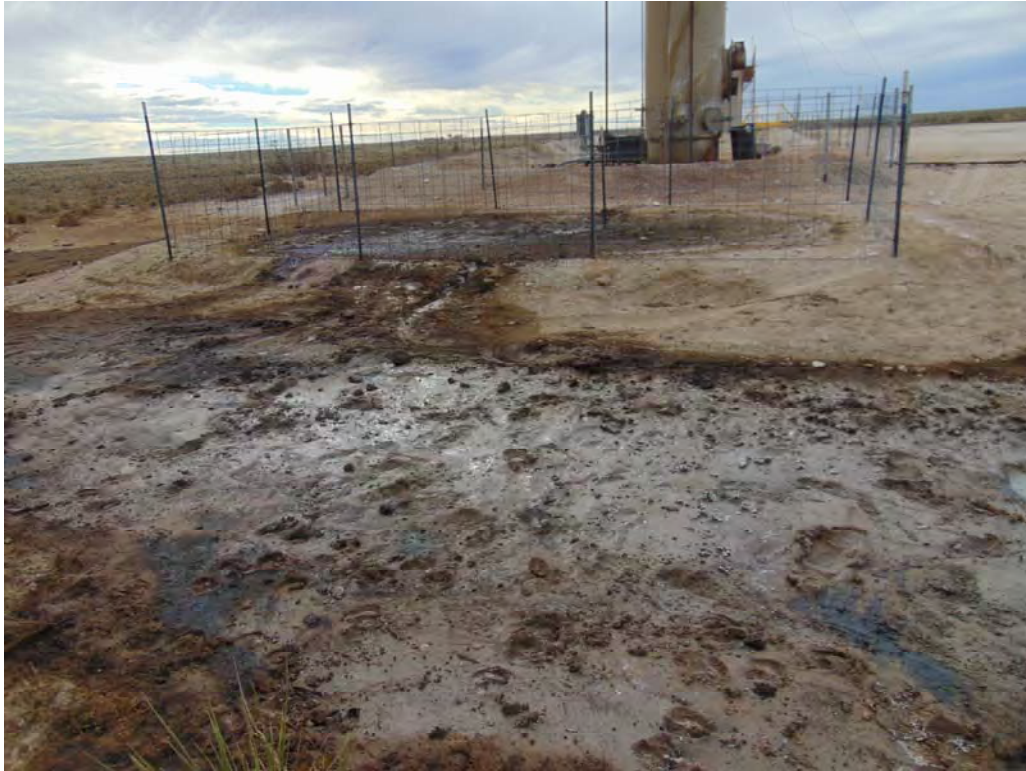
Photograph #1- Point of release

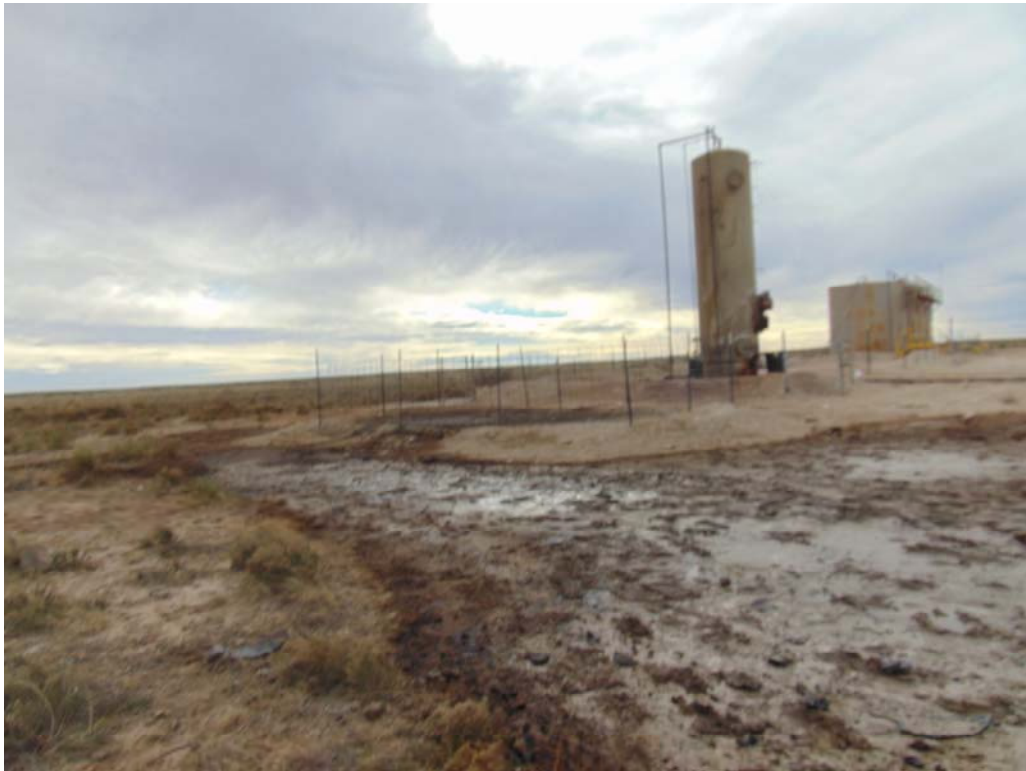
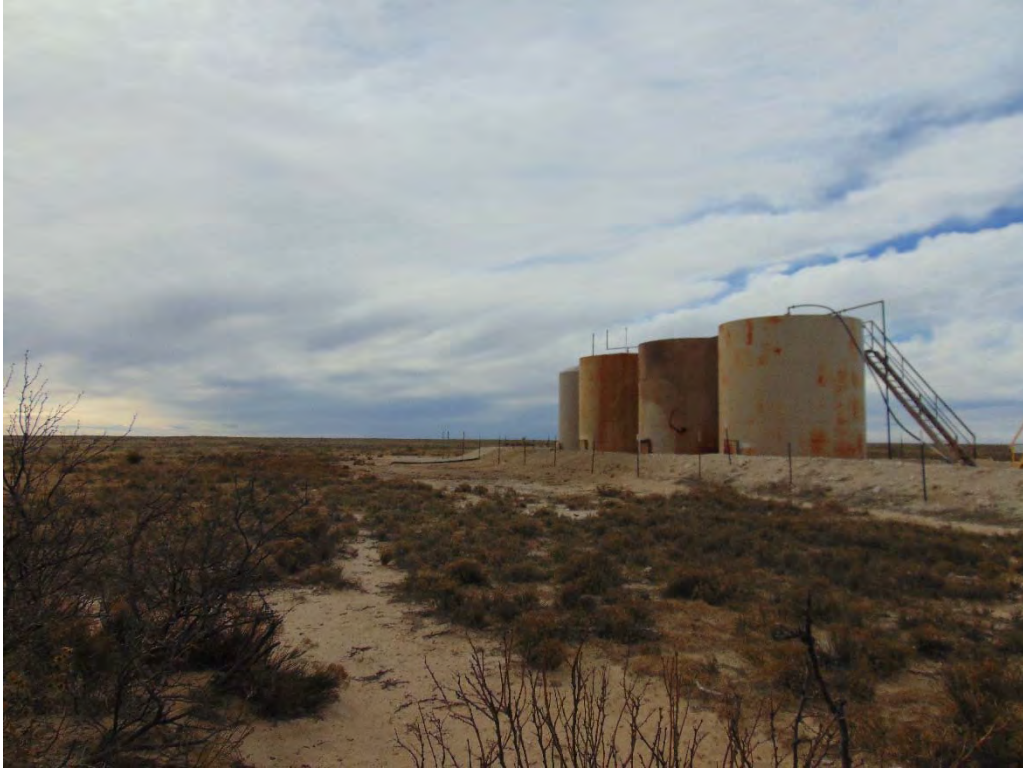
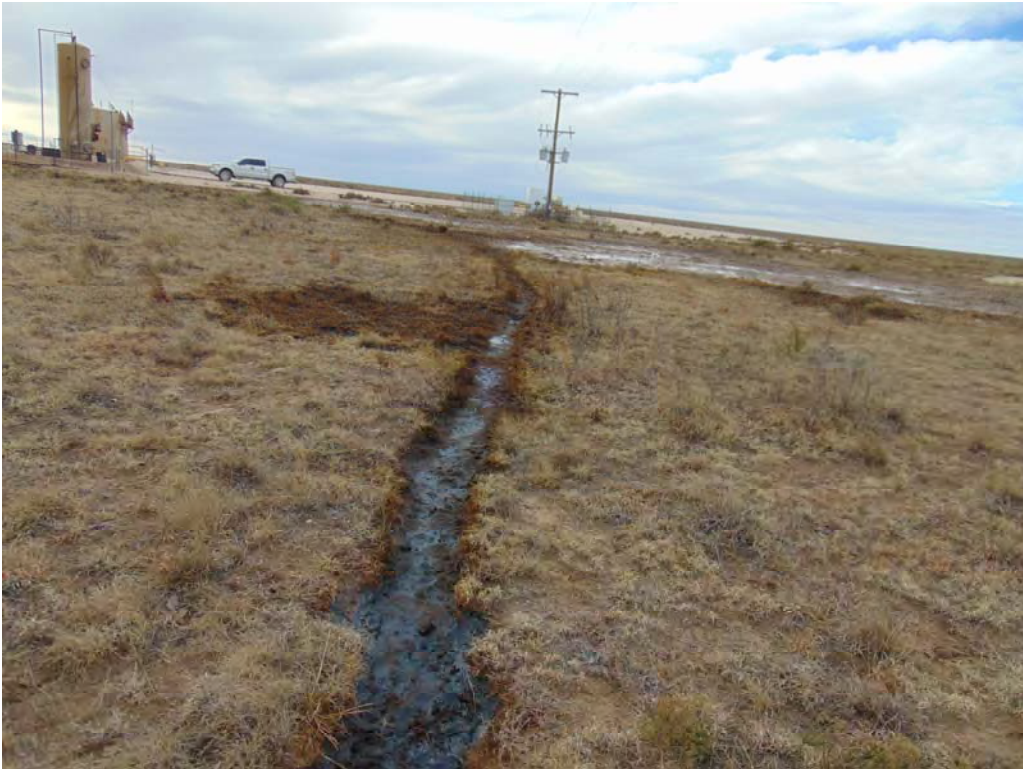
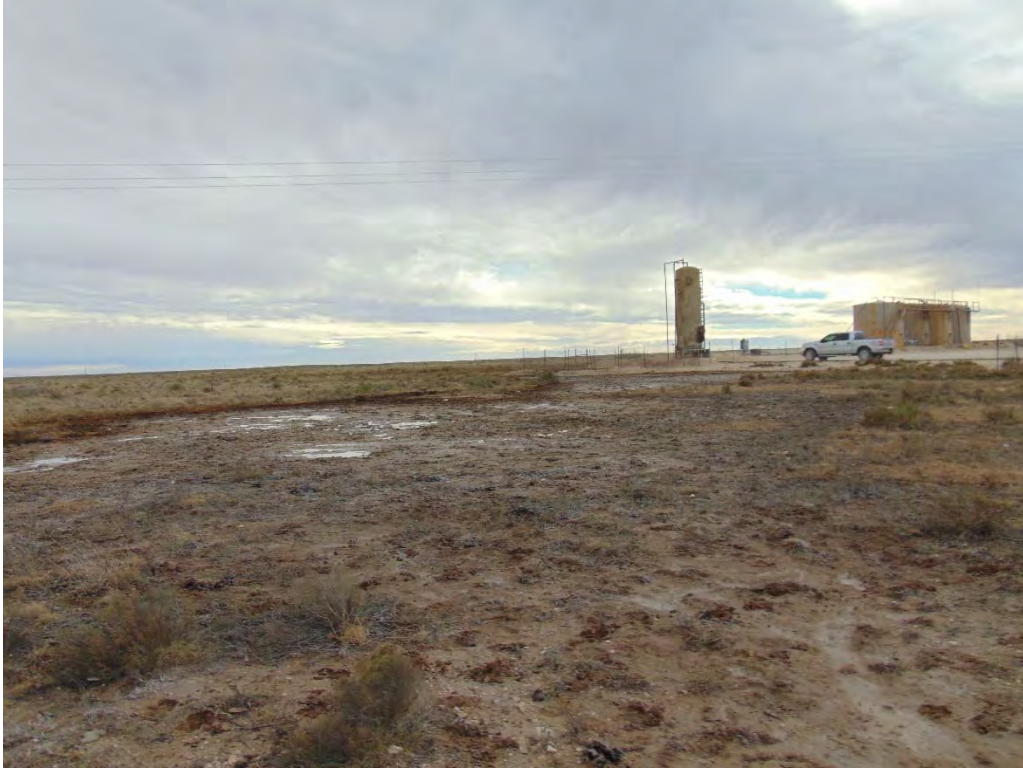
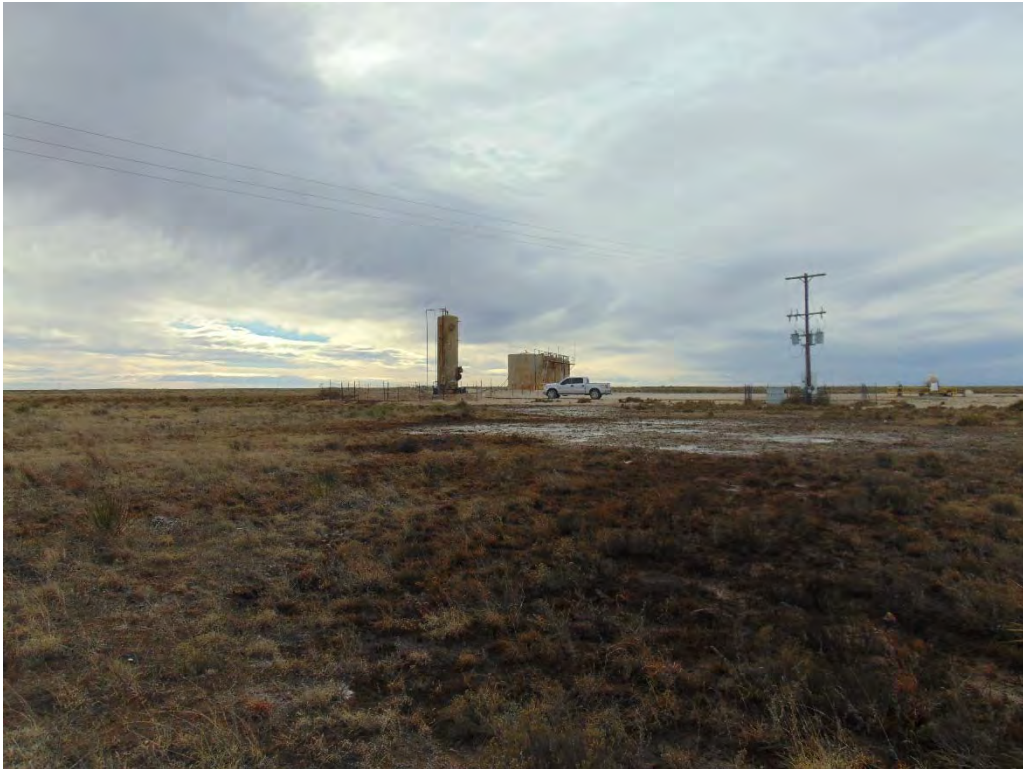
Photograph #2- Looking across release area.

Photograph #3- Looking across release area.

Photograph #4- Looking across release area.

Photograph #5- Looking across release area.

Photograph #6- Looking across release area.

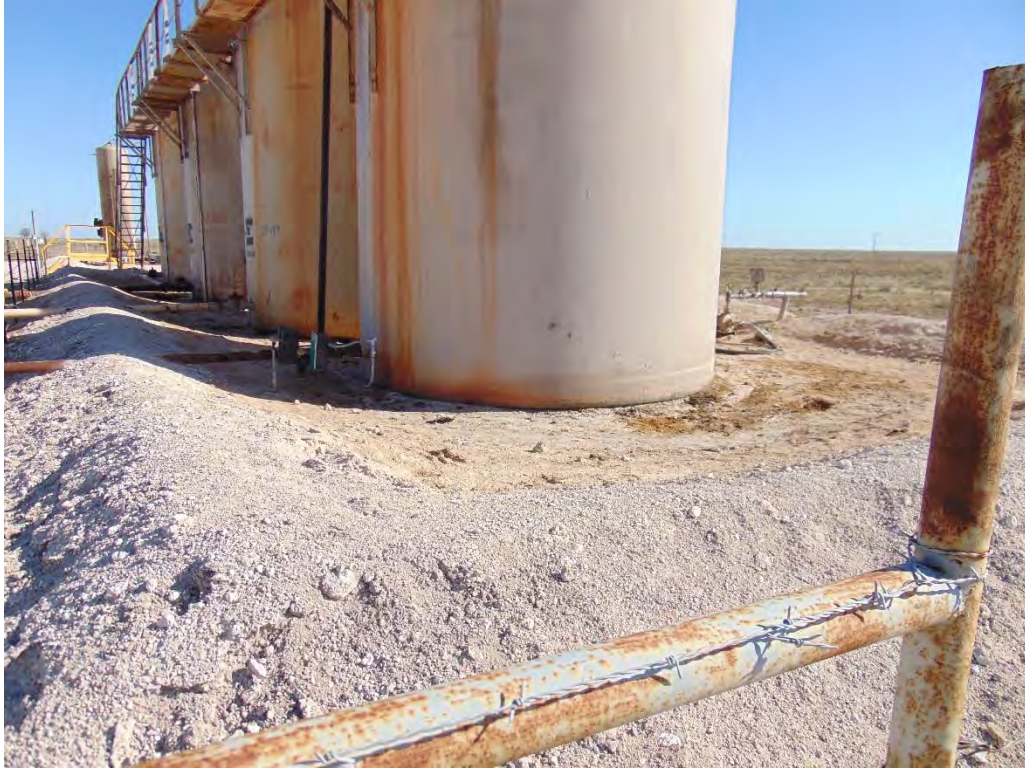
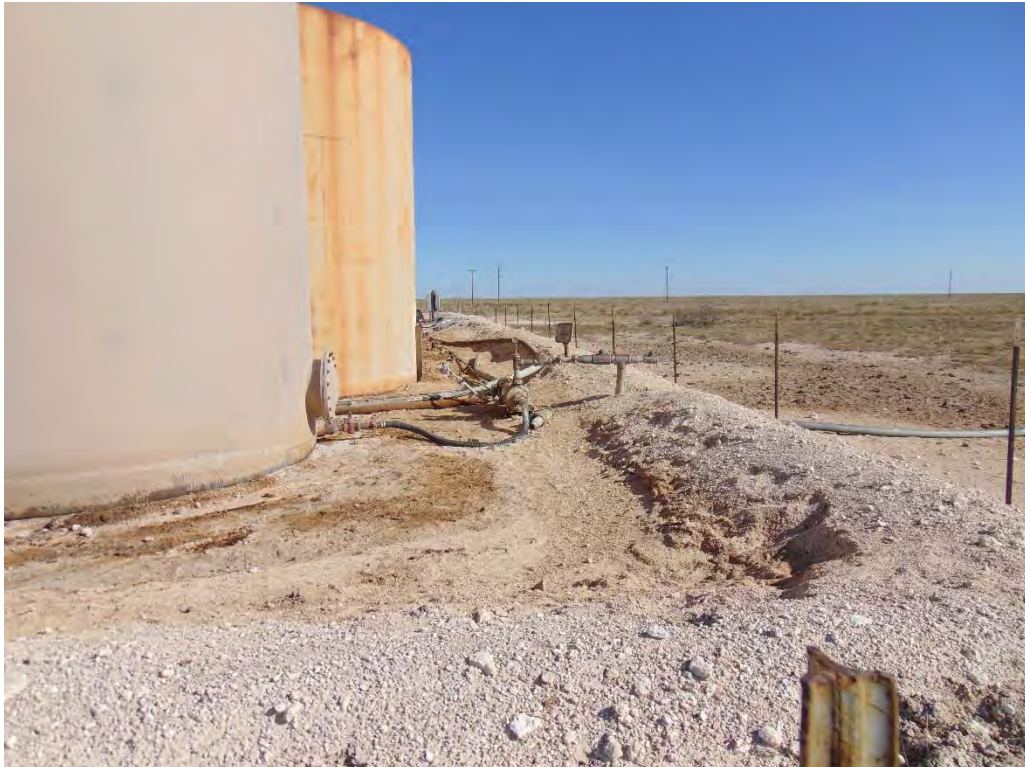
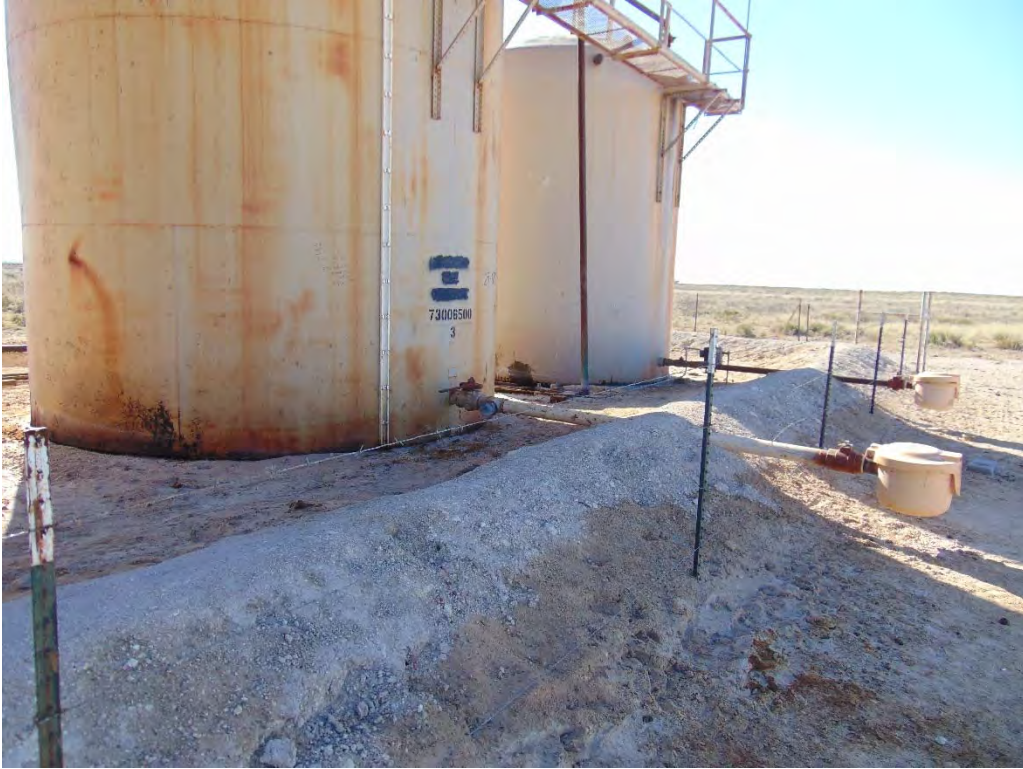
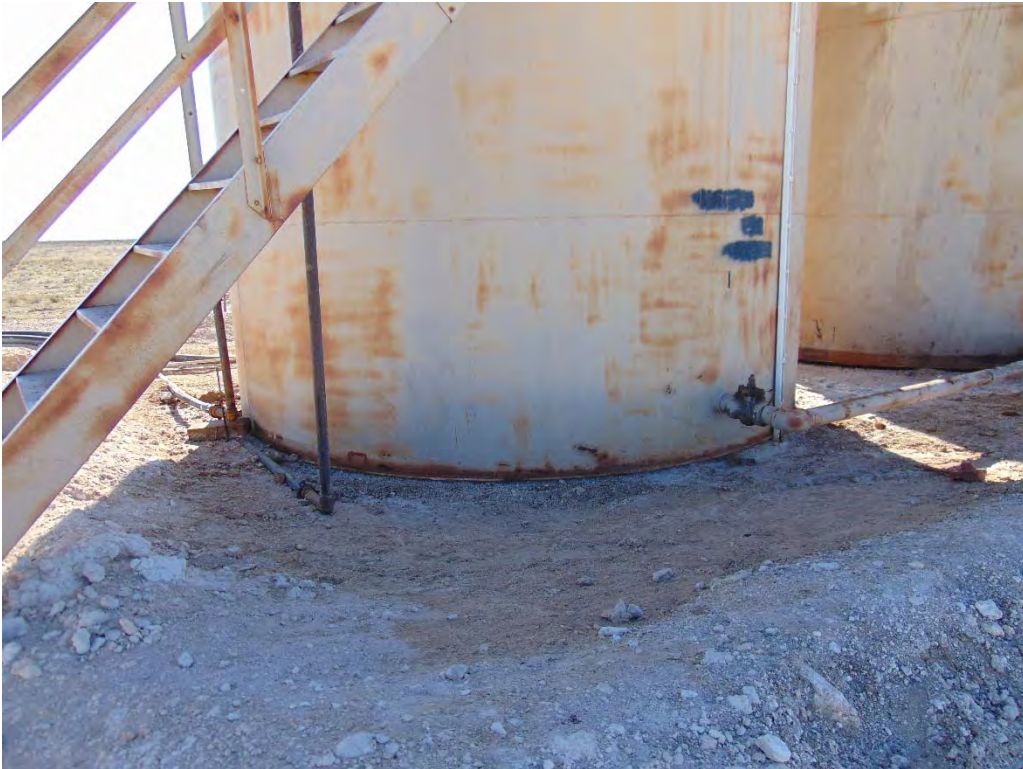
Photograph #7- Looking across second release area.

Photograph #8- Looking across second release area.

Photograph #9- Looking across second release area.

Photograph #10- Looking across second release area.

The second release area, being within the bermed containment of the tank battery, will be excavated approximately six inches, taking extreme care to not compromise the stability of the tanks or process equipment. All contaminated soil will be hauled to a state approved disposal facility. The excavated area will then be backfilled with caliche, to finish grade. The berms around the tanks will also be removed during excavation activities and replaced with clean caliche.

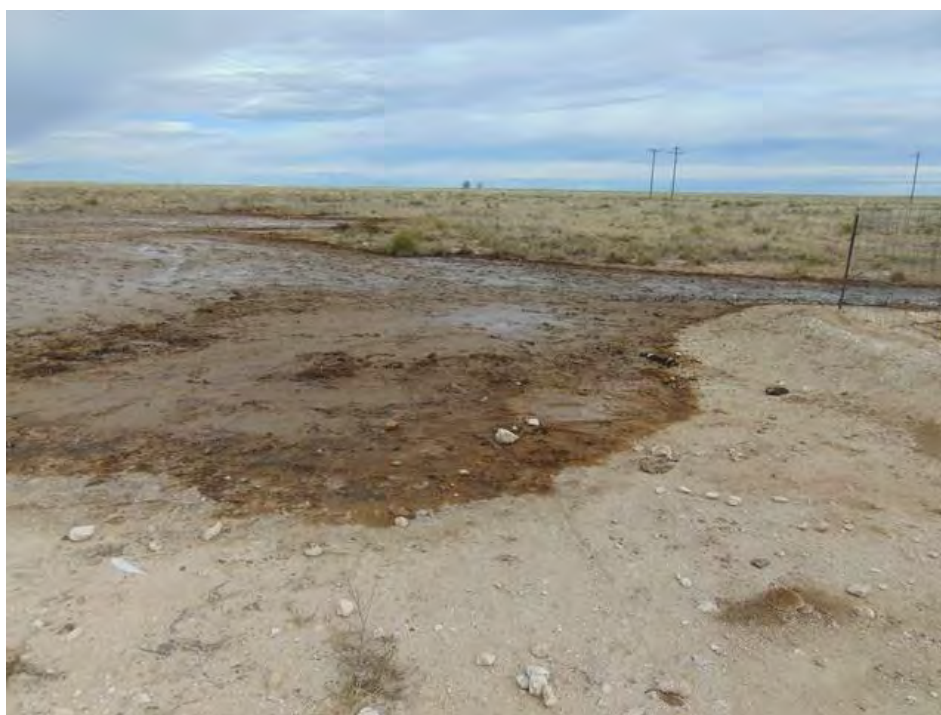
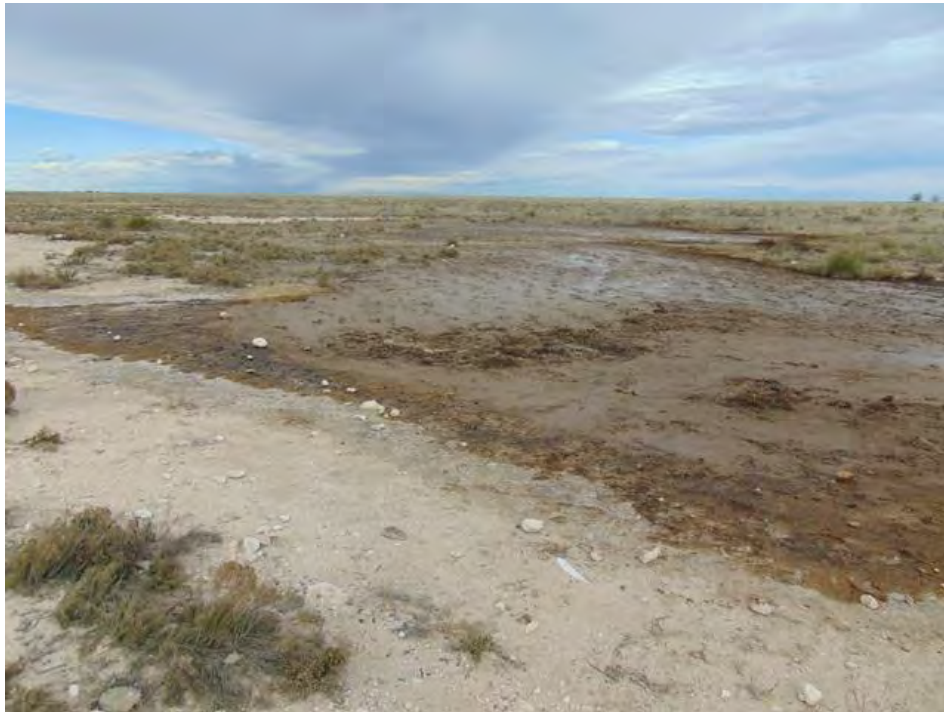
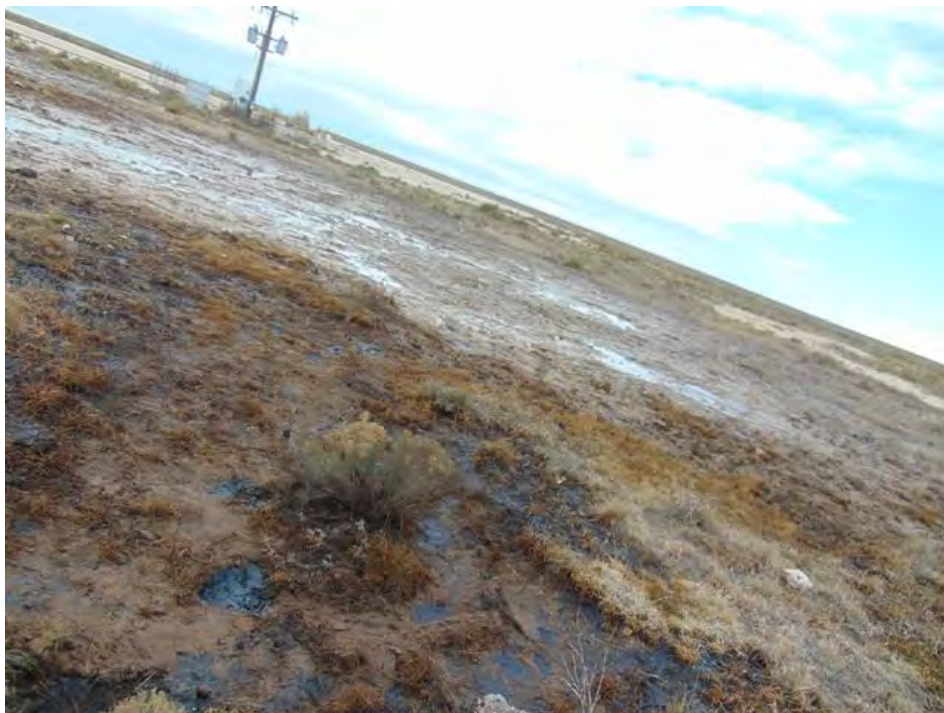
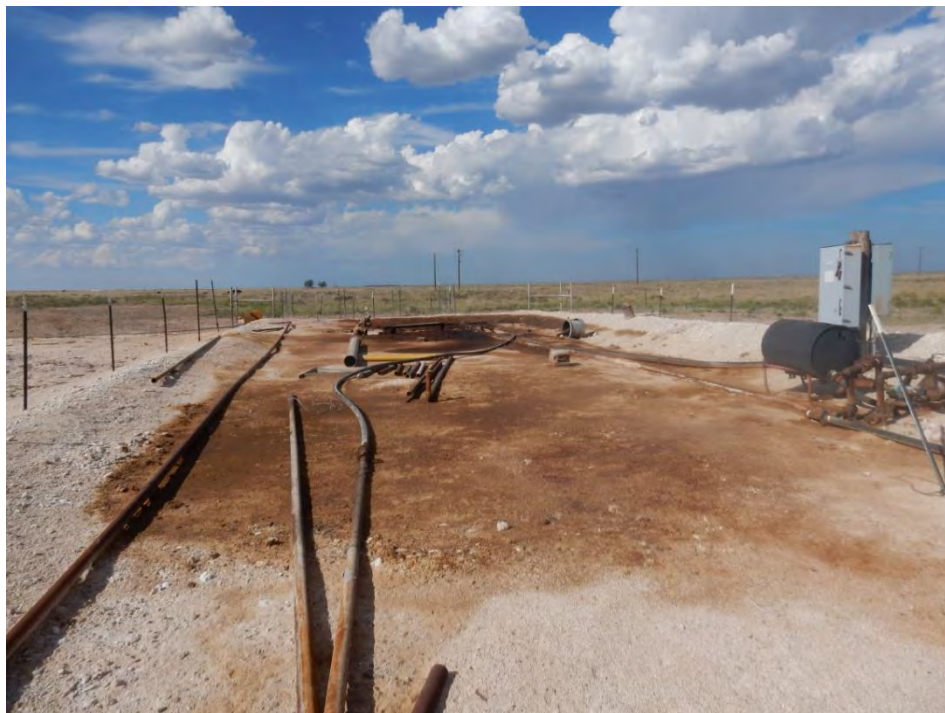
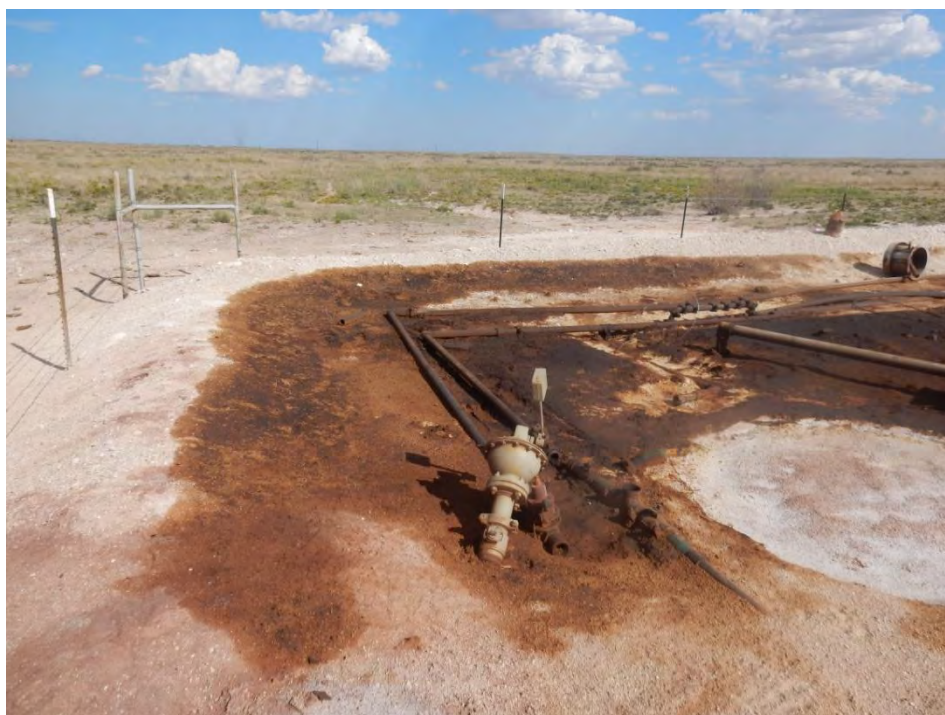
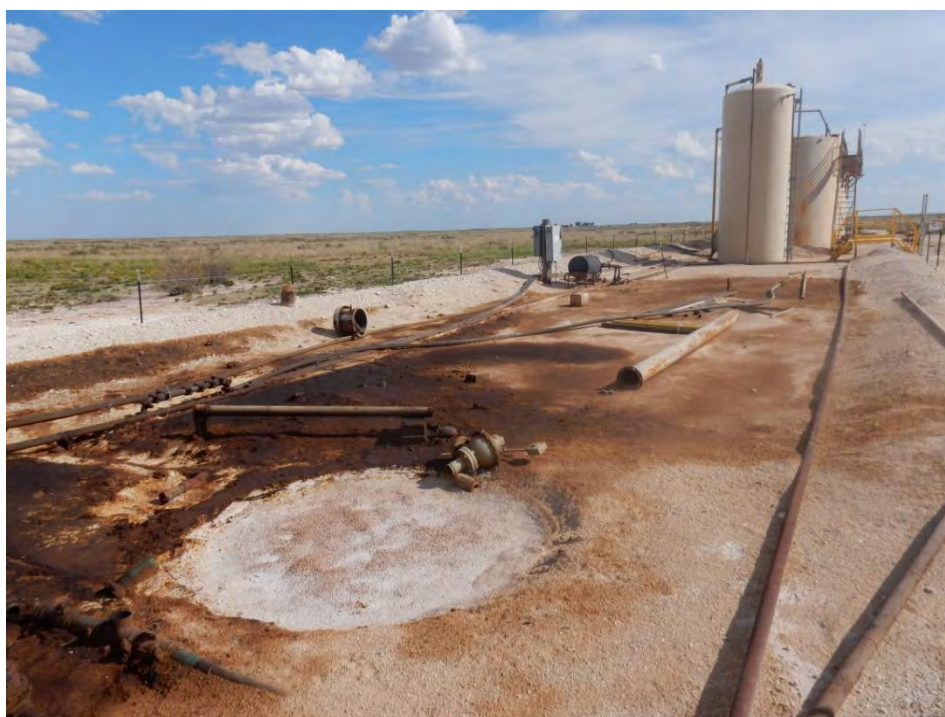
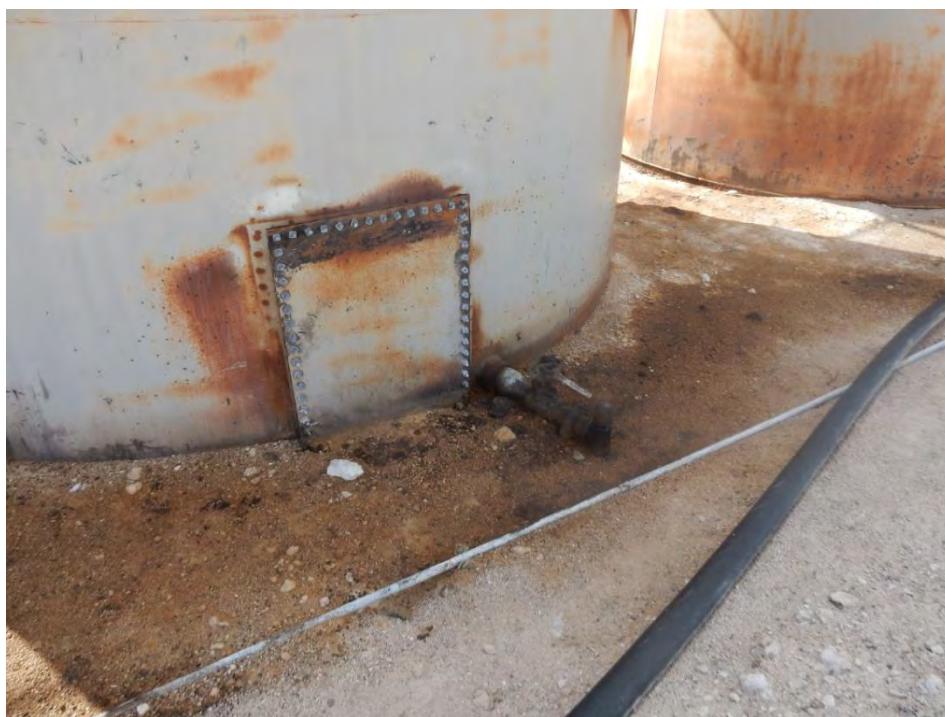
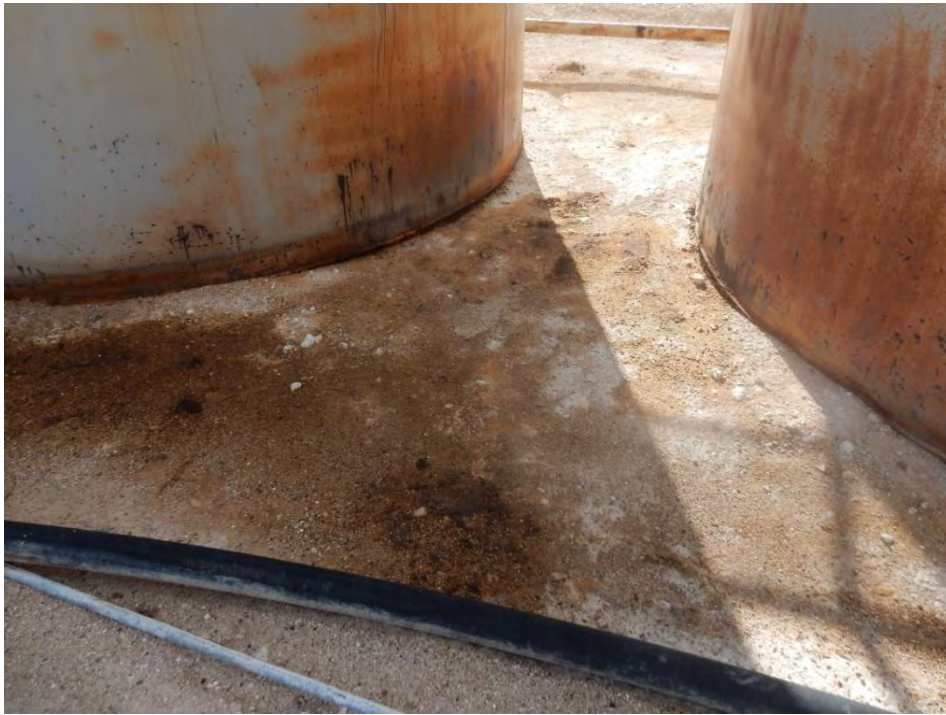
Site Prior to Remediation Viewing East

Site Prior to Remediation Viewing West

Site Prior to Remediation Viewing Southwest

Site Prior to Remediation Viewing North, September 14, 2017

Site Prior to Remediation Viewing East, September 14, 2017

Site Prior to Remediation Viewing South, September 14, 2017

Site Prior to Remediation, September 14, 2017
