Remediation Completion Report

February 20, 2017

**Oilfield Water Logistics (OWL) Produced Water Pipeline Release
Nearby OWL Red Hills SWD
Section 36, T25S, R36E, Lea County, New Mexico – Case No. 1RP 4498**

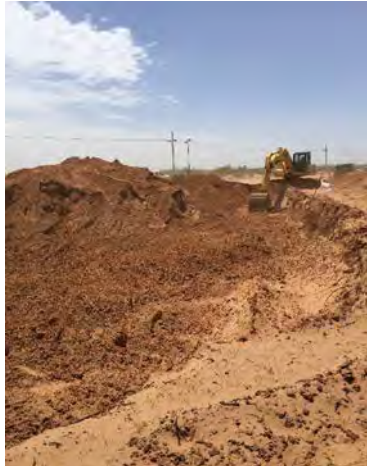
Photo 1: View of the excavation area.

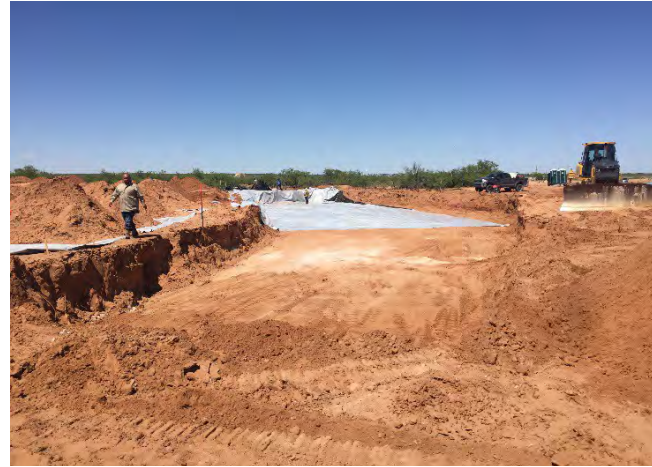
Photo 2: View of sampling area with plastic sheeting.

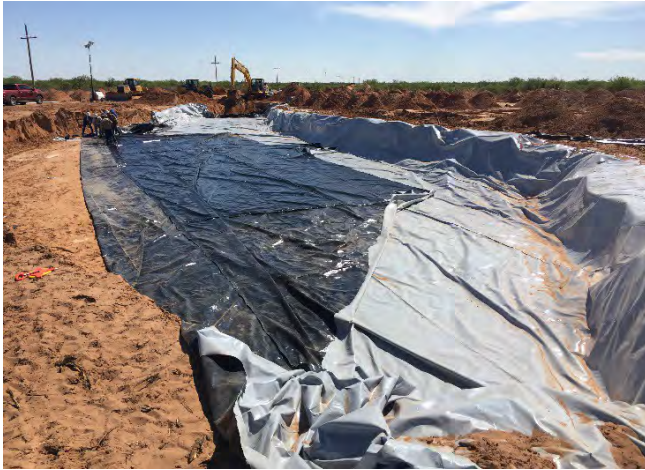
Photo 3: Additional view of the excavation areas being constructed.

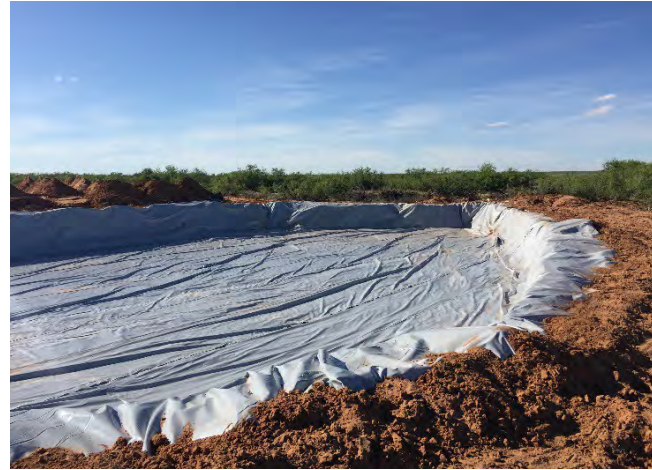
Photo 4: View of completed excavation area.

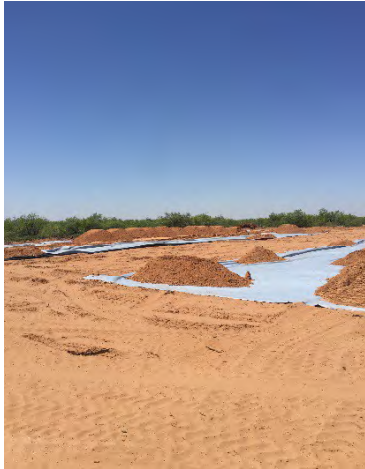
Photo 5: View of the soil stockpiles and blending areas.

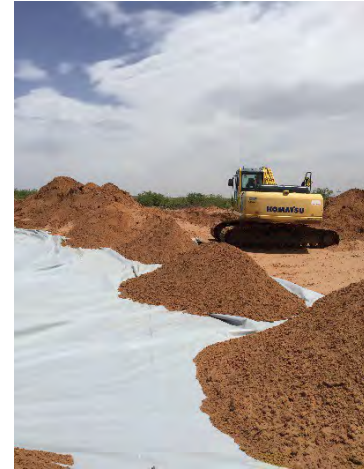
Photo 6: View of the soil stockpiles and blending areas.

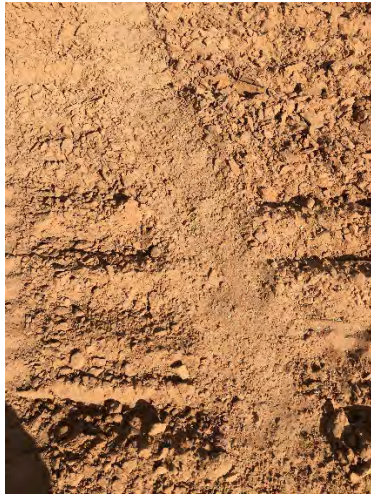
Photo 7: View of the BLM reseeding.

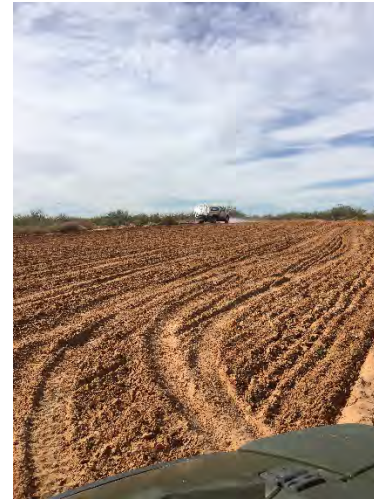
Photo 4: View watering of the reseeded area.
