Carter Lease Well #001 Battery

REMEDIATION WORK PLAN

API No. 30-025-30854

NMOCD Case #: 1RP-4990

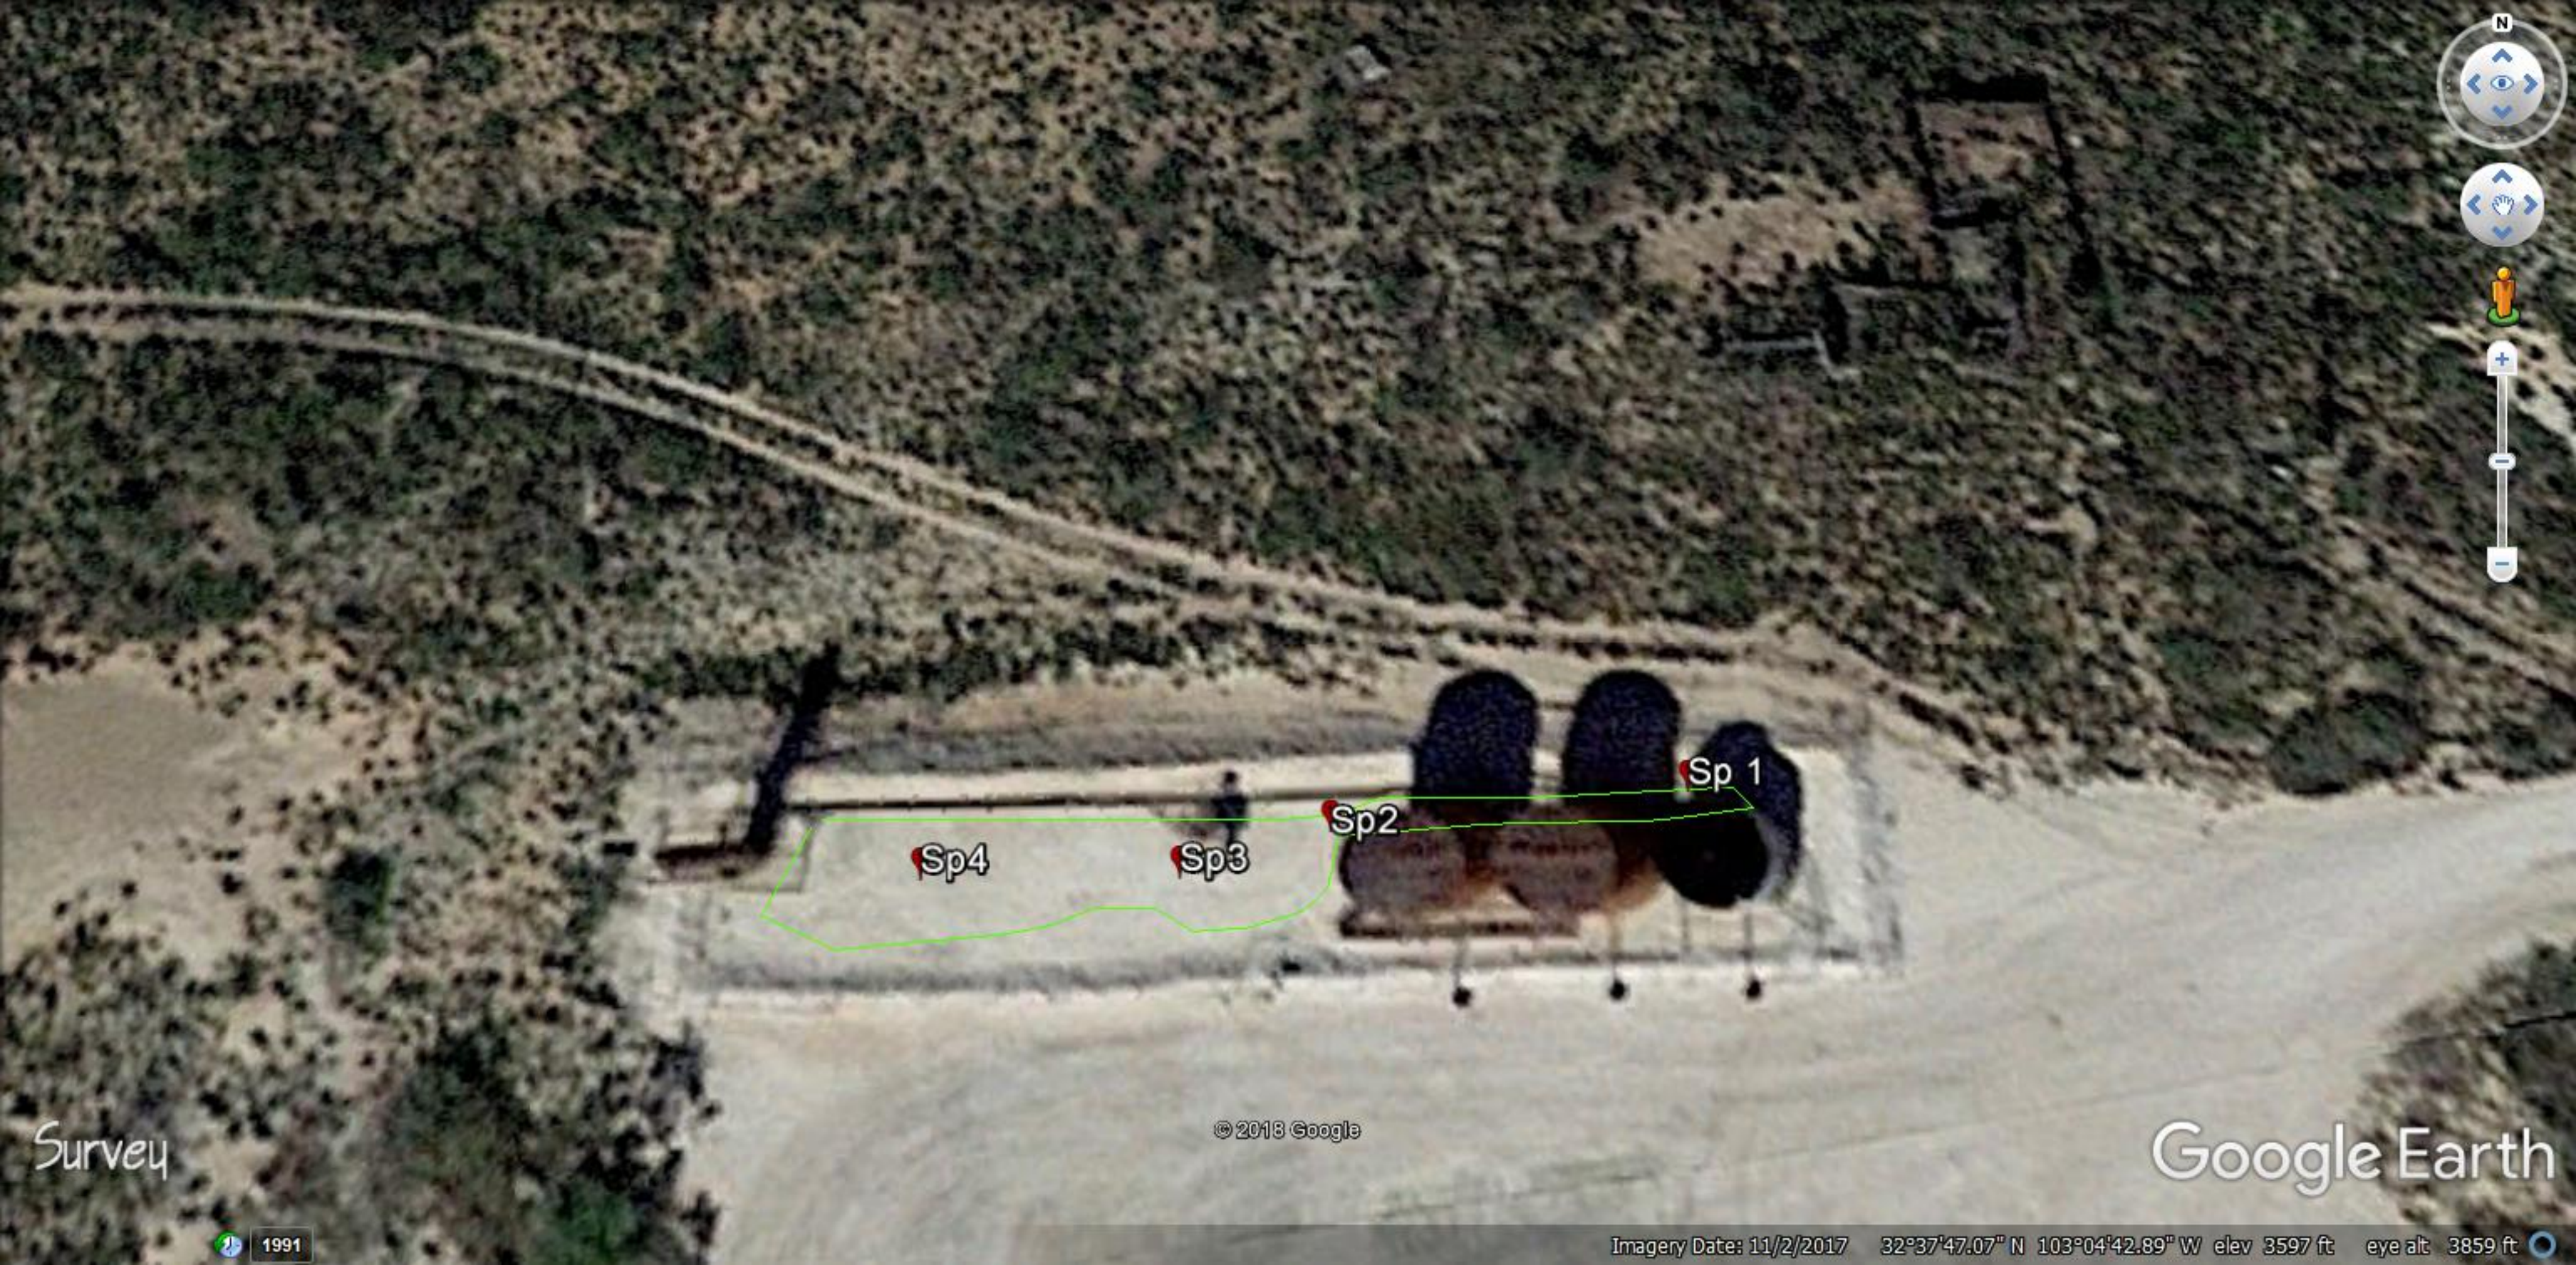
Figures: Site Diagram

On March 27th, 2018 DFSI personnel were on site to obtain samples within the leak area (Figure 1). Four sample points were set, then samples were obtained and field sampled for chloride levels, as well as BTEX (Appendix II). The BTEX samples were performed using a Mini Rae Photoionization Detector (PID). Clean field samples were submitted for laboratory analysis at Cardinal Laboratory of Hobbs, NM to obtain confirmation (Appendix III). Based on analysis, chlorides, TPH and BTEX did have a decline as samples were taken at deeper intervals. Sp1 was not able to be fully delineated due to auger refusal. Mechanical boring was not used due to safety issues with active production lines and the water tank obstructing the sampling area.

Survey

Due to safety hazards, which include tanks and underground lines (as depicted in site photos) to maintain tank integrity, the entire release area will be excavated to a depth of 1' bgs. Sp1 will be fully delineated and any other sampling required will be done at the time of excavation, with a lab confirmations before backfill is completed. A 20ML liner will be placed and properly seated to insure contamination migration will not incur further and also prevent possible future incidents to not migrate past liner as well. The excavation will be backfilled with clean, imported caliche to ground surface and contoured to the surrounding area. Berms will be rebuilt and compacted as well. Seeding of the site is not warranted. Additional remediation will occur at time of site abandonment if needed.

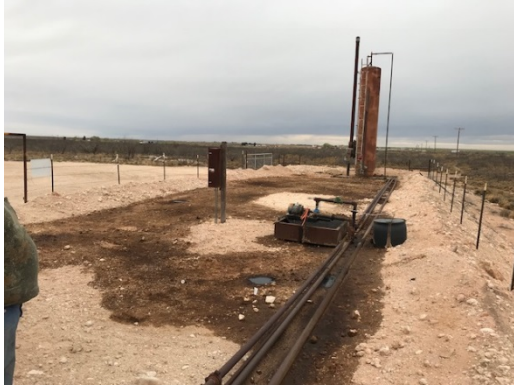
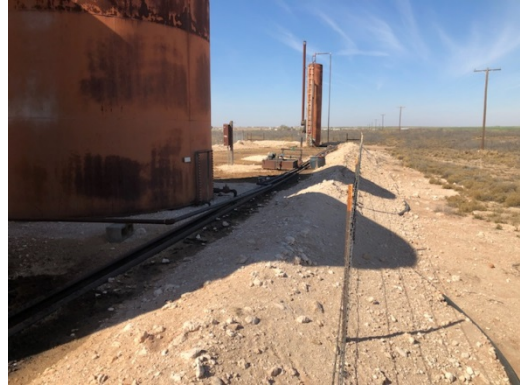
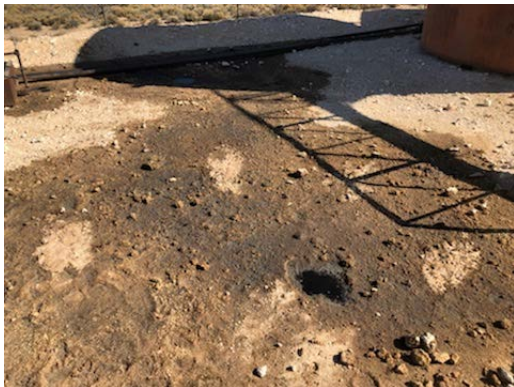
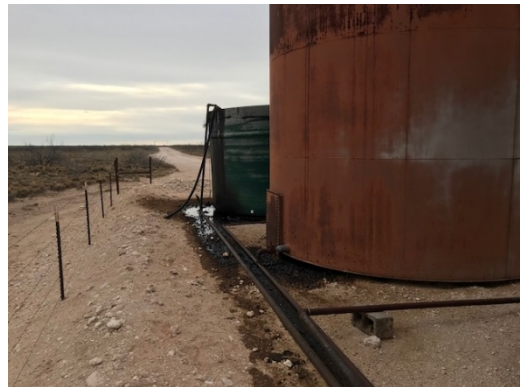
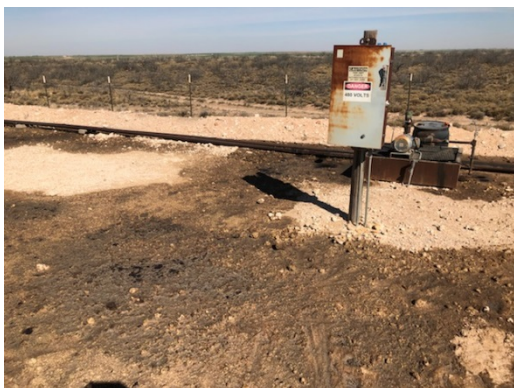
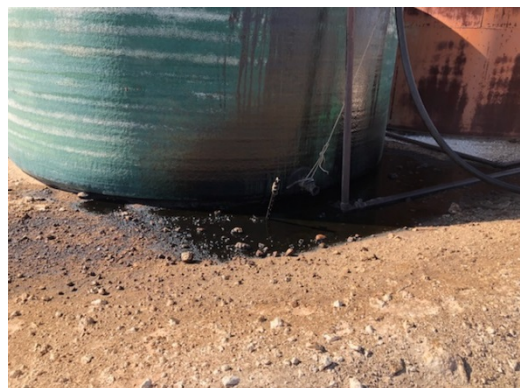
Photo Page:

The site is located north of Eunice, NM, in Lea County. The spill site resulted from an open top water tank running over. Approximately 3 barrels of oil and 60 barrels of water was released inside the bermed area. 2.5 bbl. oil /40 bbl. of water were recovered. An initial C-141 was submitted to NMOCD on March 12th, 2018. (Appendix I).
