## State of New Mexico Energy, Minerals, and Natural Resources Oil Conservation Division (OCD) Stage II Remediation Plan

Case Number: 1RP-4935

North Hobbs Satellite 31 East CO2  
32.71476°, -103.17909°

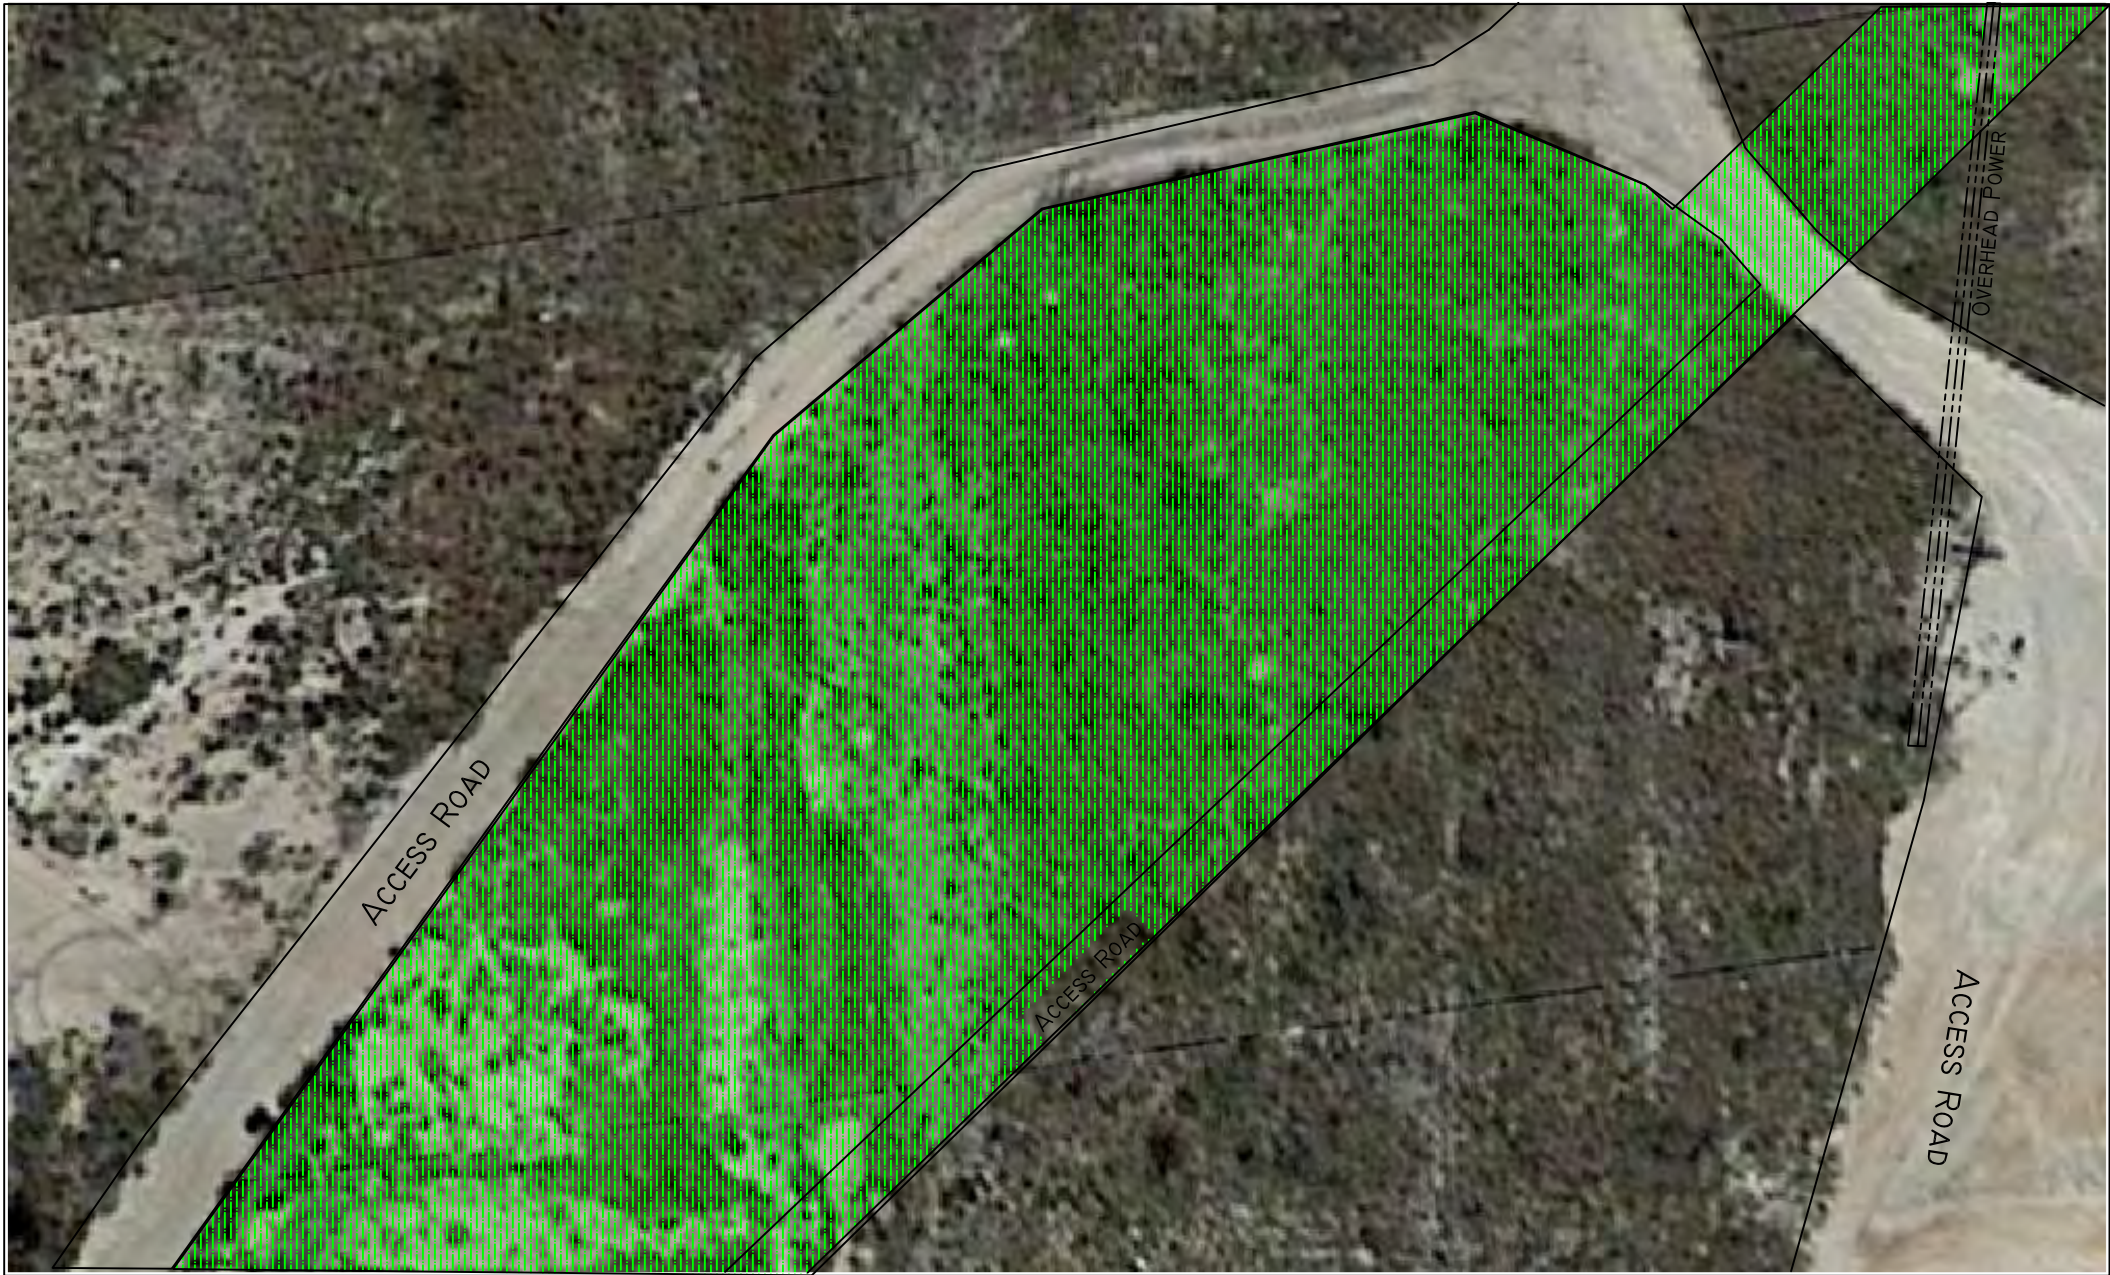
AREA FOR SEEDING

<small>Texas Registered Engineering Firm F-9992 Texas Licensed Surveying Firm 10193863 5012 50th Ste. 204 P: 806-783-9944 Lubbock, TX 79414 F: 806-783-9966 www.R2Meng.com</small>	COMPANY: VENABLE'S CONSTRUCTION
		PROJECT: IRP-4935
		TITLE: SEEDING AREA
		LOCATION: HOBBS, NM
		DATE: 5-2018

Seeding of the location is recommended for June or July 2018. Seed will be planted a quarter to half- inch deep using a disc type or similar rangeland drill sufficient to accommodate variations in seed sizes. If the broadcast method is exacted, seeding rates should be doubled. Seeding can be accomplished as early as late May 2018 given all dirt work for the location is stabilized. Soil in this area will be tilled to reduce compaction. Seed-bed preparation will be performed to provide a hospitable environment for germinating seed by breaking up impermeable soil layers that have formed and increasing void spaces for air and water. Ground shall be roughed-up prior to planting, by raking, harrowing or other methods. The seed mixture used will be approved by the New Mexico State Land office.
