RE: Closure Report
COG – BC Federal #032
API #: 30-025-38829
RP #: 1RP-4811
Unit Letter G, Section 20, Township 17S, Range 32E
Lea County, New Mexico
Release Date: September 10, 2017

EnTech Consulting Corporation (EnTech), has prepared this closure report documenting remediation of the COG Operating, LLC (COG), BC Federal #032 release, located in Lea County, New Mexico (hereinafter referred to as the “Site”).

ATTACHMENT A – SITE PHOTOGRAPHS
COG BC Federal #032, Lea County, New Mexico
Release Date: September 10, 2017

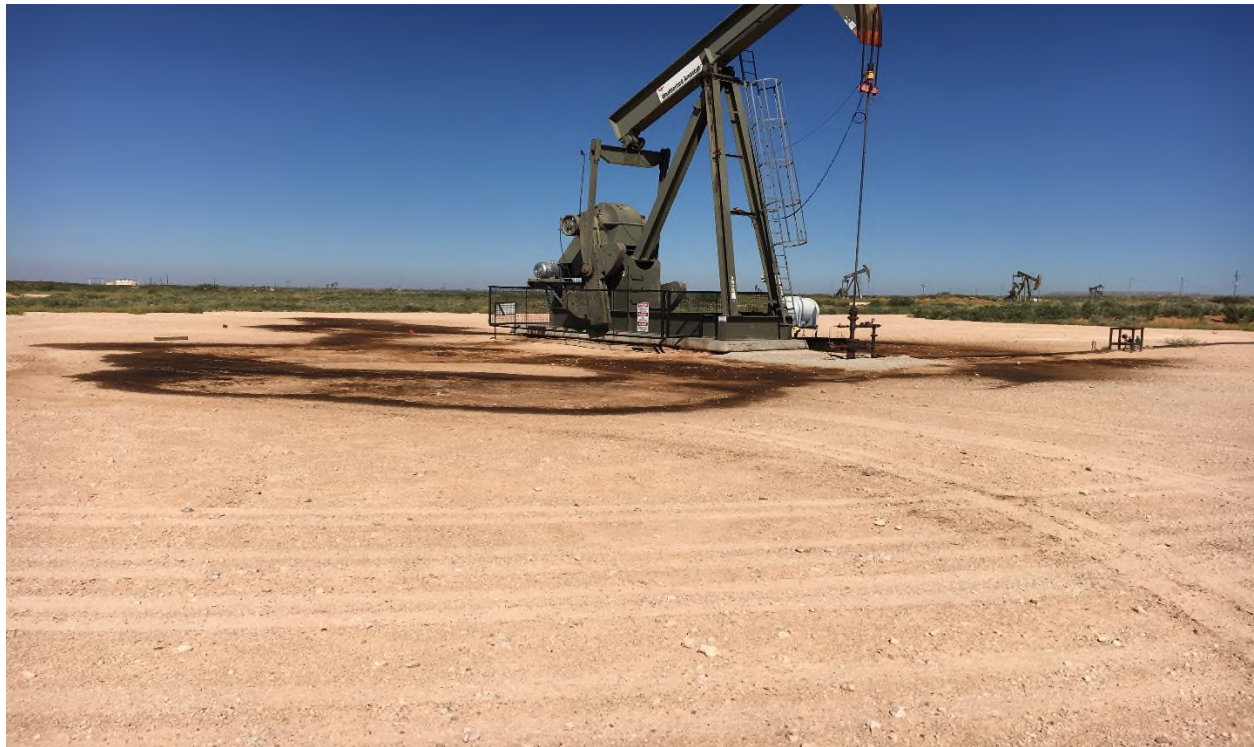
Photo 2: Northwestern view across well pad and impact area (09/19/2017).

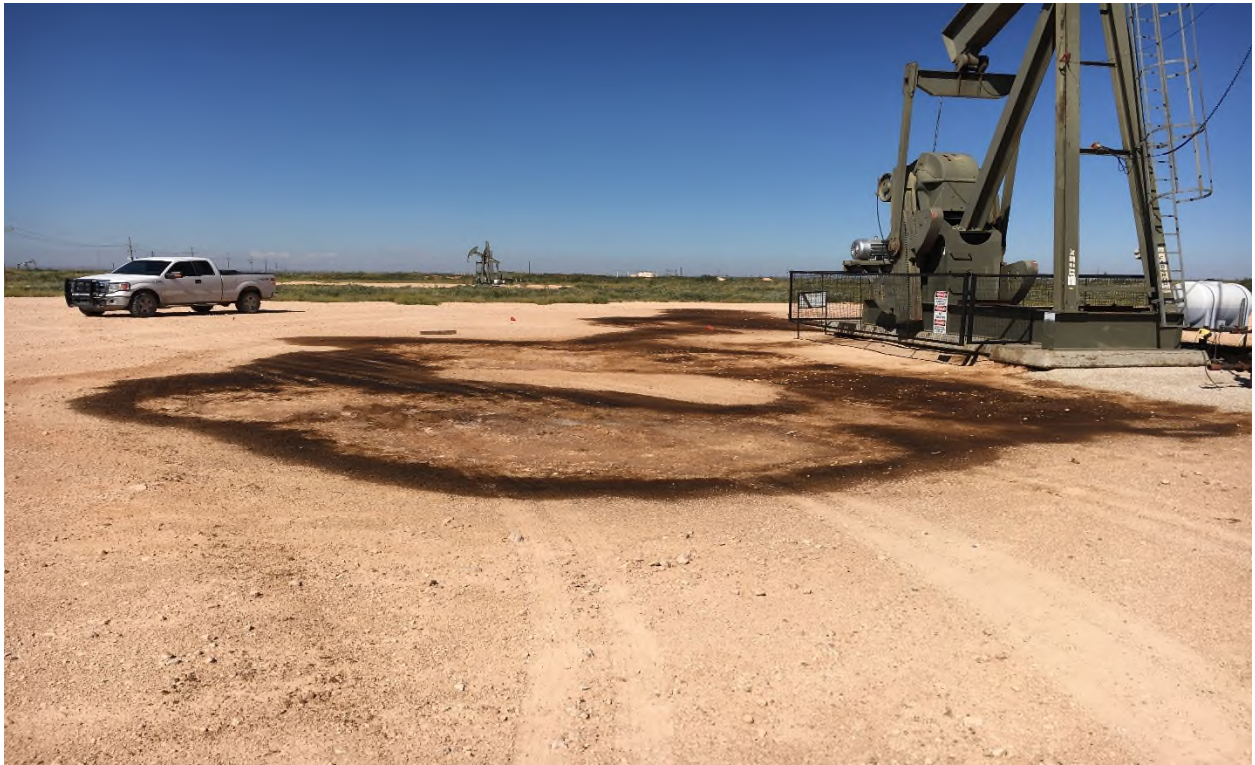
Photo 3: Northeastern closeup view of release area and impacted caliche on well pad (09/19/2017).

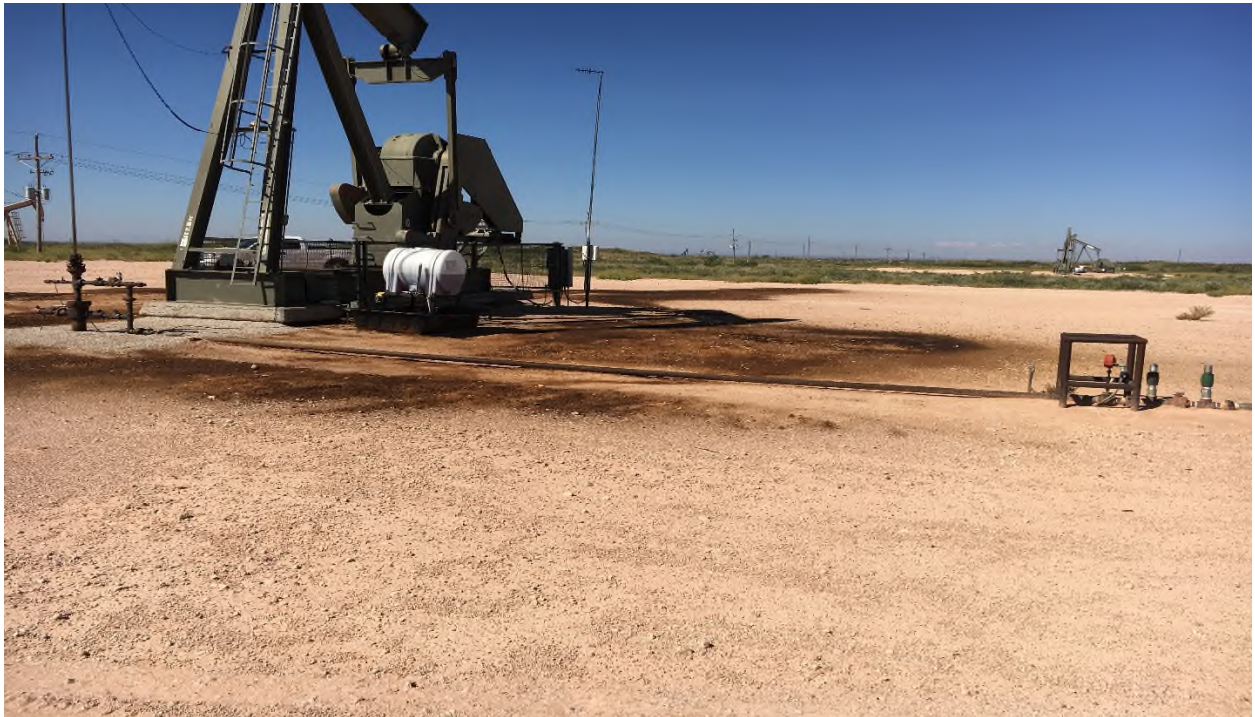
Photo 4: Southwestern closeup view of release area and impacted caliche on well pad (09/19/2017).

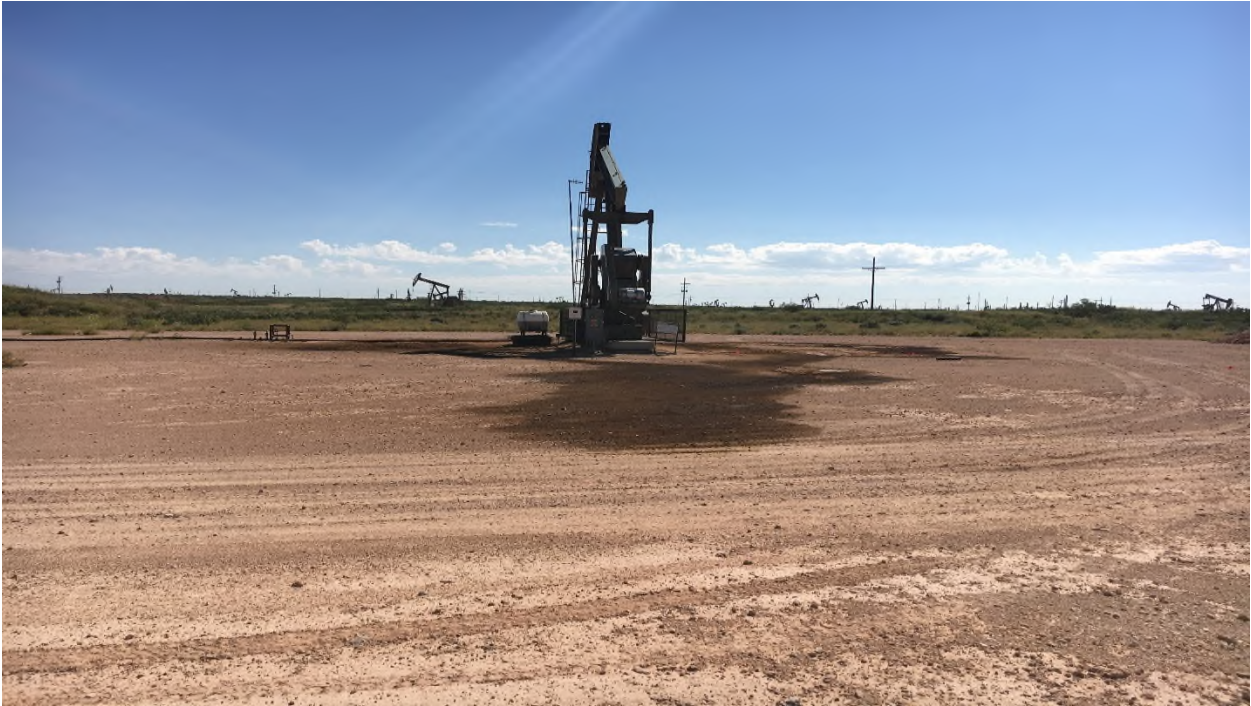
Photo 5: Eastern closeup view of release area and impacted caliche on well pad (09/19/2017).

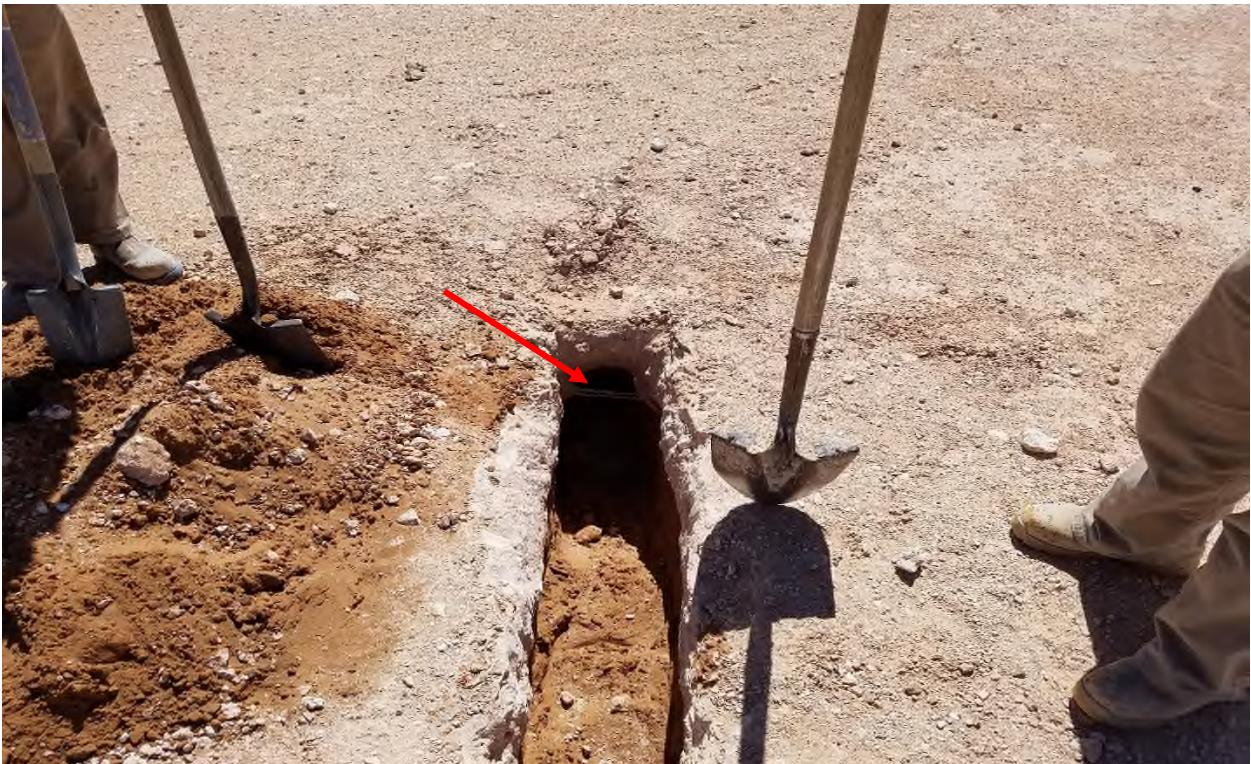
Photo 6: closeup view of exposed 440-volt power line from southwest corner of pad to panel at pumping unit [power line denoted by “red” arrow] (04/17/2018).

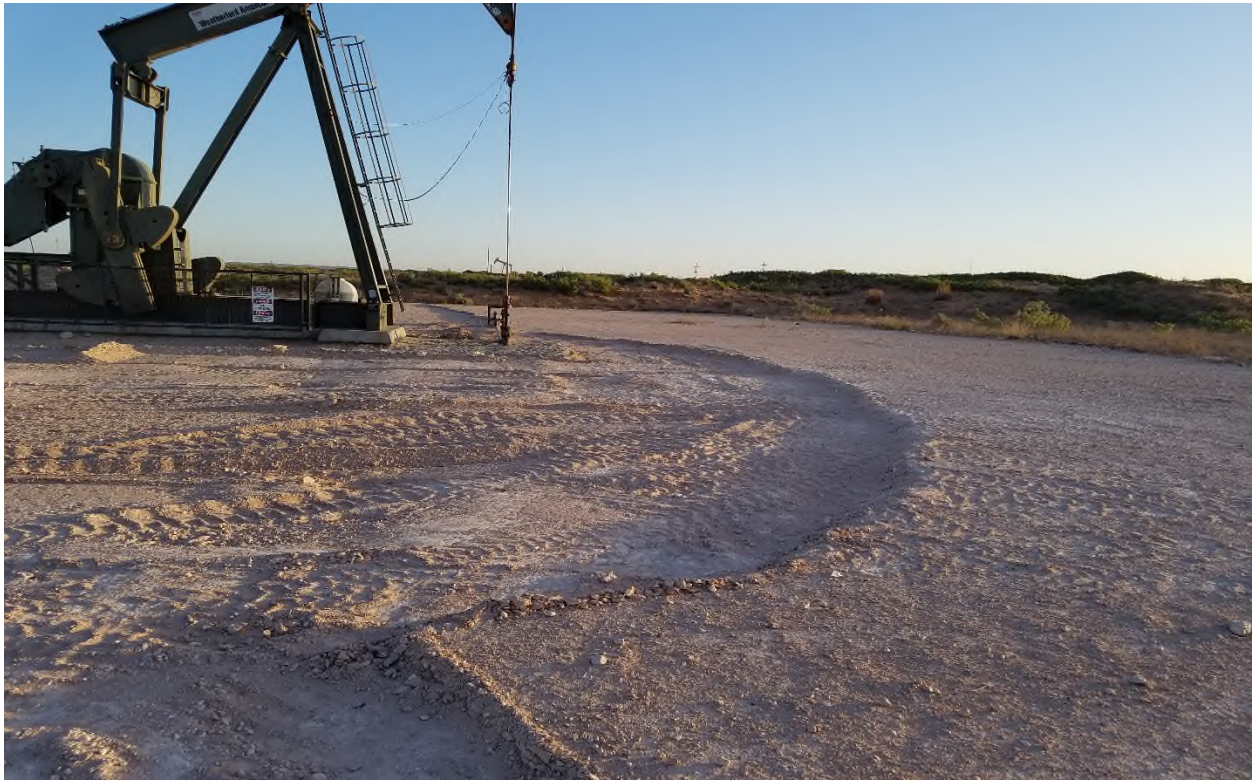
Photo 7: Northern view of excavation on eastern end of pumping unit (04/17/2018).

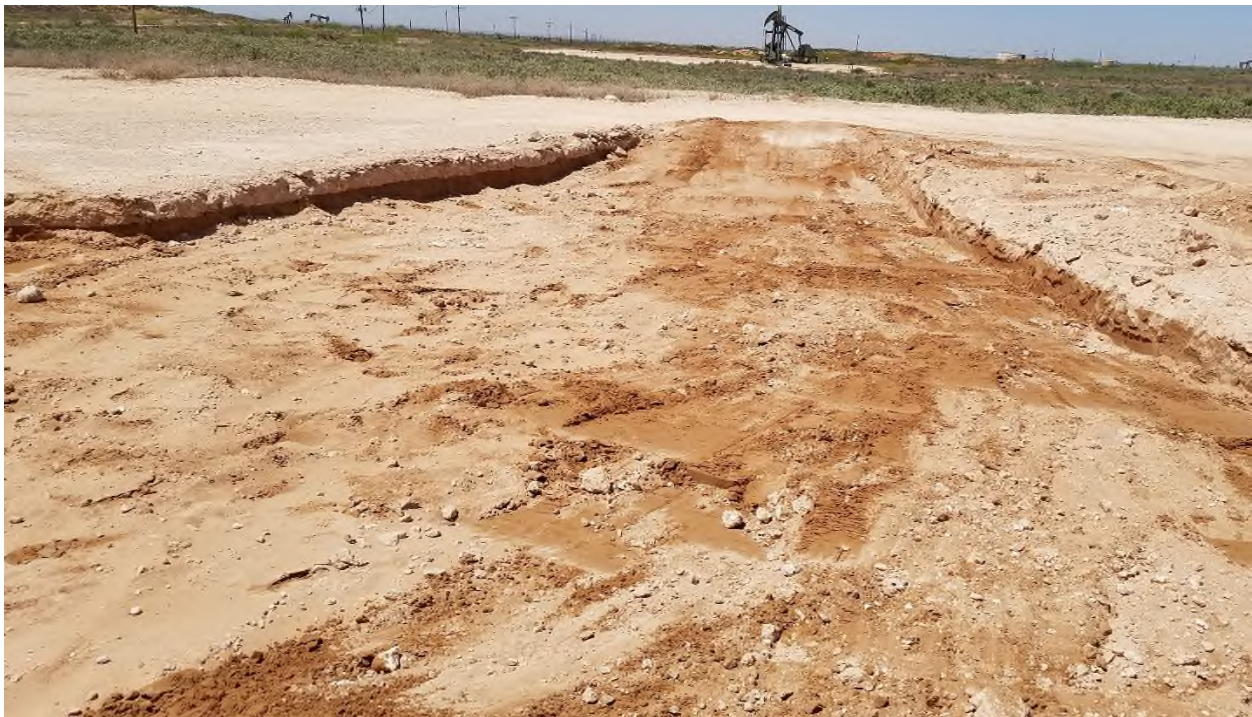
Photo 8: Western view of excavation on western end of pumping unit [representative to sample locations B-1, B-2, SW-1, SW-2, and SW-3] (04/18/2018).

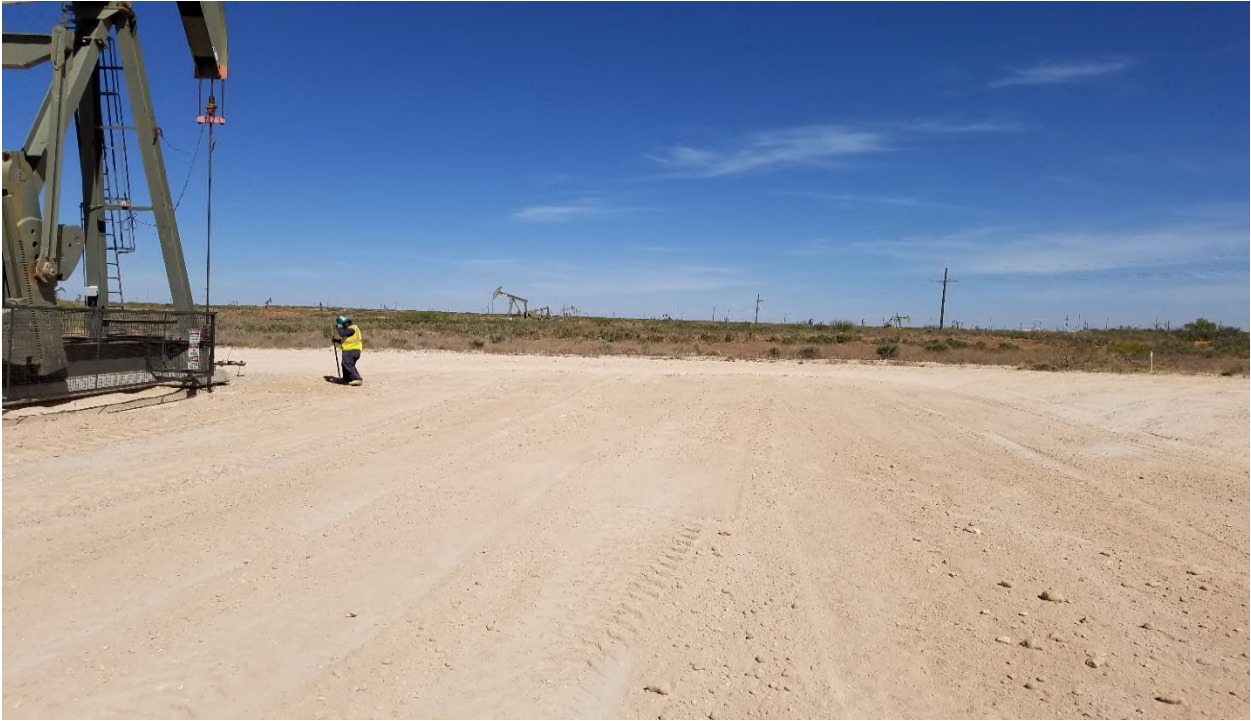
Photo 9: Eastern view on southern side of pumping unit after backfilling with imported caliche (04/18/2018).

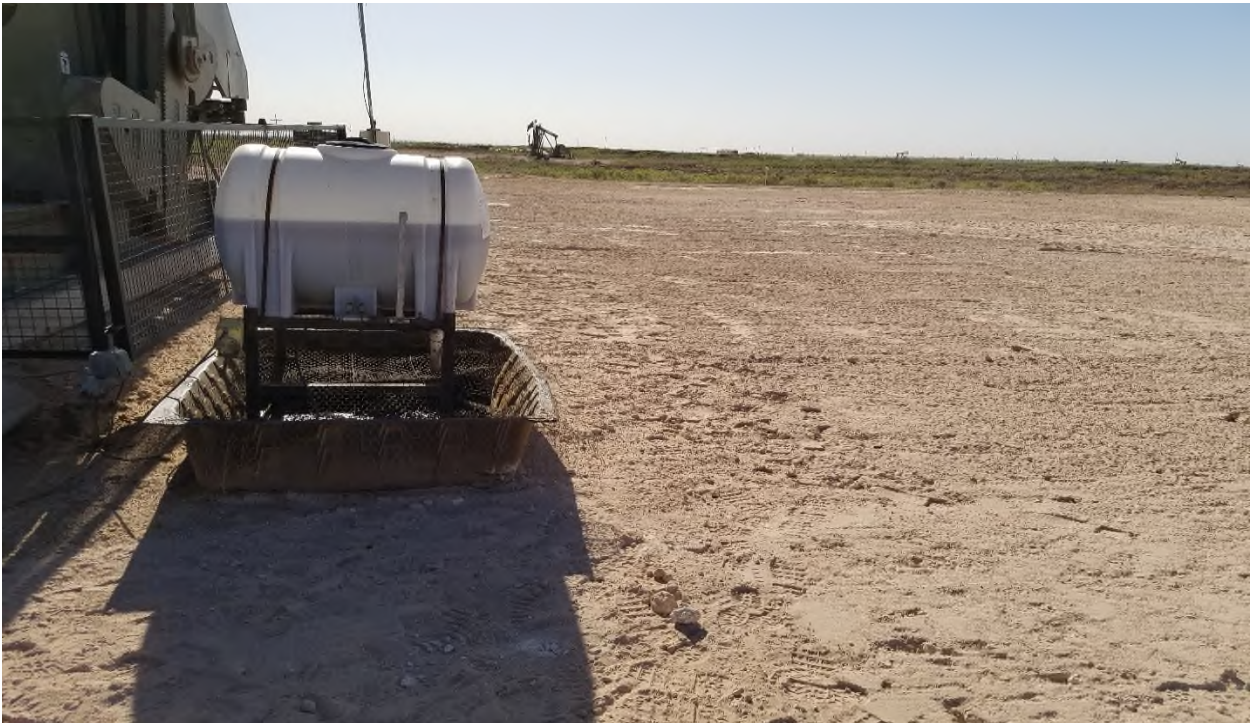
Photo 10: Western view of northern side of pumping unit after backfilling with imported caliche (04/18/2018).

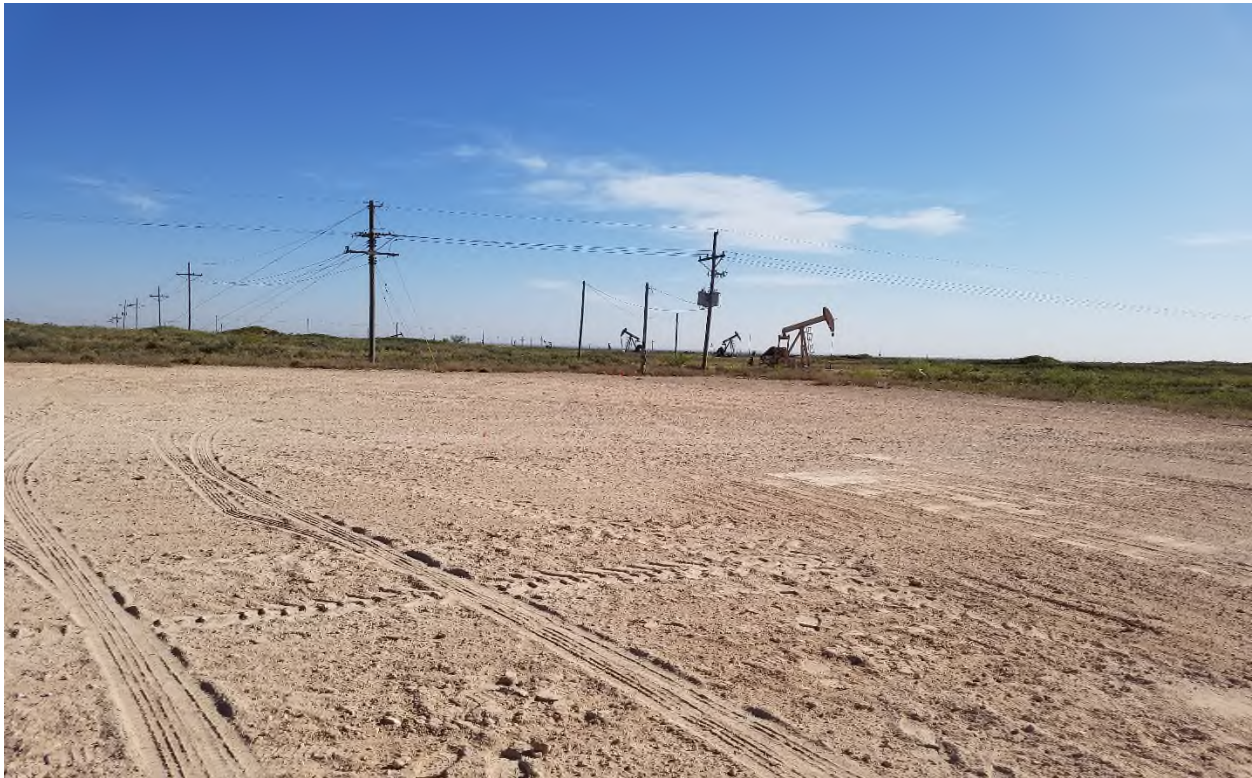
Photo 11: Southern view across backfilled location from western side of pumping unit (04/18/2018).

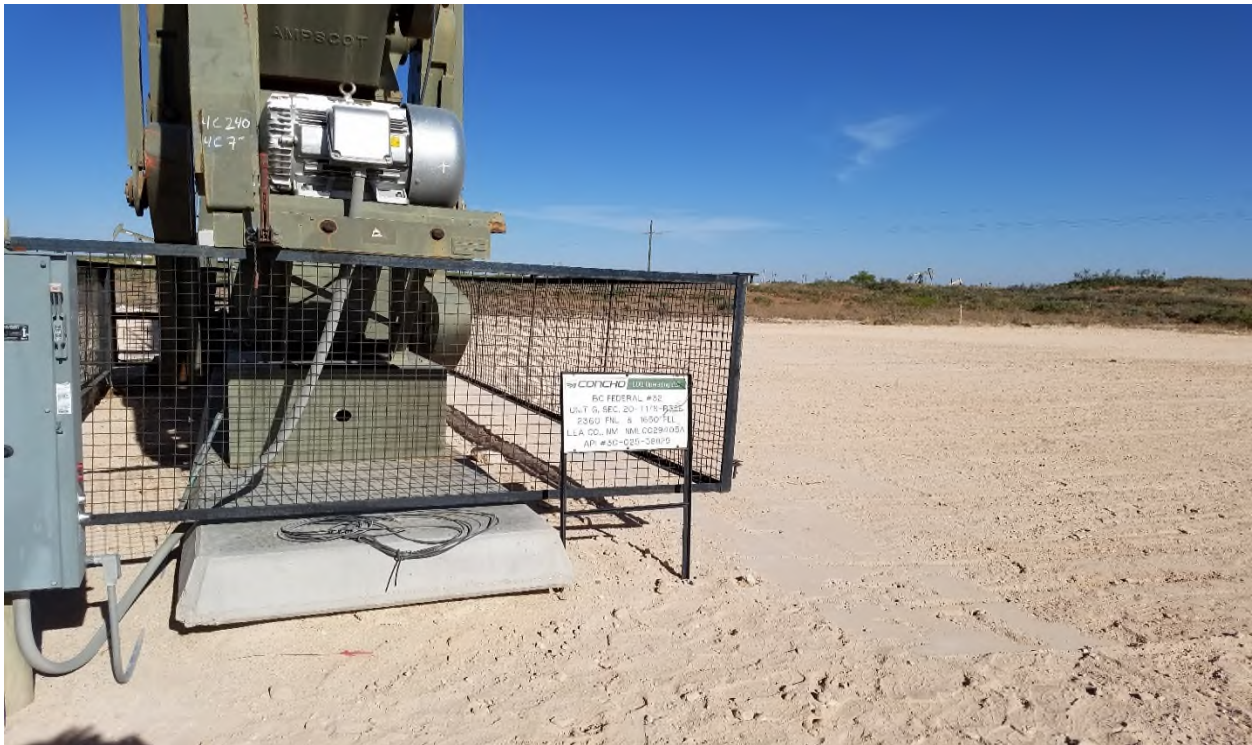
Photo 12: Eastern view across backfilled location from western side of pumping unit (04/18/2018).
