**Report Type: Work Plan 1RP-4974**

Site:	ARU Tank Battery					
Company:	Grand Banks Energy Co					
Section, Township and Range	Unit F	Sec. 11	T 16S	R 32E		
Lease Number:	API No. 30-025-00386					
County:	Lea County					
GPS:	32.939420° N			103.738051° W		
Surface Owner:	State					
Mineral Owner:						
Directions:	From intersection of HWY 82 and 249 travel east on HWY 82 for 1.6 mi, turn north onto Mendel Rd for 4.60 mi, turn east onto Patterson Rd and continue for 0.85 mi to location.

**Re: Work Plan for the Grand Banks Energy Co., ARU Tank Battery, Unit F, Section 11, Township 16 South, Range 32 East, Lea County, New Mexico. 1RP-4974.**

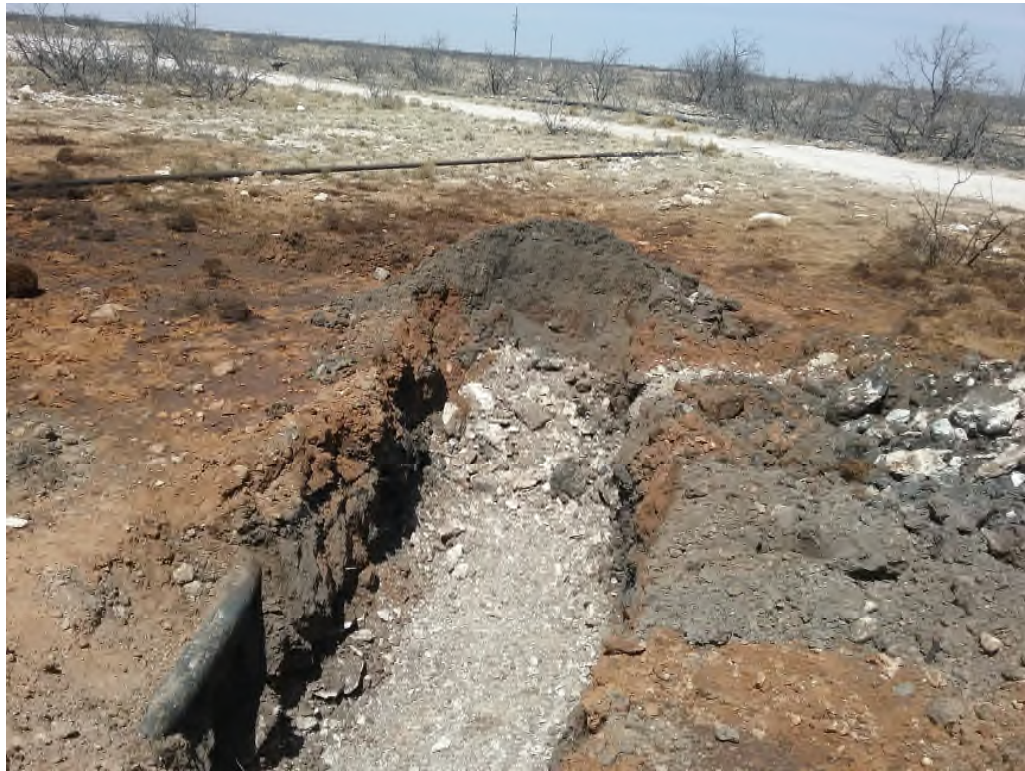
Referring to Table 1, the area of trench (T-1) did not show any TPH concentrations above the RRAL. The areas of trenches (T-2 and T-4) showed a shallow impact to the soils, with elevated concentrations at 0-1' of 28,800 mg/kg and 78,700 mg/kg. The TPH concentrations then declined to below the RRAL at 2.0' below surface with concentrations of 253 mg/kg (T-2) and 1,480 mg/kg (T-4).

View North – Area of T-1

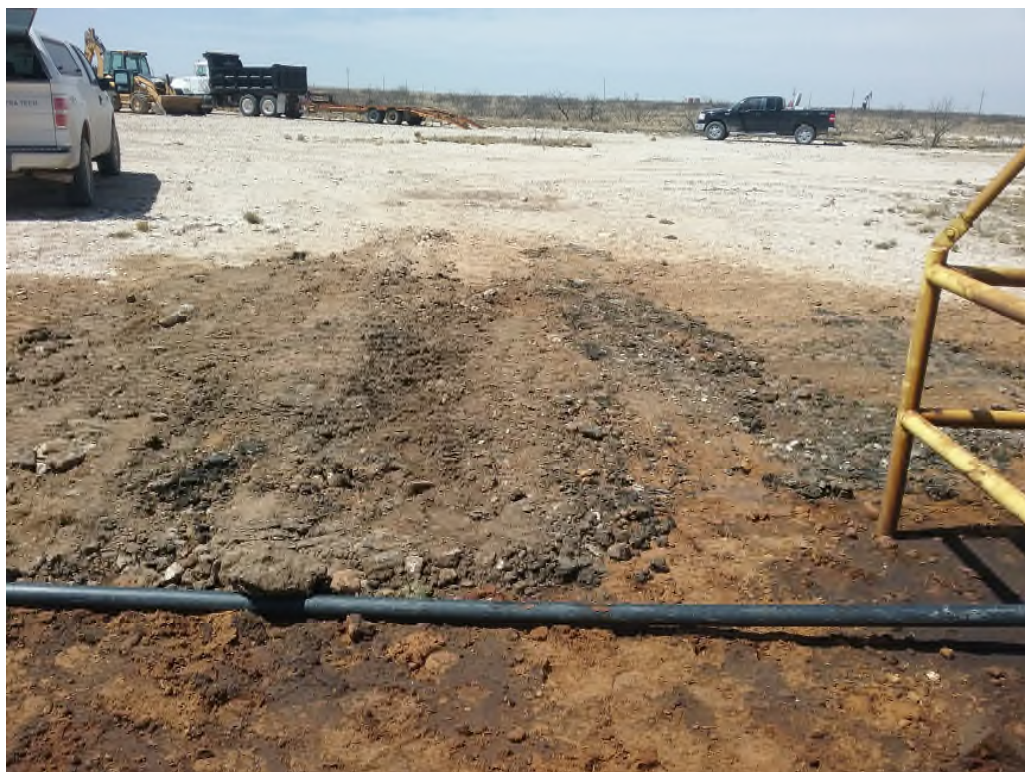
View West – Area of T-2

Based on the laboratory results, Grand Banks proposes to remove the impacted material as highlighted (green) in Table 1 and shown on Figure 4. To remove the soil exceeding the RRAL, the areas of trenches (T-1 through and T-5) will be excavated to approximately 1.0' to 3.0' below surface. The area of trench (T-6) will be excavated to between 3.0' to 4.0' and the area of trench (T-7) will be excavated to 10.0' below surface.

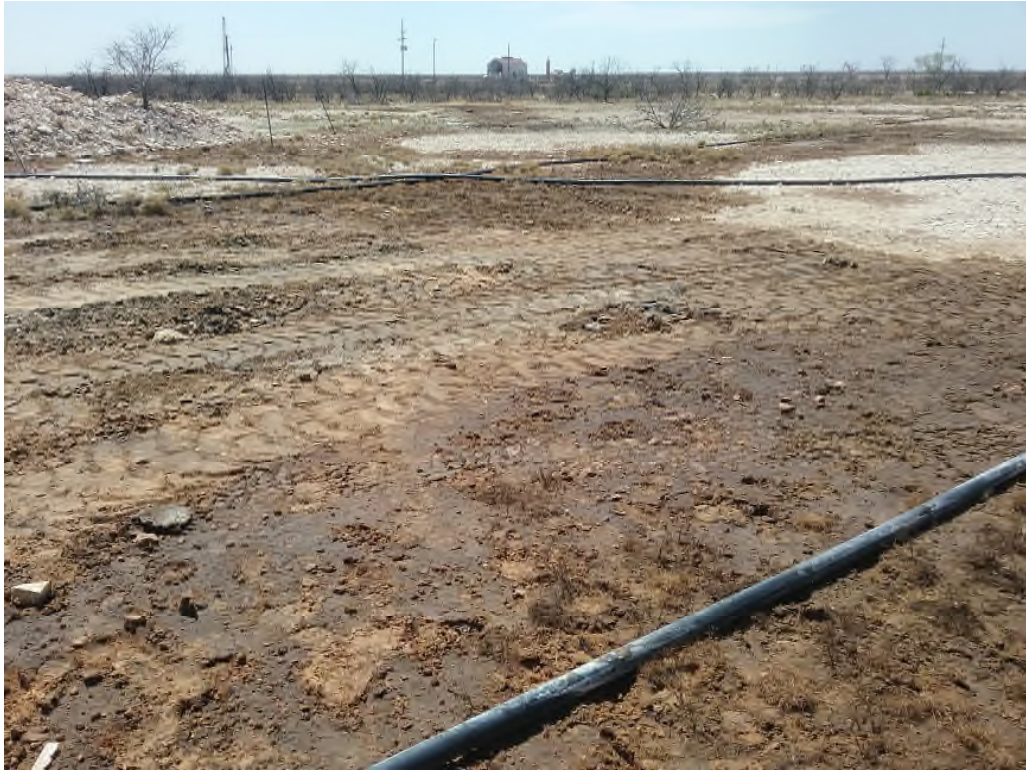
The areas of trenches (T-5 and T-6) showed TPH highs of 34,200 mg/kg and 54,800 mg/kg at 0-1' before declining to below the RRAL at 3.0 and 4.0', respectively. The areas of trenches (T-3 and T-7) were not vertically defined and showed TPH concentrations with bottom trench concentrations of 6,830 mg/kg at 2.0' and 5,590 mg/kg at 10.0' below surface, respectively. Deeper samples were not collected due to a dense formation in the area.

View South – Area of T-3

NMOCD approves of the preliminary delineation for 1RP-4887 & 1RP-4974. The proposed delineation/remediation for T-3 and T-7 area is also approved. Confirmation sidewall and bottom samples are required. Any deferred areas must be identified with GPS coordinates.

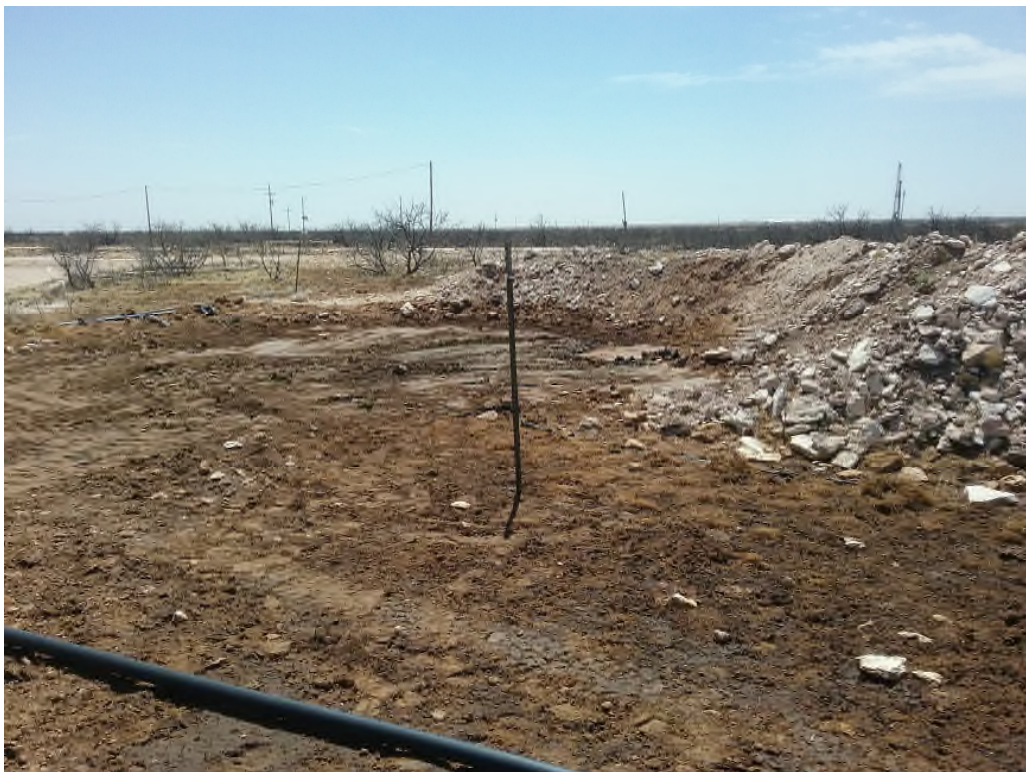
View South – Area of T-4

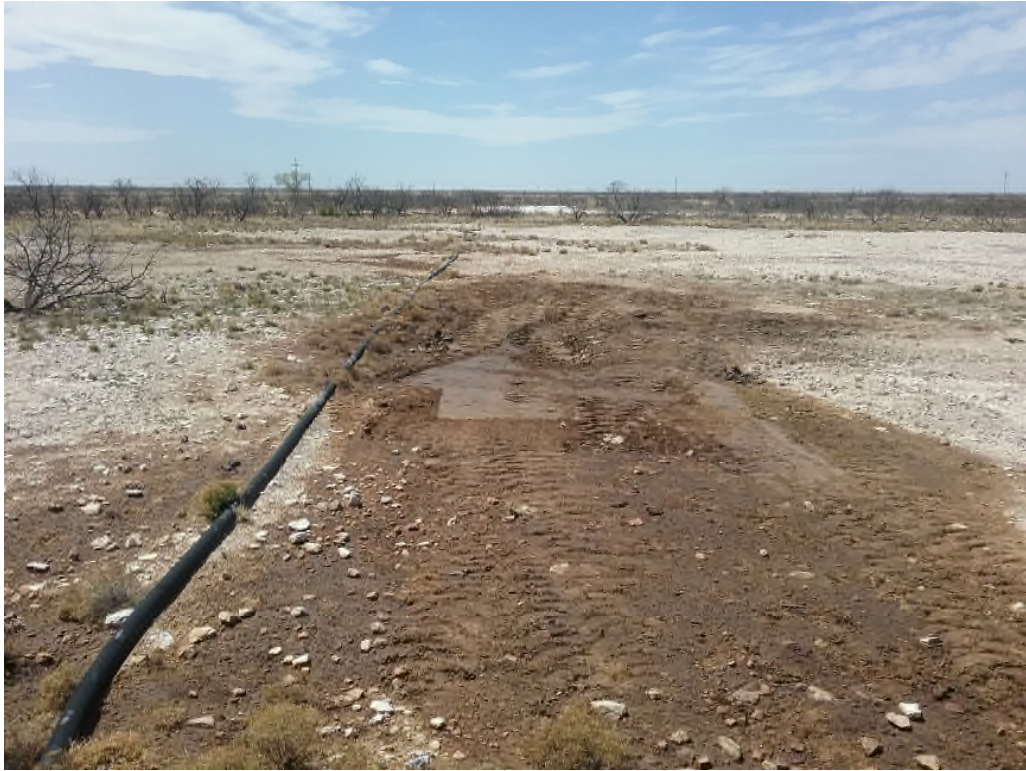
The chloride concentrations detected did not show a significant impact to the soils. The area of trench (T-5) showed chloride concentrations of 748 mg/kg at 0-1' and 808 mg/kg at 2.0', which then declined with depth to 530 mg/kg at 3.0' below surface. None of the other samples collected showed chloride concentrations above the 600 mg/kg threshold.

View Southwest – Area of T-5

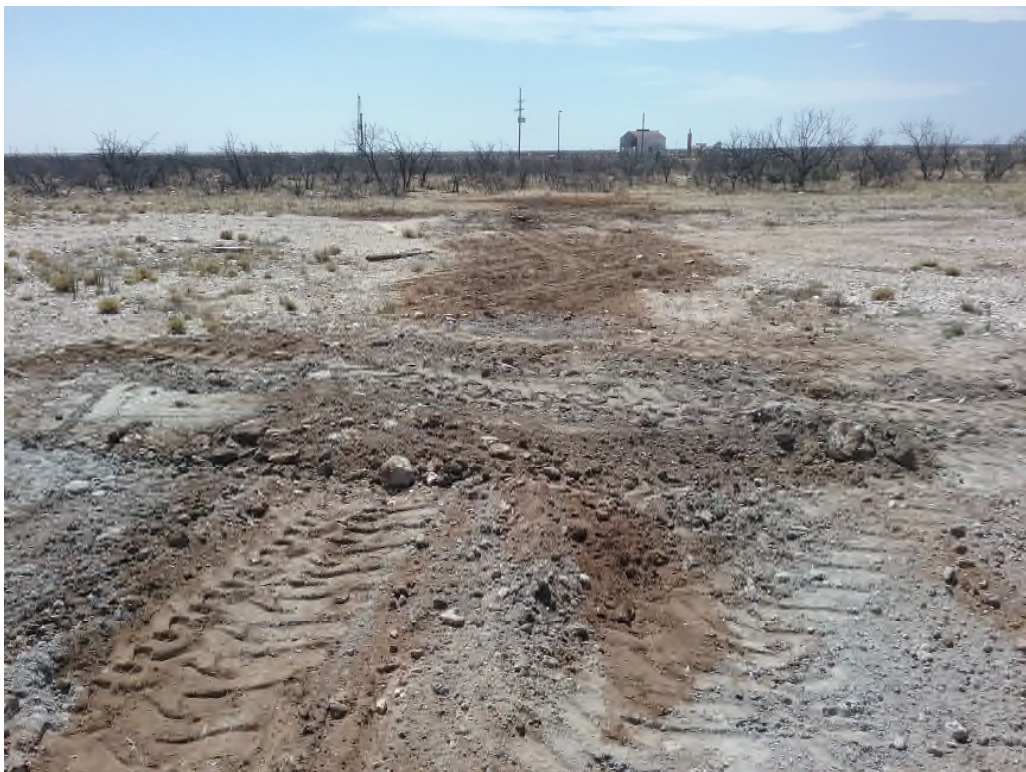
View South – Area of T-6

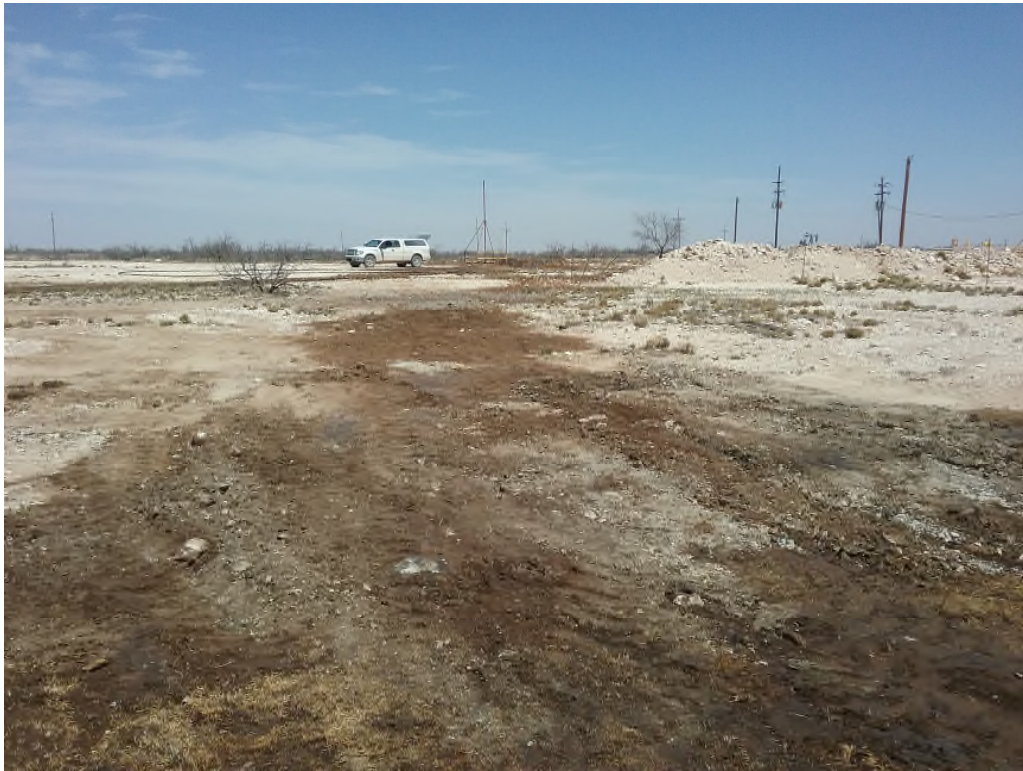
View North – Area of T-7
