**RE: Corrective Action Plan (CAP) Report and Soil Closure Request  
Rice Operating Company – BD SWD System  
BD Jct. F-15 (1R426-255): UL/F, Sec. 15, T21S, R37E**

# BD Jct. F-15

Unit F, Sec. 15, T21S, R37E

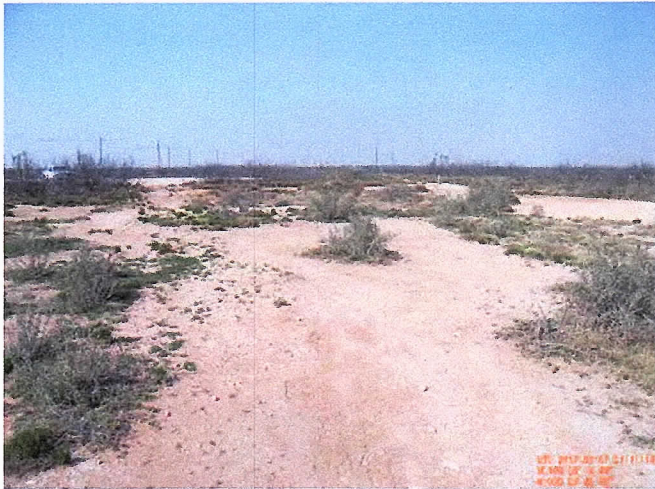
Site prior, facing north

3/7/2017

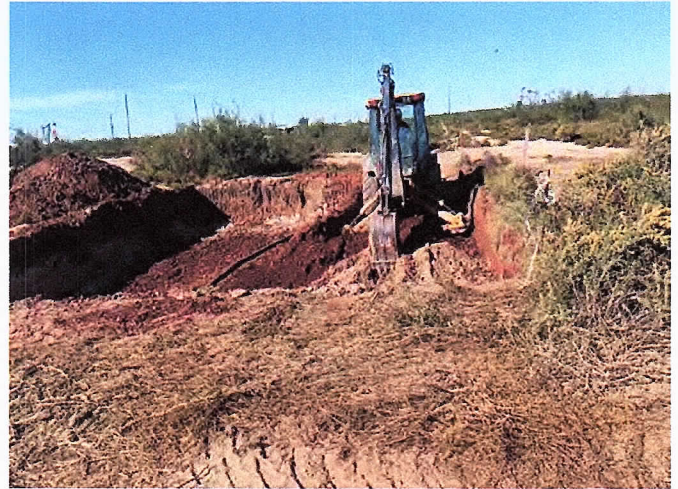
Excavating the site to 5 ft bgs, facing north

10/23/2017

In order to inhibit the downward migration of residual constituents through the vadose zone, ROC installed a 20-mil reinforced poly liner across the site with the dimensions of 35 x 50 ft, which covered the previously installed 30 x 30 ft clay liner. A total of 396 cubic yards of excavated soil were taken to a NMOCD approved facility for disposal. The bottom of the excavation was padded with 6 inches imported blow sand and a 20-mil reinforced liner was installed and properly seated at 4.5 ft bgs. The top of the liner was padded with 6 inches of imported blow sand, and the excavation was backfilled to ground surface with blended backfill soil and imported top soil. A sample of the blended backfill and a sample of the imported top soil were field tested for hydrocarbons using a PID, resulting in readings of 0.5 and 1.1 ppm, respectively. Each sample was sent to a commercial laboratory for analysis of chloride and returned a result of 16 mg/kg and <16 mg/kg, respectively. The backfilled site was then seeded with a blend of native vegetation. Vegetation above the liner will also provide a natural infiltration barrier for the site, since plants capture water through their roots thereby reducing the volume of water moving through the vadose zone. Documentation of this work is included in the Appendix.

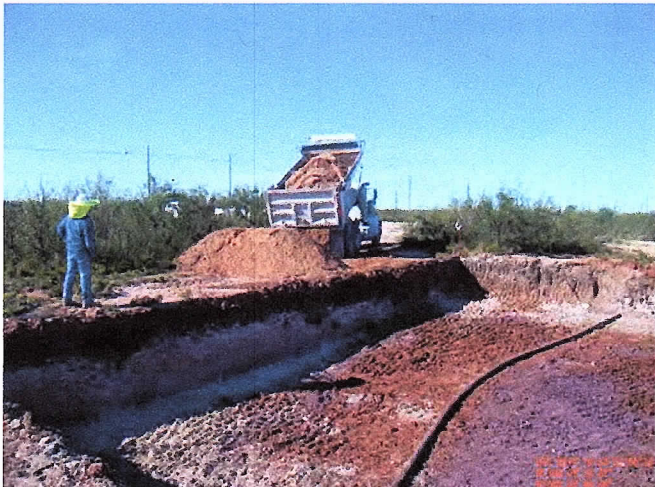
Excavation complete to a depth of 5-ft bgs and importing soil, facing northwest

10/30/2017

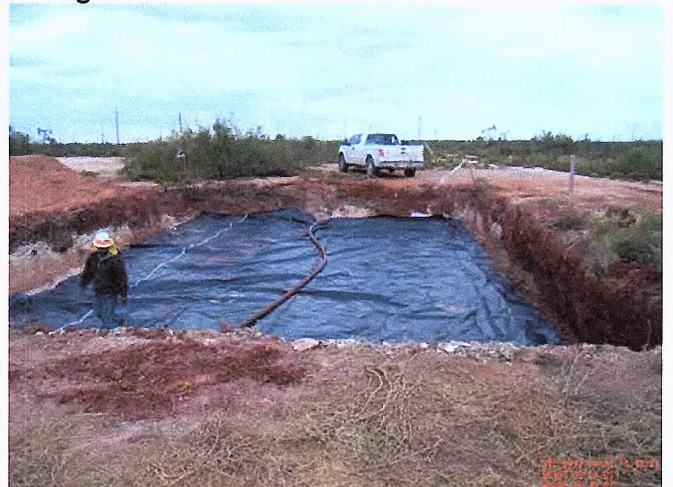
20-mil reinforced liner installed at 4.5 ft bgs, facing north

10/31/2017

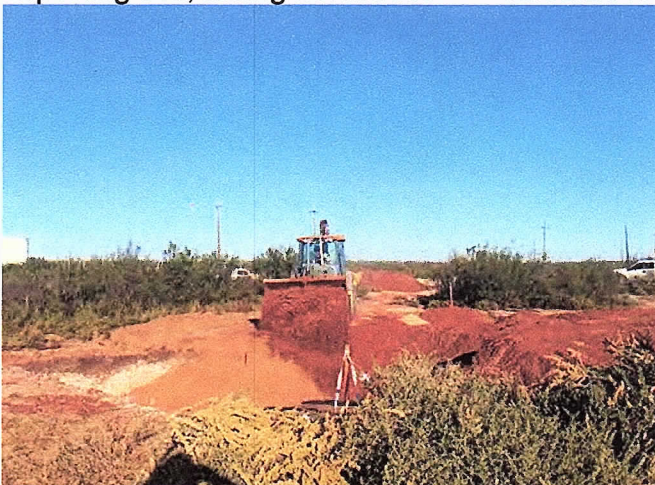
Backfilling above the liner, facing southeast

11/1/2017

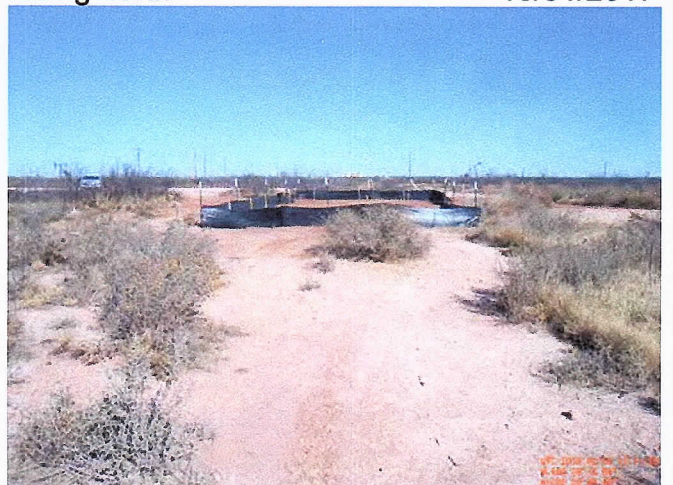
Site complete, facing north

2/8/2018
