**RE: Corrective Action Plan (CAP) Report and Soil Closure Request  
Rice Operating Company – BD SWD System  
BD Jct. B-1 (1R426-256): UL/B, Sec. 1, T22S, R36E**

# BD Jct. B-1

Unit B, Section 1, T22S, R36E

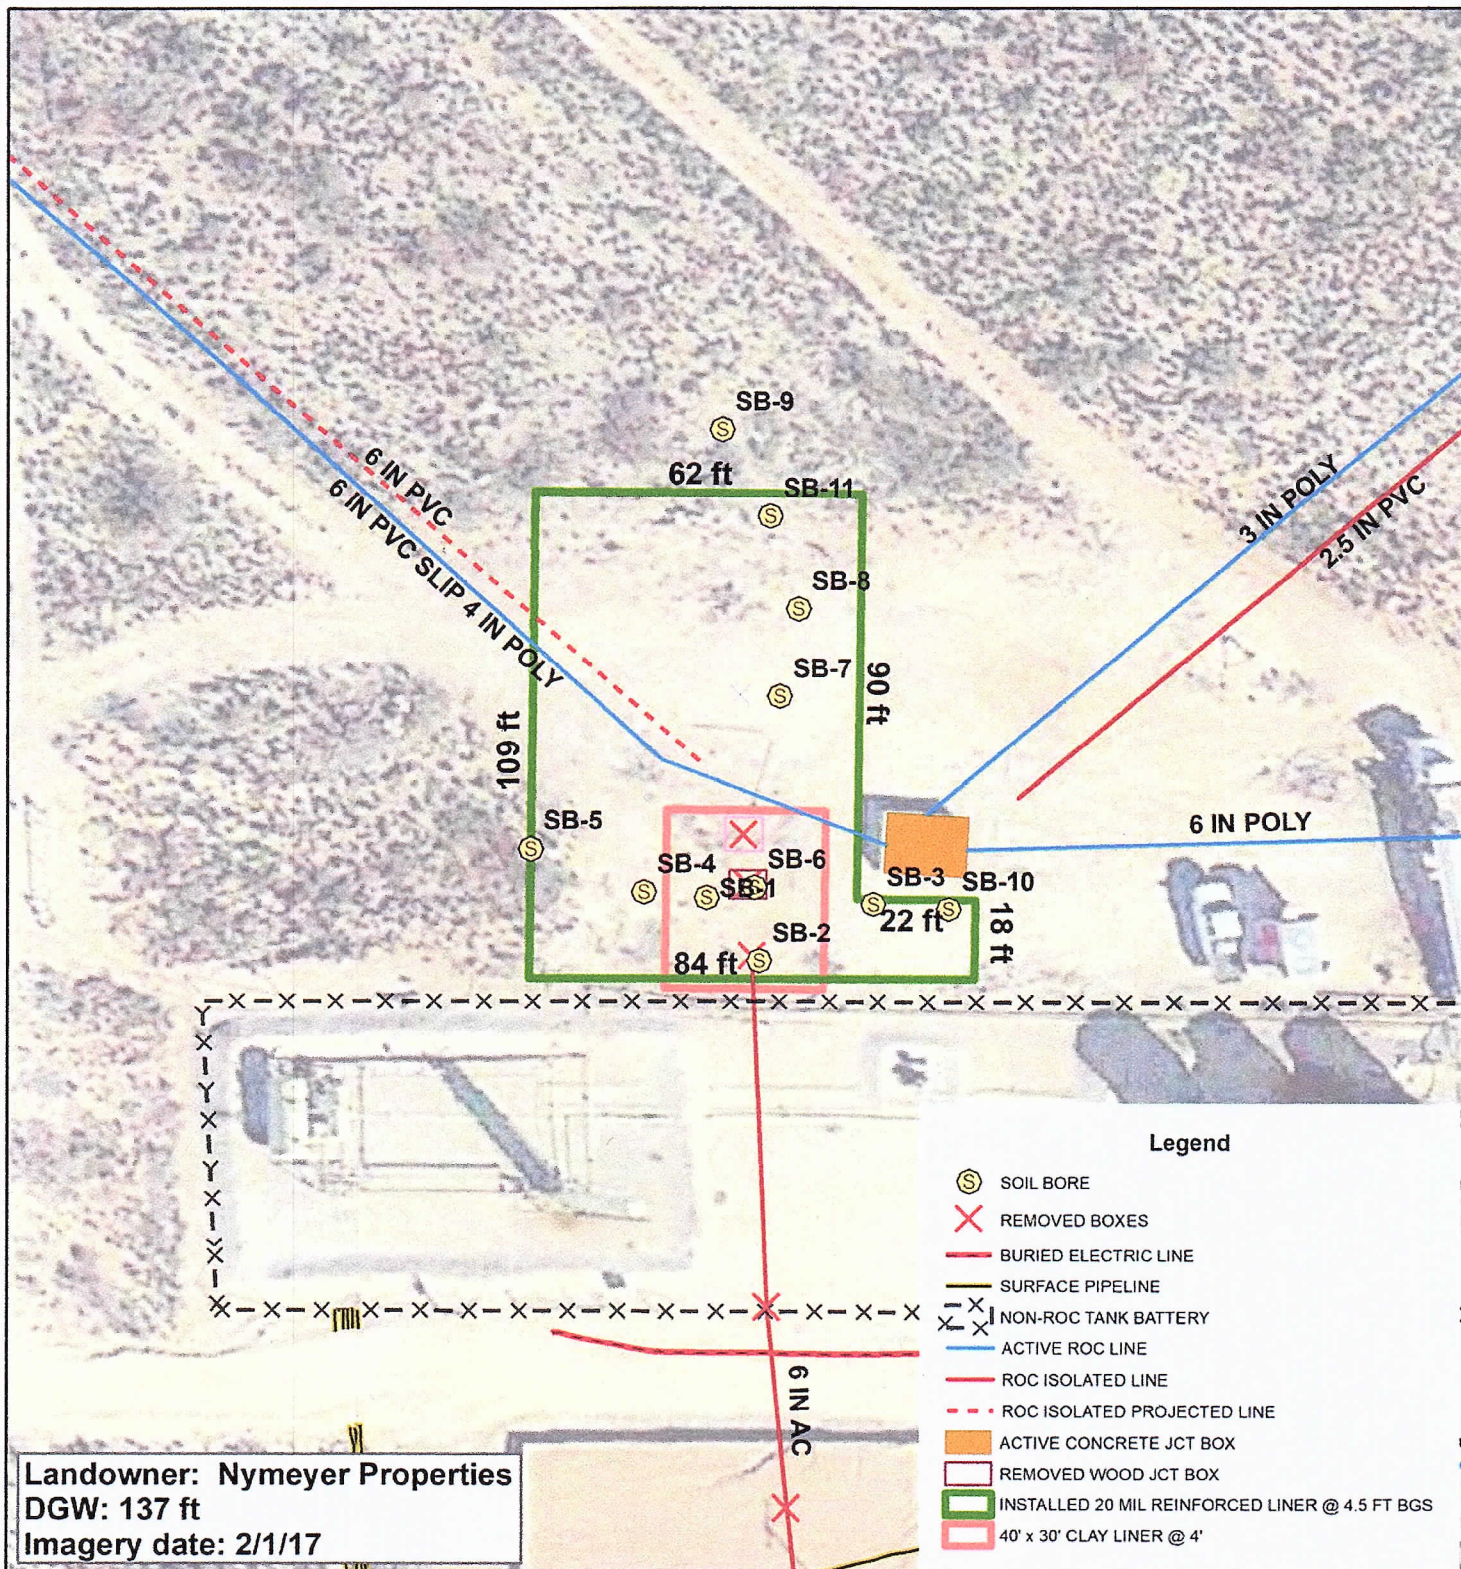
# Installed Liner

In order to inhibit the downward migration of residual constituents through the vadose zone, ROC installed a 20-mil reinforced poly liner across the site with the dimensions of approximately 62 x 109 ft, which covered the existing 30x40-ft clay liner. A total of 1,524 cubic yards of excavated soil were taken to a NMOCD approved facility for disposal. The bottom of the excavation was padded with 6 inches imported blow sand and a 20-mil reinforced liner was installed and properly seated at 4.5 ft bgs. The top of the liner was padded with 6 inches of imported blow sand, and the excavation was backfilled to ground surface with imported top soil (a total of 1,560 cubic yards of imported soils). A sample of the imported blow sand and a sample of the imported top soil were field tested for hydrocarbons using a PID, each resulting in readings of 0.2 ppm, 0.2 ppm, respectively. Each sample was sent to a commercial laboratory for analysis of chloride and returned a result of <16 mg/kg, and 16 mg/kg, respectively. The backfilled site was then seeded with a blend of native vegetation. Vegetation above the liner will also provide a natural infiltration barrier for the site, since plants capture water through their roots thereby reducing the volume of water moving through the vadose zone. Documentation of this work is included in the Appendix.

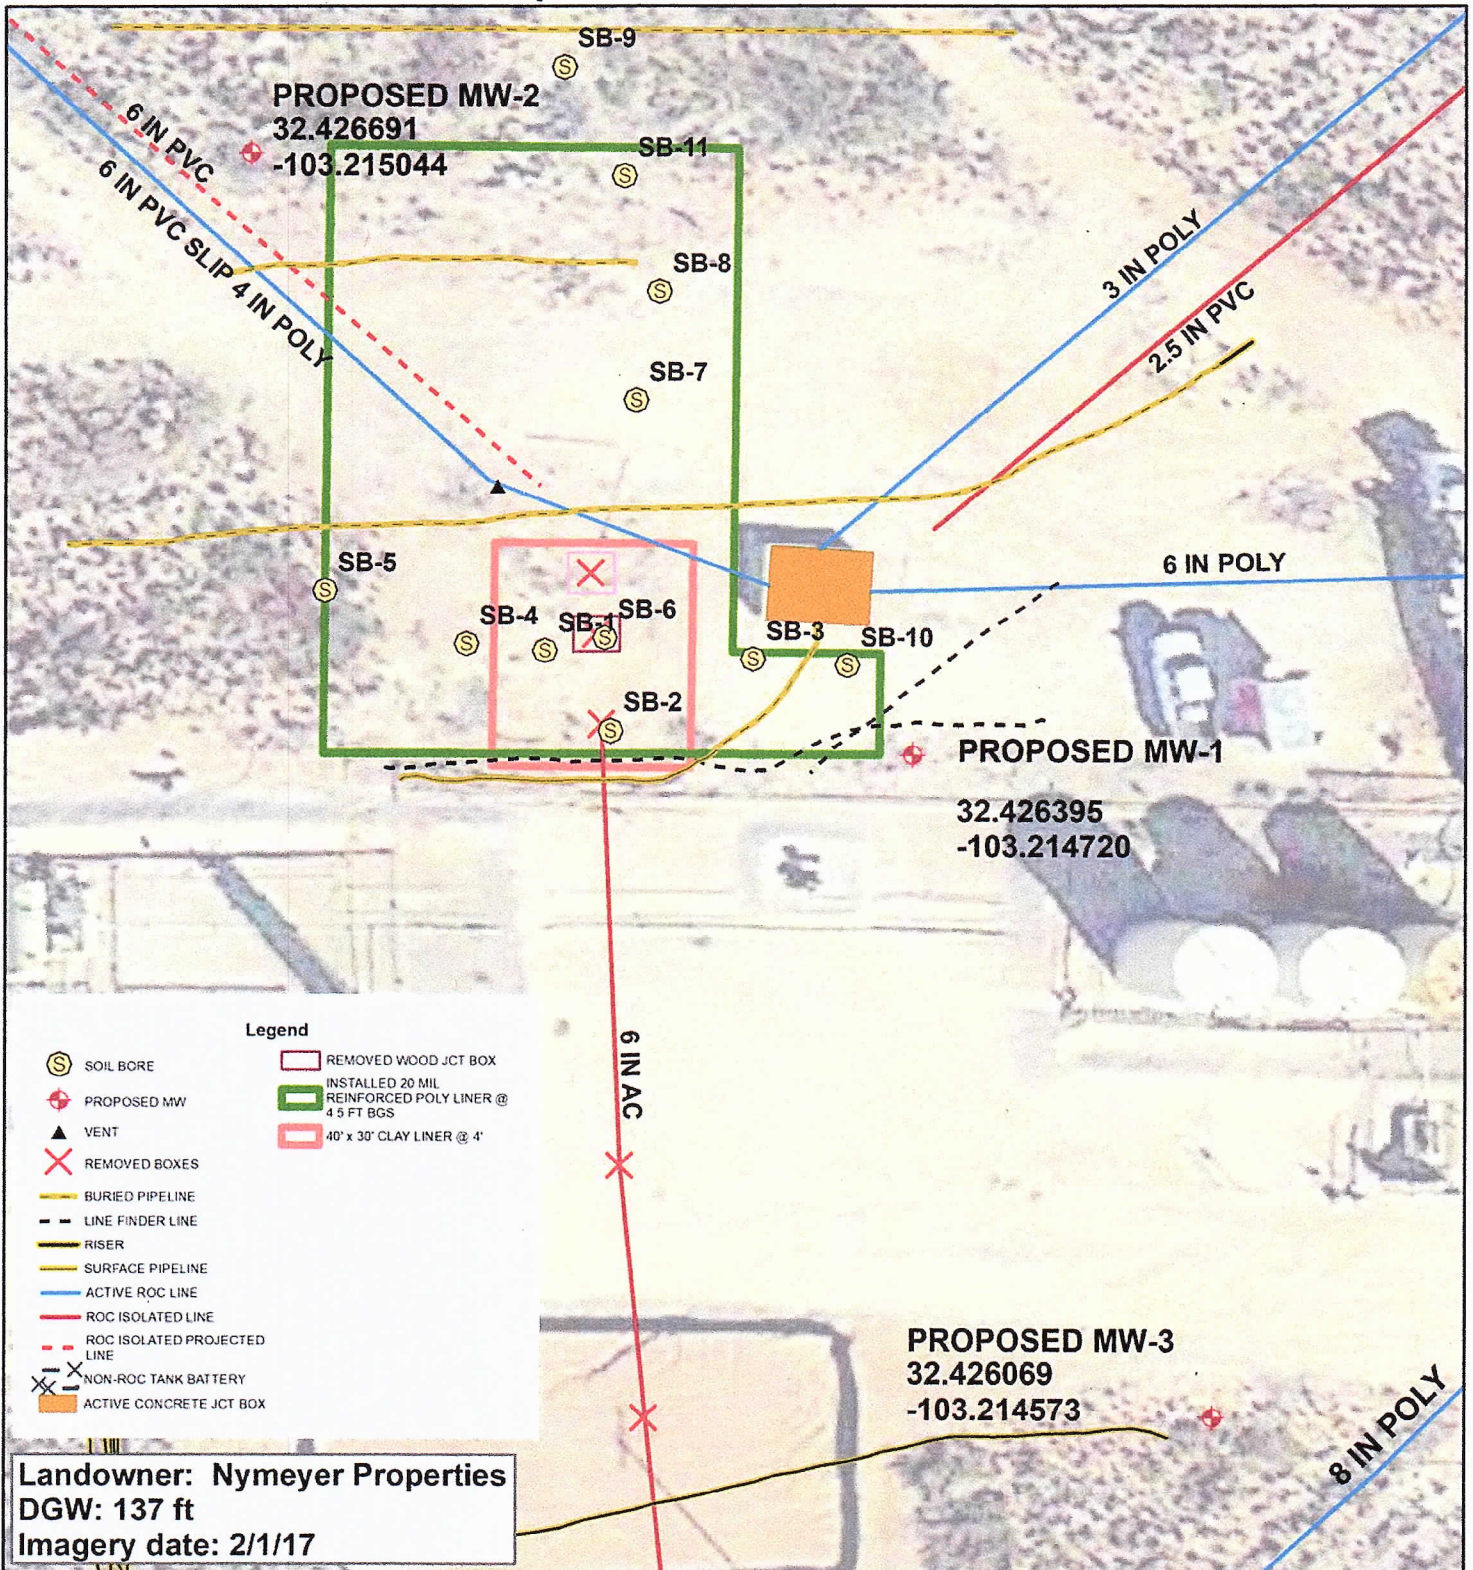
# Proposed Monitor Wells

In order to determine what affect the residual chlorides may have had on the groundwater quality below the site, BEST recommends that ROC install a near-source monitor well (MW-1) located approximately 60 feet down-gradient of the former junction box. To determine if there is an up-gradient source of contaminates coming onto the site, MW-2 will be installed approximately 90 feet up-gradient of the former junction box. Also, an additional monitoring well will be installed approximately 170 feet downgradient of the former junction box (see Proposed MW Locations). Additional monitoring wells may be required to fully delineate groundwater quality. The monitor wells will be installed to NMOCD and EPA standards and then sampled quarterly. Once the monitor wells at the site have been analyzed for chloride and BTEX readings, ROC will either submit a groundwater remedy to NMOCD to address groundwater quality at the site or submit a termination request for site closure.

Underground facilities are  
spatially projected  
and need to be field verified.

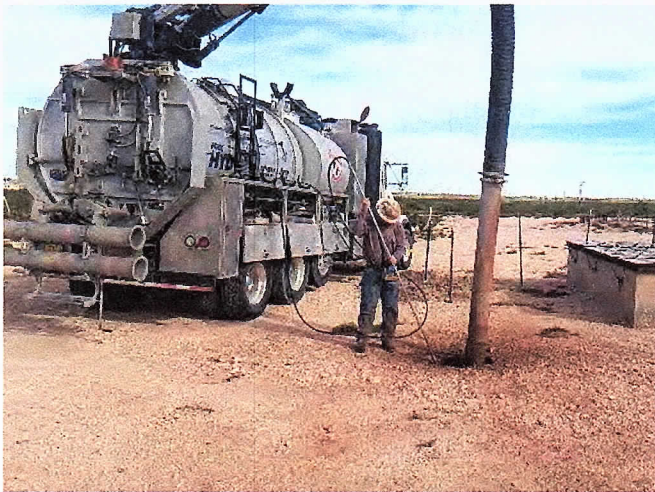
11/6/2017

Spotting lines with hydrovac,  
facing east

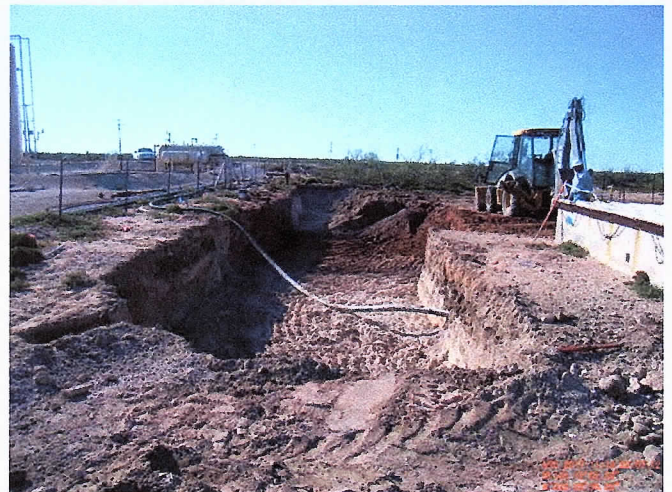
11/14/2017

Excavating the site to 5 ft bgs,  
facing west

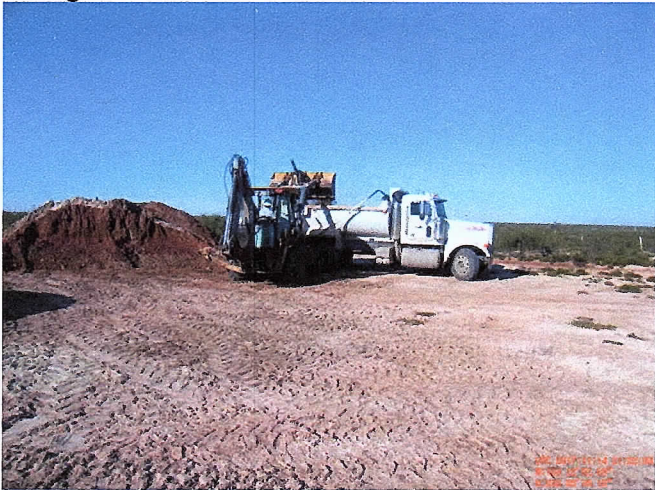
11/14/2017

Exporting excavated soil,  
facing northwest

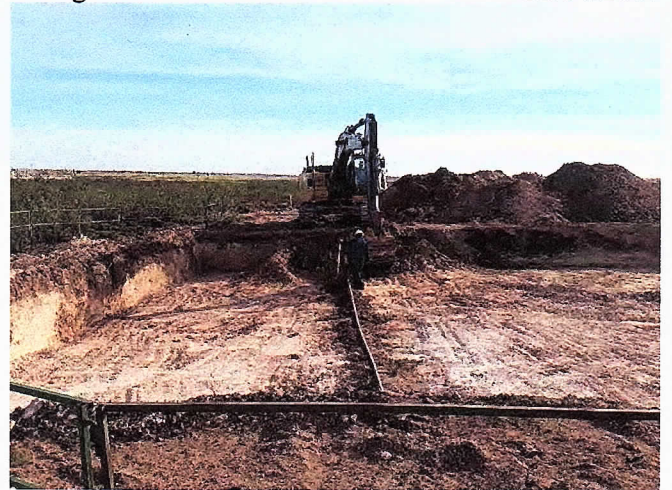
11/22/2017

Excavating the site, facing east

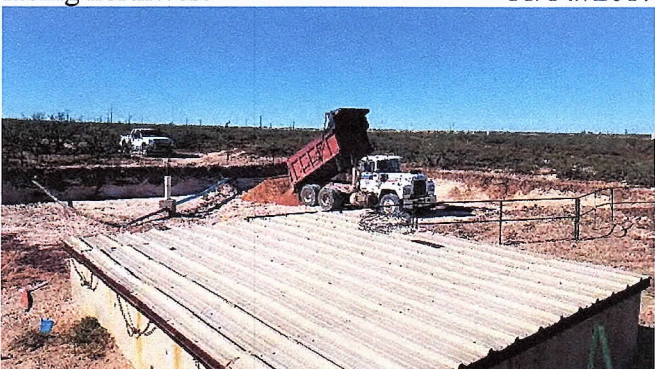
11/27/2017

Importing blow sand, facing northwest

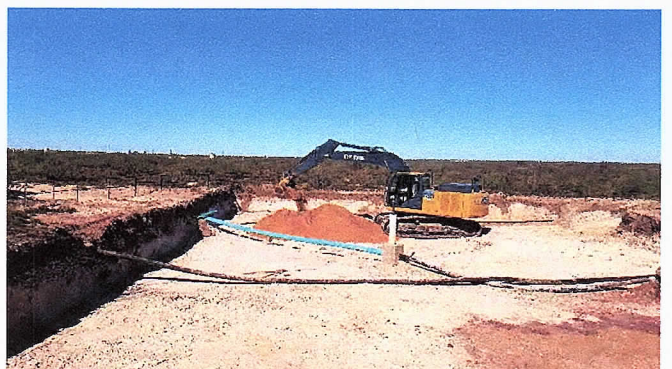
11/27/2017

Padding excavation with imported blow sand,  
facing north

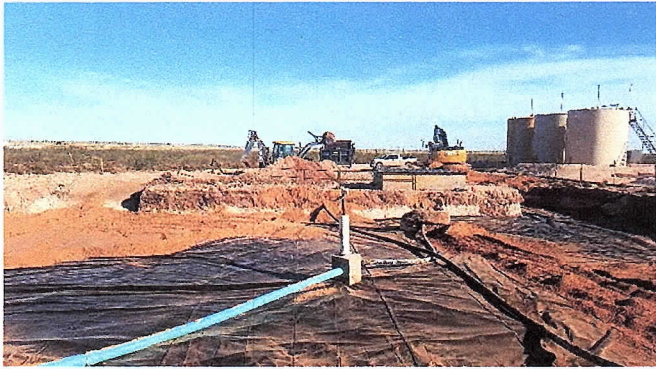
Padding the 20-mil, reinforced liner with imported  
blow sand, facing east 11/29/2017

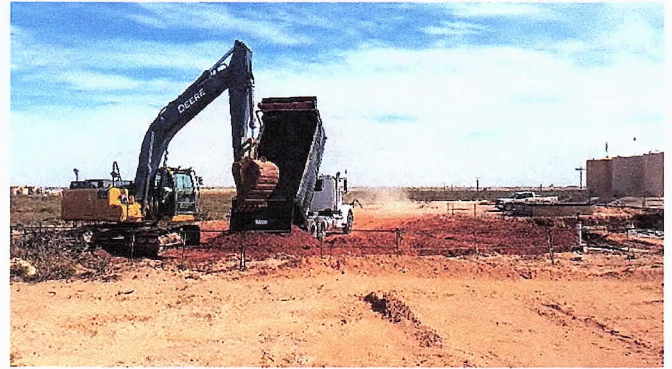
Completing backfill, facing east 12/4/2017

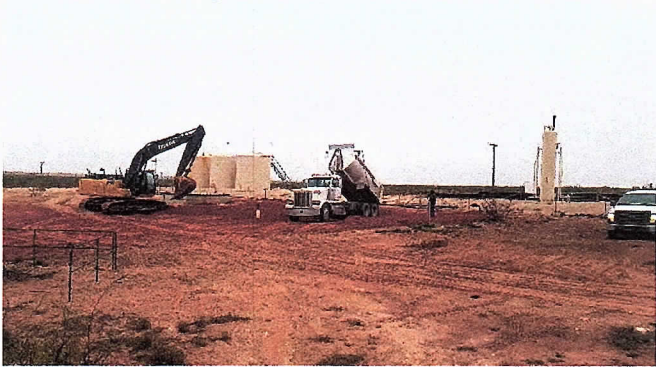
Backfilling the excavation with imported soil,  
facing southwest 12/6/2017

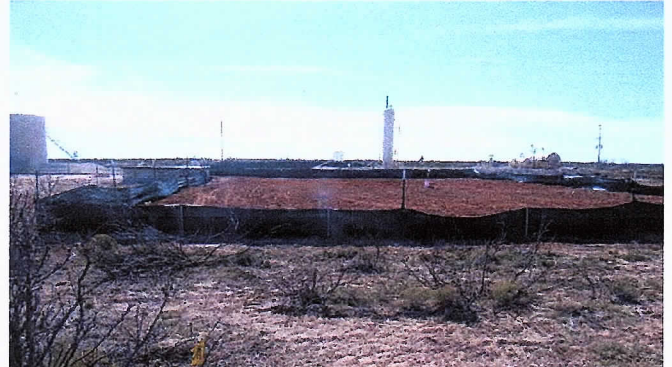
Site seeded, and silt net fence installed,  
facing south 12/18/2017
