# **Site Investigation Report & Corrective Action Plan**

**Everest 2 State #1**

**Lea County, New Mexico**

**Project: 17-461**

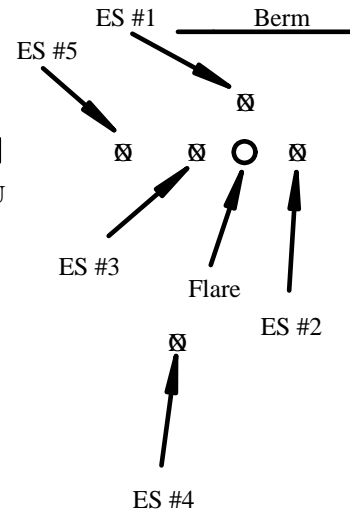
## **FIGURE 1**

On August 30<sup>th</sup>, 2017 approximately 60 barrels of produced water were released as a result of power failure. Electrical power was lost and the air compressor used to supply air to the controls on the separator was not operable. As a result, the produced water carried over and was released near the flare. Approximately 57 barrels of produced water were recovered. The impacted area was estimated to be about 3,750 square feet (**Figure 1 and Appendix A**). A copy of the C-141 is provided as (**Figure 2**).

**Impacted Area**

400 Barrel Storage Tanks

3 Phase Separator

VRU

Soil Pile

Based on this information, and since none of the analytical results indicate that there are soils impacted above the suggested cleanup levels, there is no further action required.

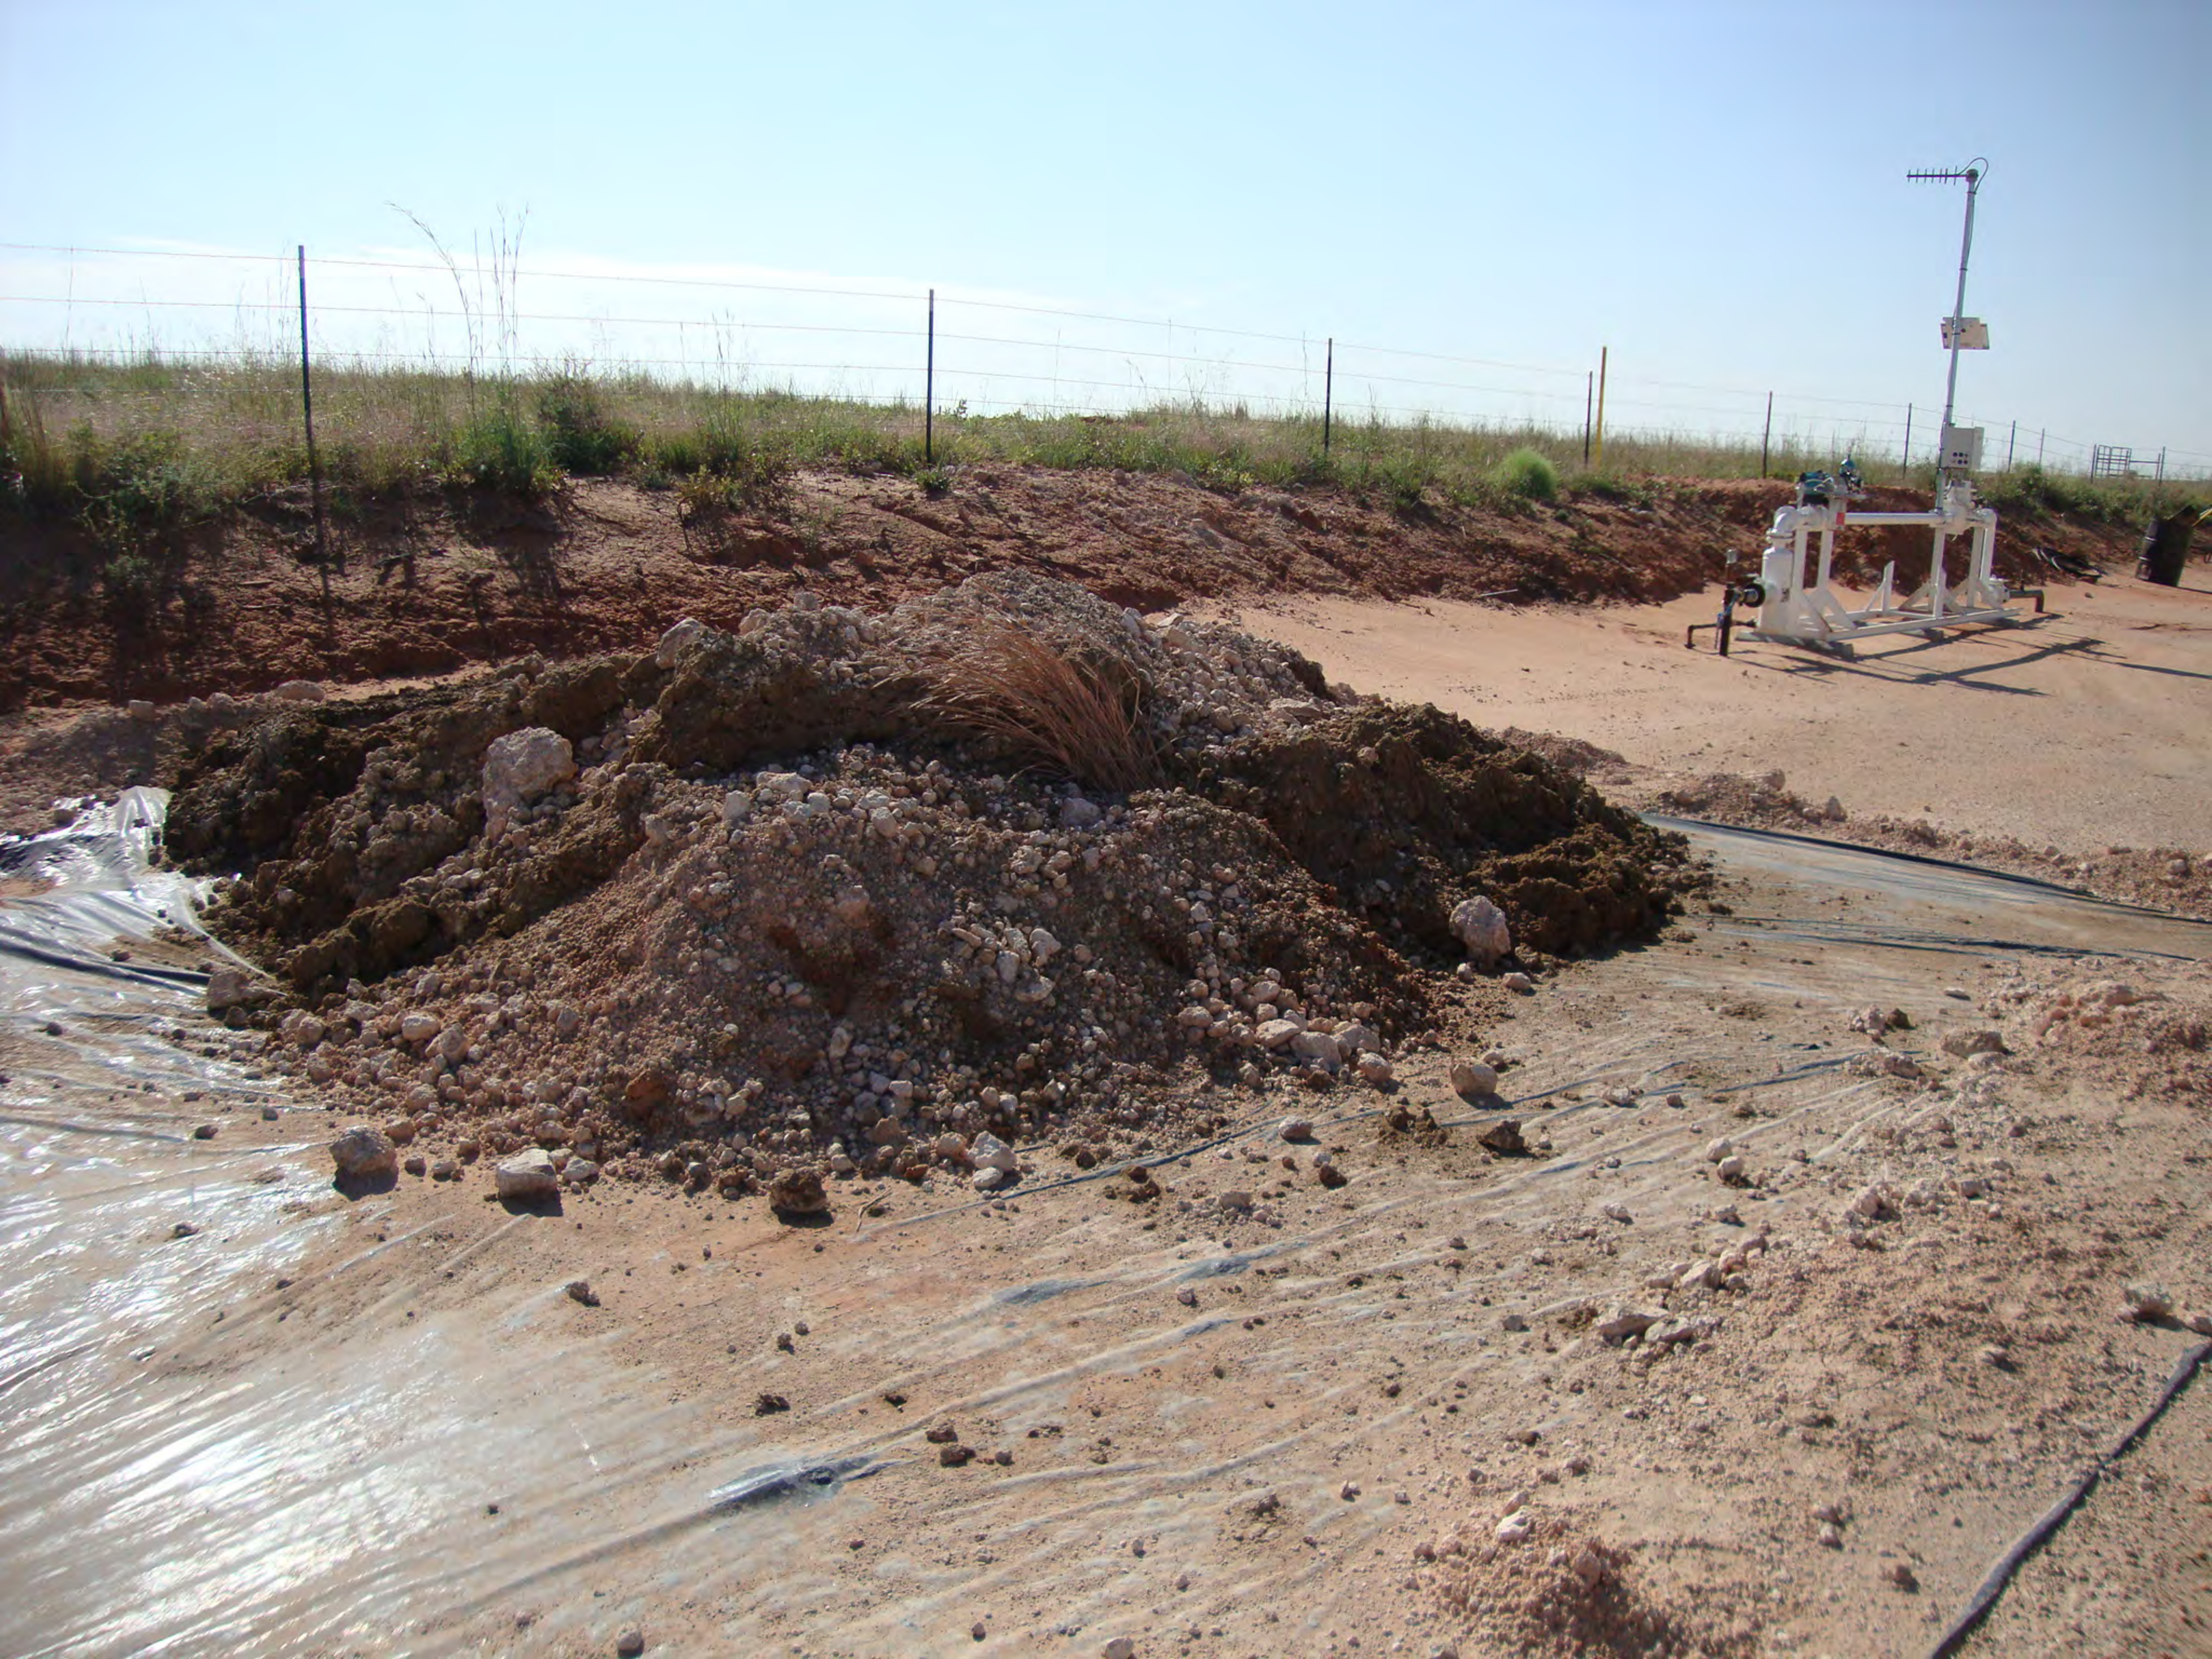
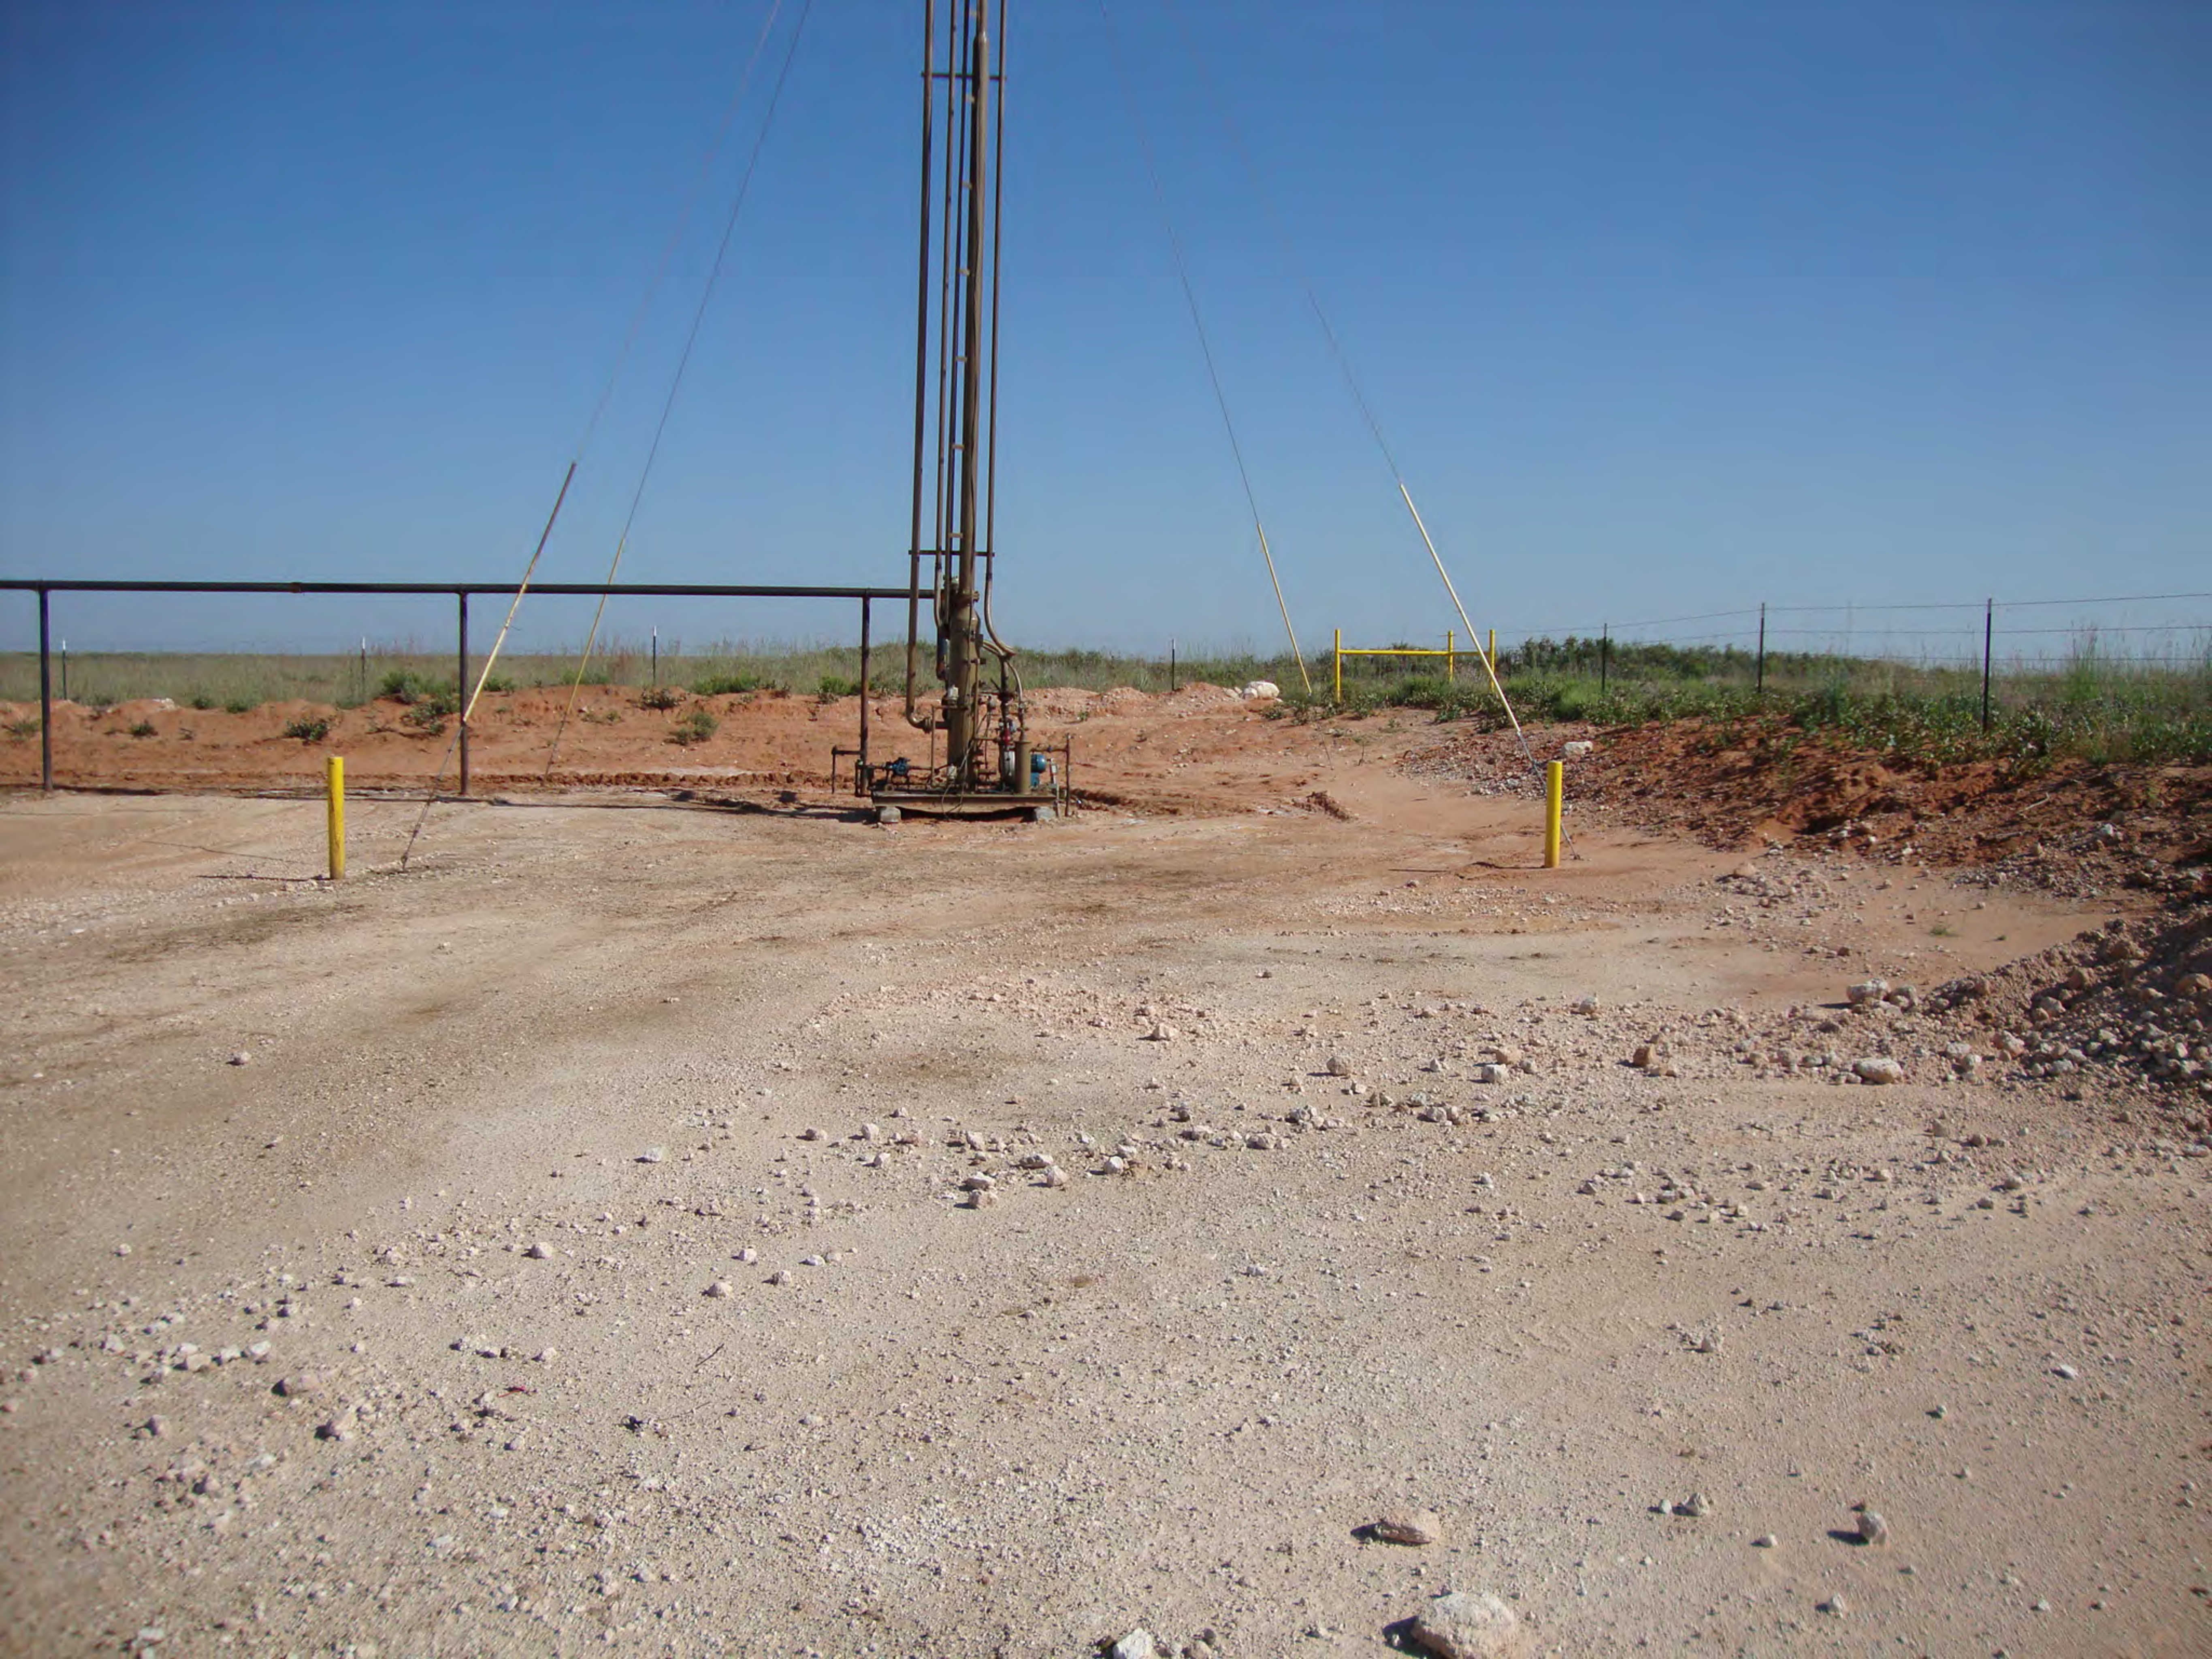
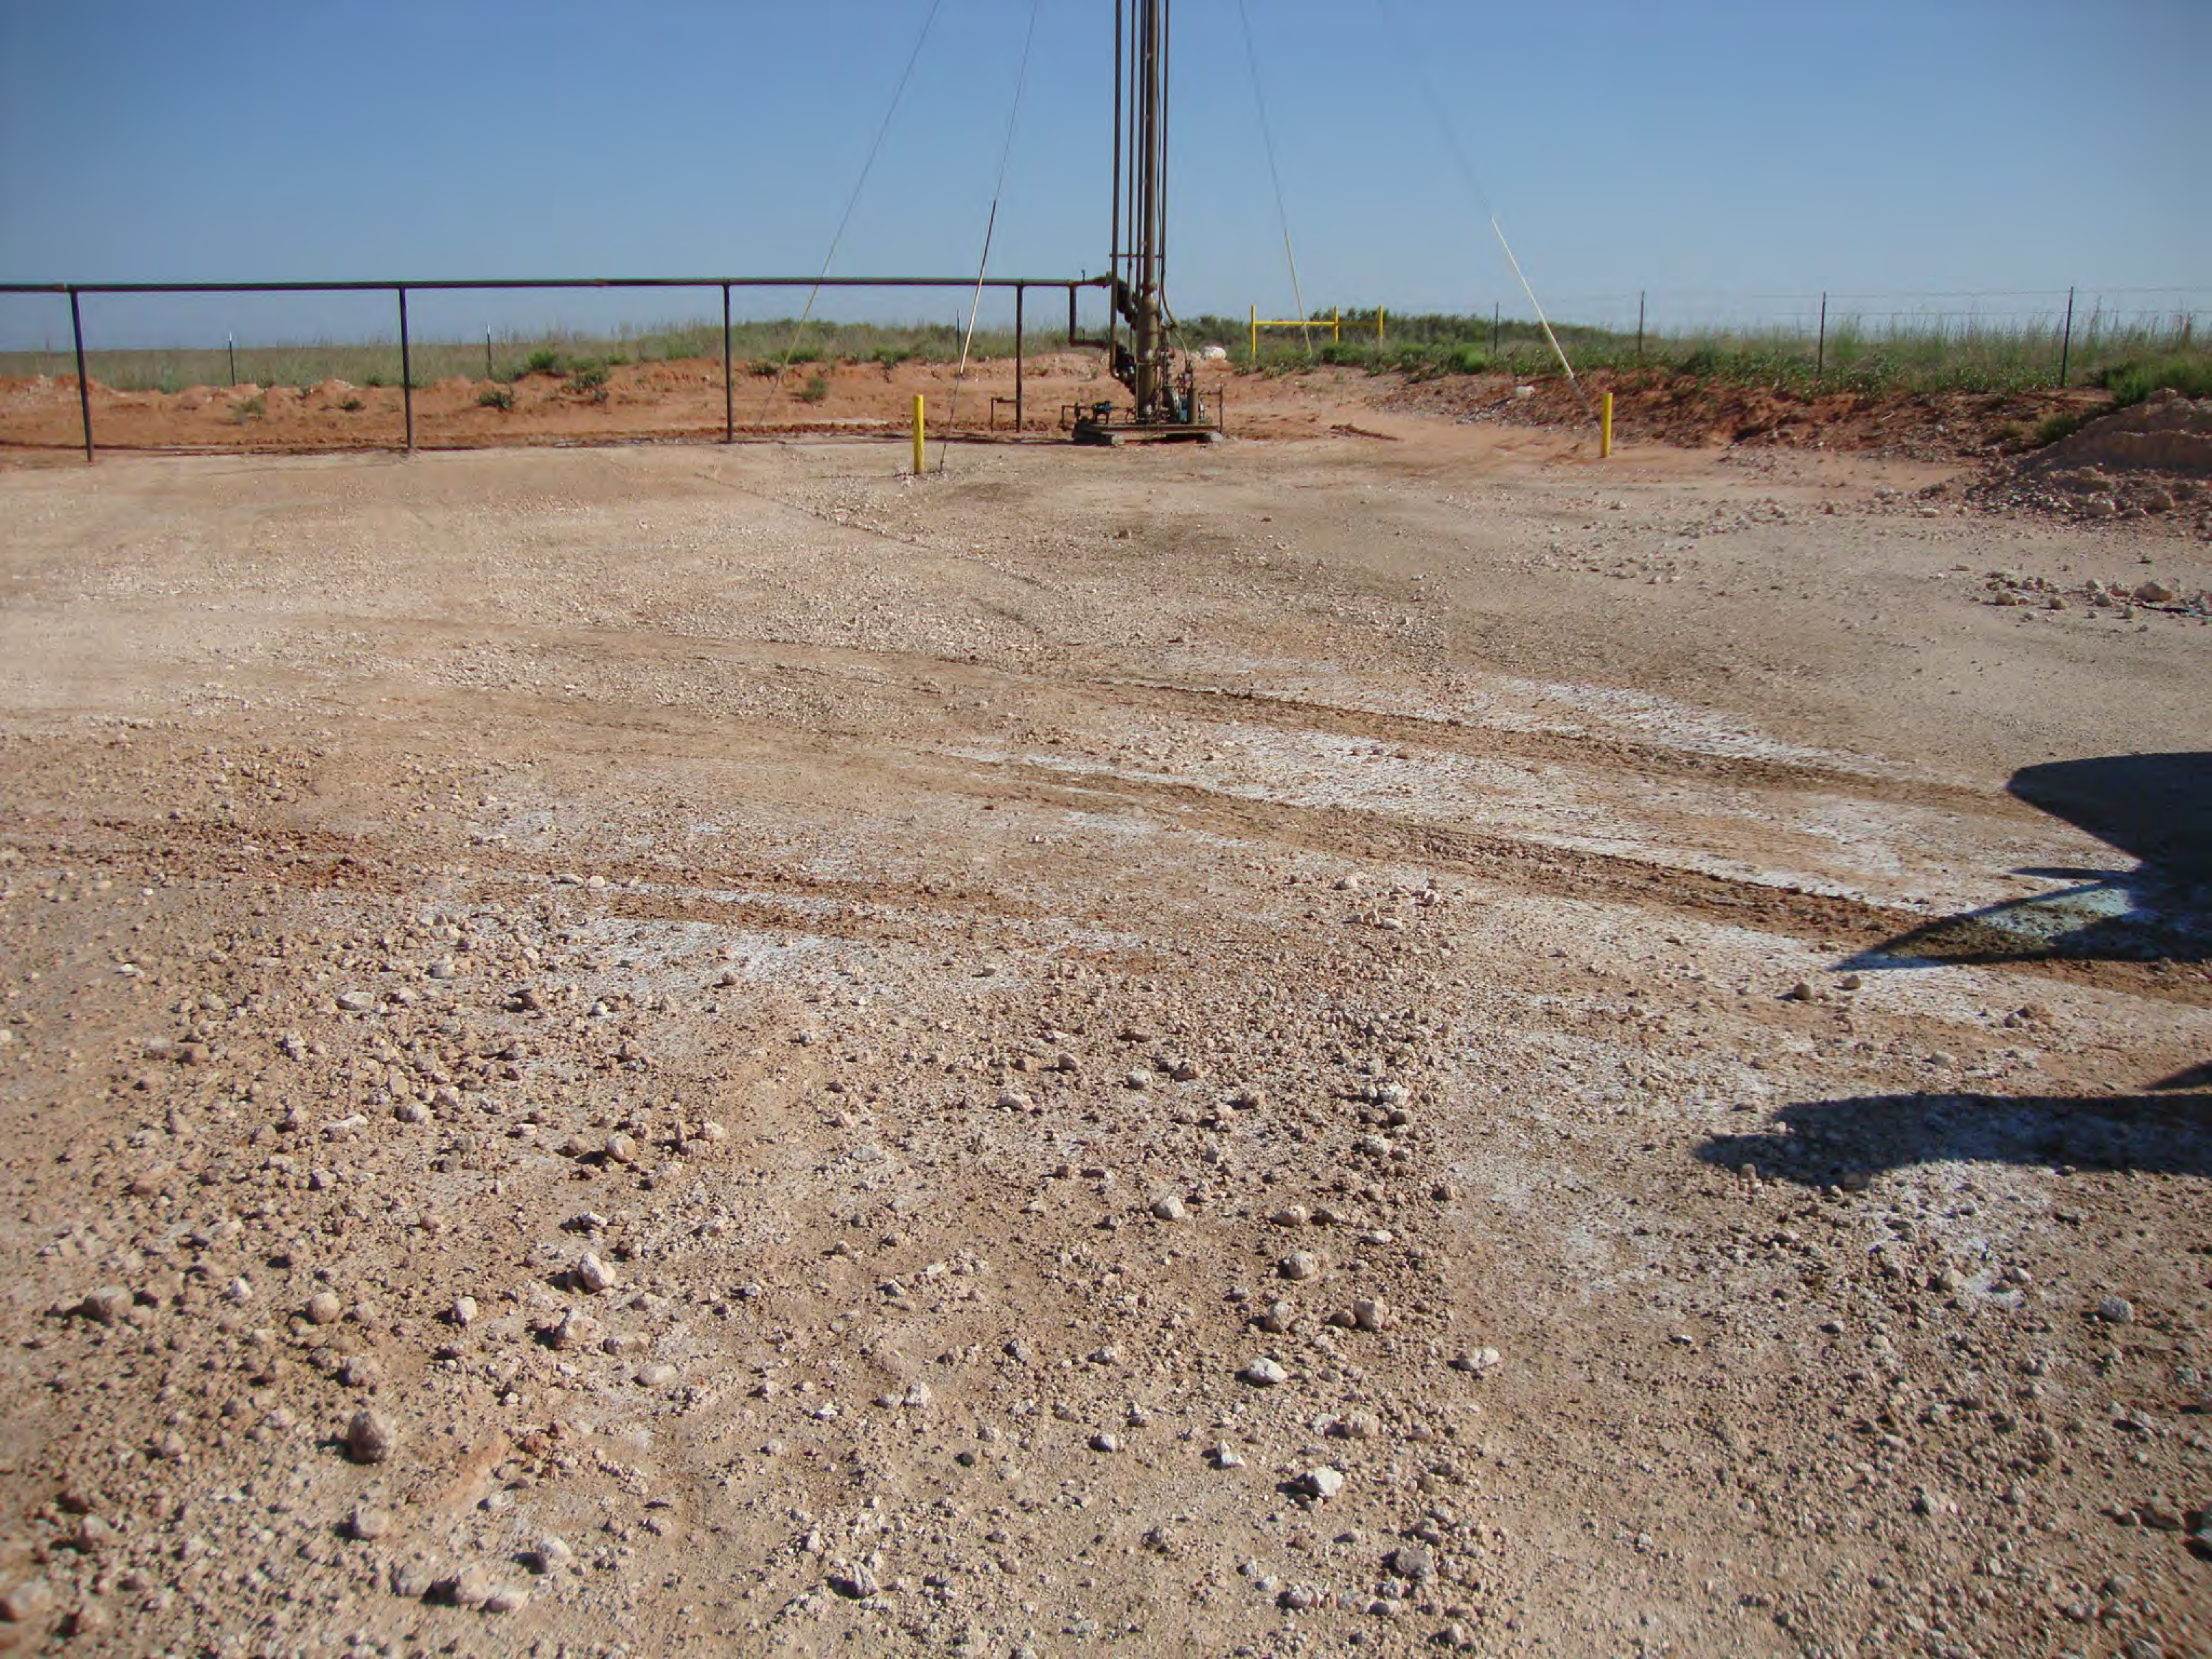
### **Impacted Area Photographs**

2. Kane personnel, Nathan Harvey and Alan Kane, P.E. began the site investigation at 9:30am on September 13<sup>th</sup>, 2017 (**Appendix D**). Photographs were taken of the impacted areas (**Appendix A**).

ROCKCLIFF OPERATING NEW MEXICO LLC  
EVEREST 2 STATE 01H  
UNIT D, SEC.2-T9S-R34E  
LEA COUNTY, NEW MEXICO  
API #30-025-43450  
EMERGENCY PH # (318)459-2382
