**Devon Energy Production Co LP
Falcon 32 State 1 Battery
Work Plan**

**Unit Letter F, Section 32, T23S, R32E
Lea County, New Mexico**

**30-025-33001
1RP-4947**

April 17, 2018

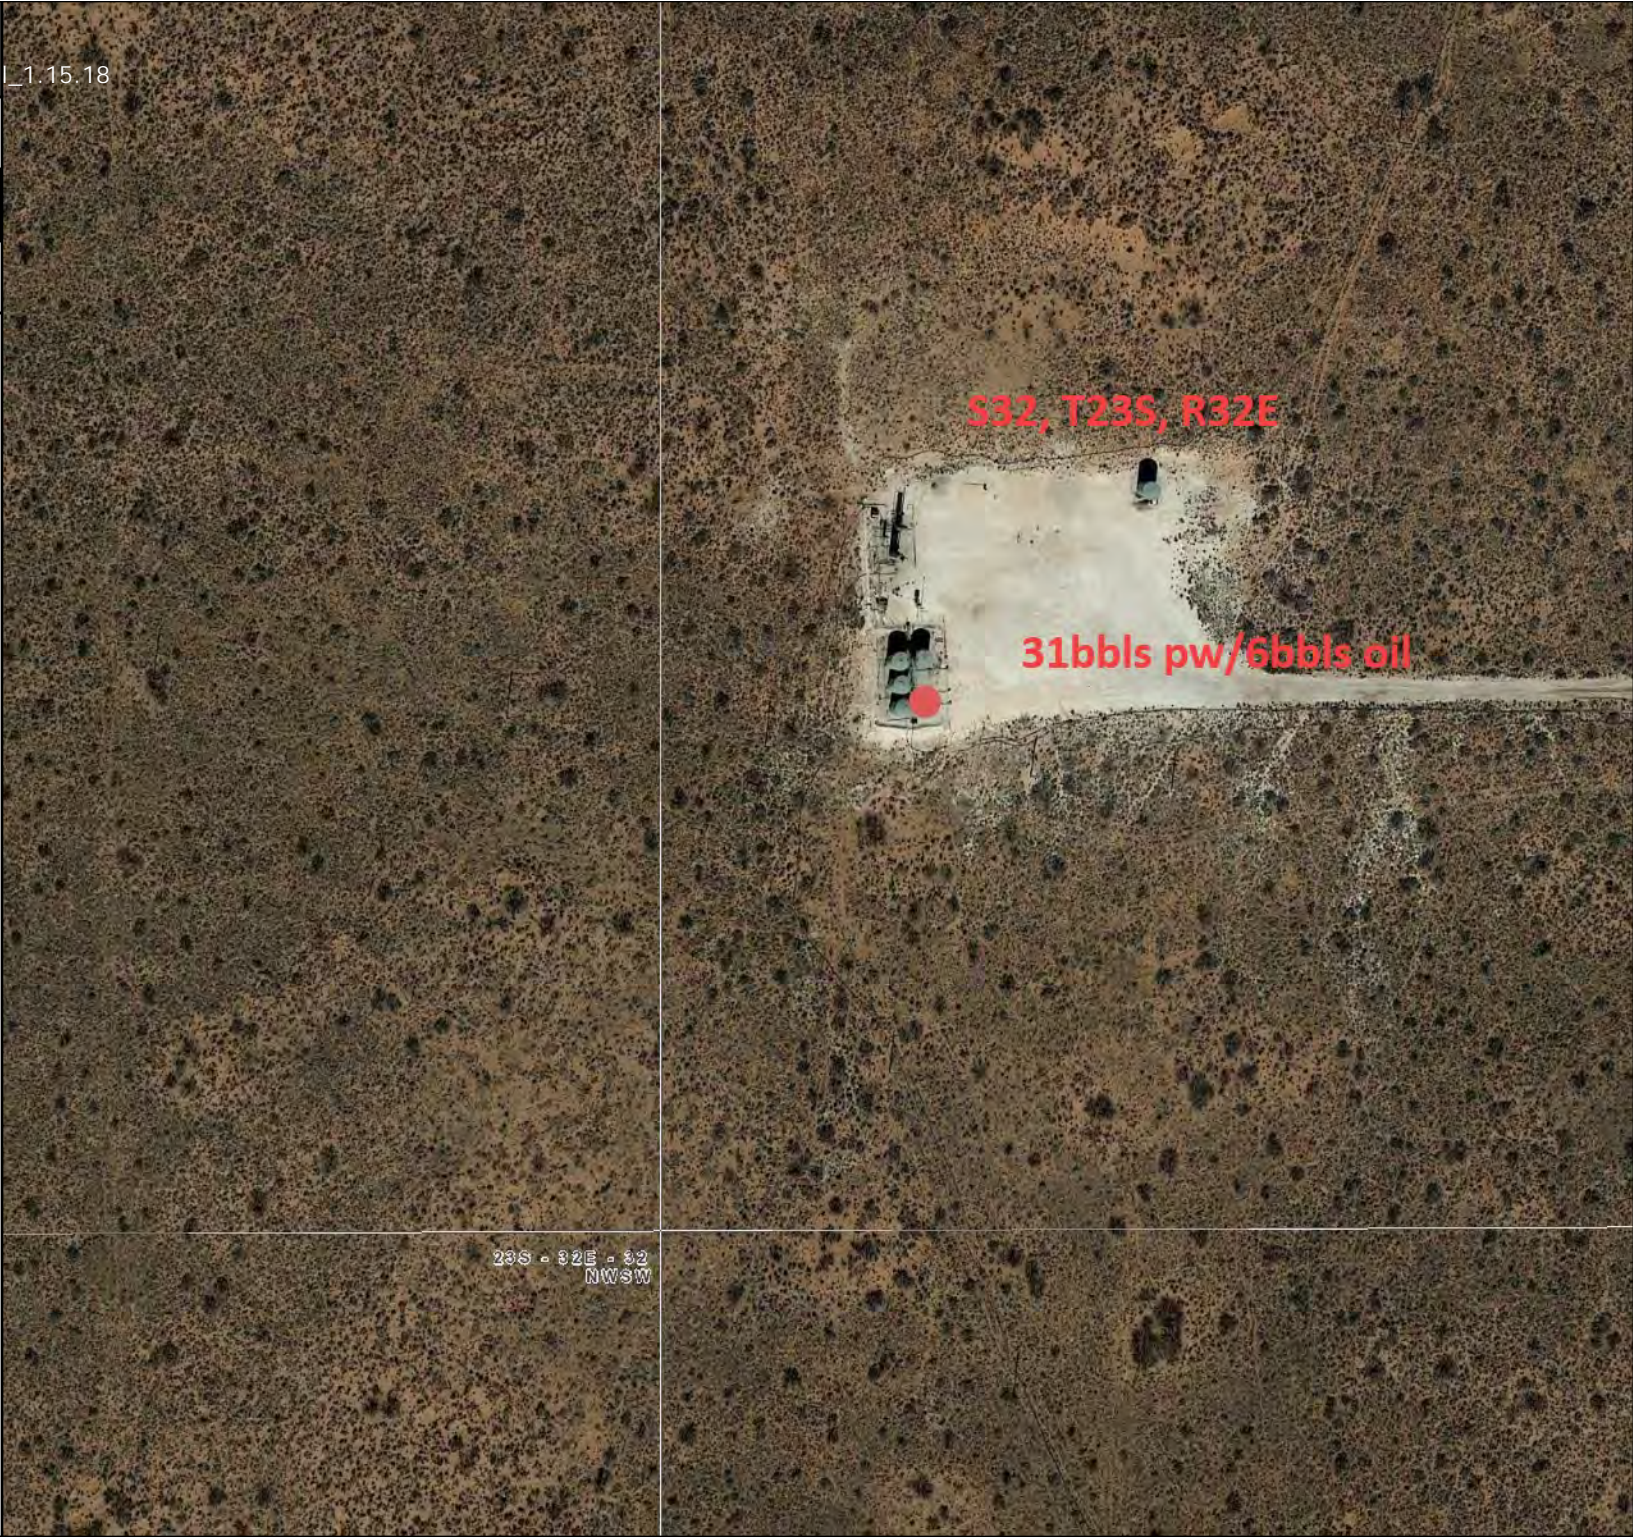
Figure 2

Site Plan

Sample Points Map 3-29-18

Sample Point 1

Sample Point 4

Sample point 3

Sample Point 2

On March 29, 2018, SESI personnel was onsite at the Devon Falcon 32 State 1 Battery for the site assessment and delineation. It was determined that the spill was contained inside the berm, and no mechanical equipment can be used. The site area was assessed to determine where the sample points were to be installed. Four auger holes were installed and field tested for Chlorides. The release area and sample points were mapped using the Juno 3B and site photos of the release area were taken. All soil samples were properly packaged, preserved and transported to Hall Environmental Laboratories of Albuquerque, NM by chain of custody, and analyzed for TPH(total petroleum hydrocarbons)(Method 8015M), BTEX, and Chlorides (Method 300). The results are recapped in the following table:
