# Site Assessment Report

New Mexico East State NCT-1 007 (1RP-4239)

Wellhead Release

Lea County, New Mexico

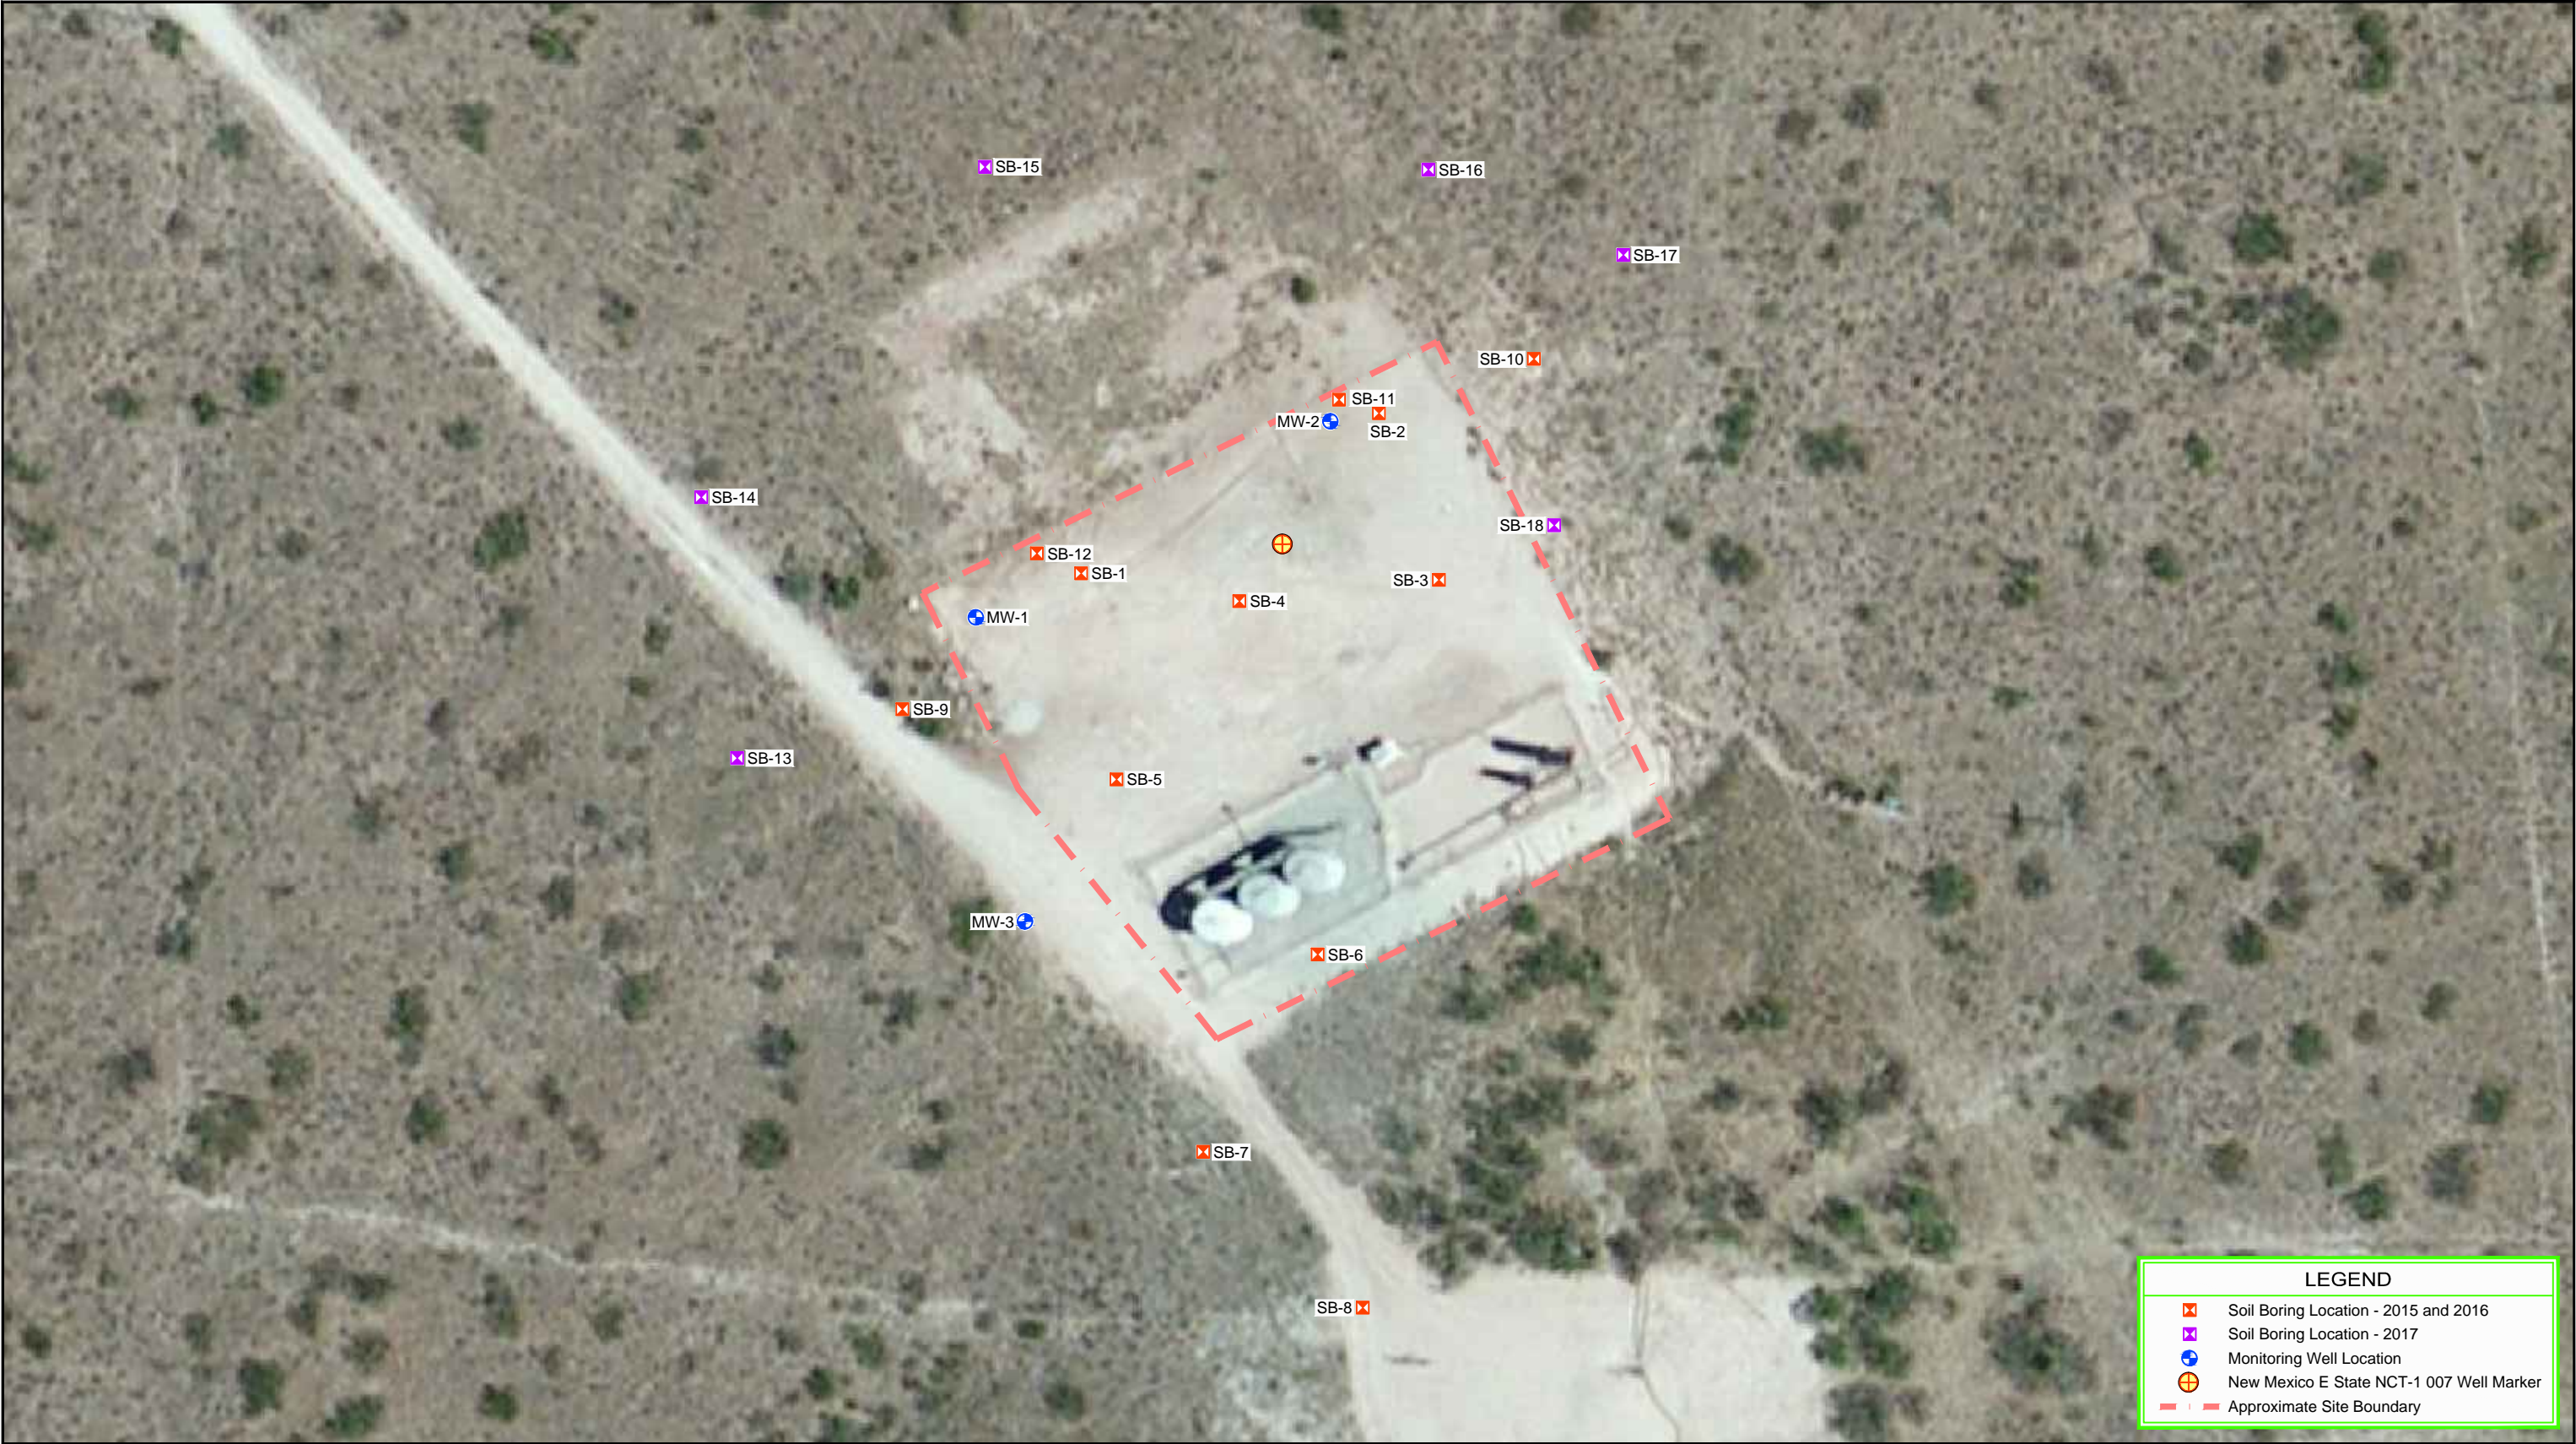
**FIGURE 3**

Site: NCT-1 007 Well Marker

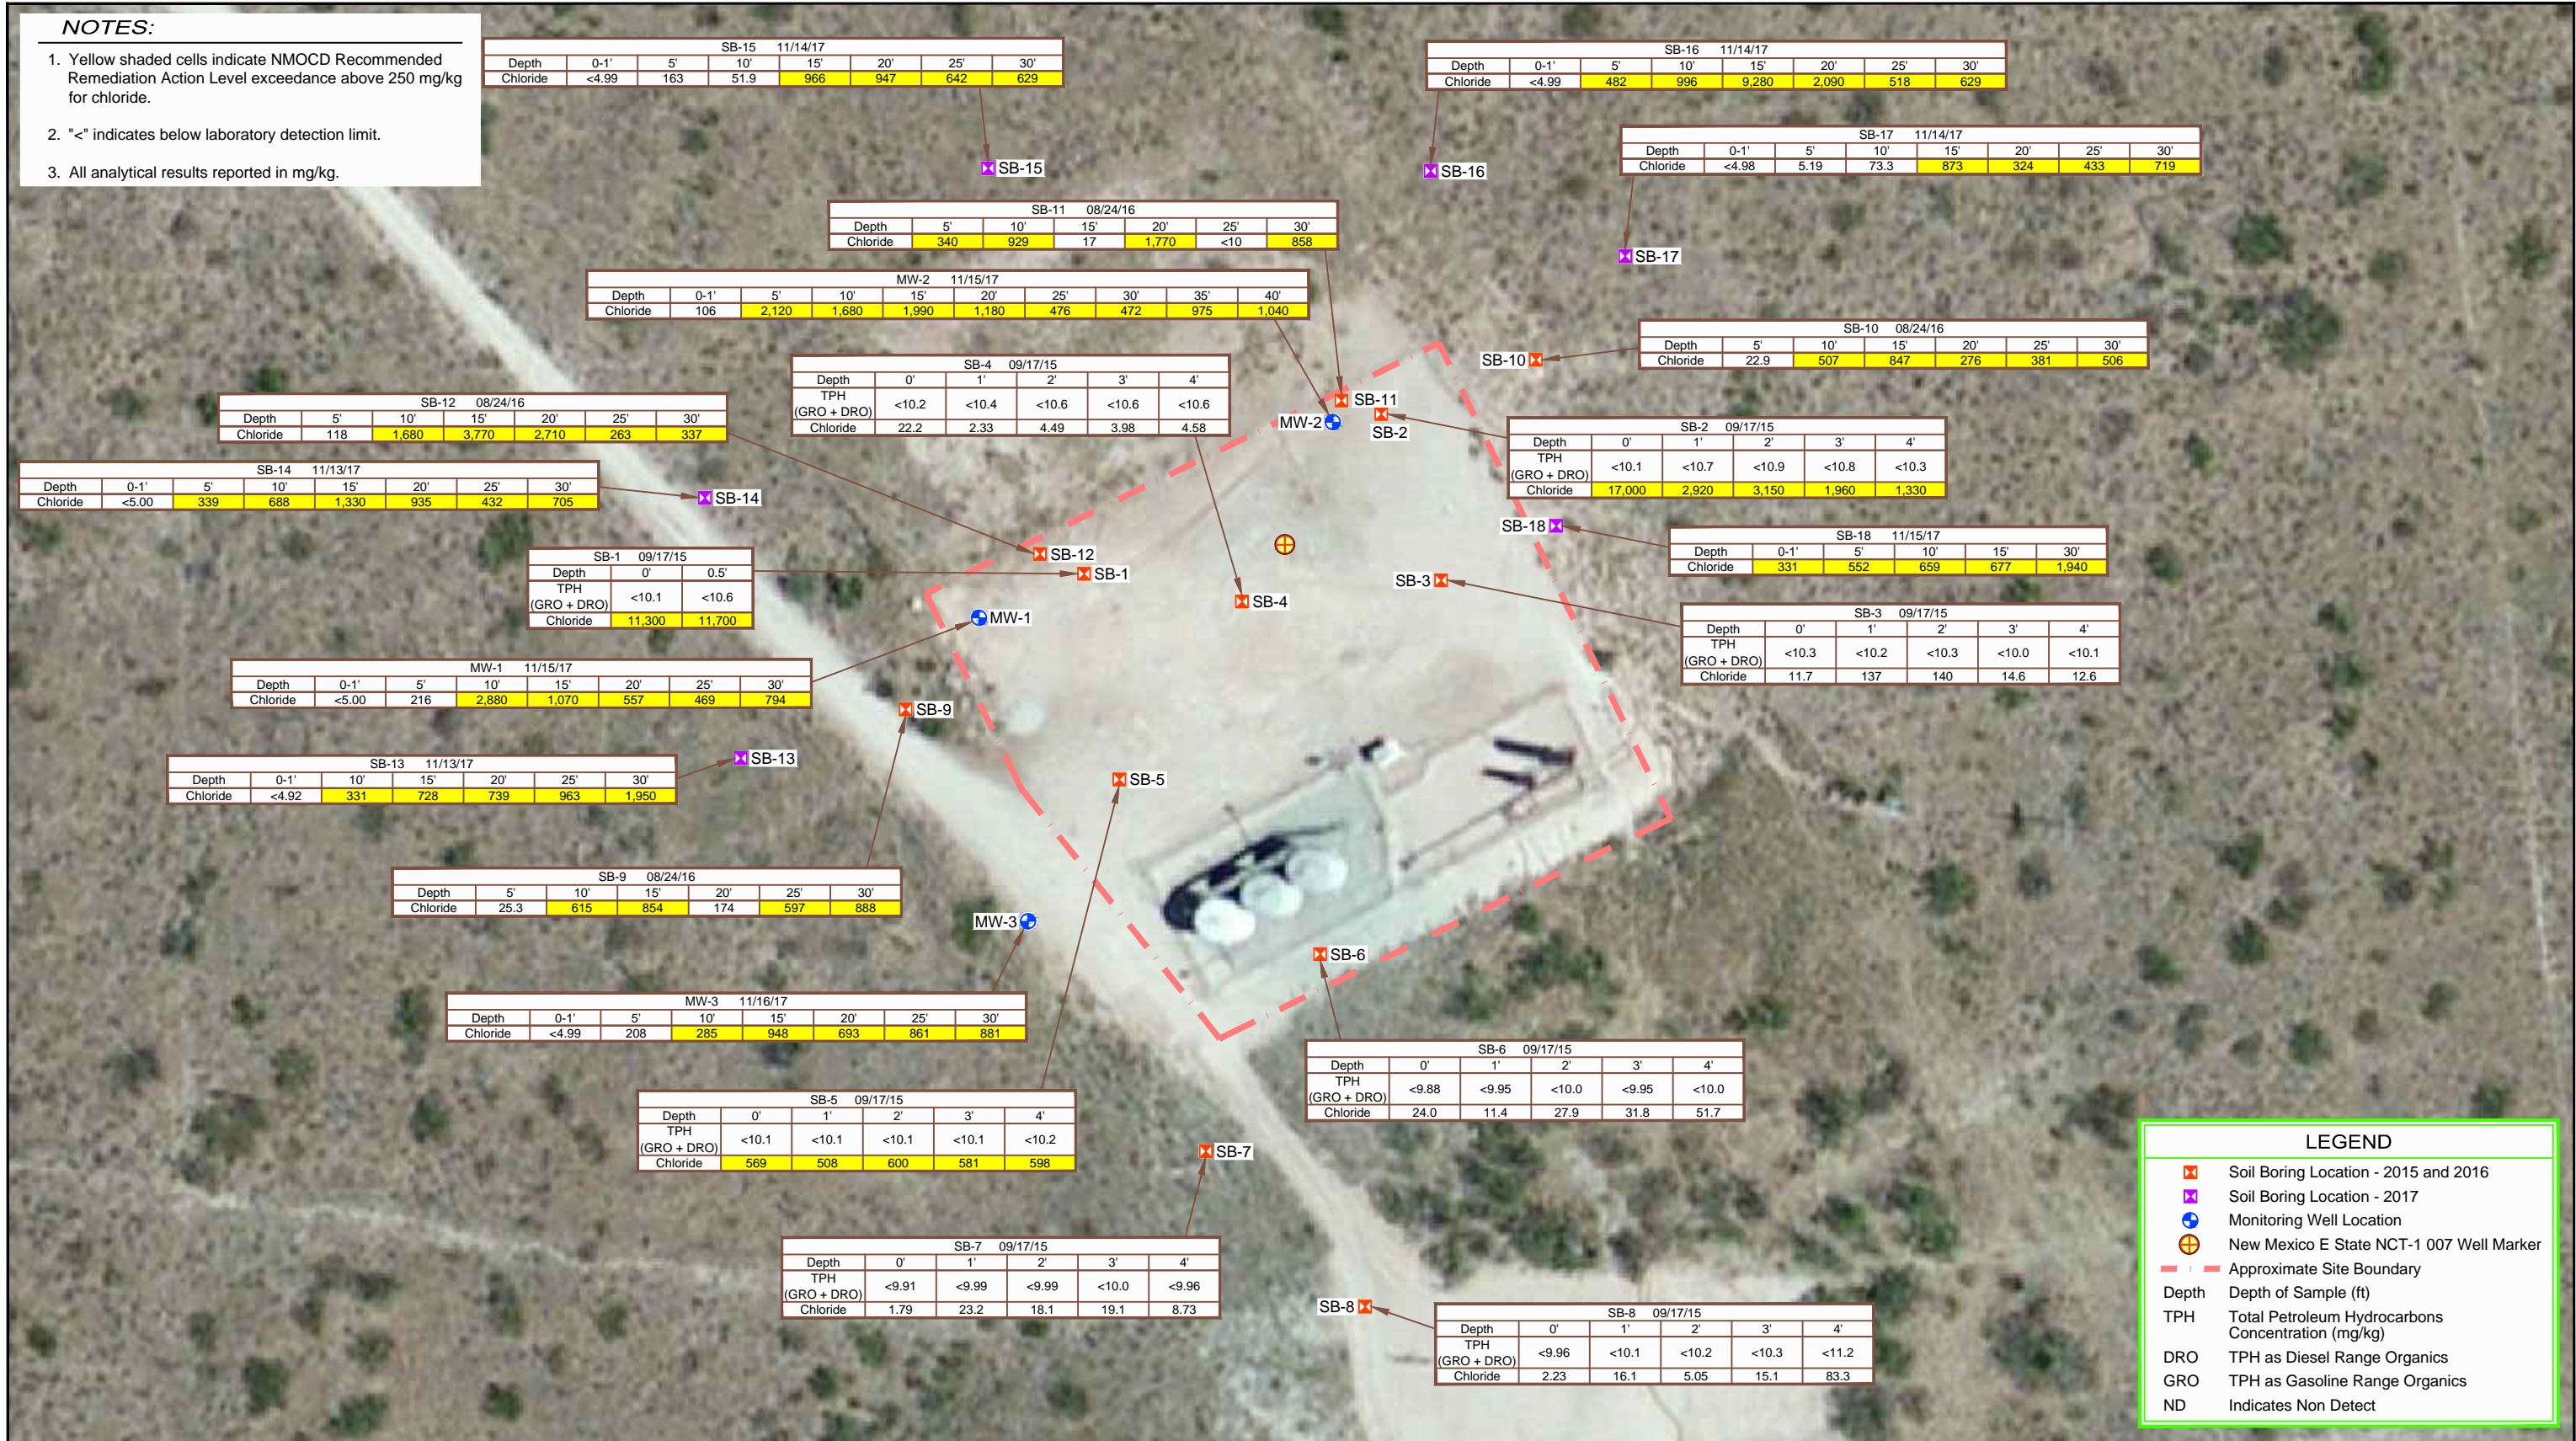
1. Yellow shaded cells indicate NMOCD Recommended Remediation Action Level exceedance above 250 mg/kg for chloride.
2. "<" indicates below laboratory detection limit.
3. All analytical results reported in mg/kg.

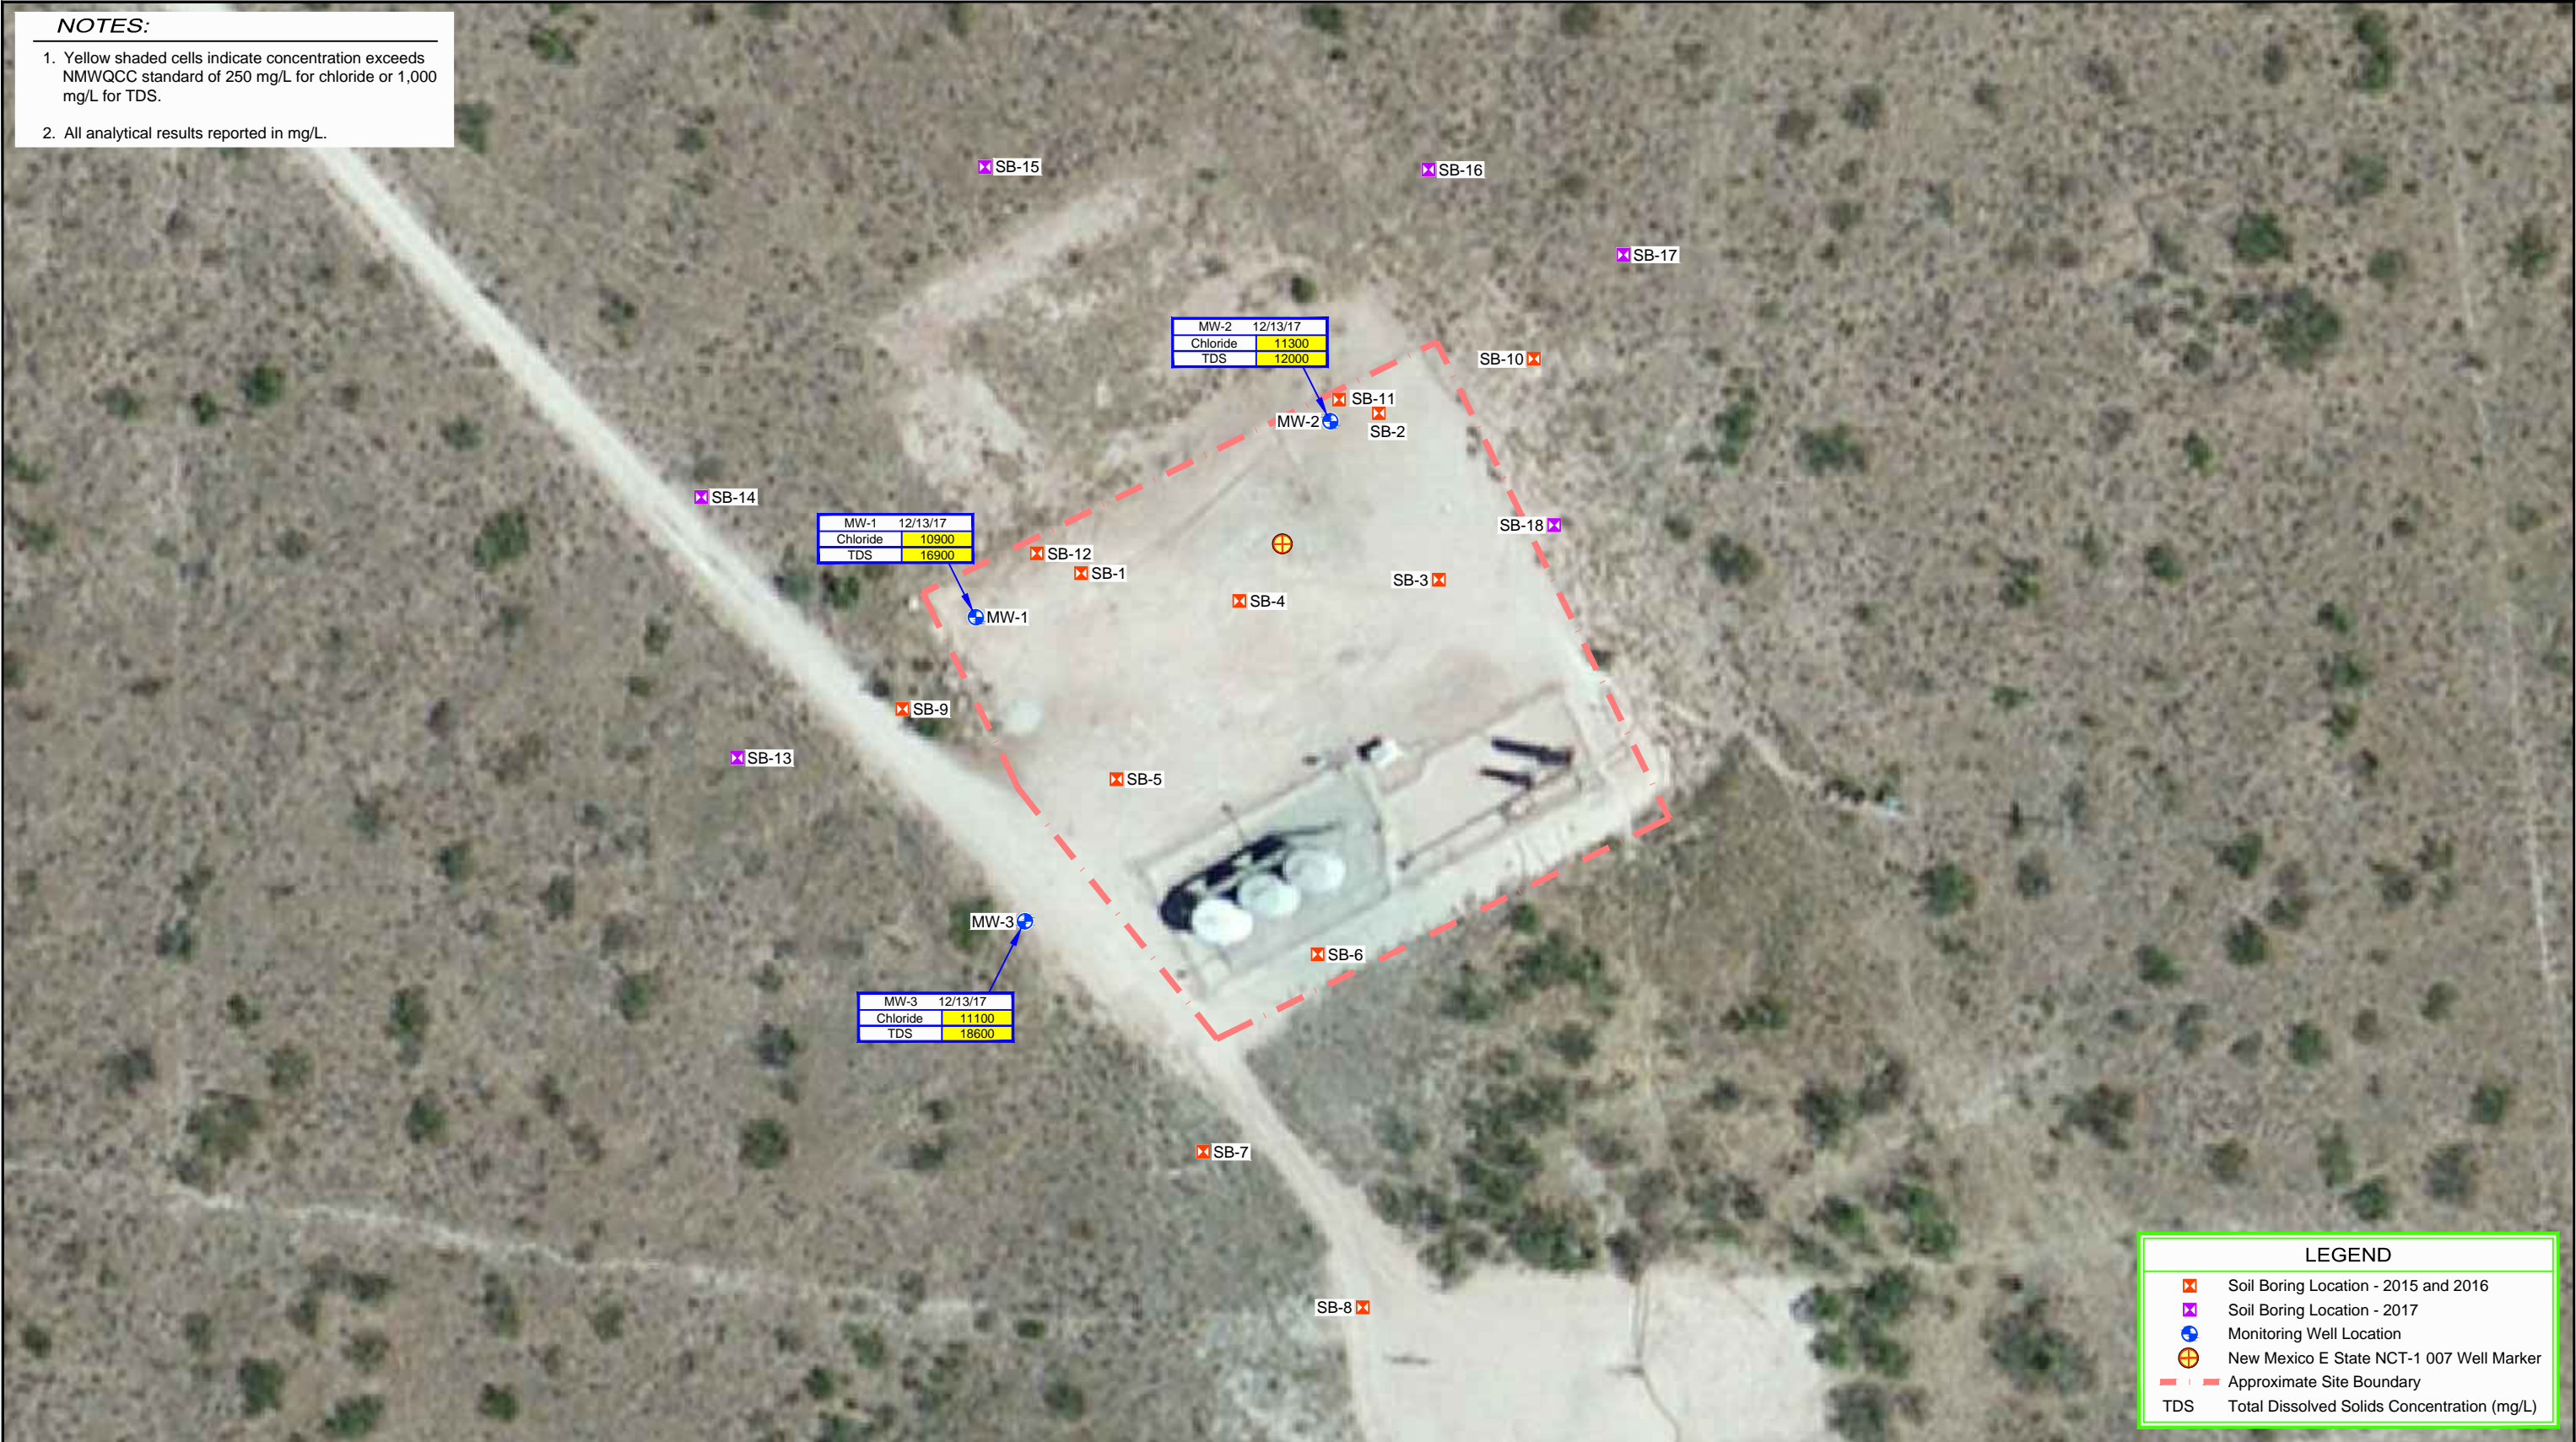
- 1. Yellow shaded cells indicate concentration exceeds NMWQCC standard of 250 mg/L for chloride or 1,000 mg/L for TDS.
- 2. All analytical results reported in mg/L.
