**Re: Chevron Vacuum Glorietta West Unit Satellite No. 4
2017 Soil Assessment Report
Case No. 1RP-3941
Lea County, New Mexico**

Soil Assessment Report

Vacuum Grayburg West Unit Satellite
No. 4 (RP-3941)
Injection Trunkline Release
Lea County, New Mexico

Chevron Environmental
Management Company

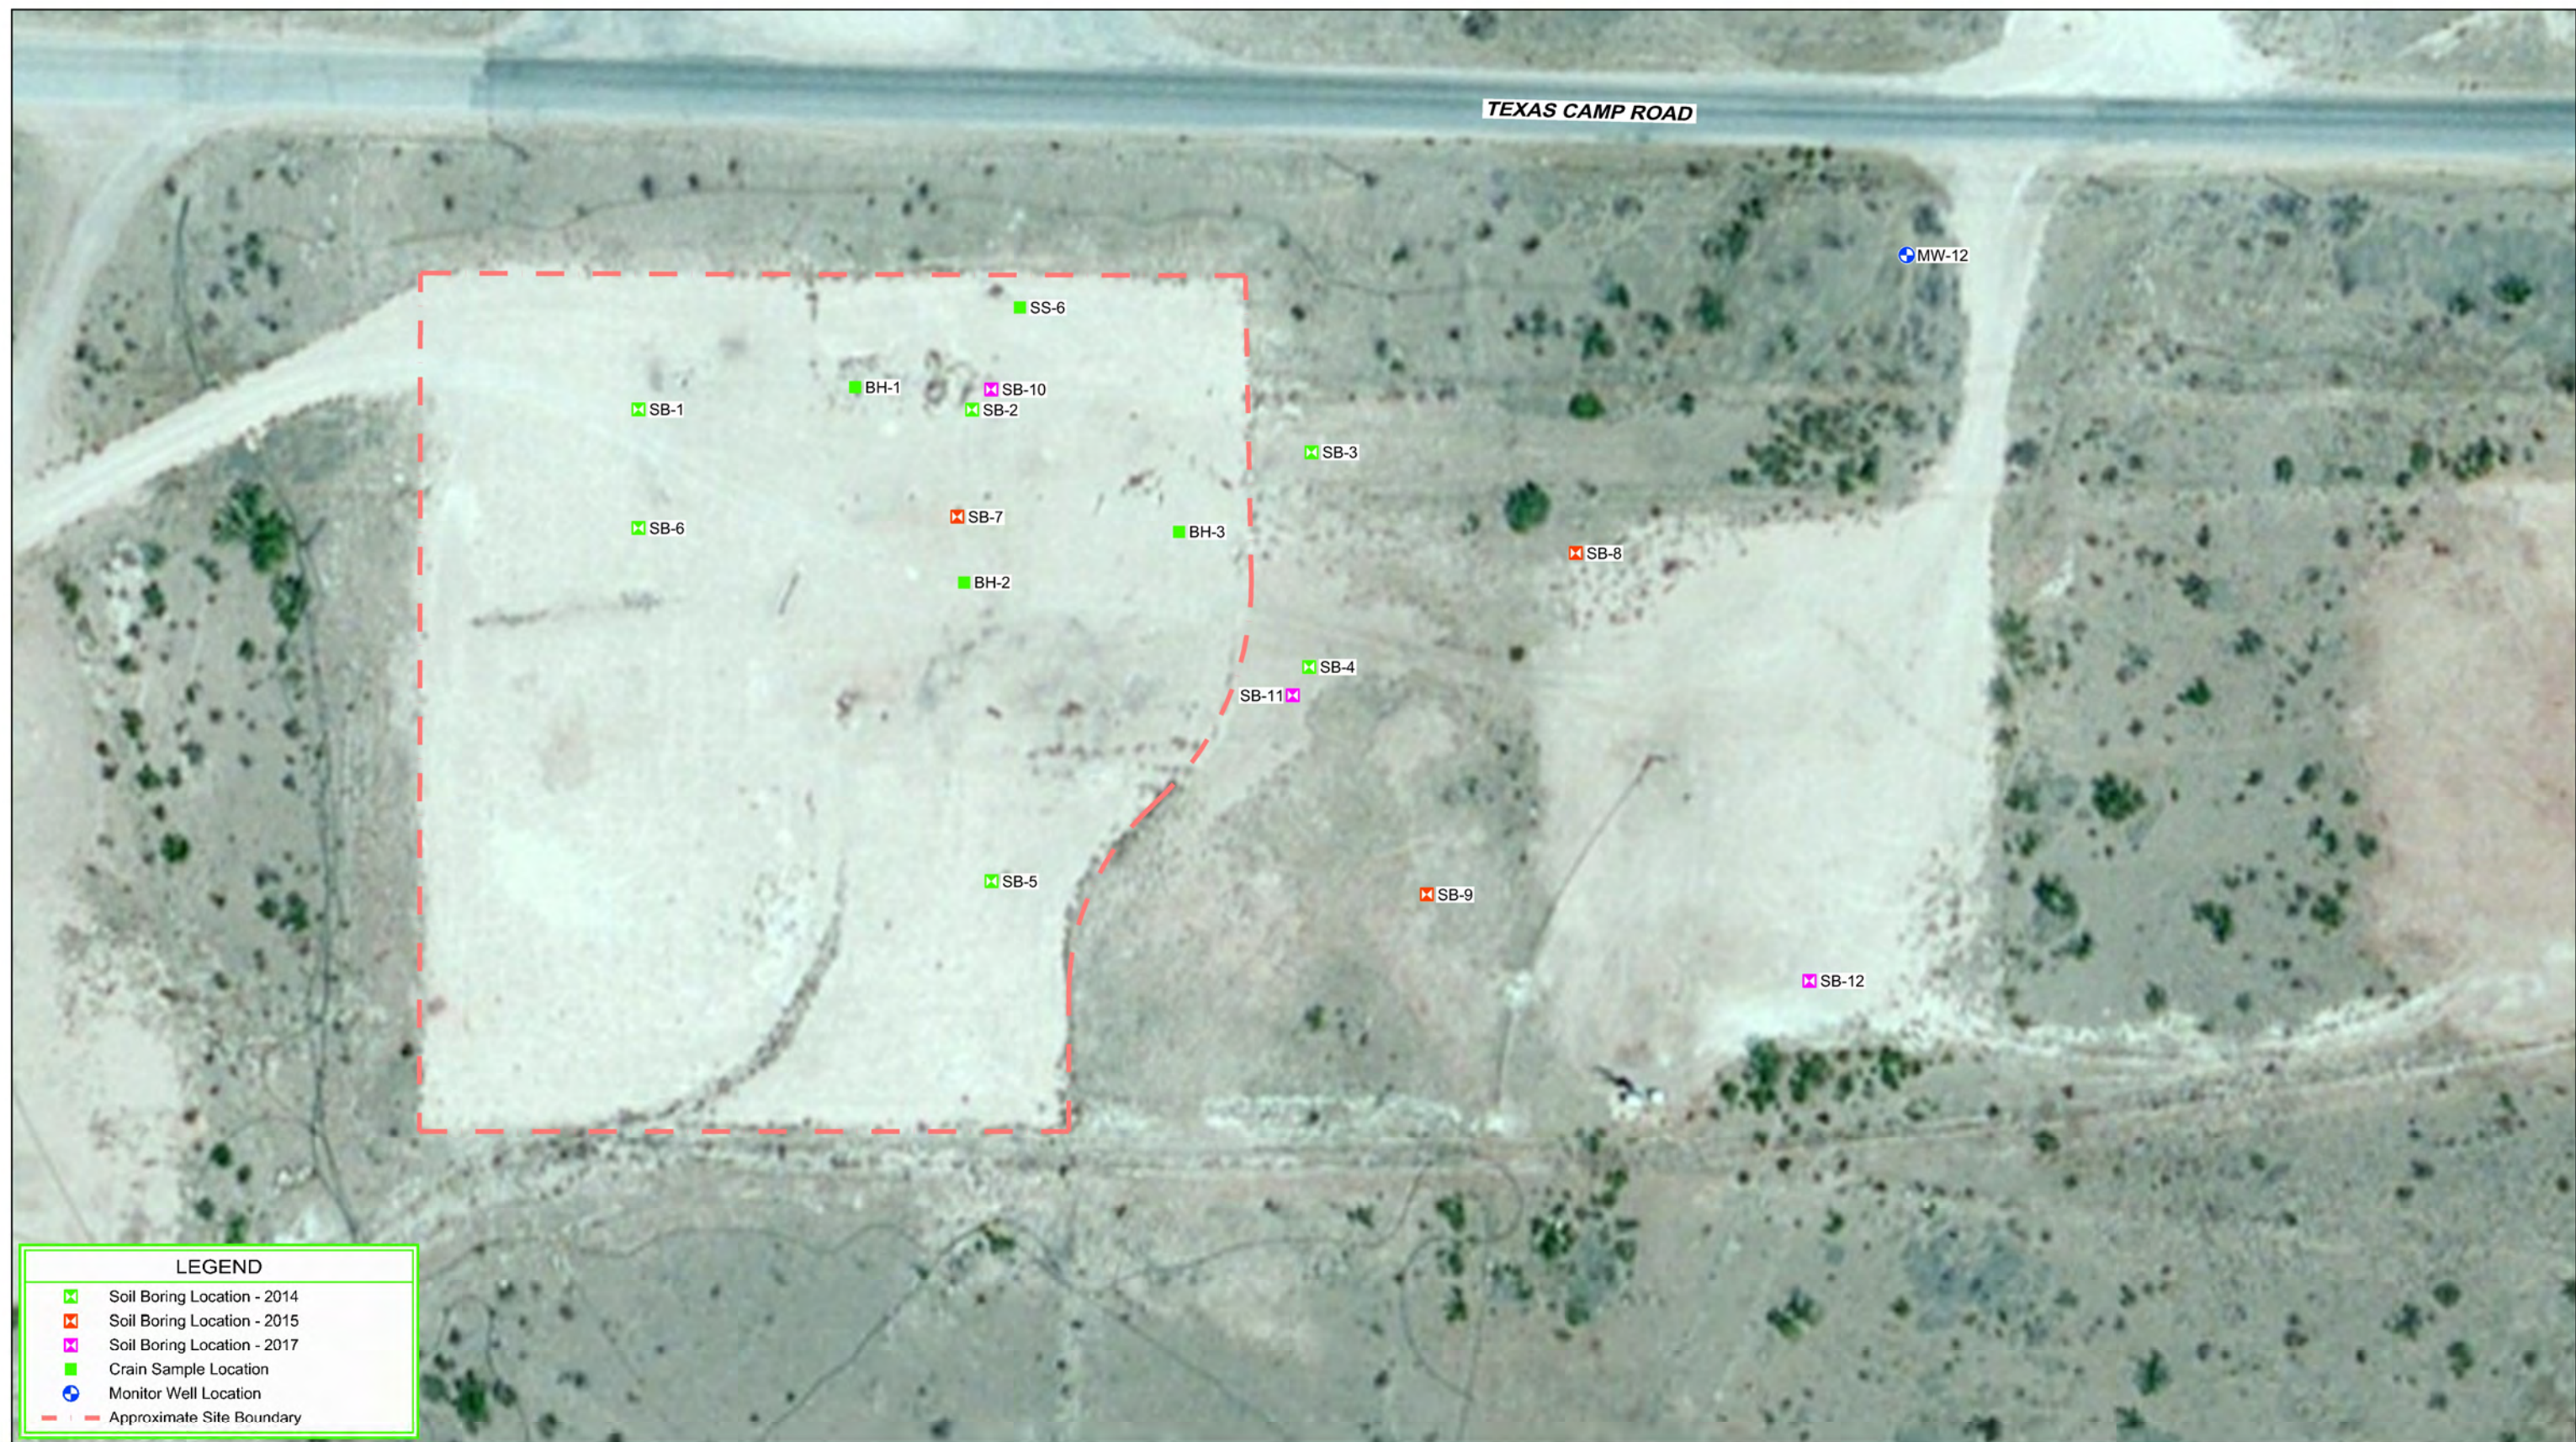
FIGURE 3

SITE DETAILS

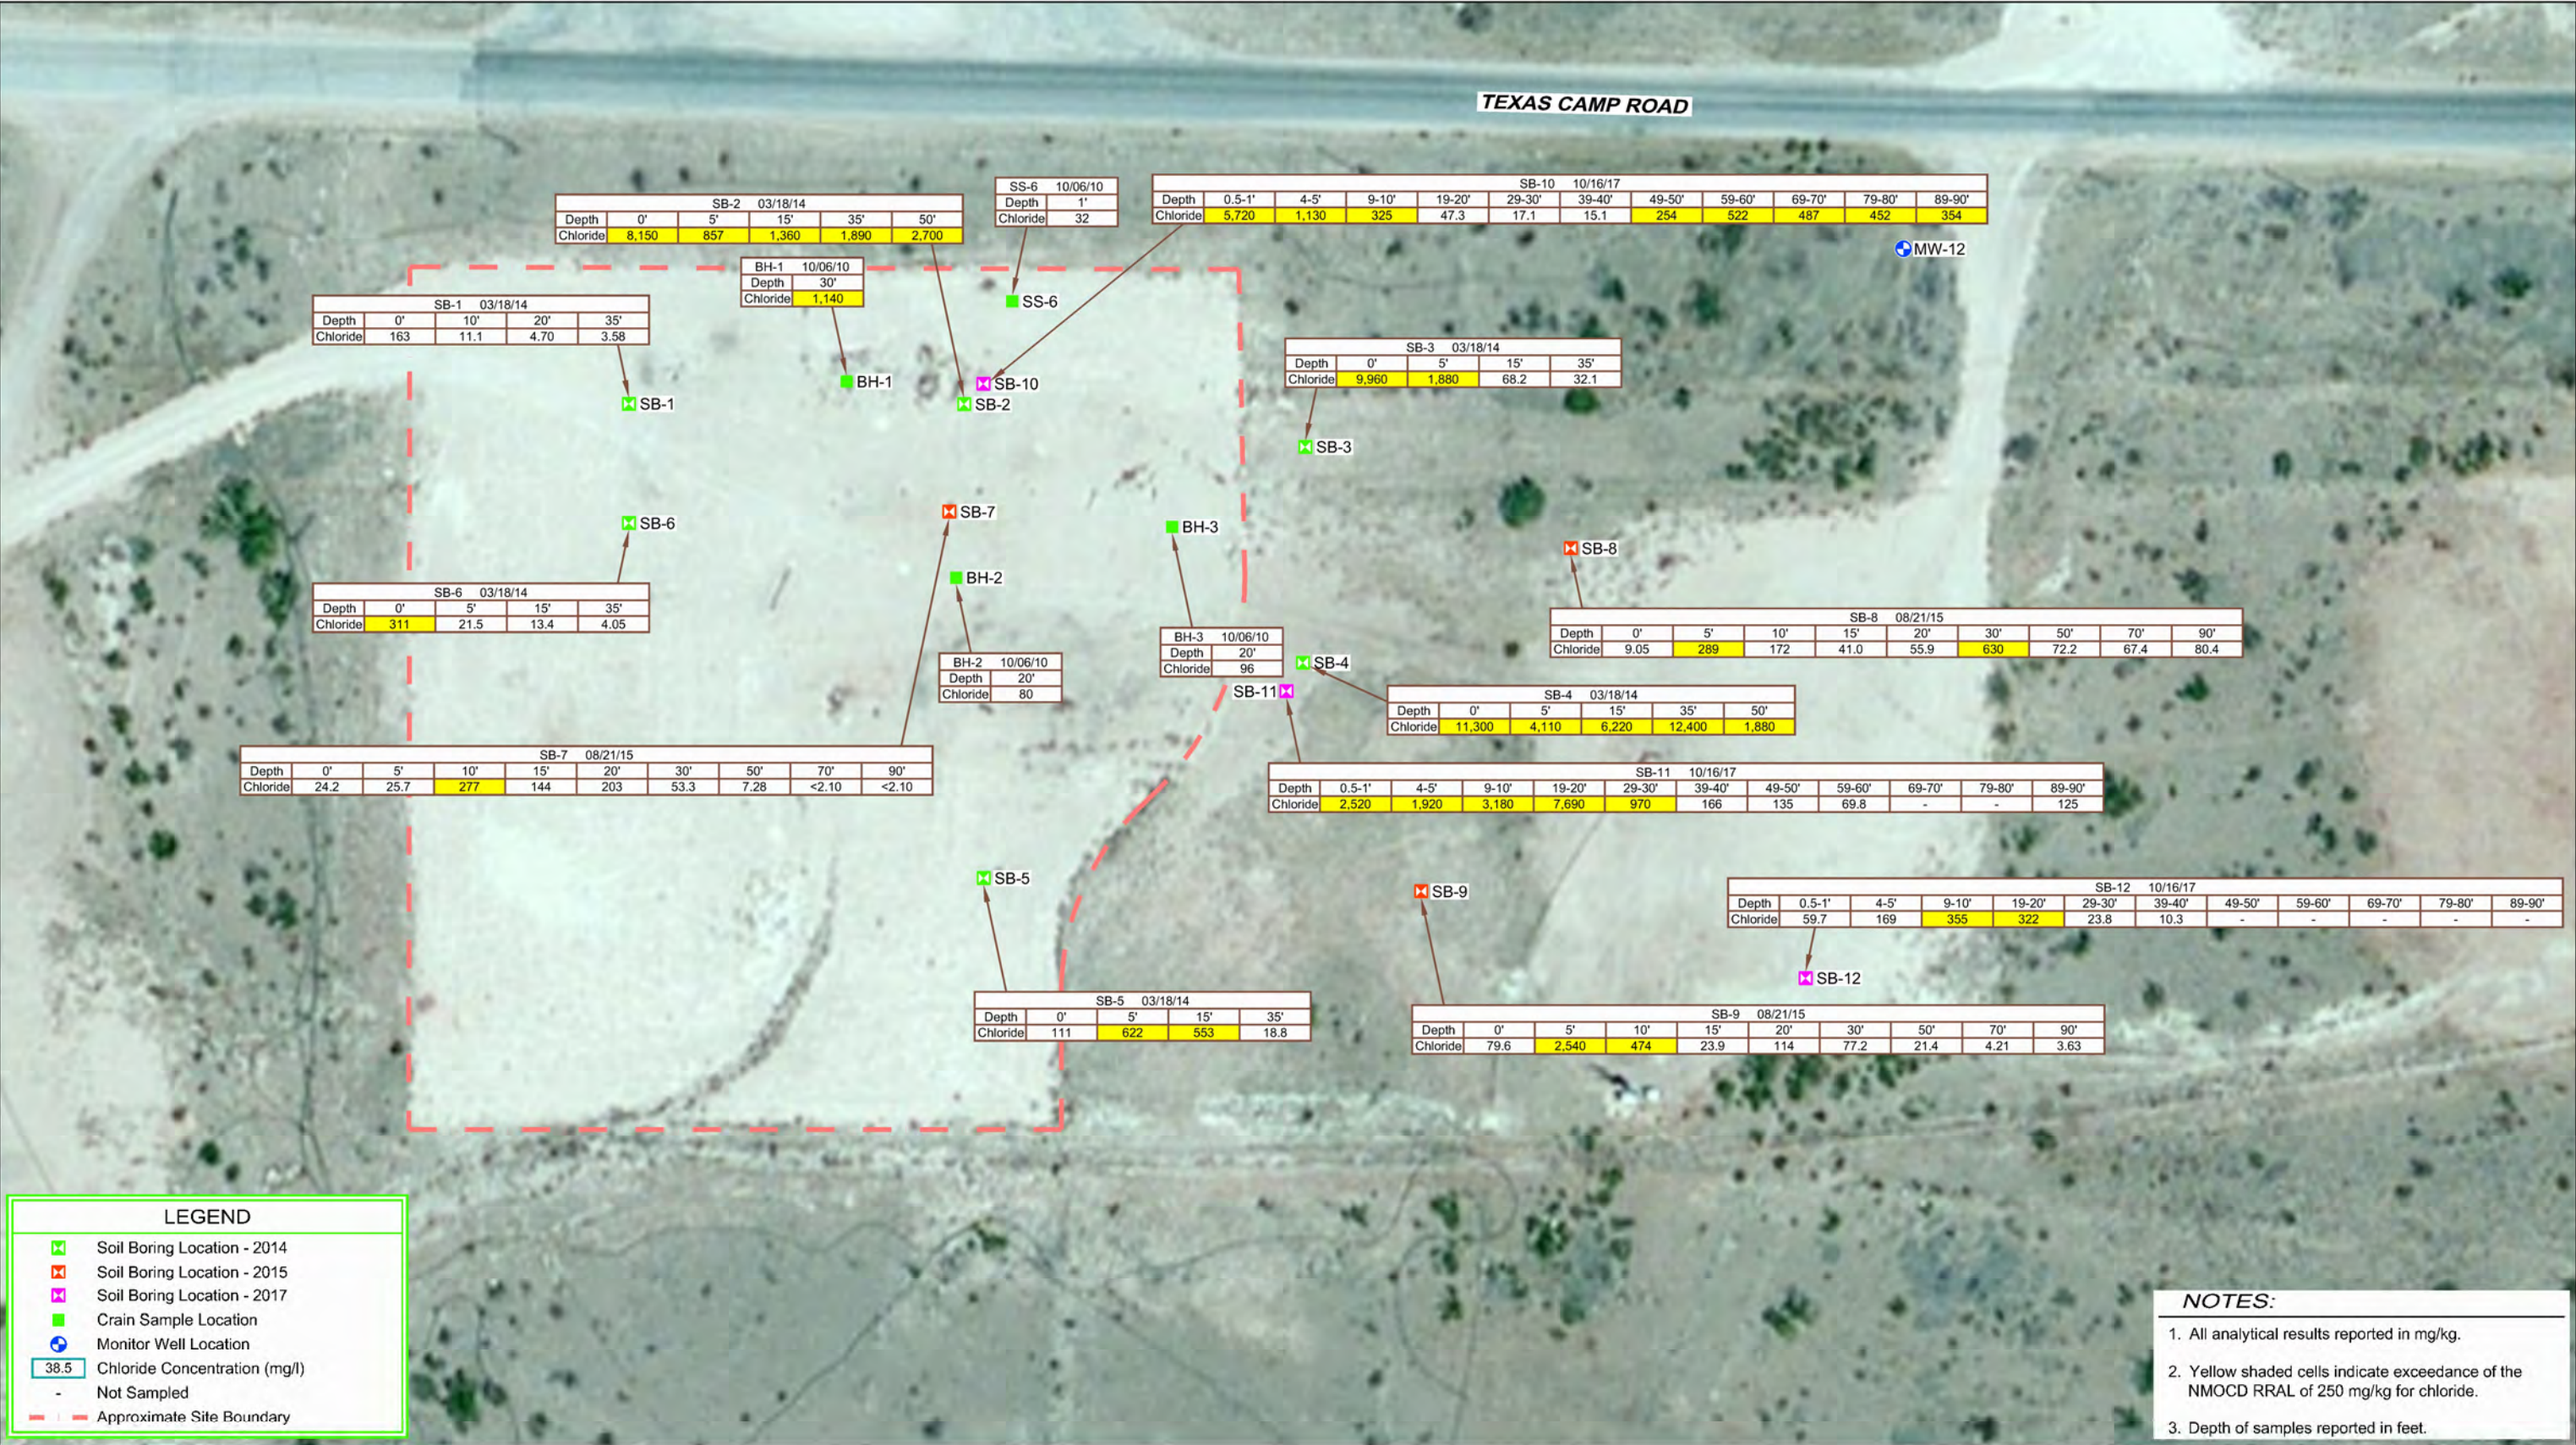
FIGURE 6

Sample ID	SB-11	10/16/17	Sample Date
	Depth	0.5-1'	Sample Depth (ft)
	Chloride	2,520	Sample Result (mg/kg)

SITE DETAILS AND ANALYTICAL RESULTS MAP

A soil analytical summary of the 2017 results is presented in Table 1. A Site Details and Analytical Results Map (2009 – 2017) is presented as Figure 6.

- Chloride concentrations above the RRALs were reported for shallow soil samples in SB-10 from 0.5 to 10 feet bgs, with the highest concentration of 5,720 mg/kg at 0.5-1 feet bgs. Chlorides concentrations above the RRALs were not reported from 19 to 40 feet bgs, but increased above

the RRAL from 49 to 90 feet bgs. The highest concentration was 522 mg/kg at 59-60 feet bgs. The soil sample from the terminal depth (89-90 feet bgs) was slightly above the RRAL at 354 mg/kg.

- SB-11 exhibited chloride concentrations above the RRAL from 0.5 through 30 feet bgs, with the highest concentration of 7,690 mg/kg at 19-20 feet bgs. Chloride concentrations were not reported above the RRAL within the remainder of the samples collected from the borehole (down to 90 feet bgs).
- Chloride concentrations were reported slightly above the RRAL in SB-12 ranging from 322 mg/kg to 355 mg/kg for soil samples collected from 9-20 feet bgs. Chloride concentrations were not reported above the RRAL from 29-40 feet bgs. Field screening of soil samples at from 49 feet to 90 feet bgs indicated chloride concentrations below the RRAL and were therefore not submitted for analytical testing
