## **PRELIMINARY RESULTS**

RE: 1RP-4624, Pride Energy Company NM 87 State #001 (Wellhead), API#: 30-025-23655 Section 33-14S-34E: Unit K, Lea County, New Mexico Site Characterization Report and Remediation Plan with Postponement Request

#### January 2018 Sample Locations

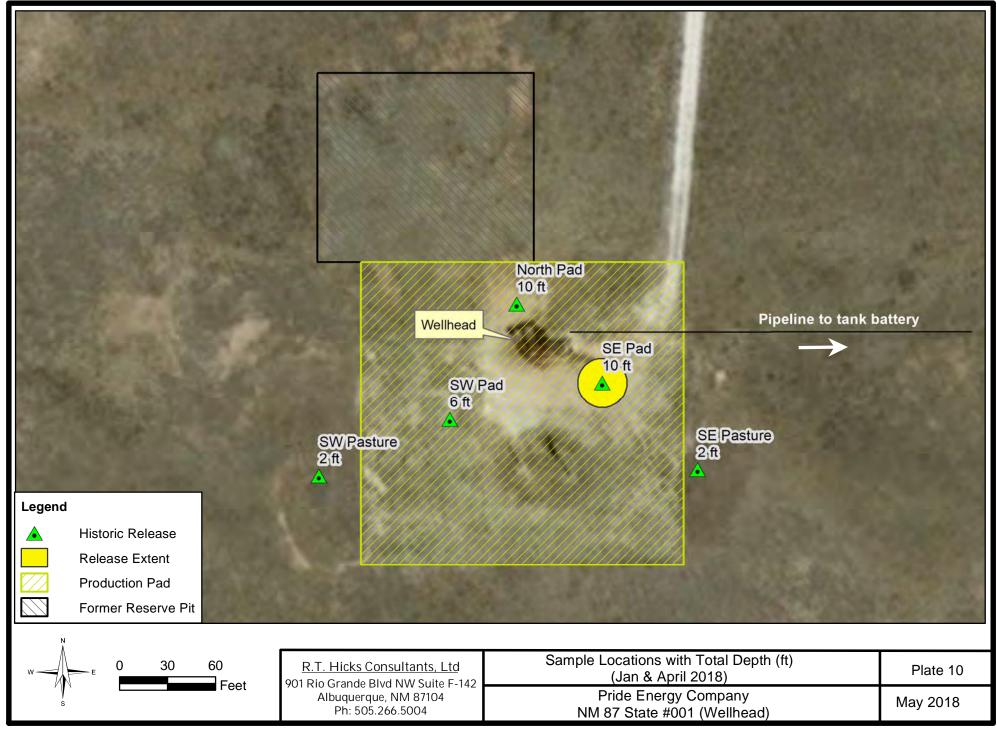
M:\Pride Energy\NM 87 State 001 Wellhead 1RP\_4624\gis\_ap\Figures\plate10\_trenchLocations.mxd

Plate 10 shows the locations of the trench and soil boring locations relative to the production pad. Plate 11 presents chloride concentration at depths between zero and 4 feet at each location during the January and April 2018 characterization activities. Appendix B discusses our January and April 2018 characterization activities.

Plate 10 shows the location of the sample locations. Exhibit A, below, shows the latitude, longitude, depth, and sampling type. Table 1 is a summary of the laboratory analysis. Appendix D contains the lithologic logs for the sample locations.

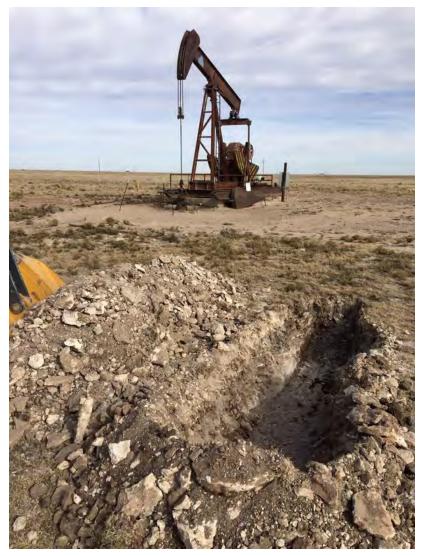
Exhibit B: Trench sample at SW Pad. Hard caliche encountered at 1-foot below ground surface. Total depth was 2-feet below ground surface. Land surface is undergoing natural restoration/re-vegetation.

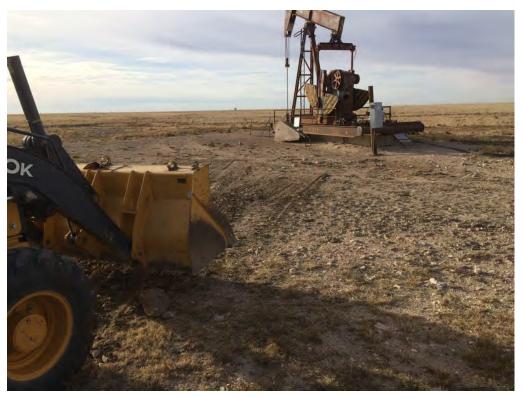
Exhibit C: Backfilling trench sample at SE Pad. Hard caliche encountered at 1-foot below ground surface. Total depth was 2-feet below ground surface.

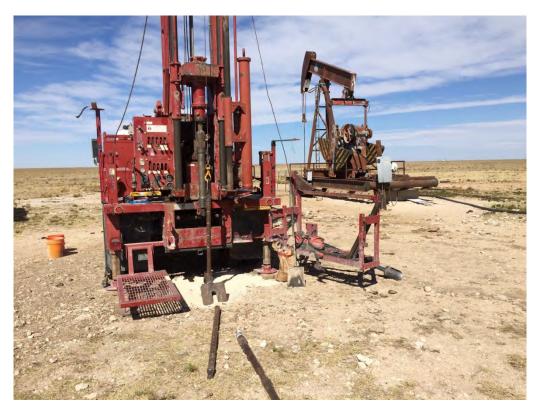
Exhibit D: Drilling SE Pad. The production pad is beginning to revegetate (foreground center).

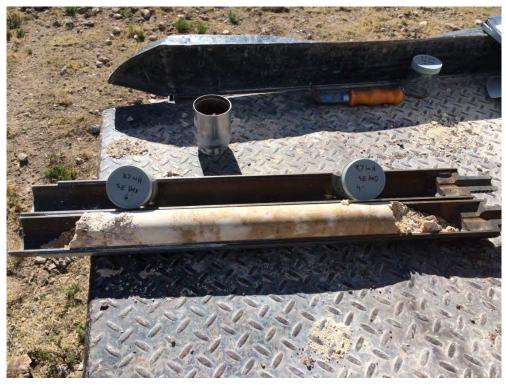
Exhibit E: Split-spoon core from 4-feet (right) to 6-feet (left) at SE Pad. Caliche dominates the core sample.

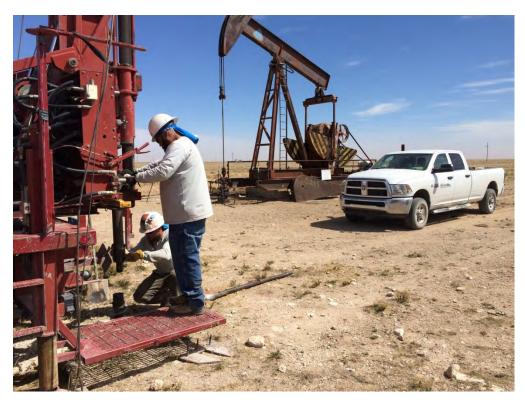
Exhibit F: Drilling SW Pad. The production pad is beginning to revegetate (foreground center).

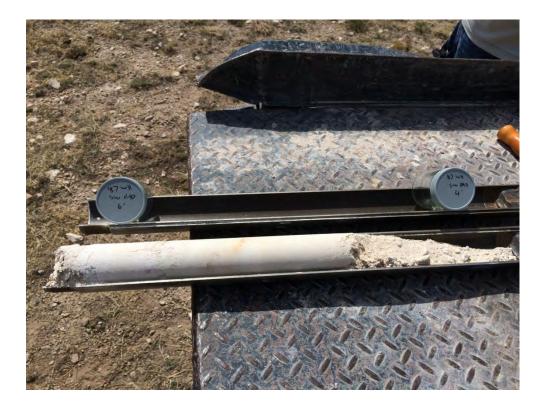
Exhibit G: Split-spoon core from 4-feet (right) to 6-feet (left) at SW Pad. Caliche dominates the core sample.
