Re: Backfill Request 1RP-5091  
Former DCP Pump Station Historical Release  
Legal: Unit F, Sec 4, T22S R36E, Lea County, NM  
Latitude/Longitude: 32.422898/ -103.274162  
Etech Proj. Number: 876-9521-000  
Depth to Groundwater: 200-275 feet - Chevron/Texaco Lea County Depth to Groundwater Map  
- OSE NM Water Rights Reporting System

Etech Environmental & Safety Solutions, Inc. (Etech) is submitting the following corrective action plan on the aforementioned site for your review and approval.

Former DCP Pump Station Historical Release

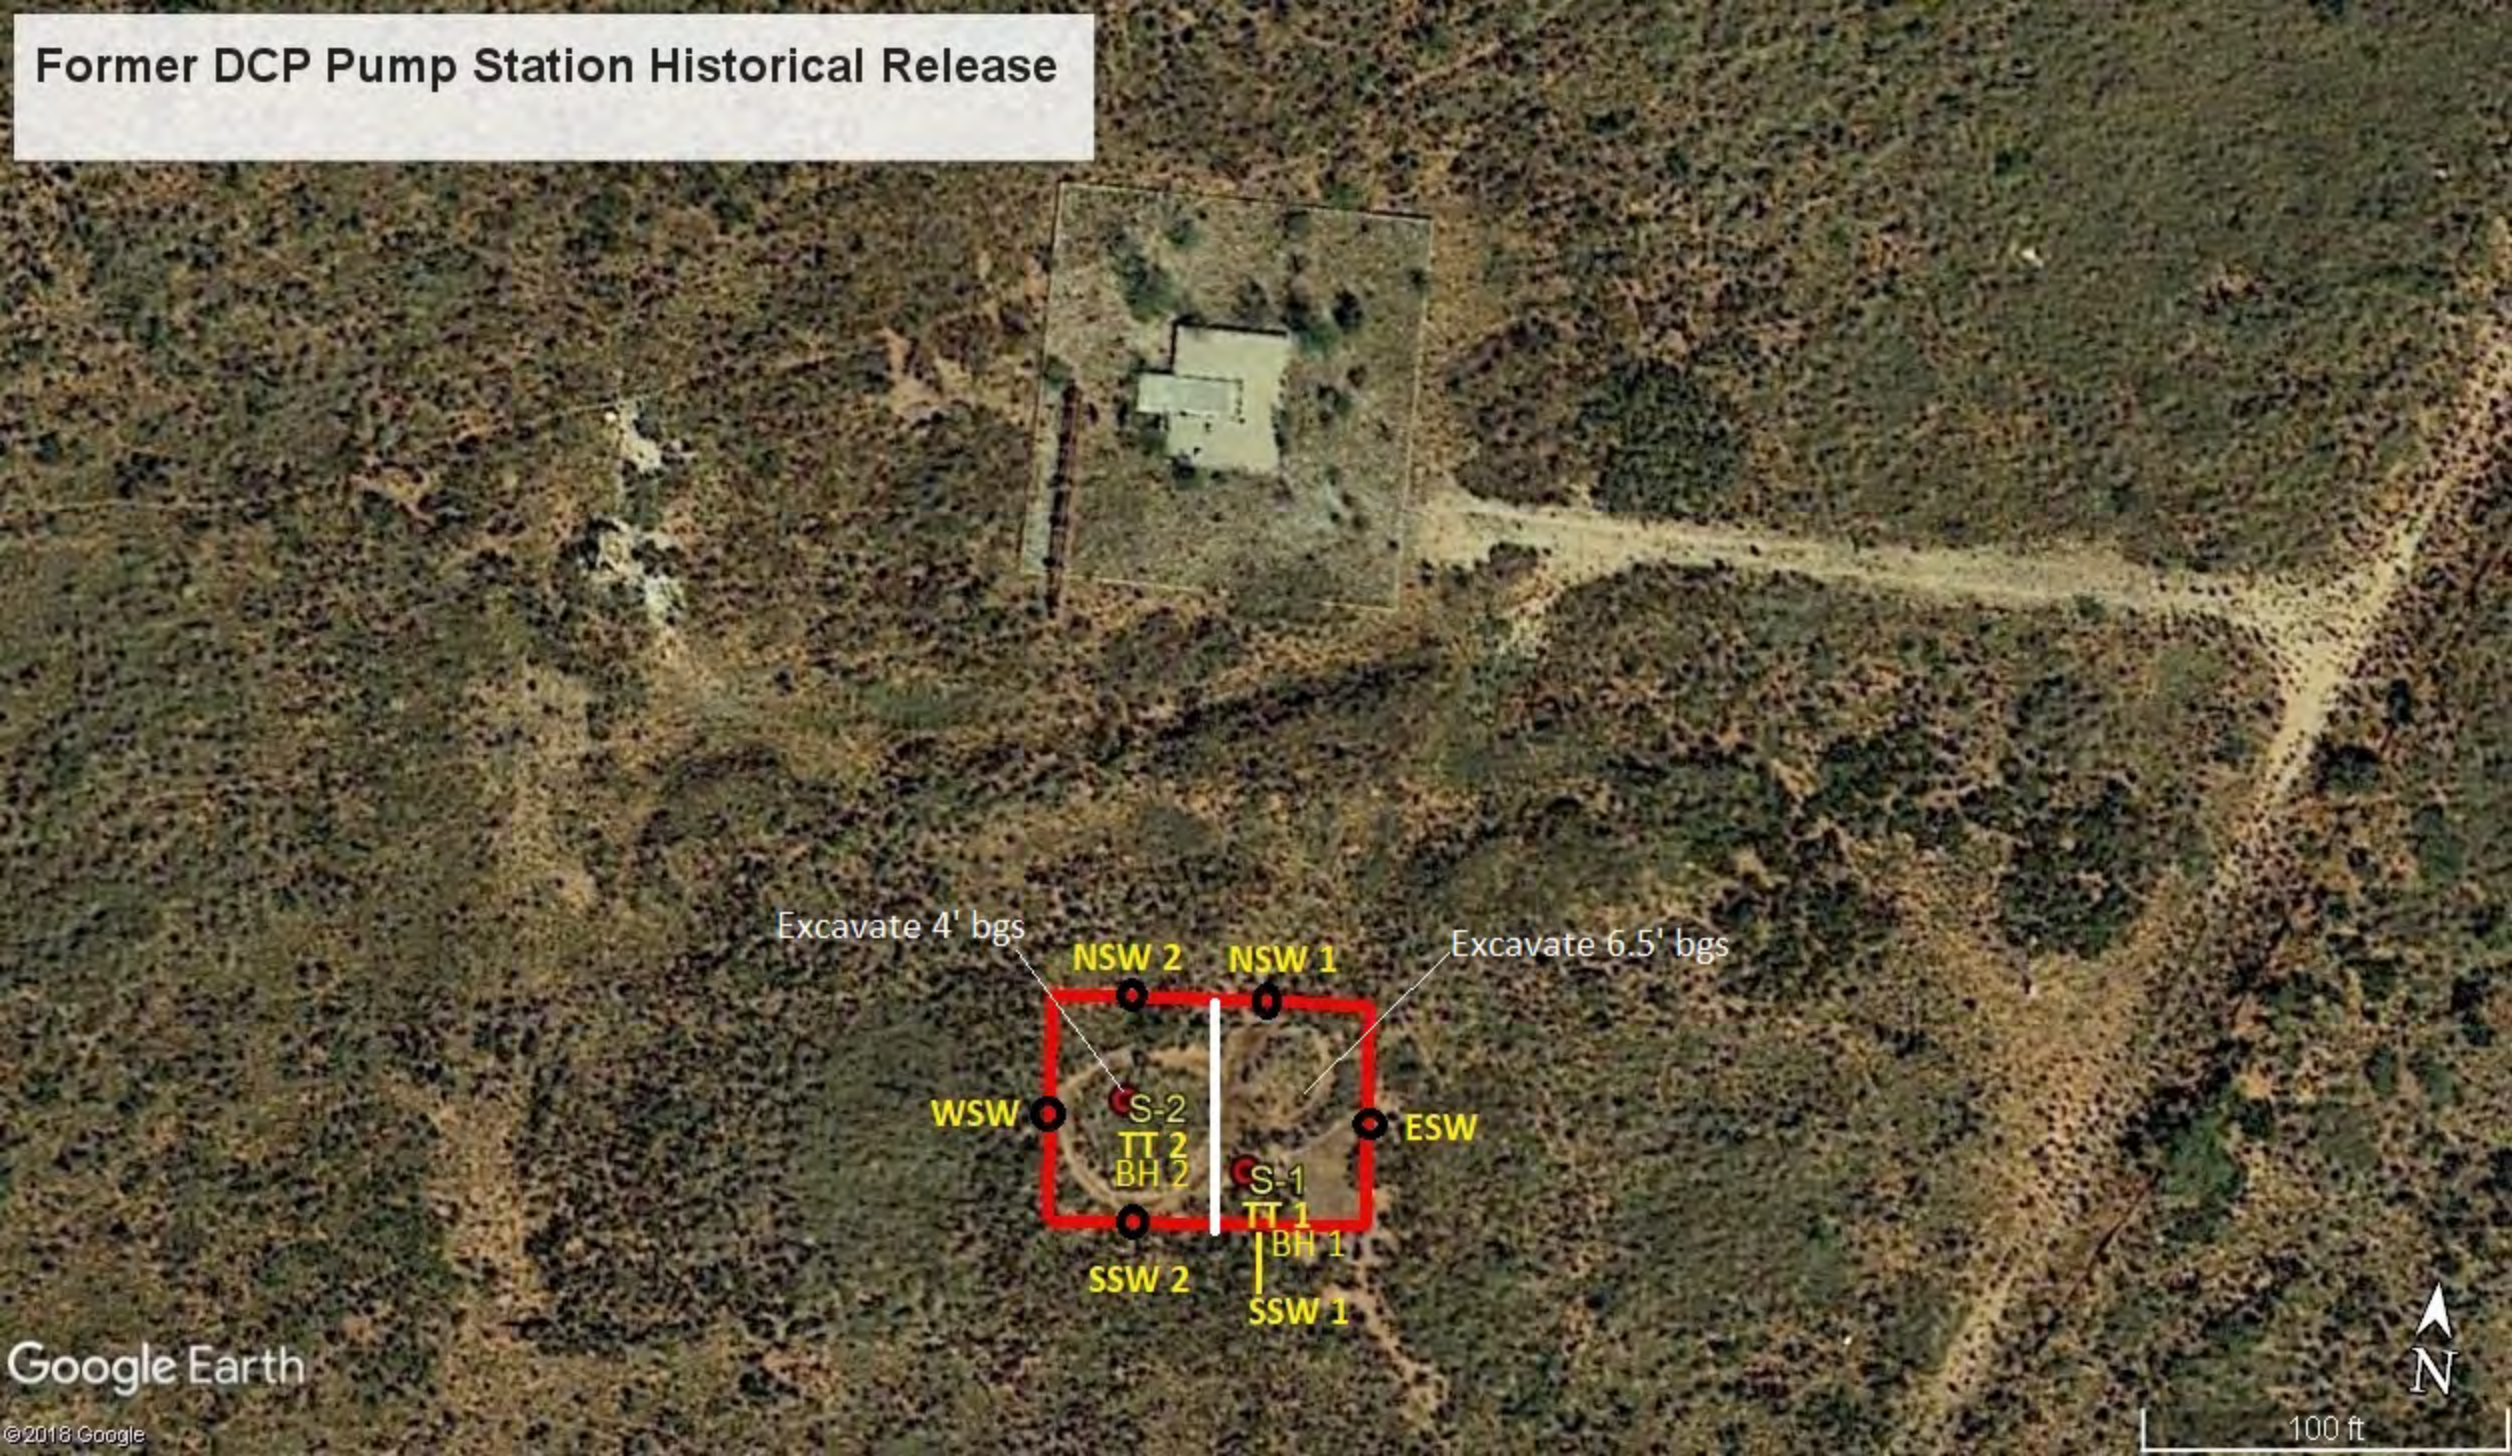
Excavate 4' bgs

NSW 2

NSW 1

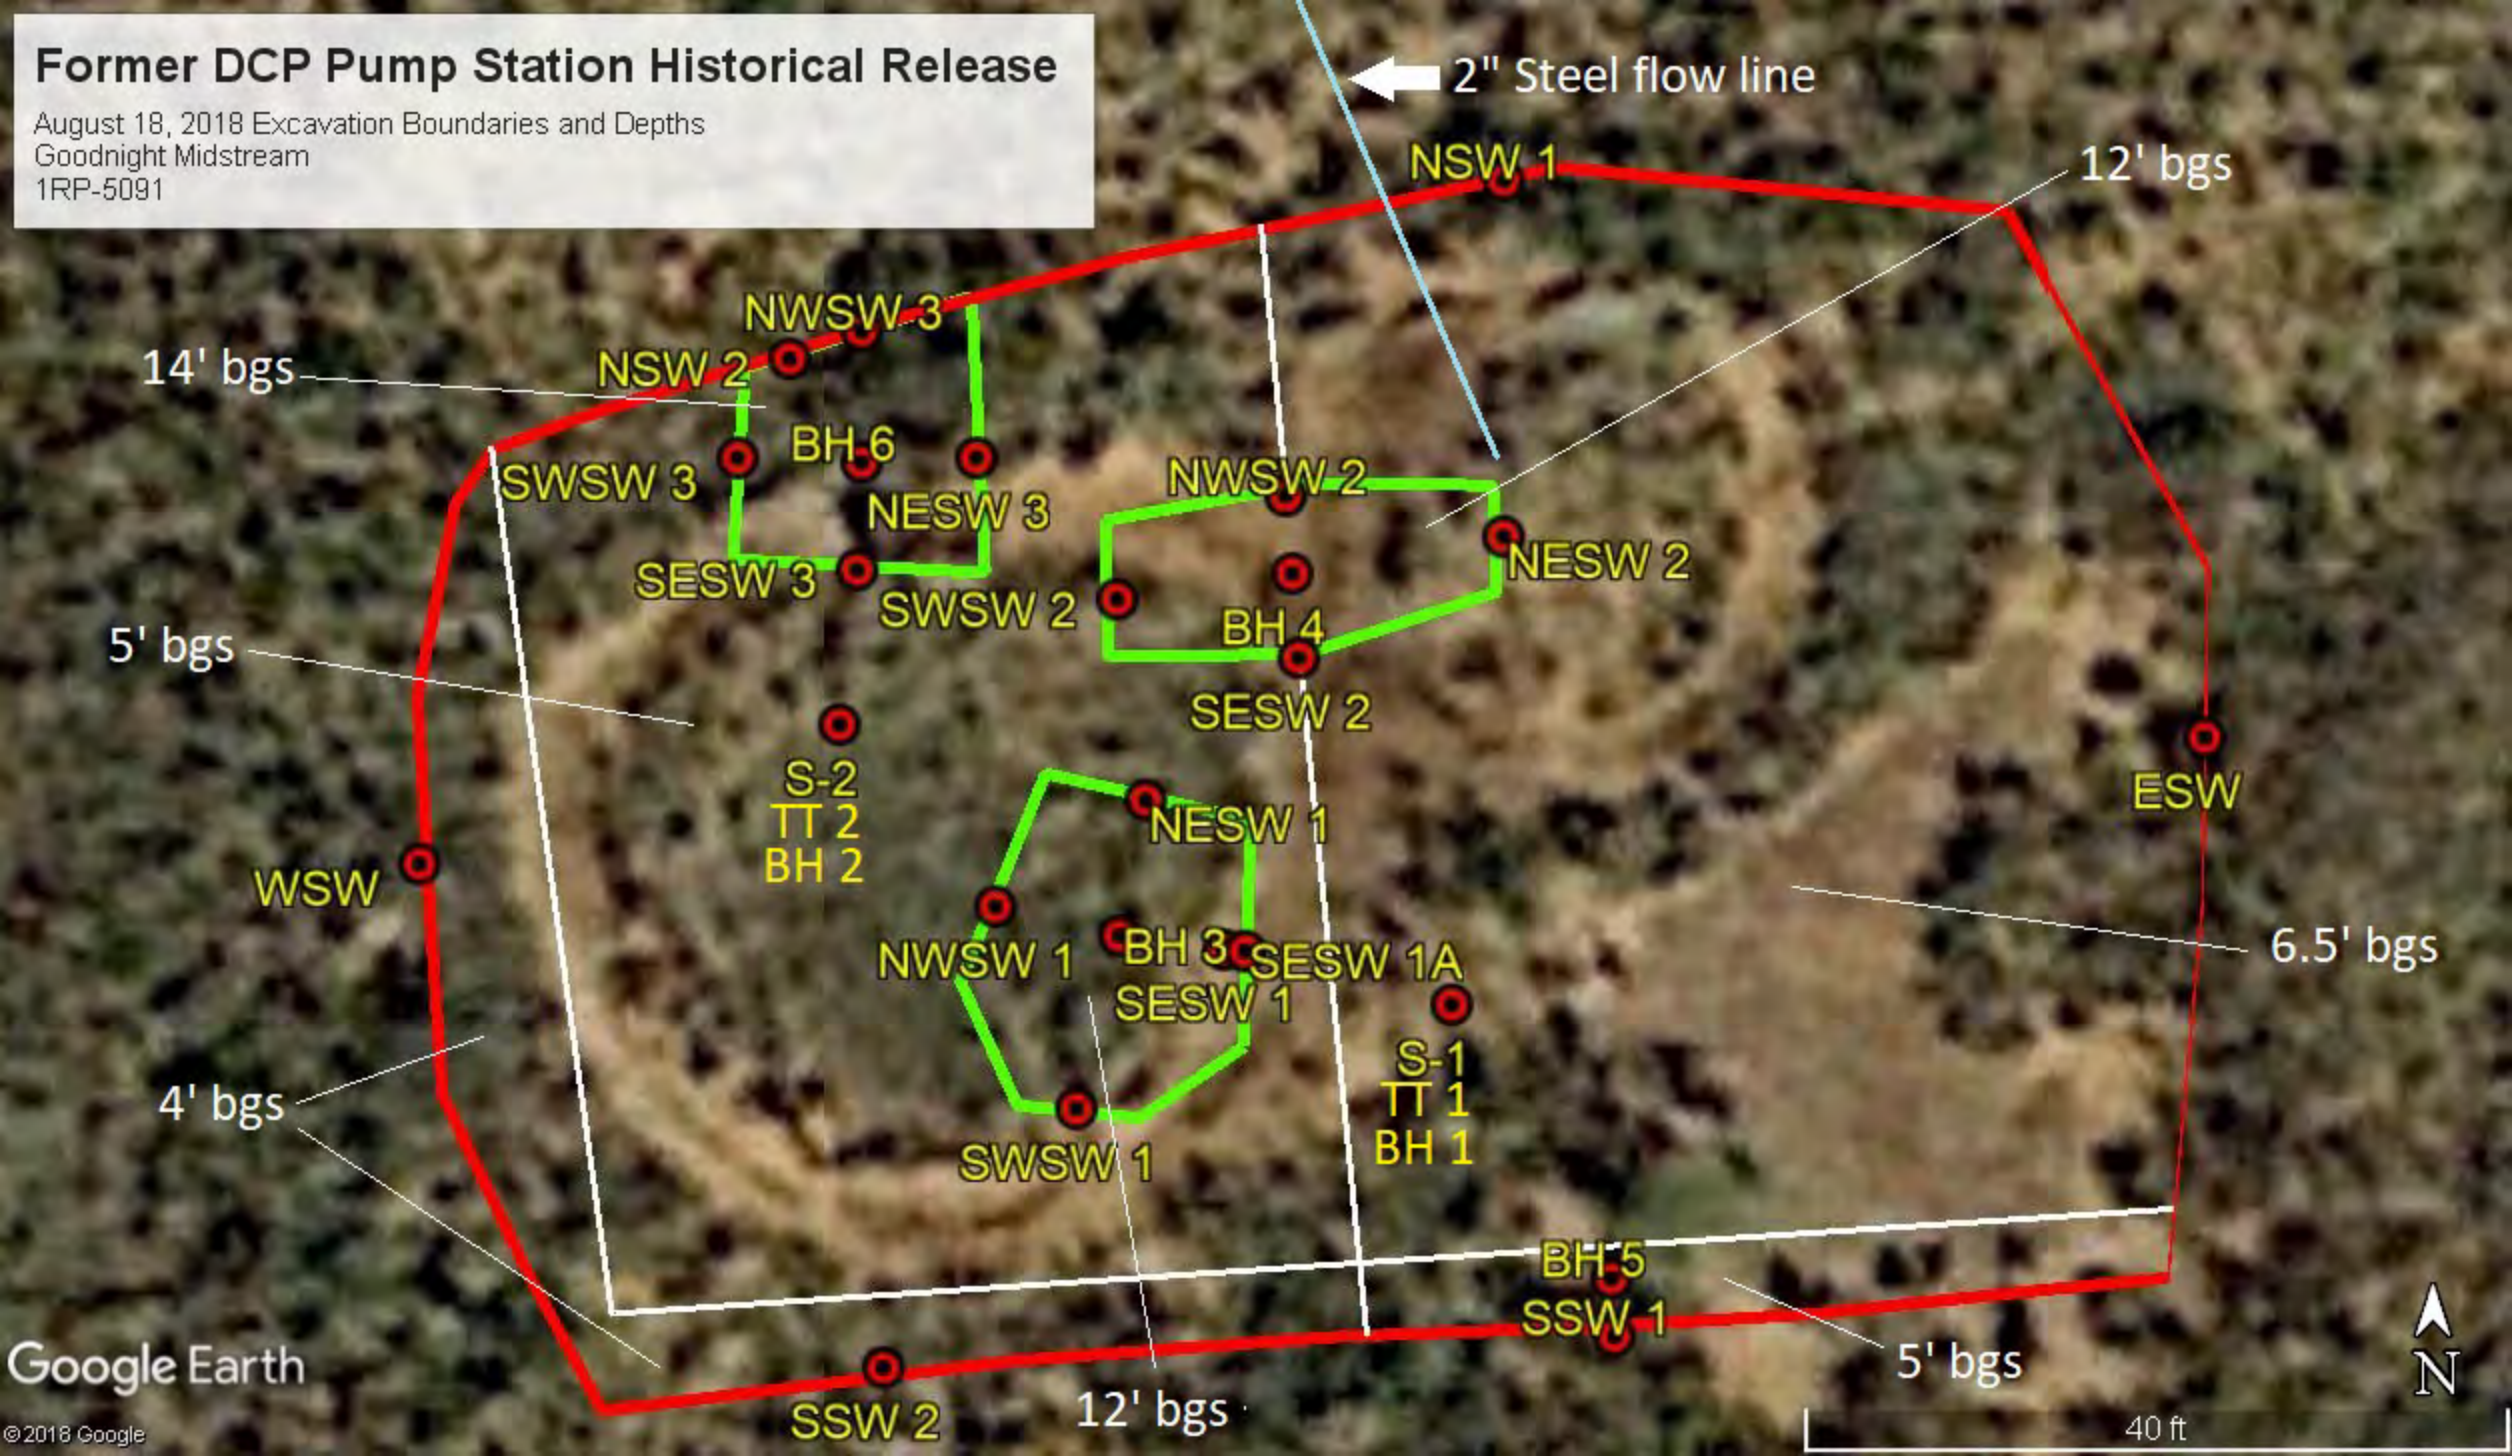
# Former DCP Pump Station Historical Release

August 18, 2018 Excavation Boundaries and Depths  
Goodnight Midstream  
1RP-5091

On August 20, 2018 through August 22, 2018, additional excavation was conducted at the site that changed the configuration and depths of the prior excavations. The additional excavation resulted in one larger excavation of varying depths. The most prominent change was observed at the north central excavation which was excavated to depths of twenty (20) feet and twenty-nine (29) feet bgs (See Attachment B – Annotated Aerial Imagery for configuration and depths of excavation).

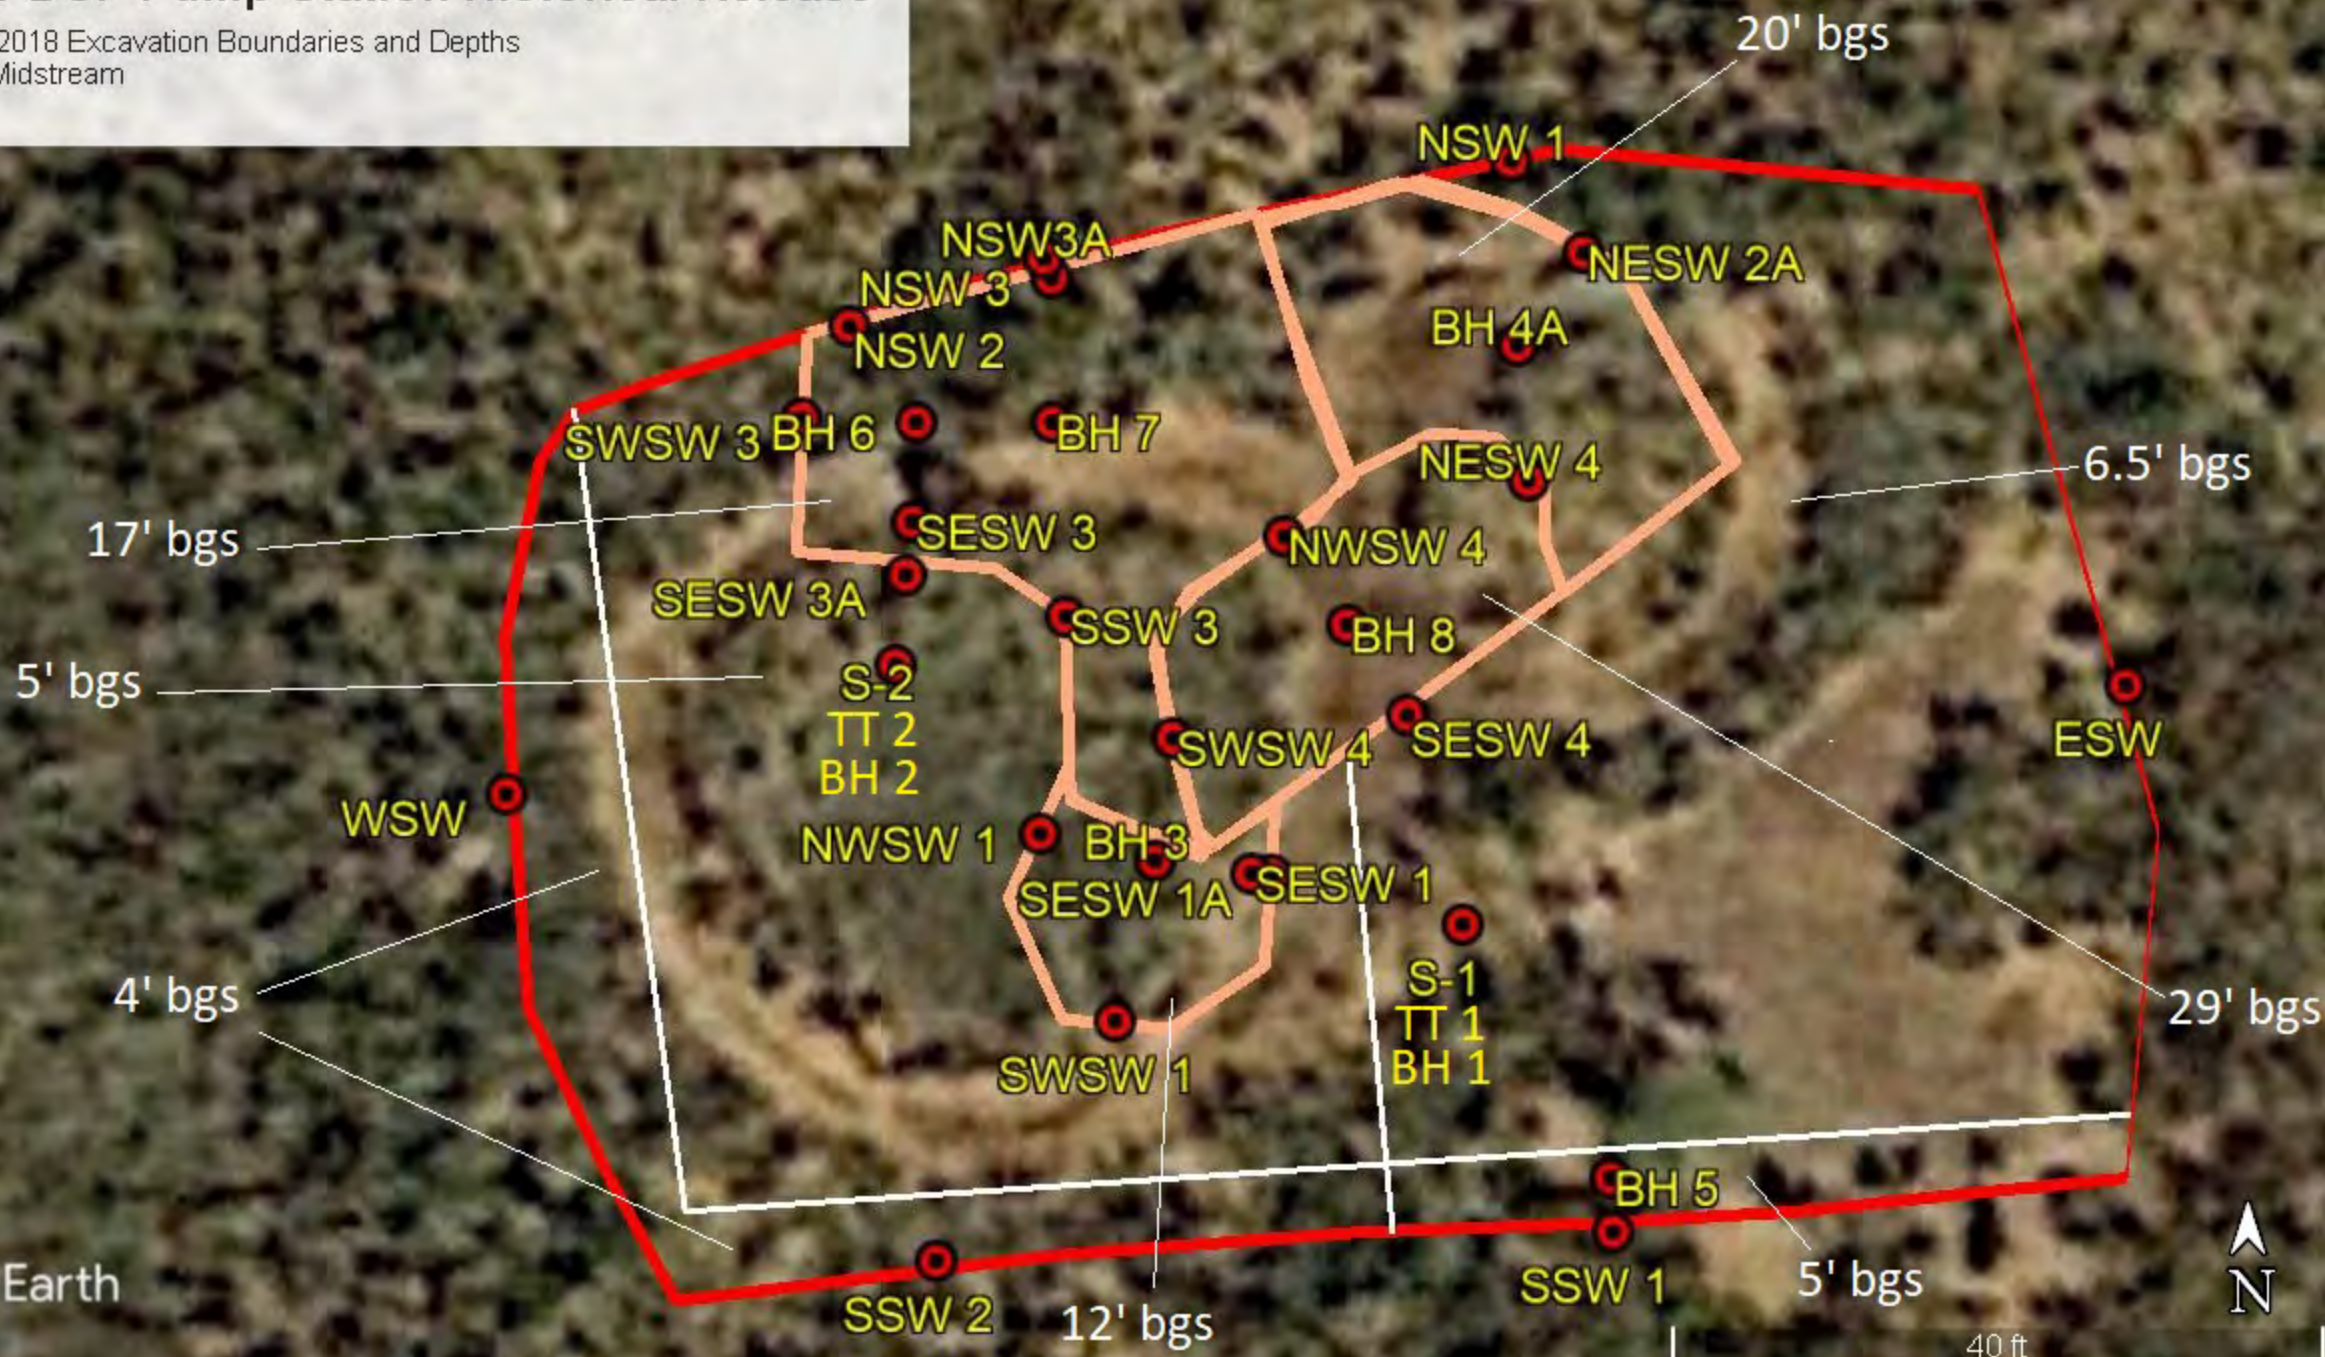
# Former DCP Pump Station Historical Release

August 24, 2018 Excavation Boundaries and Depths  
Goodnight Midstream  
1RP-5091

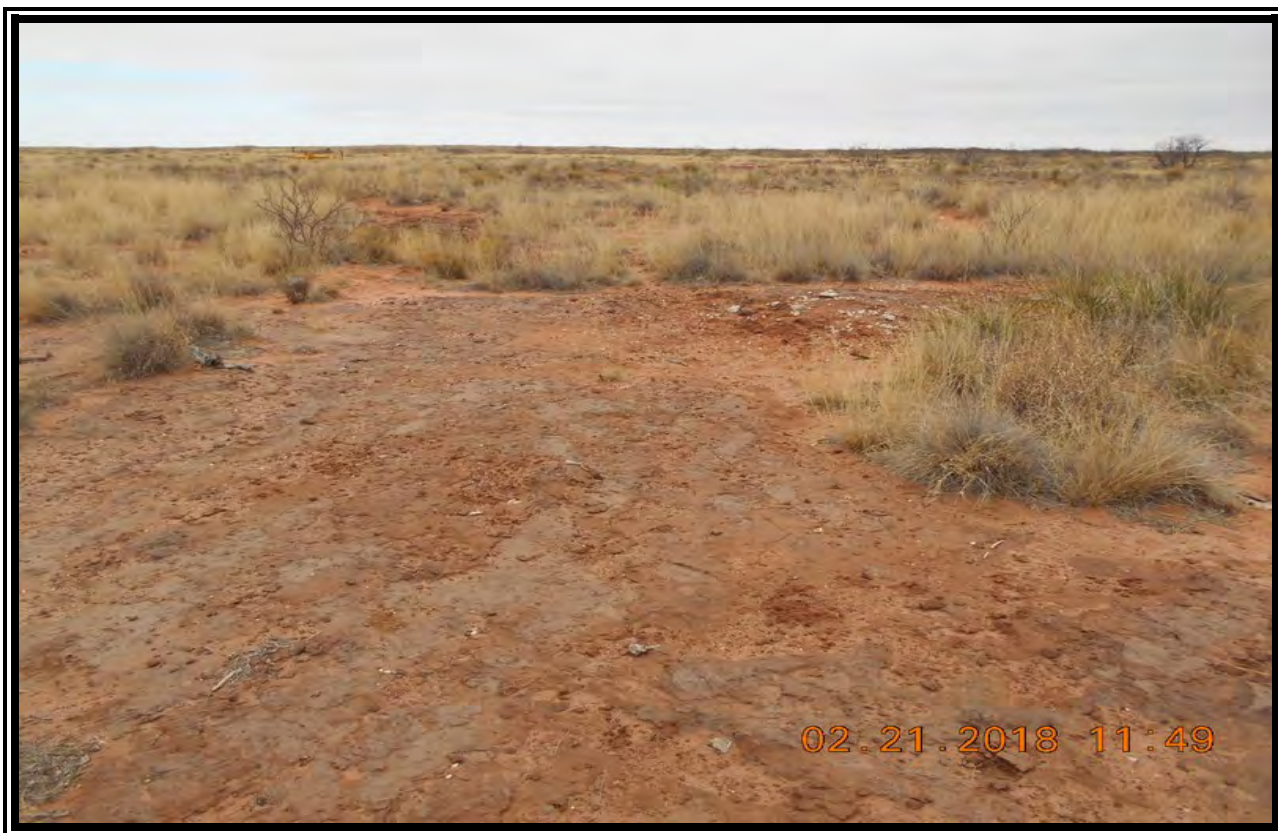
View of release looking northwest.

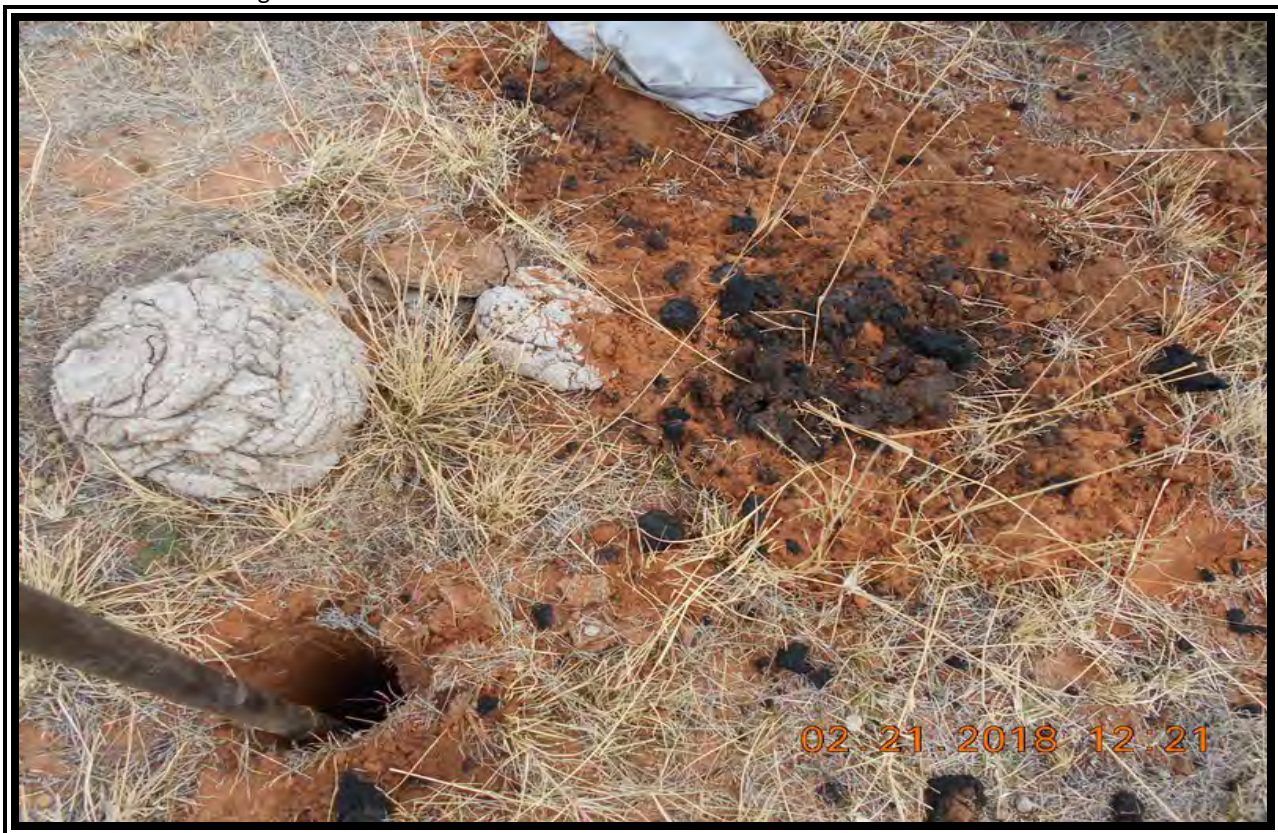
View of auger hole S-1.

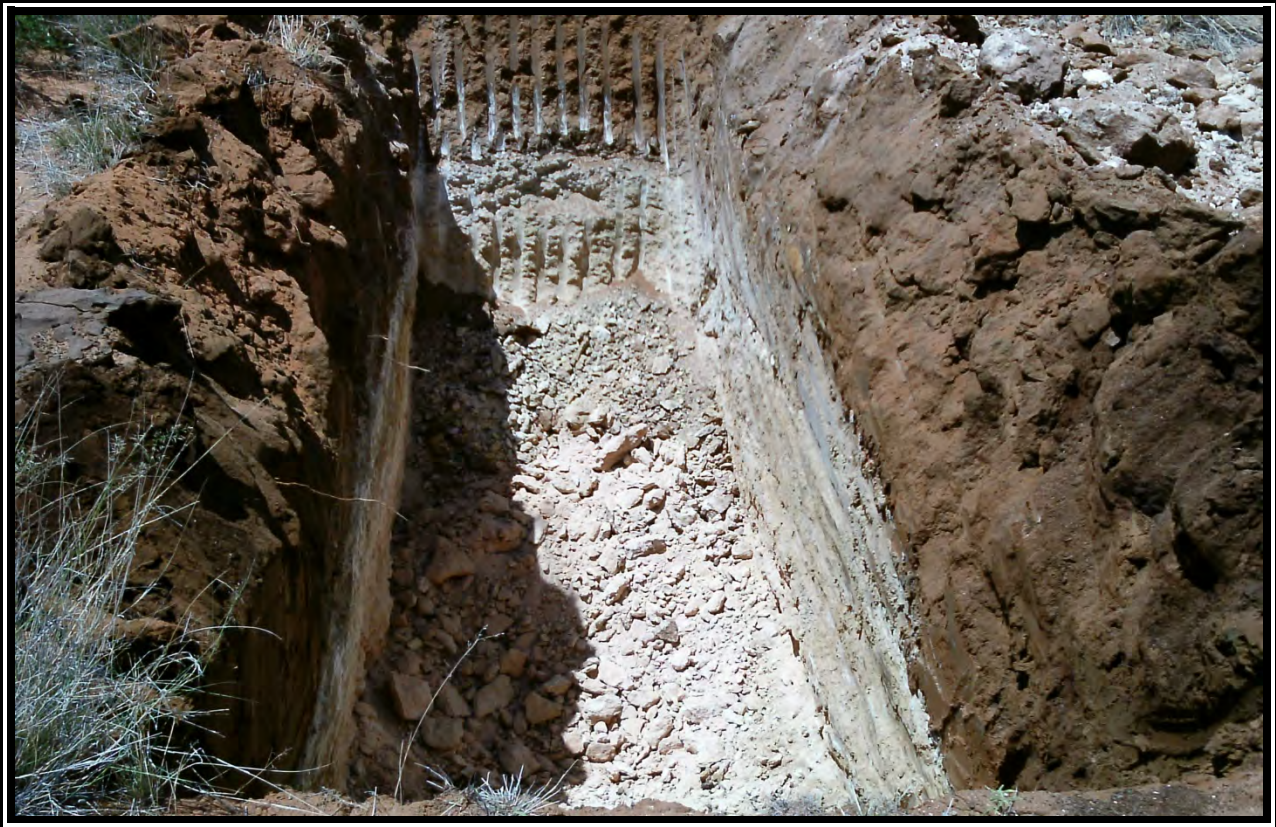
View of Test Trench 1 after excavation looking south.

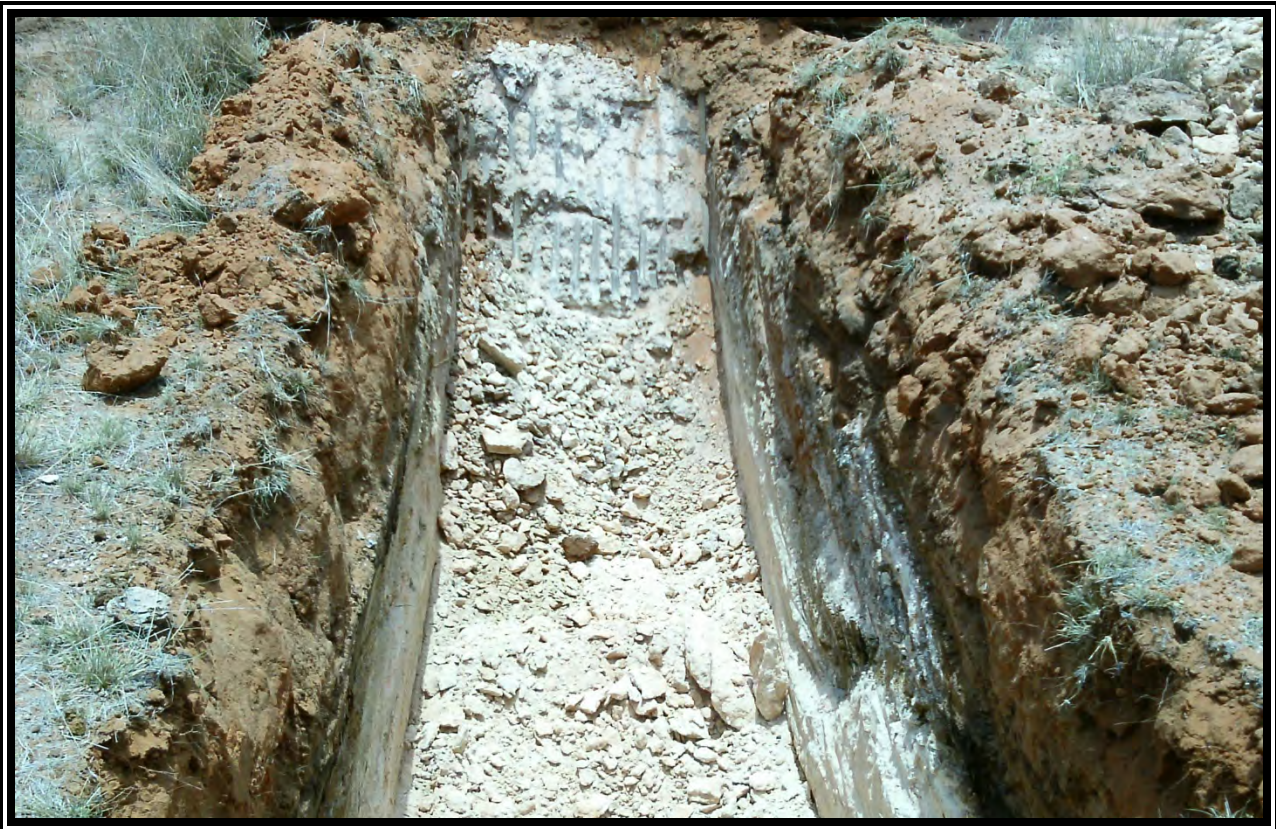
View of Test Trench 2 after excavation looking south.

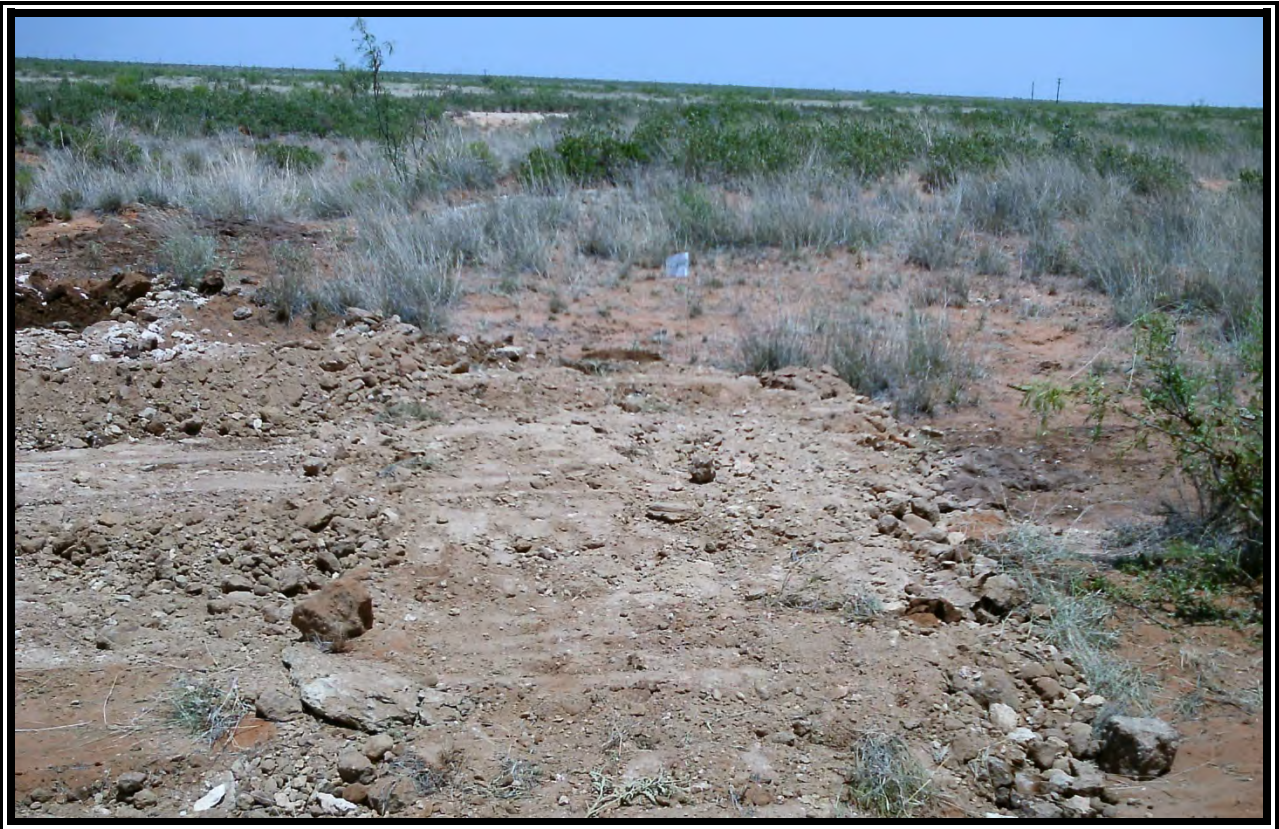
View of Test Trench 1 after backfilling looking west.

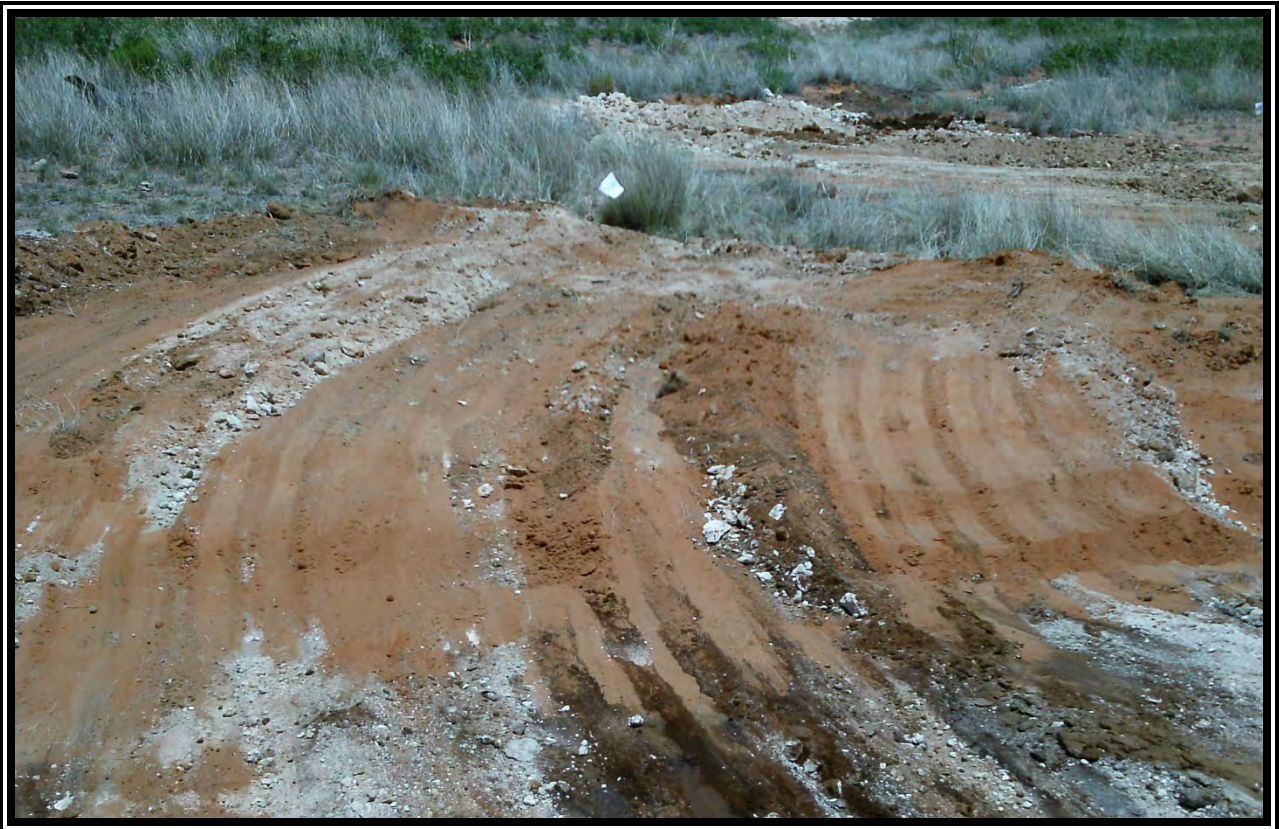
View of Test Trench 2 after backfilling looking west.

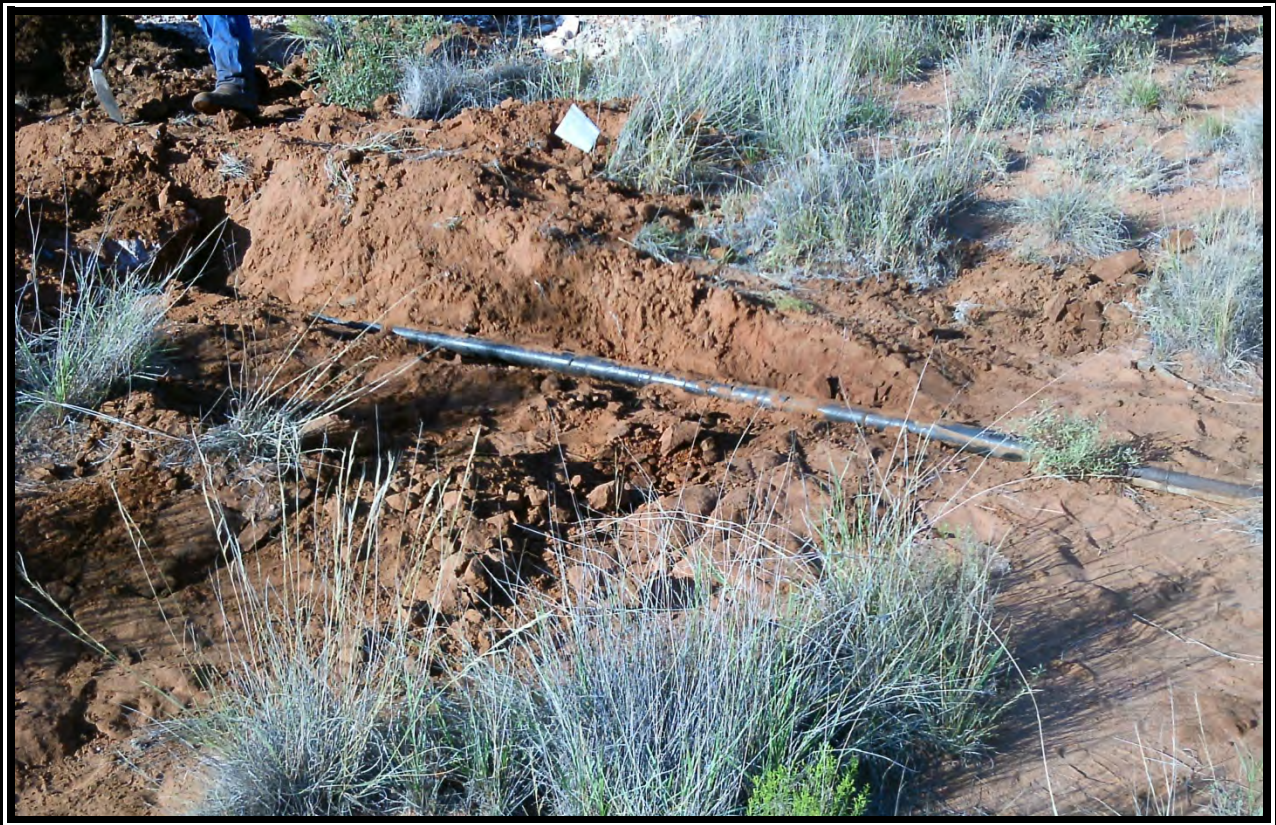
View of uncovering 2" steel flow line looking southwest.

Excavation began on the east side of the impacted area to an initial depth of six and half (6.5) feet bgs. The concrete support was removed from around the steel line and steel line was completely exposed and found to be uncapped. Discoloration and stain was found near the end of the steel line. The line was observed to be very slowly dripping water. The line was then traced back to the pump station pad to the north. The excavator was utilized to remove the steel line from the excavation to the pump station pad where it was placed on the concrete pad.

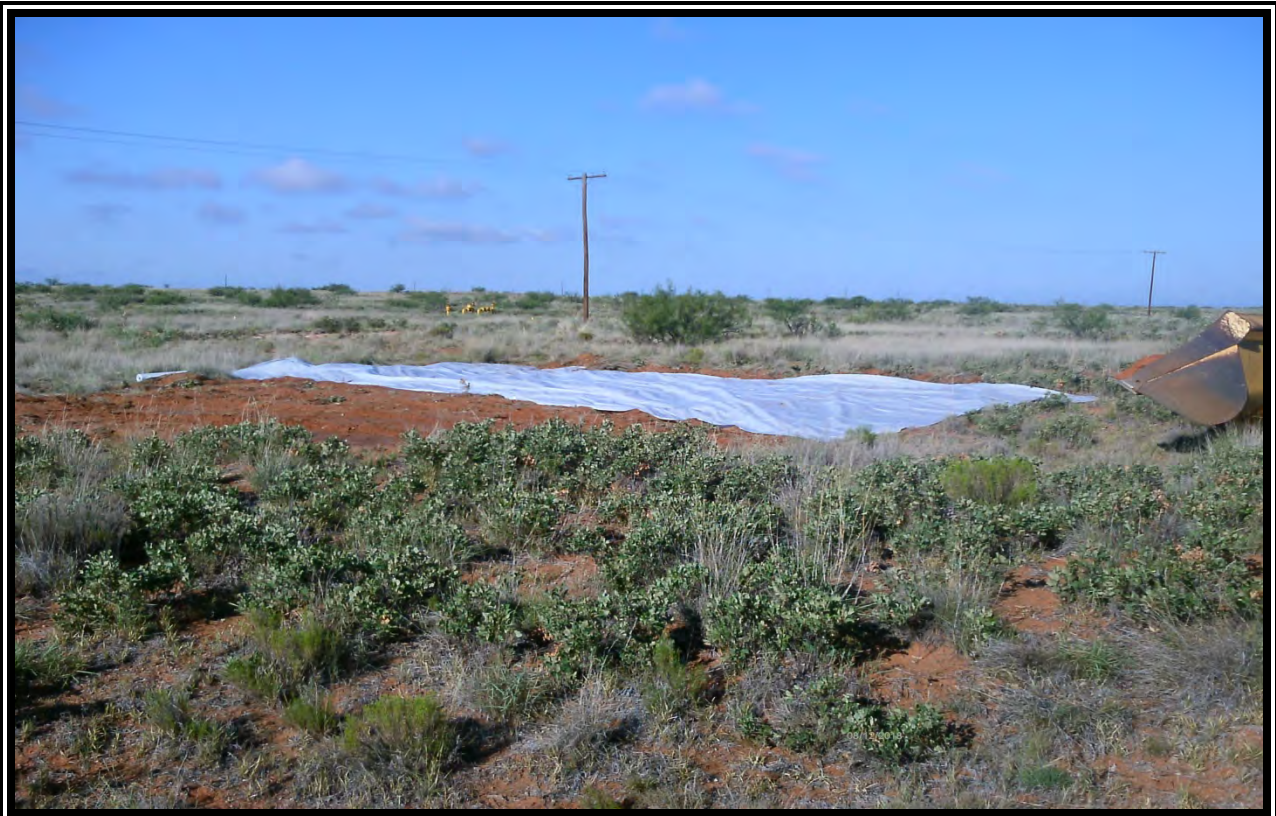
Laying down plastic looking southwest.

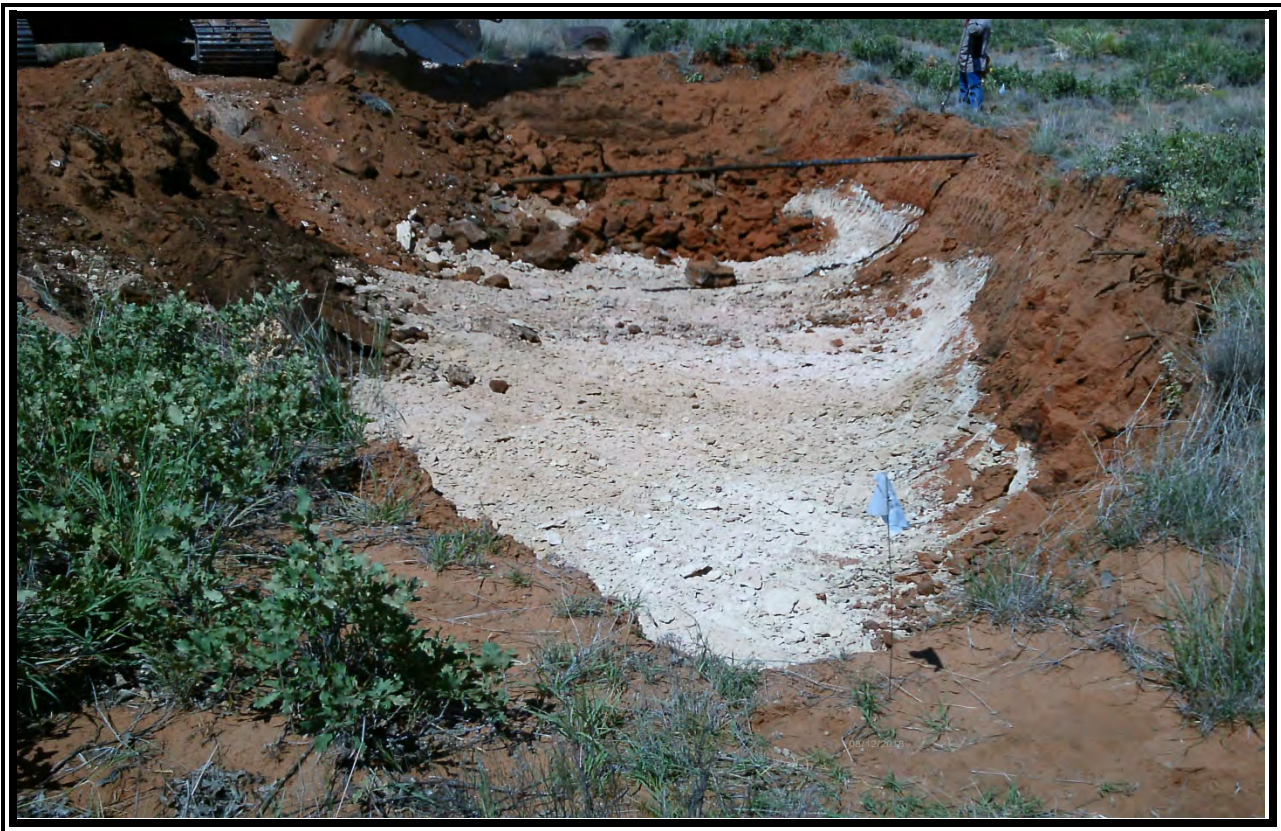
Excavation in northeast portion of site with 2" steel flow line extending into excavation looking northwest.

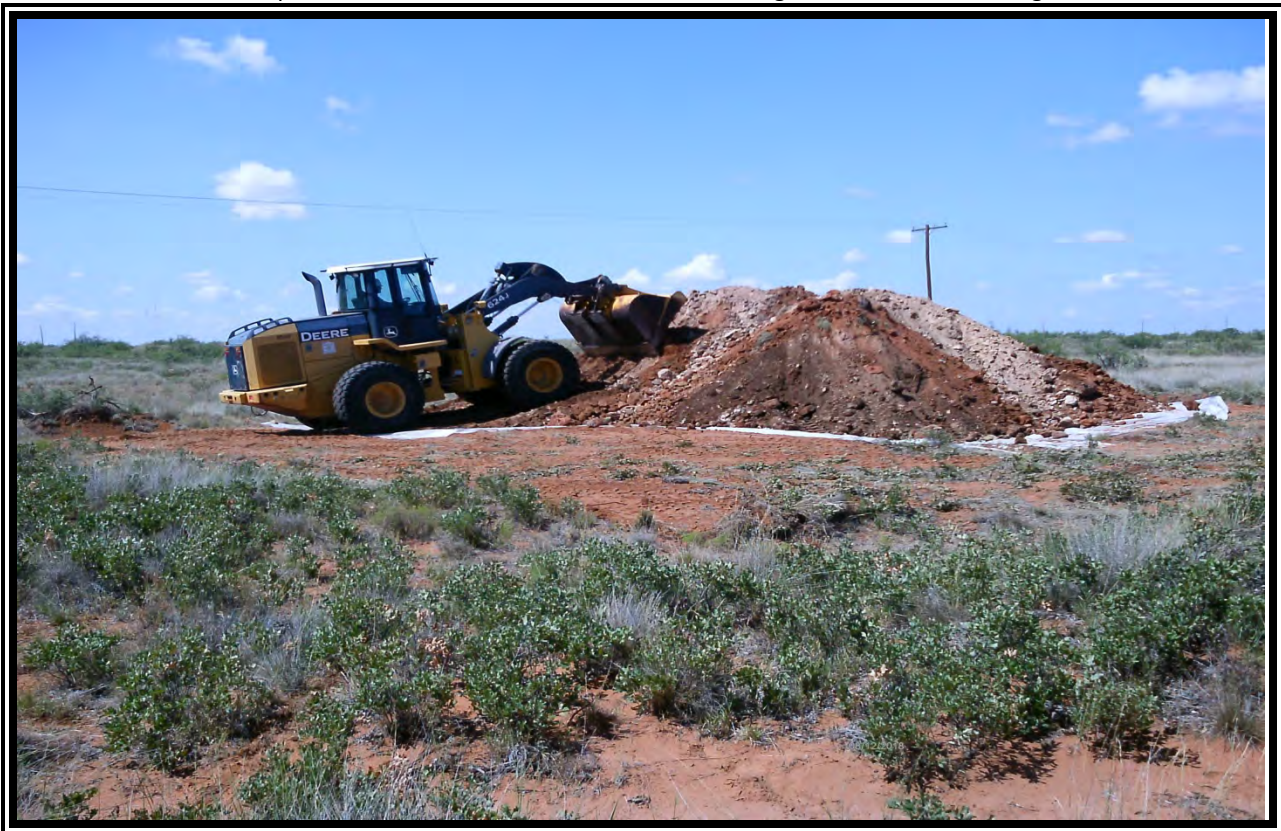
Placing excavated soils on plastic looking southwest.

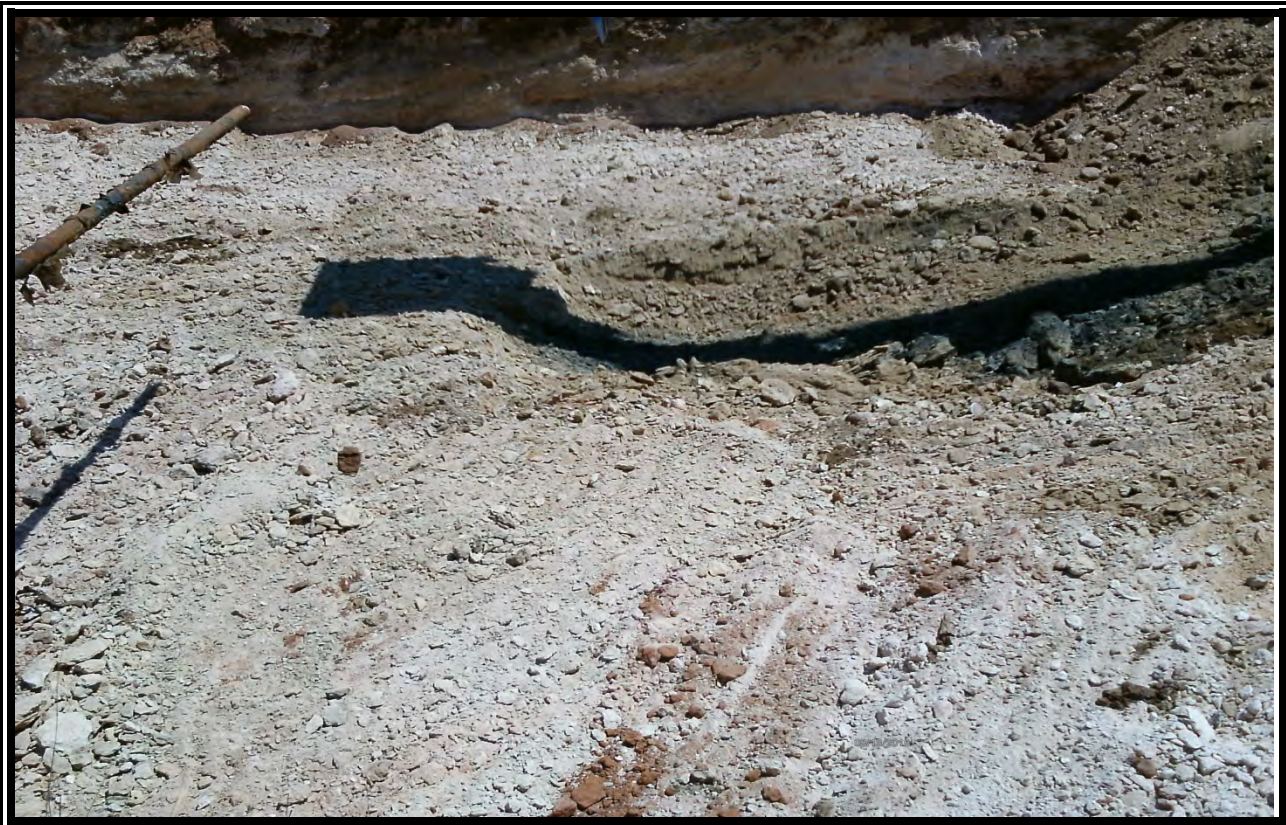
Discolored soils near end of 2" steel flow line looking south.

Excavation of the stained and discolored areas was conducted. The area in the south central portion of the site was excavated to a depth of twelve feet bgs. The area in the north central portion of the site near the end of the steel line was excavated to a depth of twelve feet bgs. The area in the northwest portion of the site was excavated to a depth of fourteen (14) feet bgs (See Attachment B – Annotated Aerial Imagery for configuration and depth of excavation).
